MINE CONFIGURATION AND ITS RELATIONSHIP TO SURFACE SUBSIDENCE¹

Jesse L. Craft and Thomas M. Crandall²

Proceedings America Society of Mining and Reclamation, 1988 pp 373-382

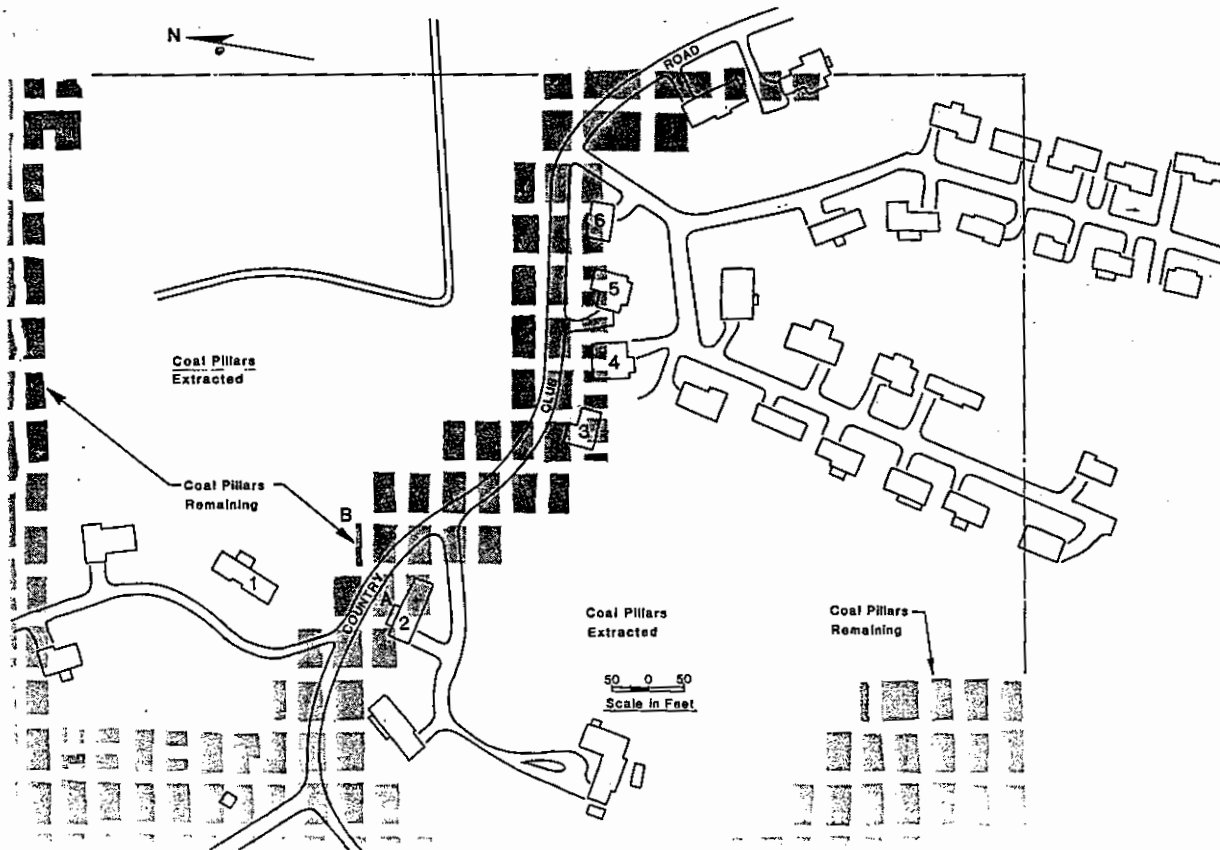
Figure 2.--Surface structures and mine map, Country Club Road Subsidence Project, Fairmont, WV.

The subsidence incident began when residents of the home marked "1" on the mine map (fig. 2) heard a loud "explosion" followed by shaking of their homes. Cracks developed in the interior walls of the structure and continued to enlarge over the next few months until completion of an OSMRE stabilization project. Cracks also began to develop in other houses along Country Club Road following the initial subsidence event. An OSMRE emergency drilling program found that the overburden thickness averaged 275 ft and the mine area was flooded. The pillars between houses "1" and "2", and the smaller pillars between houses "3" and "5" were crushed.

Based on the drilling evidence and the configuration of the pillars shown on the mine map, it appears the initial failure is attributable to a "bridged roof" between the offset of the pillars at point "A" and crushing of the thin pillar at point "B" (fig. 2). When the bridged roof failed, it caused failure of the pillars between house "1" and "2" and triggered adjustments of the overburden all along the pillar line. These adjustments resulted in additional pillar crushing, further consolidation or settlement in the already collapsed retreat area adjacent to the pillars, and, thus, considerable damage to the surface structures.

Remedial measures on this project were two-fold. A rock anchor system was installed at House "1" to stabilize the steep hillside (Mates et al. 1986). Cement grout was injected to fill mine voids and stabilize the existing pillars within the subsidence zone.

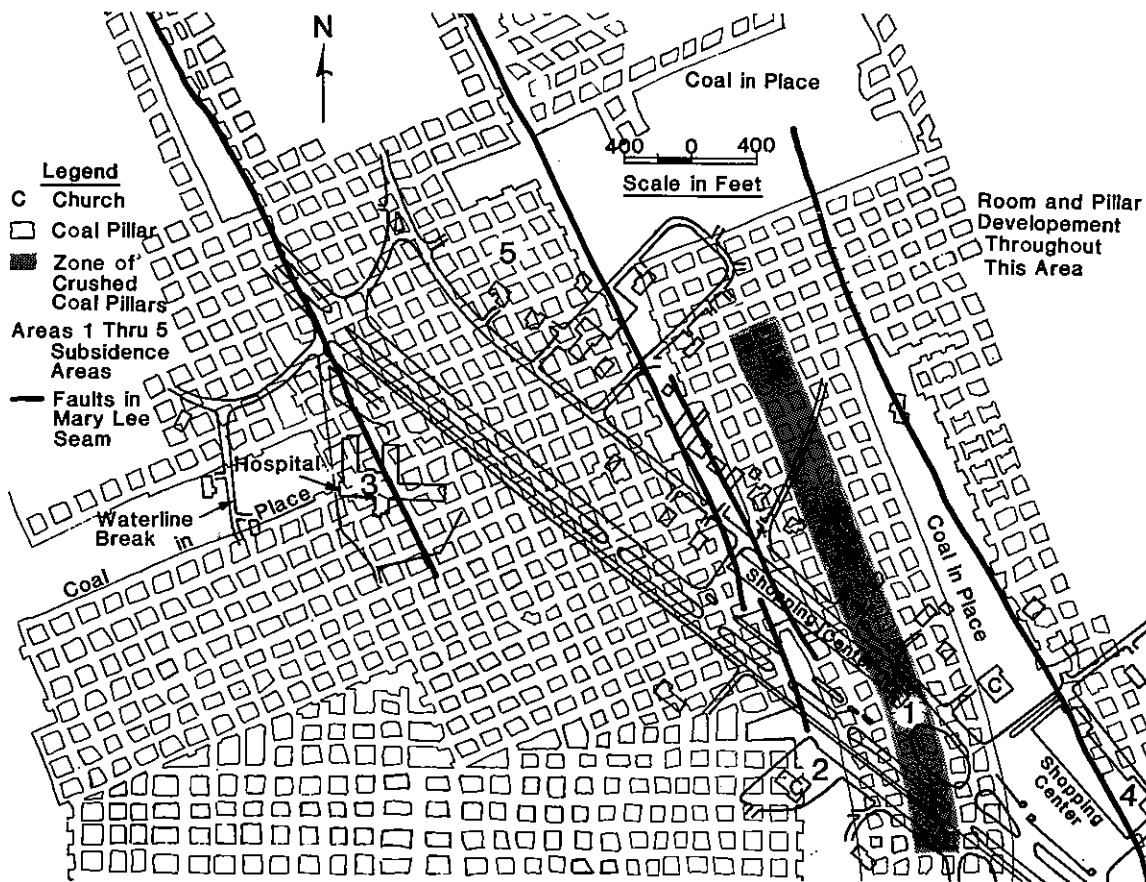
Figure 3.--Surface features and mine map of the Mary Lee Seam, Graysville Subsidence Project, Graysville, AL.

In mid-1980, the U.S. Bureau of Mines, under a cooperative agreement with OSMRE, conducted an in-depth investigation of the site and concluded that the affected area actually encompassed a total of 42 homes, 2 shopping centers, 2 service stations, 2 churches, and a hospital (fig. 3). The areas damaged by surface subsidence were some distance from each other, yet all were related to similar mining and geologic conditions (Morrison et al. 1987).

The Pratt (Blossburg B Mine) and Mary Lee (Flat Top Mine) Seams were mined at depths of 200 and 700 ft, respectively. Of the five distinct subsidence areas identified in figure 3, Areas 1 and 5 were of an emergency nature, and remedial stabilization measures were implemented (Morrison et al. 1987).

The geotechnical investigation focused on Area 1 (fig. 4). The Pratt Seam mine map shows no mining in the most disturbed part of the area. Examination of mine maps in the Mary Lee Seam revealed that mine development in Area 1 (fig. 3) was controlled by faulting, and that reported subsidence events were clustered along the coal left in place along and between the fault zones.

Pillar strength calculations (Morrison et al. 1987) indicated that the pillars within the fault block (table 2) have a safety factor of 1.2 and could carry the overburden load when the entire block of coal contained within the gravity fault block is involved in the support system. However, the calculation of the support within the panel yields a safety factor of 0.6 which indicates the pillars have marginal strength to carry the loads. Pillar strength estimates also indicated that panels on both sides of the faulted area have a safety factor of only 1.0. However, the area to the west of the fault block would be more prone to settlement/subsidence than the area to the east because of the narrower barrier rib and the interrupted panel design (fig. 3).

It was concluded that the barriers associated with the faults, and subjacent to the hospital, are acting much like a pair of fulcrum blocks, with a lever beam extending out over the large panels in both directions. The subsidence associated with Area 1 is the result of the development of a strain arch between the two fault barriers, as the overburden settled over the large panels. Subsidence occurred when horizontal friction at the center of the strain arch between the two fault barriers equaled zero, causing vertical loading and crushing of the center pillars.

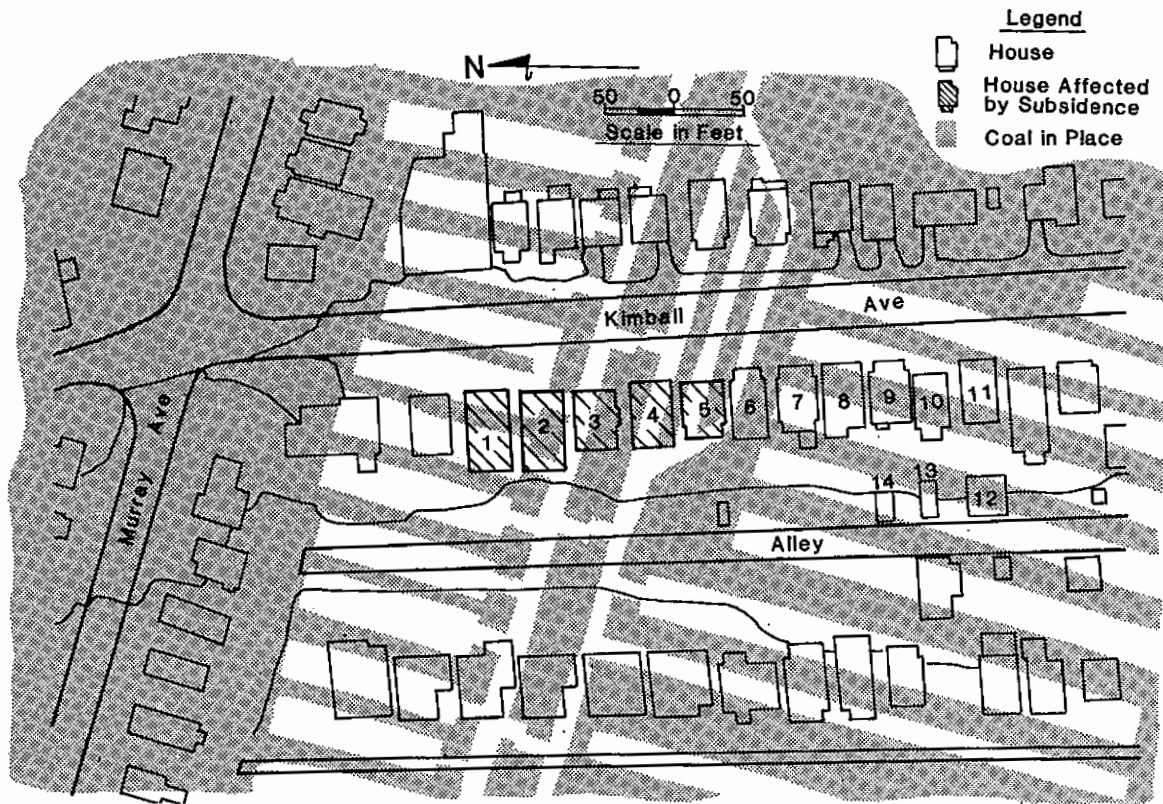
Figure 4.--Surface structures and mine map, Arnold-New Kensington Project, Arnold, PA.

Figure 4 is a mine map which also includes surface topography and location of homes. The map shows large coal pillars along a haulageway directly beneath the properties. Drilling authenticated the presence of the pillars and identified 6-ft open voids. Earlier drilling by the Pennsylvania Department of Environmental Resources encountered approximately 3 ft of light brown silt partially filling the void under the alley behind the center house (fig. 4, House 3). This material strongly resembled the Quaternary age Carmichaels Formation, a 90-ft-thick terrace

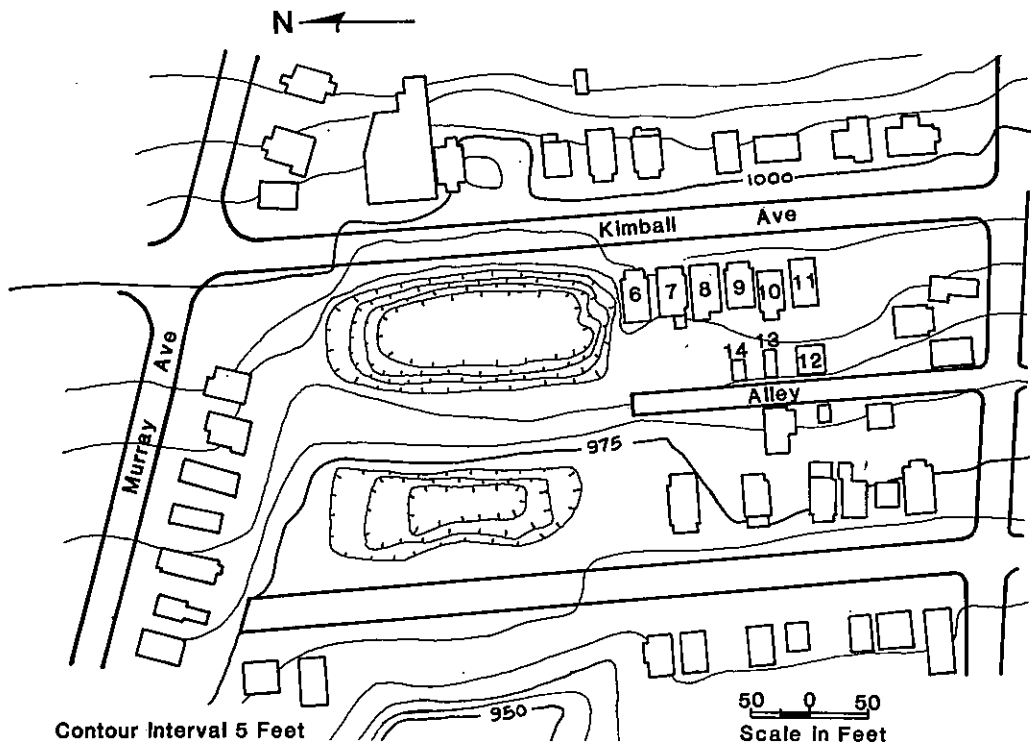
Figure 5.--Topography and urban development in 1952, Arnold-New Kensington Subsidence Project.

deposit in this area. Local citizens indicated that the subsidence area was an old sand pit that had been filled in with household trash and brush and covered over. A topographic map constructed from 1952 aerial photography showed the sand pits (fig. 5). Drilling also confirmed the character of the fill in these pits. There was some suggestion that the problem was related to this fill area. This fill, however, did not explain the magnitude of the subsidence occurring at the site. At this point in the investigation, there was no evidence of failure in the mine, yet a major depression was continuing to develop on the surface.

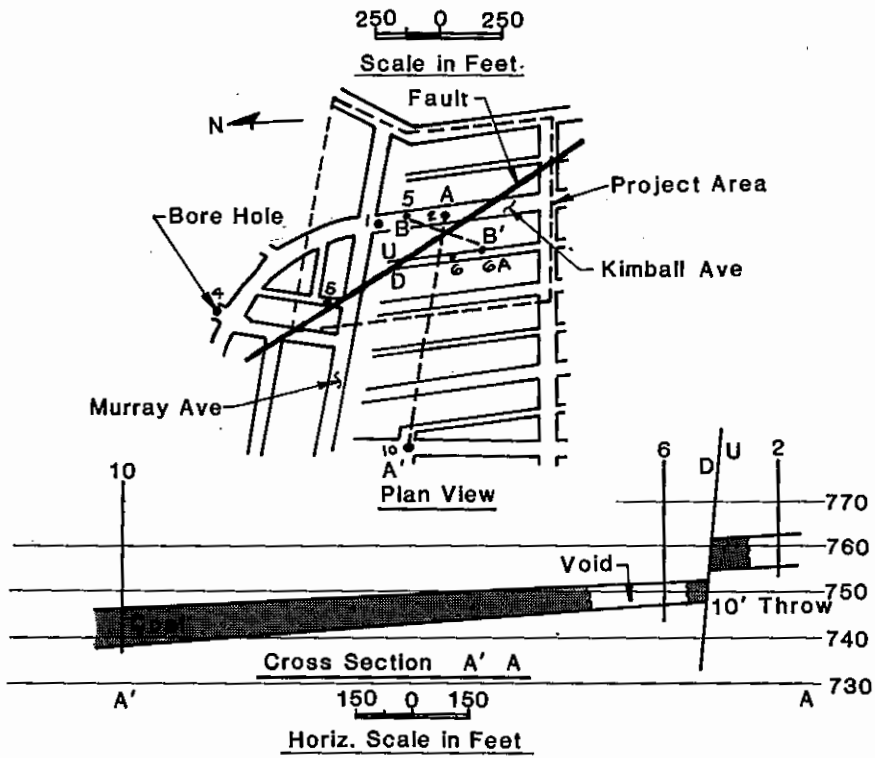
Figure 6.--Plan map and cross-section A-A, Arnold-New Kensington Subsidence Project.

OSMRE subsequently implemented a drilling program in and around the problem area. The drilling in the immediate vicinity of the subsidence area identified a normal fault situated directly below the houses (fig. 6) with a vertical throw of 10 ft. The drilling program also established that the coal seam was 260 ft below the surface, and the base of the Carmichaels Formation was 90 ft below the surface. Silts of the Carmichaels Formation were recovered in one core hole at a depth of 245 ft. Borros anchors were installed both in front of and behind the houses at various depths to attempt to identify the zone of movement within the terrace deposits. Inclinator casing was also installed in front of and behind the houses to measure movement in the fill and the underlying Carmichaels Formation.

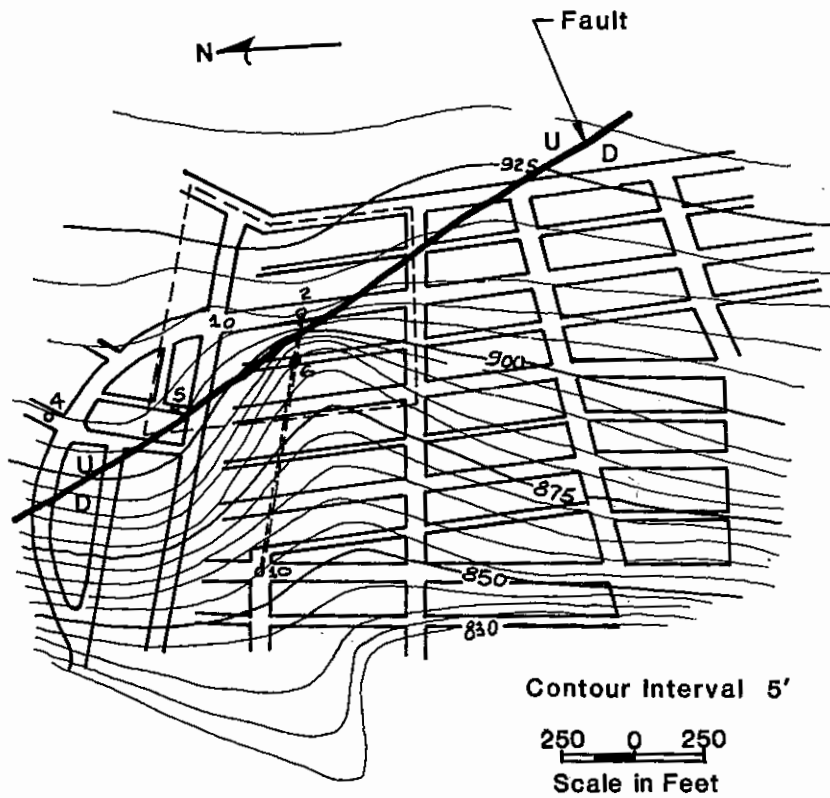
Figure 7.--Bedrock topography underlying the Carmichaels Formation as reconstructed from drilling records, Arnold-New Kensington Subsidence Project (note nick point developed at the fault line).

Information from Pennsylvania Department of Environmental Resources drilling was plotted on a map and the Carmichaels Formation/bedrock contact was contoured (fig. 7). Also plotted on this map is the trace of the near-vertical fault as defined by the OSMRE drilling program. This map

indicates a pre-Carmichaels stream valley located at the center point of the surface depression and a nick point (waterfall) on the fault line. The sum of information indicated the development of surface geomorphology was fault-controlled with a strong possibility of valley stress release jointing exposed at the pre-Carmichaels interface.
