# INVESTIGATION OF A SUBSIDENCE EVENT NEAR FLUSHING OHIO<sup>1</sup>

Charles M. Ledney and Joan L. Hawk<sup>2</sup>

**Abstract:** An investigation was undertaken to determine the cause and extent of events which caused problems to a number of residences along State Route 149 near Flushing, Belmont County, Ohio. The events began in 1988 and continued through 1991 and affected nine homes. The type of problems occurring, as well as surface effects, compared to available mine maps of the area, indicated the problems were caused by subsidence from coal mining. The mining occurred in the Pittsburgh seam at a depth of between 180 and 220 feet. The mining beneath the site took place between 1975 and 1977 and was of the room and pillar type. A subsurface investigation was performed, along with "down the hole" video camera inspections to provide necessary subsurface information for analysis of the subsidence event. Factors of safety were calculated for pillars throughout the mine. Based on this analysis, it was determined that pillar failure caused the subsidence event. Once a determination was made as to the likely cause of the subsidence, the data was re-examined to determine the possibl

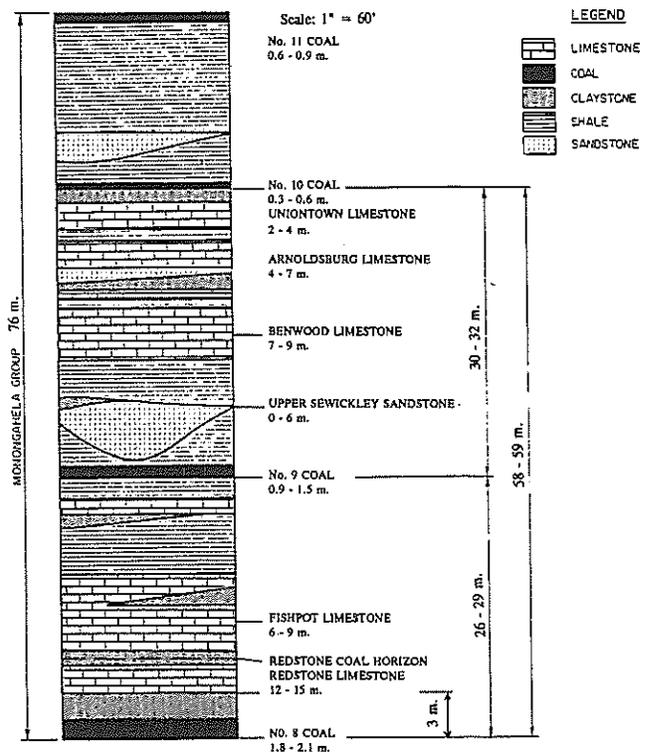
Figure 1. Generalized stratigraphic column of project area.

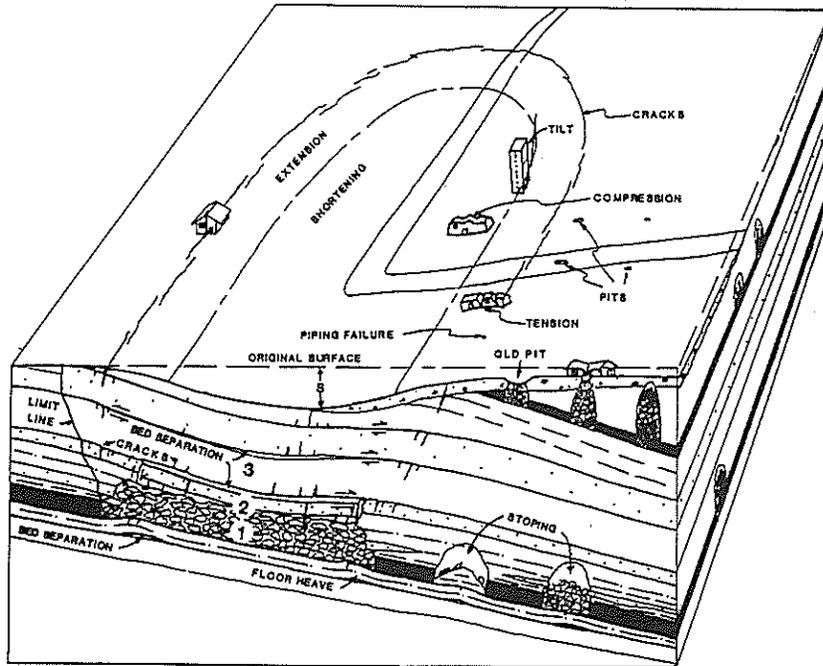
The rock core shows that the overburden of the No. 8 coal is fractured. High angled fractures are common. The fracture surfaces are rough to jagged, with some forming a "criss-cross" pattern while others consist of 2 high angle parallel fractures, generally less than 3 cm. apart. These irregular fractures are indicative of subsidence of the overburden and are most commonly found in the zone of caving and/or zone of breaking as shown in Figure 2.

the rock strata lying above the Upper Sewickley Sandstone, while high angle fractures predominate below the sandstone. The horizontal separation ranges from 2.5 cm. to 5.1 cm. in width. This separation is indicative of the zone of downwarping of strata as shown on Figure 2.

Figure 2. Conceptual diagram showing coal mine subsidence processes and deformation above extraction areas and mine openings. In downwarped zone: 1) zone of caving, rotation of caved fragments, and permanent bulking; 2) zone of breaking with little rotation of caved fragments, much cracking and bed separation, some permanent bulking; 3) zone of downwarping of strata as laterally constrained plates with local separation along planes of stratification, little or no permanent bulking. (AEG, 1987)

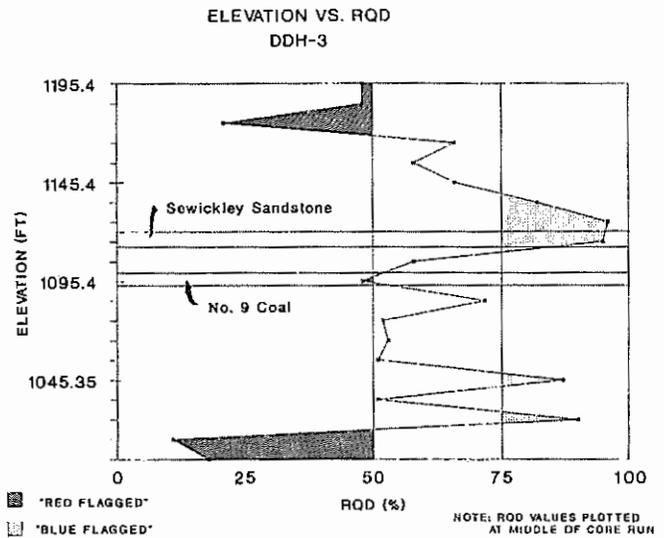
Figure 4. Example of graph depicting RQD values obtained from drill core versus elevation.

To further investigate the location of the initial event, plots of RQD vs. elevation for DDH-1 through DDH-10 were examined. The RQD values are indicative of fracturing in the strata, with low RQD values being representative of areas with the greatest fracturing. A "flagging" technique was used on the individual RQD vs. elevation plots. The flagging technique involved drawing vertical lines at 50% and 75% RQD on the individual plots. Areas less than 50% on the plots were "red flagged" and areas above 75% were "blue flagged" (see Figure 4). The 50% value was chosen as it represents the cut-off below which rock is considered poor. The 75% was chosen as it represents values above which rock is considered good. All pre-mining factors being equal at the site, the RQD values at the site should be fairly consistent and furthermore, below the zone of weathering, the rock quality should generally be good at this site. The latter is true due to the generally competent lithologies present and general lack of premining structural deformation in the units above the mine (both of which could affect the RQD).

RQD values in the uppermost portions were low, representing the weathered zone; most borings demonstrated higher values in the Sewickley Sandstone and markedly lower values in the No. 9 coal. The trends in RQD below the No. 9 coal then began to vary until most borings disclosed a dramatic drop above and continuing to the No. 8 coal horizon.

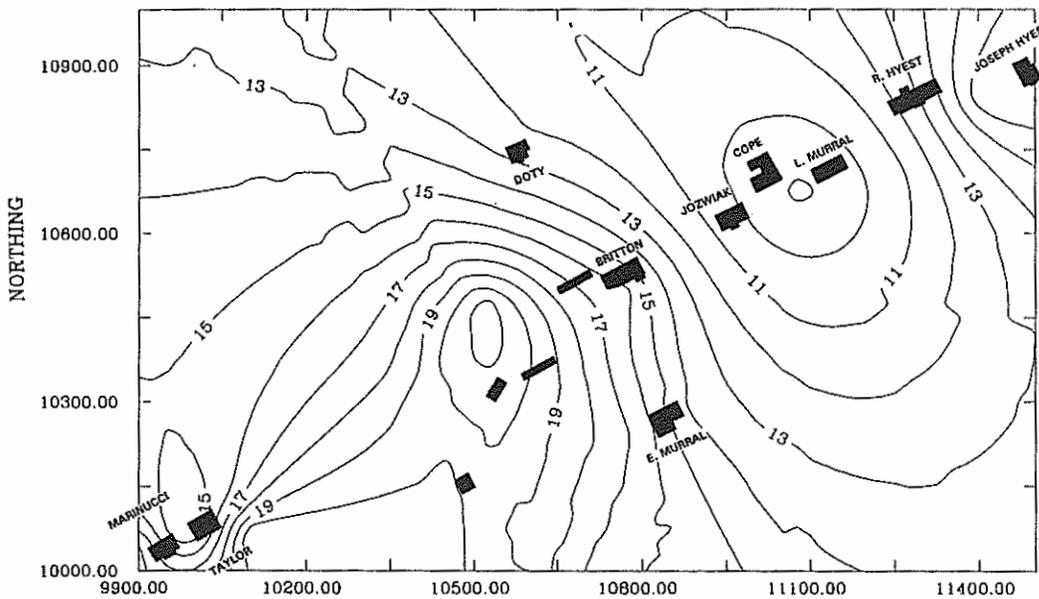
Figure 3. Map showing ratio of mine overburden thickness to Sewickley Sandstone thickness.

The trends of the two maps suggested that a relationship exists between this sandstone thickness, the overburden and the surface expression of the subsidence. In order to determine this relationship, the two maps were combined into a second order map called the Overburden/Sewickley Thickness Ratio Map (see Figure 3). To combine the two maps, we again used the Surfer computer program. In this procedure, a matrix operation was performed in which the grid values from the overburden grid were divided by the grid values from the sandstone thickness grid. The resulting grid was then contoured. Contour lines on this map represent lines of equal overburden/sandstone thickness ratios. The areas with the larger values represent areas where the sandstone is the thinnest, and overburden is the greatest. Areas with the lower values represent areas where the sandstone is thicker and overburden is less. The mapping shows that the area slightly west of the Britton residence has a ratio of 21:1; that is 21 m. of overburden for every meter of sandstone.

This indicates that while the overburden stress on the pillars is greater in this region, the competent sandstone unit is thinner and less able to provide ground support. The area with the largest ratios (18 to 21) corresponds with the area in which we believe the initial subsidence event occurred.
