INVESTIGATION OF ALLEGED SUBSIDENCE DAMAGE TO A RESIDENTIAL STRUCTURE IN INDIANA¹

Abstract. An investigation was undertaken by the Indiana Division of Reclamation (DOR) on behalf of the Indiana Department of Insurance (DOI) to determine if mine subsidence due to old underground works was resulting in structural damage to a residential structure in Alfordsville, Indiana. The owner had alleged that subsidence was causing damage to the structure and had filed a claim under the Indiana Mine Subsidence Insurance Fund. Previous reports that addressed the damage to the owner's house and their possible causes are summarized. Core drilling, gamma logs, borehole TV camera observations, and elevation surveys indicated no evidence of mine workings in the two coal seams present below the owner's house. The rock cores showed no signs of disturbance that would be expected if a mine collapse had occurred at shallow depth and progressed to the surface. The gamma logs were in agreement with core descriptions. Elevation measurements of points on the house indicated a continuing differential settlement of the house; surface elevation measurements in the vicinity of the house did not exhibit such a co

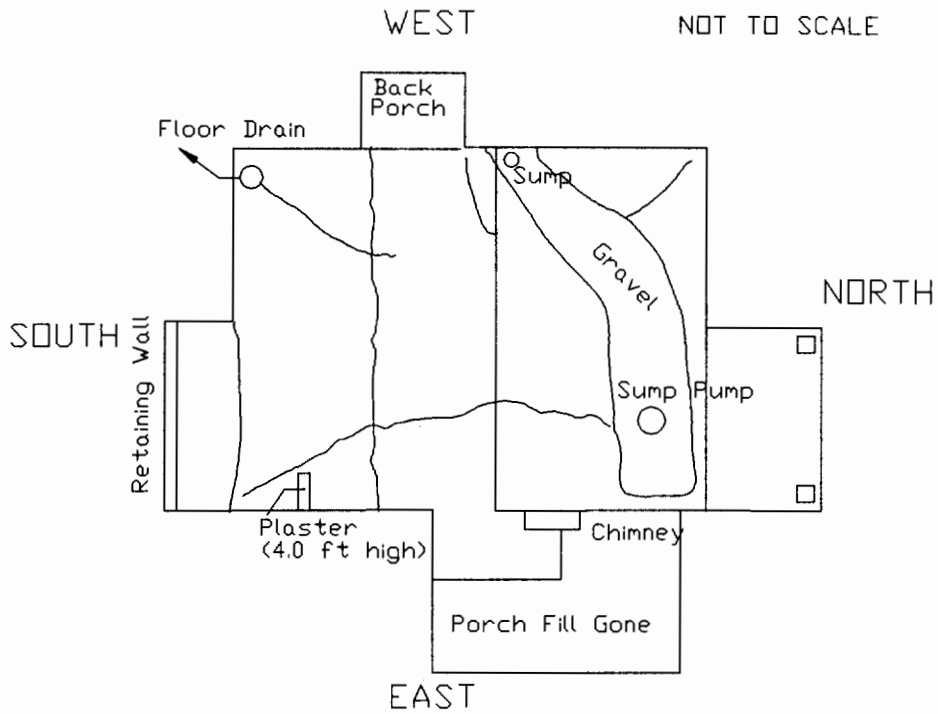
Figure 1. Basement floor plan of the house showing mapped cracks in relation to other relevant structural features.

reports. BH #4 was also inclined and drilled towards the house to intercept the coal seam below the house foundation. The coal seam below the foundation on the south side of the house was intercepted by BH #5; this area is also where a concrete wall has been poured in the basement (Figure 1). The lithologic description of BH #2, #3, #4, and #5 are more or less identical except for variations due to changes in surface topography.

(5) The clay content of the unconsolidated material in all holes increased with depth and was particularly high from 7 to 15 ft. The moisture content within this range also appears to be close to its plastic limit. Therefore, heavy loading conditions such as those created by the two concrete blocks cast in the basement (Figure 1), could easily mobilize the shear strength at these horizons and cause considerable settlement.

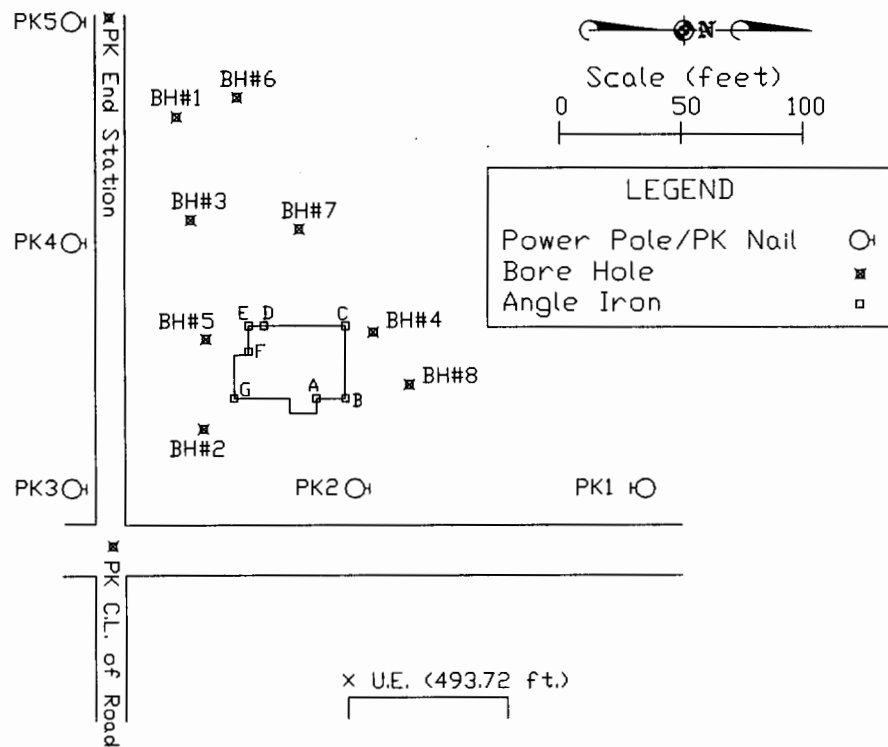
Figure 2. Location of borehole and survey monitoring points with respect to the house.

(2) The south side of the house (Figure 2, points E, F, and G) has shown a consistent downward movement trend while the north side has shown a consistent upward trend. The magnitudes of movement are thus opposite (downward movement of one part of the house resulting in uplift of other parts) although not equal and can be seen in Table 1.

Most points on the house showed almost no change in elevation except for those on the south side (Figure 2, points E, F, and G). The southeast corner

of the house (point G) shows the maximum downward movement which decreases rapidly with increasing distance from the house (Figure 2, points F, E, and A).

The movement of points A through F on the house appears to be a reaction to the larger downward movement of the southeast corner point G. The existing damage in the house and the soft clayey strata in the unconsolidated overburden tend to camouflage such effects.

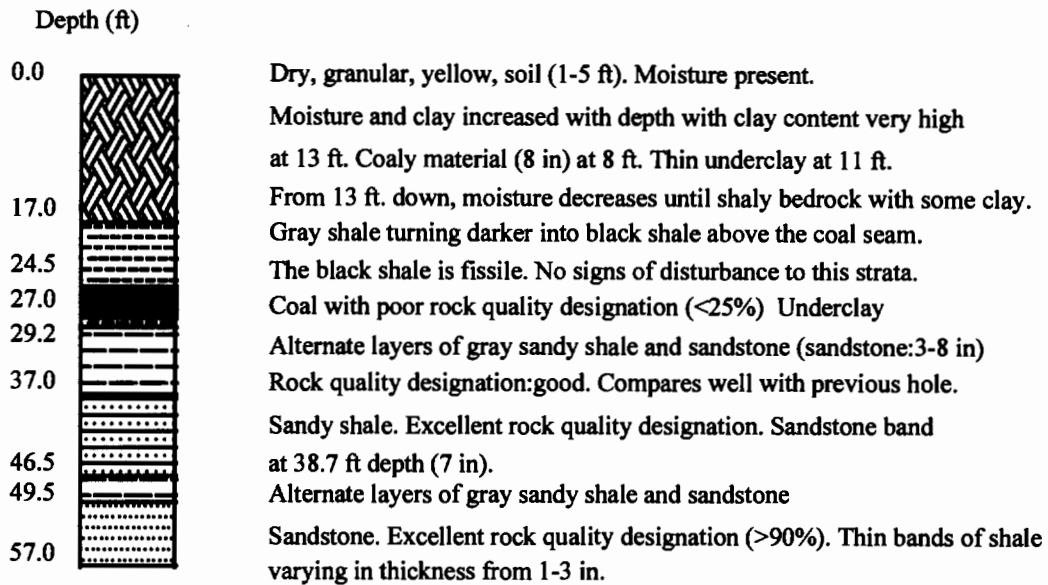
A lithologic log for BH #2 is shown in Figure 3; this is typical of the area around the house. Brownish yellow and granular top soil was observed up to a depth of 9 ft. Moisture and clay content increased with depth to 13 ft. Some underclay and siderite was observed between 11 to 13 ft. The moisture content in the clayey unconsolidated material was estimated to be at or above its plastic limit which indicates a flowing tendency of the soil. Bedrock was encountered from 17 to 24 ft and consisted of gray shale sometimes banded with sandstone. A 3-ft coal seam (referred to as the coal seam) was encountered at 24 ft. It was underlain by about 1.25 ft of underclay. Alternate layers of sandy shale and sandstone were observed below the underclay to a depth of 48 ft, which was underlain by a competent sandstone strata to a depth of 57 ft where drilling was terminated.

Figure 3. Typical lithologic description of soil and rock overburden strata around the house.
