SALT MINE SUBSIDENCE AND ASSOCIATED DAMAGE: A CASE HISTORY¹

Gennaro G. Marino, Ph.D., P.E.²

Abstract. Based on case data a subsidence and the associated damage is reported. The subsidence occurred over a room and pillar salt mine in the U.S. The mine was approximately 305 m (1,000 feet) deep, and sustained a massive collapse resulting in approximately 2.7 m (8.8 ft) of surface settlement. Because of the size of the subsidence it resulted in damage to about 20 surface structures and significantly modified drainage on the ground surface. This paper presents the results of an engineering investigation performed on this subsidence event.

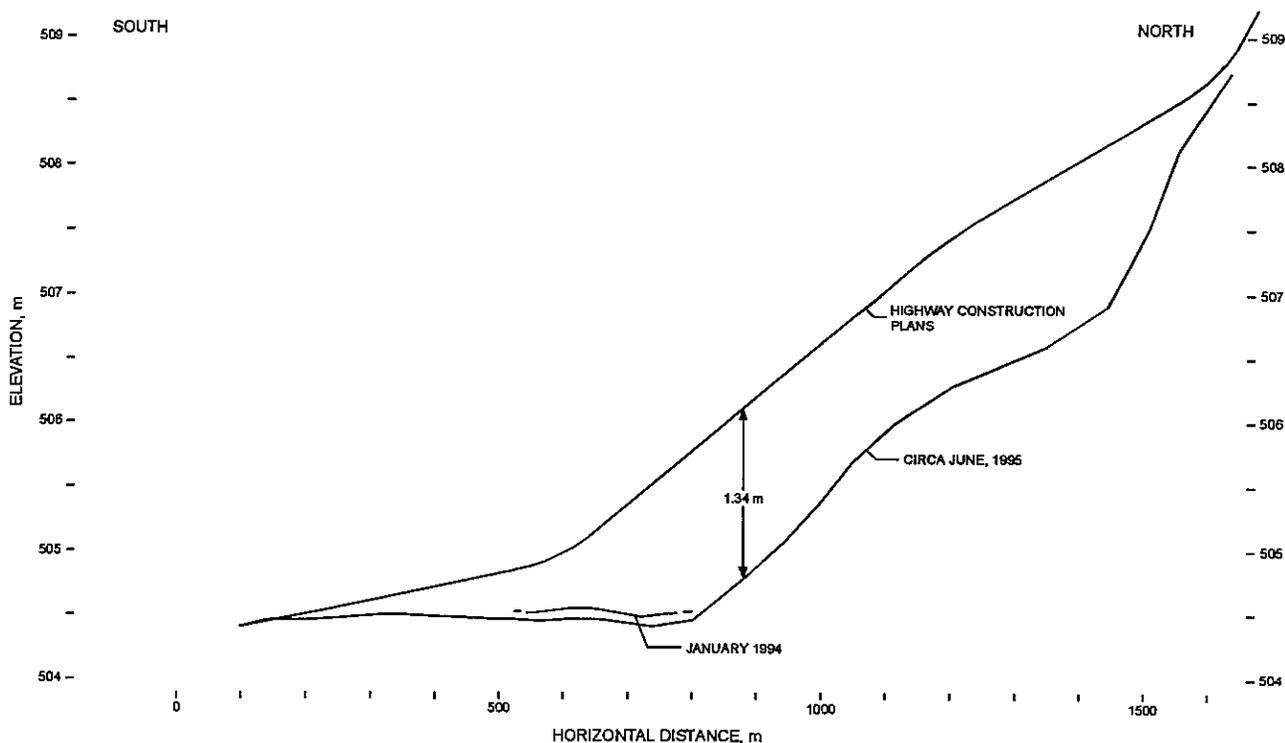
FIGURE 2 PRE-SUBSIDENCE ELEVATIONS AND POST-SUBSIDENCE ELEVATIONS (1994 AND 1995) ALONG HIGHWAY

Subsidence measurements along the northern part of the highway appear to indicate that the subsidence is propagating northward. This outward progression of subsidence is caused by overburden loads being transferred from yielding pillars to less yielding pillars resulting in the less yielded pillars now becoming overstressed. The mine area to the north was not mapped, however.

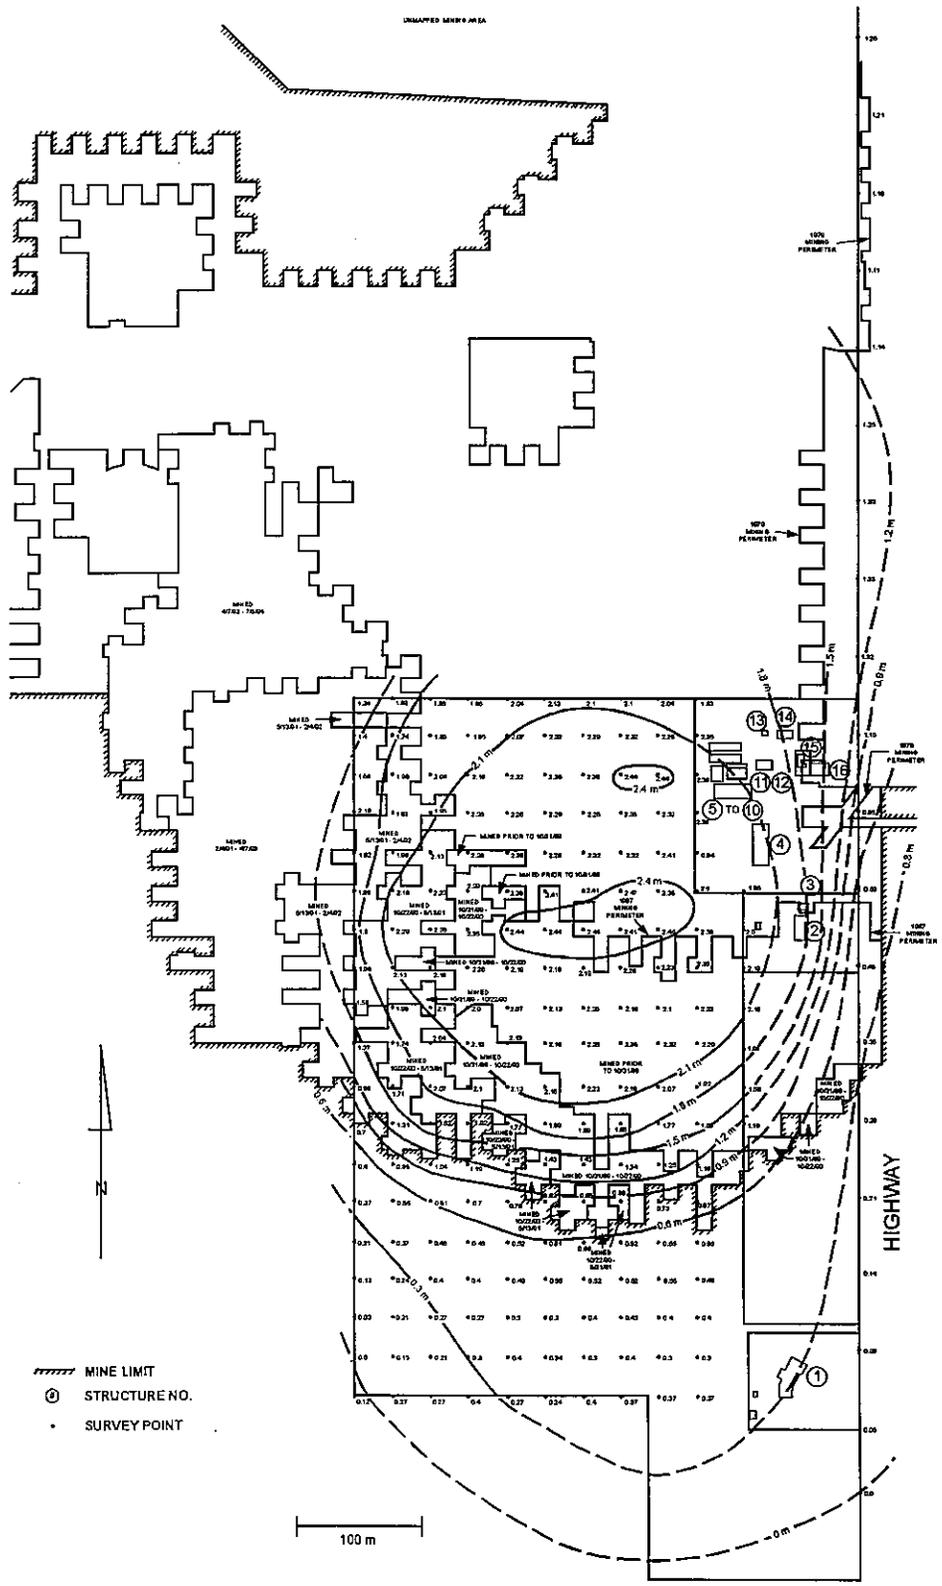
FIGURE 3 APPROXIMATE SUBSIDENCE CONTOURS IN 1995 OVER SALT MINE

By comparing the subsidence contour maps for 1993 and 1995 it can be seen that the maximum subsidence increased from about 1.7 m to 2.5 m (5.5 ft to 8.1 ft). Also, the sag subsidence became less irregular, more symmetrical, and more developed. Based on Figure 3 the angle of draw measures to be from 31° to 42° to approximate zero subsidence to the south. The areas in which the contours are most closely spaced (i.e., the maximum slope zone) is just inside the ribs. In other words of the areas measured the most abrupt subsidence profile features are on the east side where a solid salt mining limit is present. In this area the maximum profile slope, tensile curvature and compressive curvature are 5.0 percent, $6.56 \times 10^{-4} \text{ m}^{-1}$ ($2.0 \times 10^{-4} \text{ ft}^{-1}$) and $5.74 \times 10^{-4} \text{ m}^{-1}$ ($1.75 \times 10^{-4} \text{ ft}^{-1}$) respectively. These profile measurements were taken over a horizontal distance of 12.2 m (40 ft).

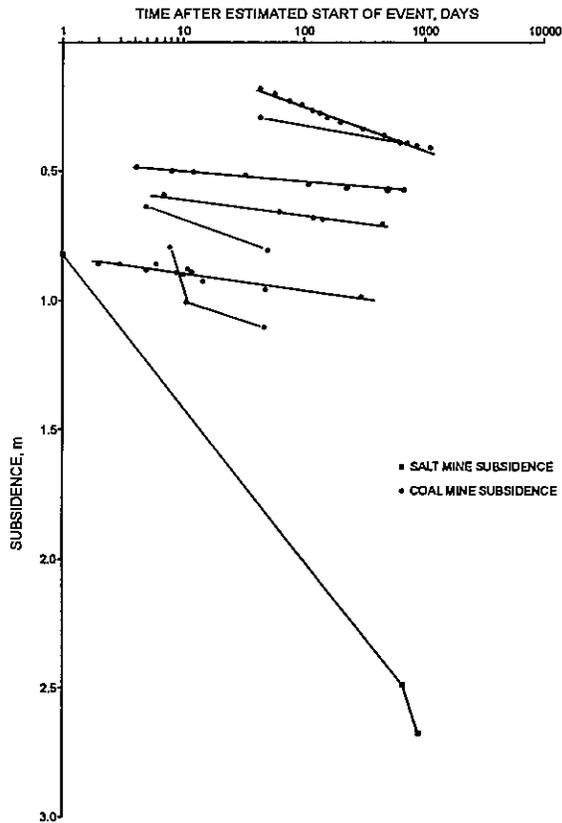
FIGURE 4 TIME RATE OF SETTLEMENT AT THE SAG CENTER AFTER INITIAL MOVEMENTS FOR A ROOM AND PILLAR SALT MINE AND COAL MINES (Marino, 1985, and Marino and DeVine, 1985)

As mentioned above, in the center of the subsidence sag there is an estimated maximum of 2.5 m (8.1 ft) of settlement by about June, 1995. From additional survey data from June 1995 to February 1996 an additional 0.2 m (0.7 ft) of settlement occurred in the area of maximum subsidence. Therefore, the maximum subsidence to February 1996 is estimated at 2.7 m (8.8 ft). The time rate of settlement in the maximum subsidence area is shown in Figure 4. Figure 4 also depicts similar time rate displacements for sag subsidence over room and pillar coal mines. Note, as expected, the salt mine subsidence has significantly greater time dependent movements than those from coal mining. This is due to the significantly greater creep properties of salt compared to coal measures.

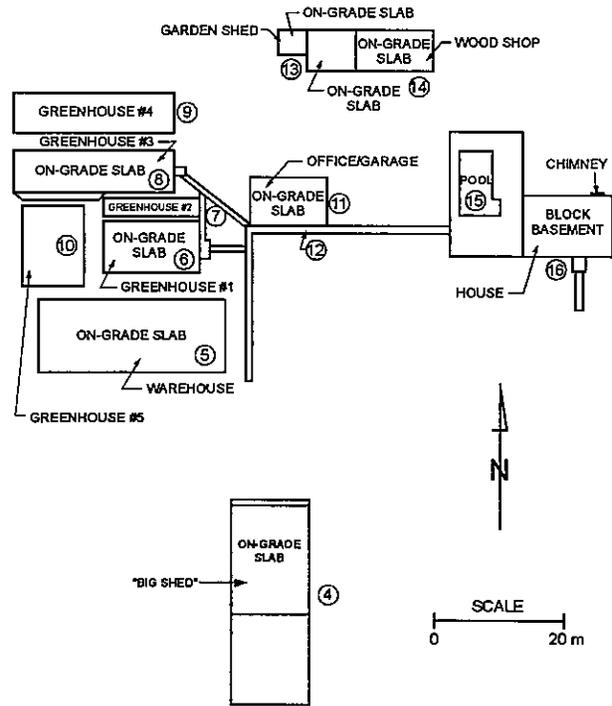
FIGURE 5 PLAN VIEW OF STRUCTURE NOS. 4 THROUGH 16

green-houses, two smaller sheds, and two larger warehouse-type structures. Figure 5 is a plan view of these structures and exterior flatwork. The first evidence of subsidence in this area was in 1993 with the pooling of water. The accumulation of flood water at this time reached 6 in. over the floor of the "Big Shed" and spread into the greenhouses.
