INVESTIGATION OF SUBSIDENCE EVENT OVER MULTIPLE SEAM MINING AREA

KEWAL K KOHLI, Ph.D

OFFICE OF SURFACE MINING RECLAMATION AND ENFORCEMENT

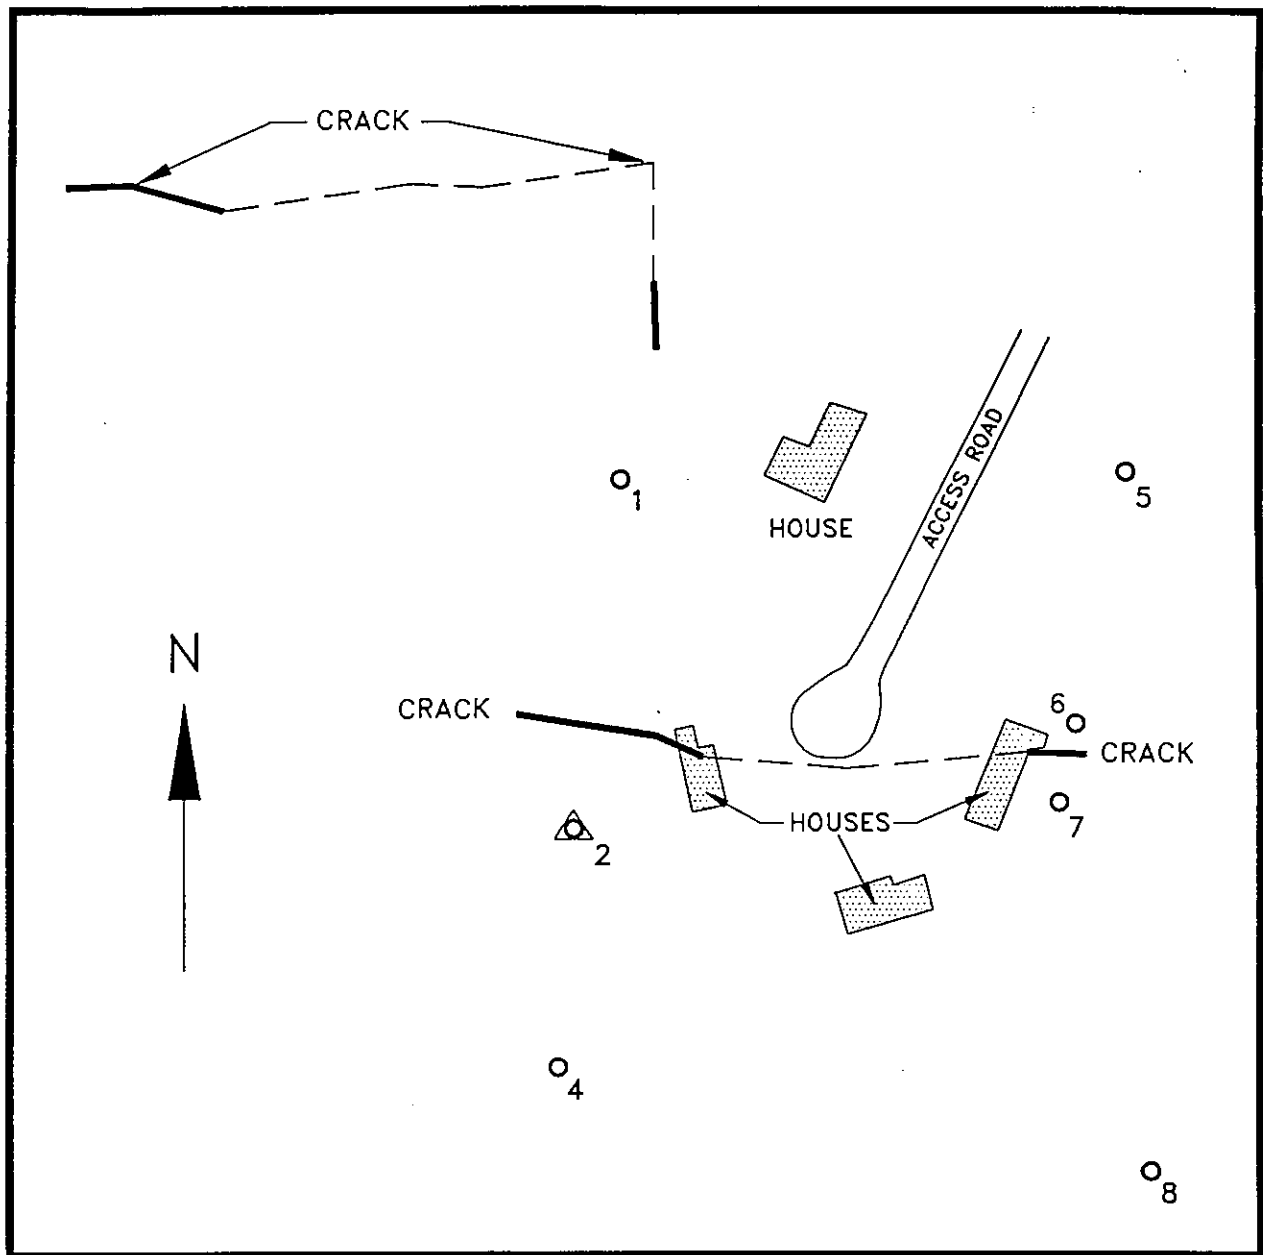
Figure 2 Location of Houses, Surface Cracks and Boreholes

In 1987, an investigation was undertaken by the Office of Surface Mining Reclamation and Enforcement (OSM) to establish the source of subsidence which caused damage to four houses (Figure 2) in Walker County, Alabama, USA so that necessary remedial measures could be planned to prevent further damage.

movement of the overburden strata above the seam in this area. But the cores from holes 6 and 7 only (see Figure 2) showed fresh cracks in the overburden strata between the American and the Mary Lee seams. That indicated recent movement of the strata above Mary Lee seam over a small area. Based on this observation, it was concluded that pillars within a small area in Mary Lee seam collapsed after these were weakened by flooding and dewatering. It caused the overburden strata lying above Mary Lee seam to bend and fracture which overloaded the pillars in the American seam. This caused the failure of the pillars over a small area in the American seam. The pillar collapse progressed in all directions due to domino effect. This was evidenced by the presence of fractures in the strata observed in the cores of all the boreholes. The failure of the pillars in the American seam caused the overburden strata to move down and finally cause surface subsidence and damage to four houses.

The cracks observed on the surface had the same orientation as the mine workings in the American seam suggesting that the surface subsidence was controlled by the American seam.

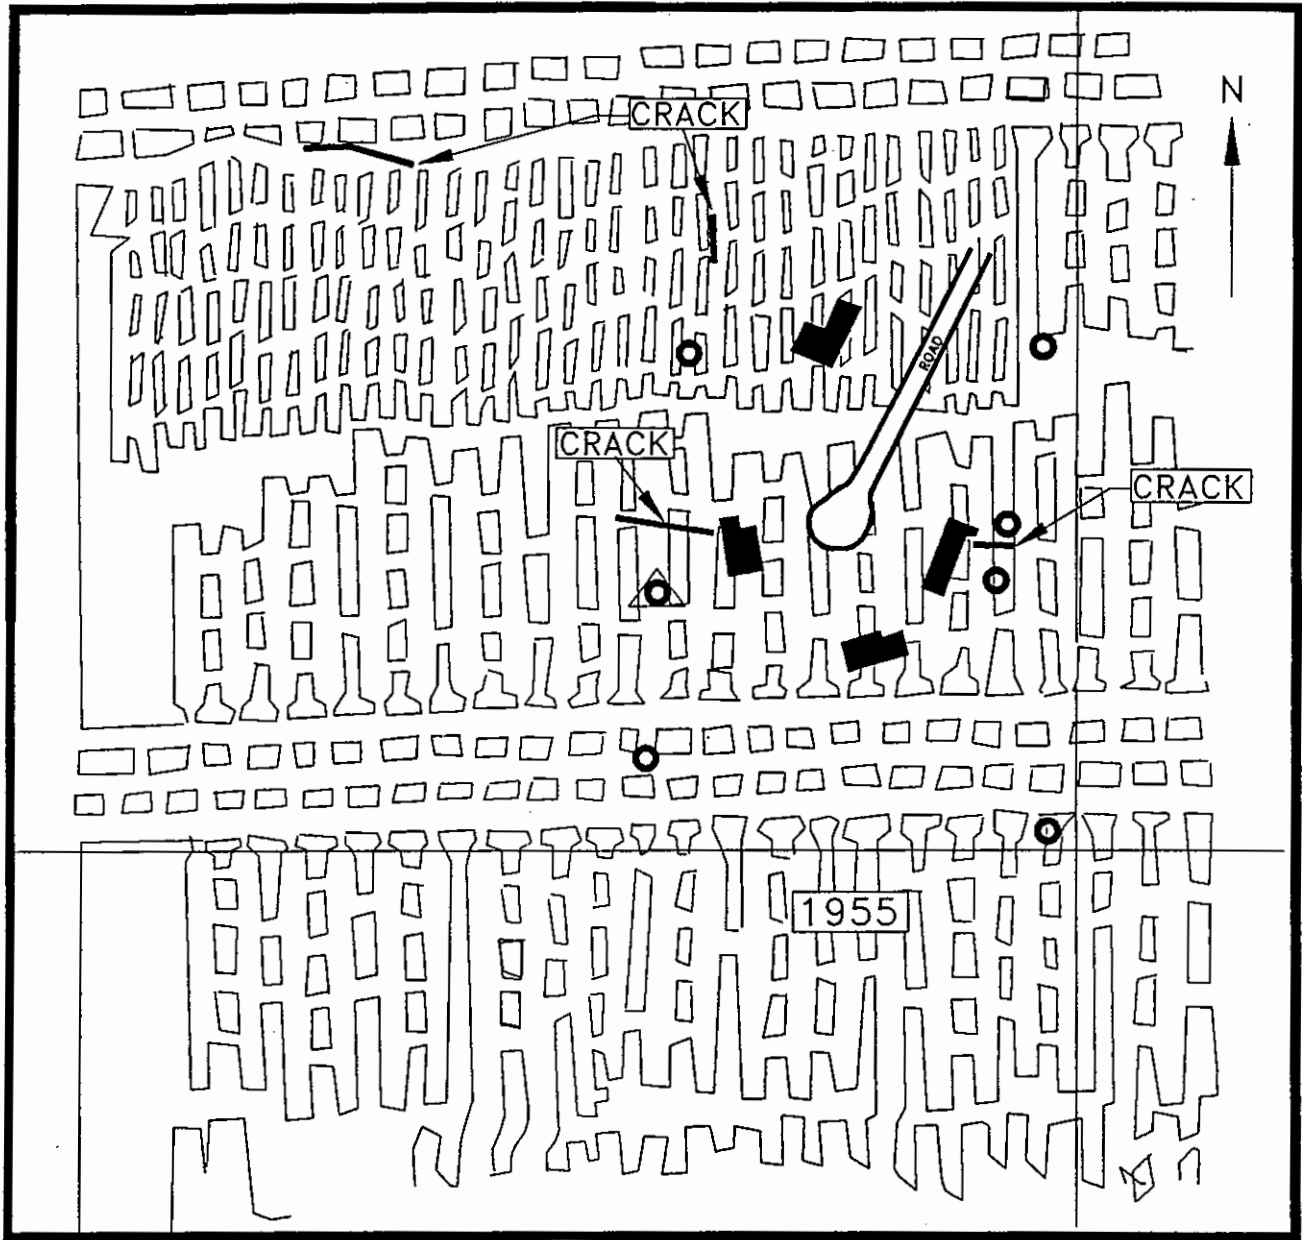
Figure 4 American Seam Workings

The American seam (upper seam) in the affected area was mined out until 1955 by room-and-pillar method leaving in place long narrow pillars (Figure 4) to support the overburden strata and was abandoned thereafter. The mining depth in the area ranged from 250 to 280 feet and the mining height was four feet.

causing them to also fail. Subsequently more pillars in the American seam failed due to the domino effect which widened the area of collapse. With the collapse of these pillars, the support to the overburden strata above the American seam was withdrawn. This caused the overburden strata above the American seam to sag, bend and fracture. The downward movement of the overburden strata progressed upward until it reached the surface and damaged the houses.

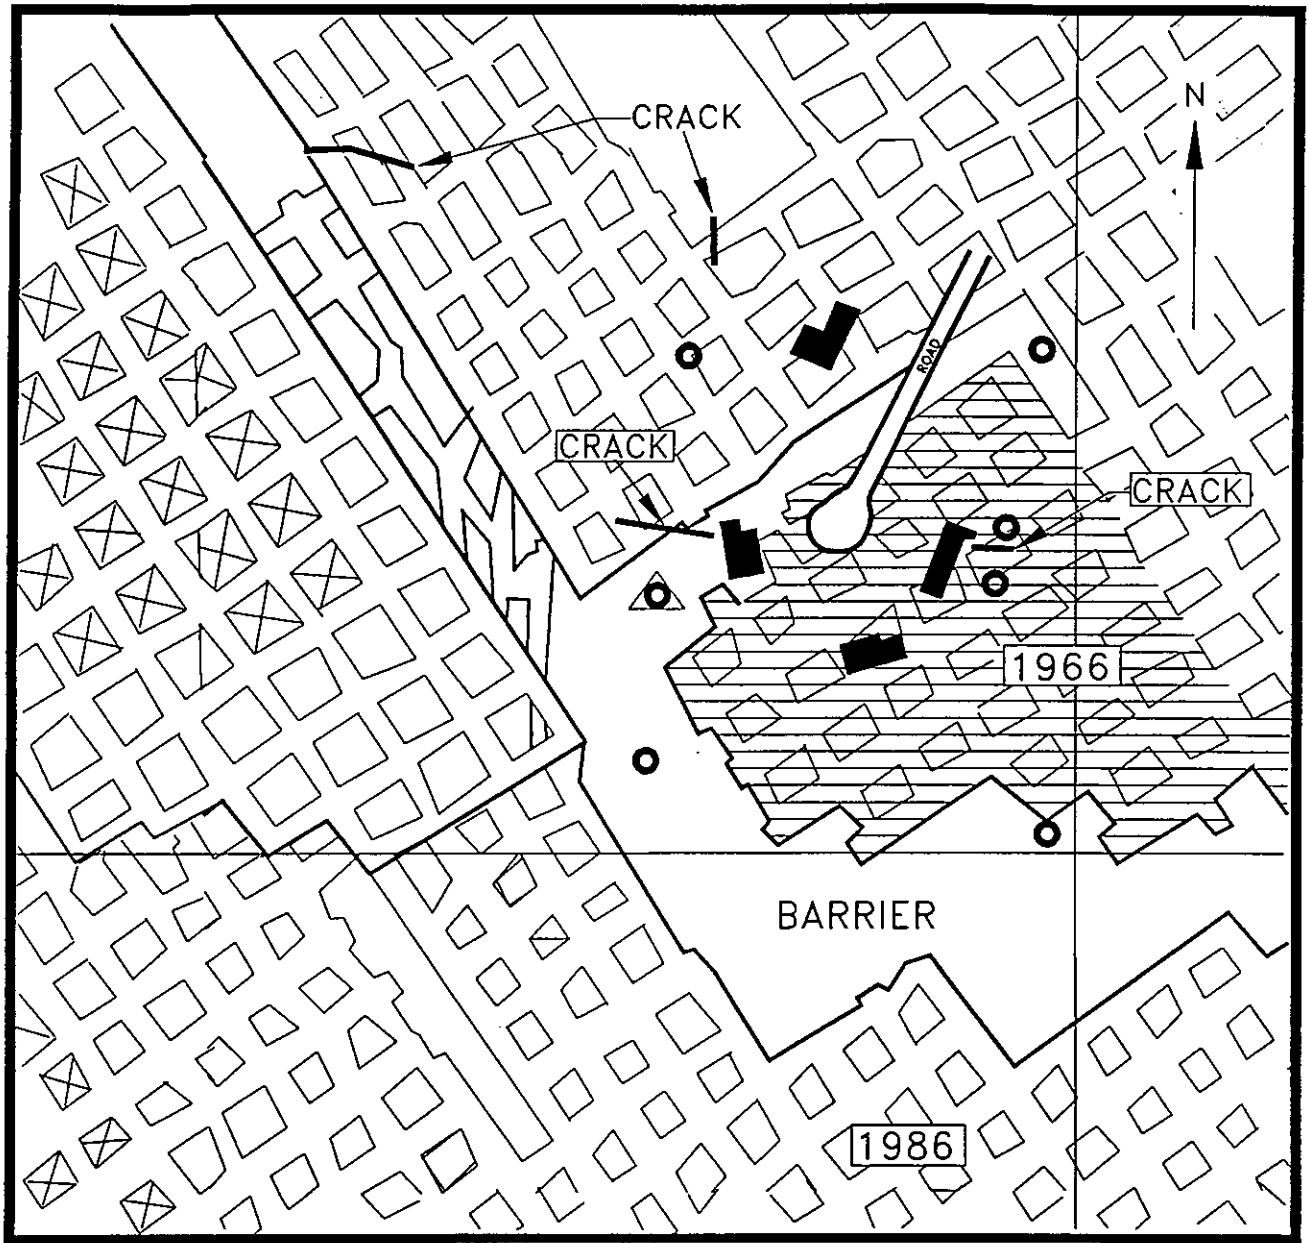
Figure 5 Mary Lee Seam Workings

The Mary Lee seam (lower seam) in the affected area was mined out until 1966 using room-and-pillar method leaving in place small rectangular pillars (Figure 5) to support the overburden strata. The mine was shut down in 1966 and allowed to be flooded thereafter. In 1986 it was dewatered to examine the condition of pillars in the flooded area to evaluate the possibility of doing retreat mining. But no mining was done because the conditions of roof, floor and the pillars were found bad. However, to the south of the affected area, a solid coal barrier of about 100 feet thick was left in place and retreat mining was done beyond this point along the barrier in 1986. In 1987, four houses located on the surface beneath the workings of Mary Lee seam, dewatered recently were damaged by subsidence.

The stability analysis of the pillars in the Mary Lee seam was also performed using conventional pillar design formulas and the compressive strength of coal obtained from the core samples. The pillar strength determined using these formulas was reduced by 25 percent to account for reduction in strength due to flooding. Most of the pillars within the collapsed area in the Mary Lee seam had a safety factor of one or below; which means these were marginally stable pillars before the collapse. The flooding of Mary Lee seam mine workings in 1966 and dewatering in 1986 had caused these pillars to weaken and ultimately collapse.

Based on subsurface exploration and the assessment of the mine maps, it was apparent that the marginally stable pillars (50 ft X 30 ft) in a small area (see Figure 5) of Mary Lee seam collapsed after these were weakened by flooding and dewatering. The collapse of these pillars caused the overburden strata above the seam to fracture and move downward. As a result pillars in the American seam above the collapsed area were overloaded
