A SUBSIDENCE ENGINEERING INVESTIGATION AT THE WILDLIFE PRAIRIE PARK¹

Gennaro G. Marino Ph.D., P.E.²

ABSTRACT. An investigation of the potential for subsidence and associated damage at the Wildlife Prairie State Park was undertaken. The park contains a variety of existing structures on about 2,000 acres of land. The investigation consisted of obtaining the best available information on the geologic and mining conditions across the site, in order to perform subsidence and damage assessment at the existing structure locations and to assess the more suitable building sites for future construction from a subsidence potential standpoint. This paper presents the results as well as the analysis conducted to achieve these objectives.

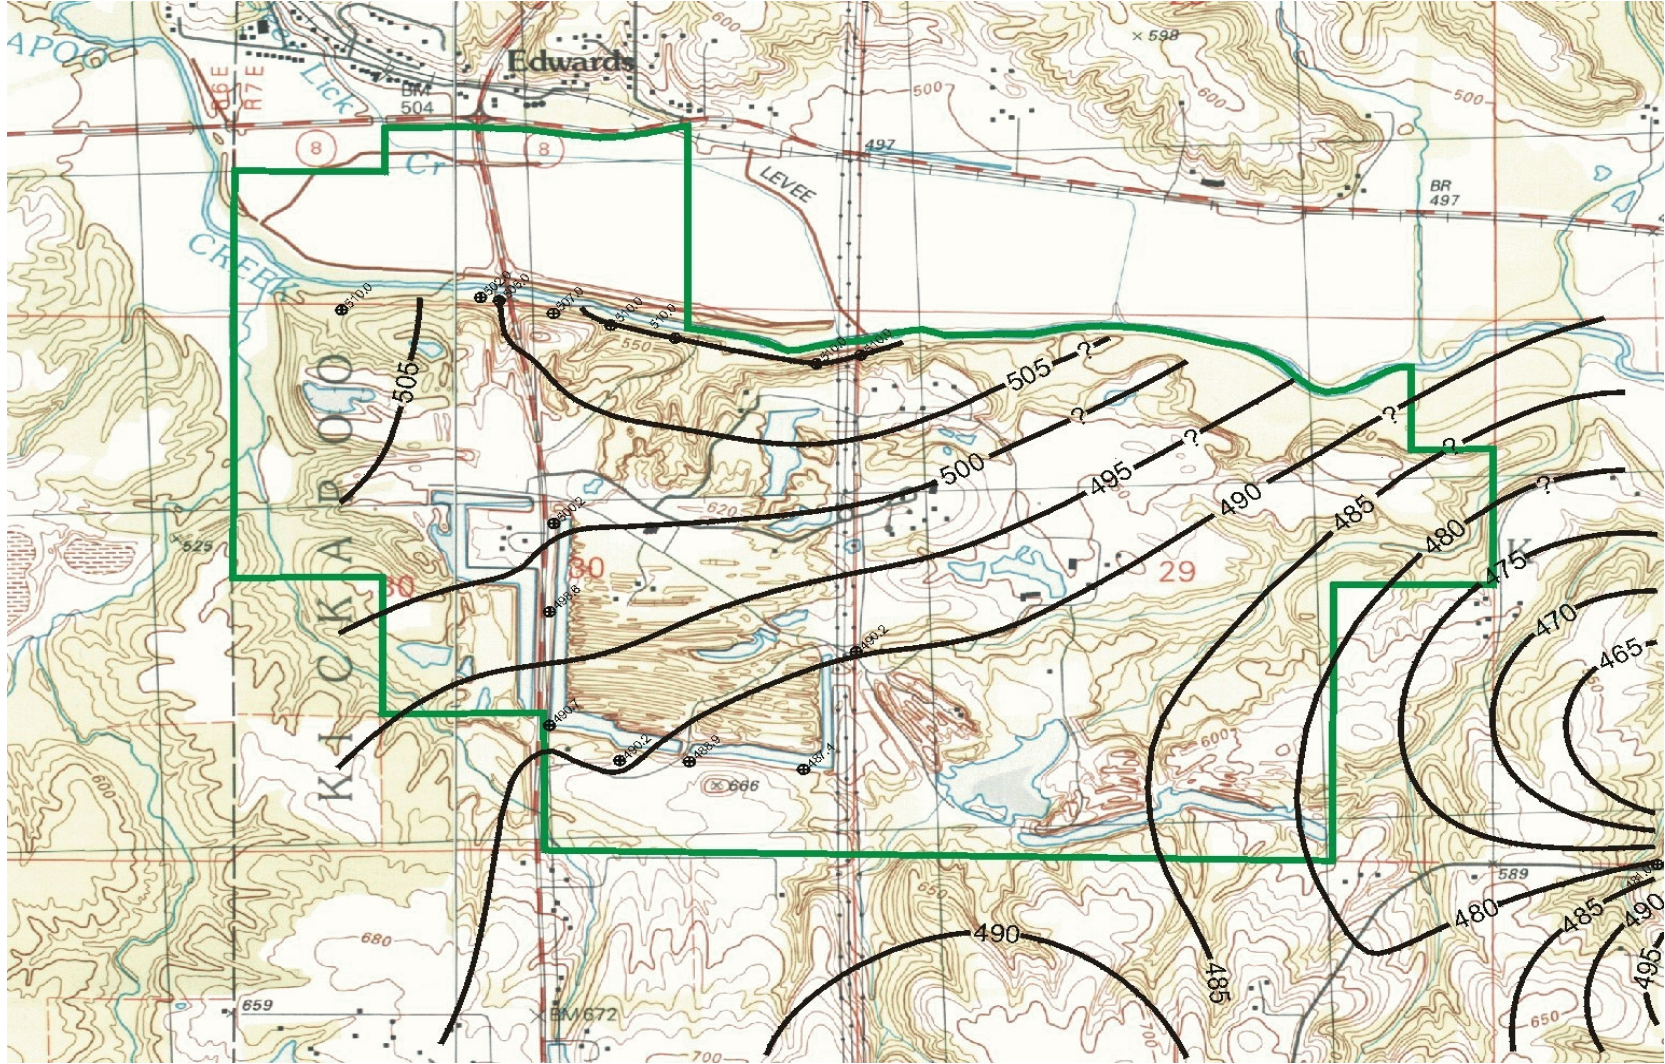
Figure 5. Structural contour map of the No. 5 Springfield coal.

The Springfield Coal seam is about 3.7-3.9 ft thick and has also been extensively mined by underground methods. The seam generally dips to the southeast as shown on Figure 5. Figure 5 is a structural contour map of the Springfield seam that was developed from the available boring data in and around the site as well as approximate portal elevations where the coal outcrops along the bluff. As can be seen from this figure the seam dips from an elevation of about 510 ft MSL at the bluff to about 470 ft MSL in the southeast corner of the site, ranging from 85 to 140 ft deep (north to south). This coal is absent in the flood plain of Kickapoo Creek due to natural erosion.

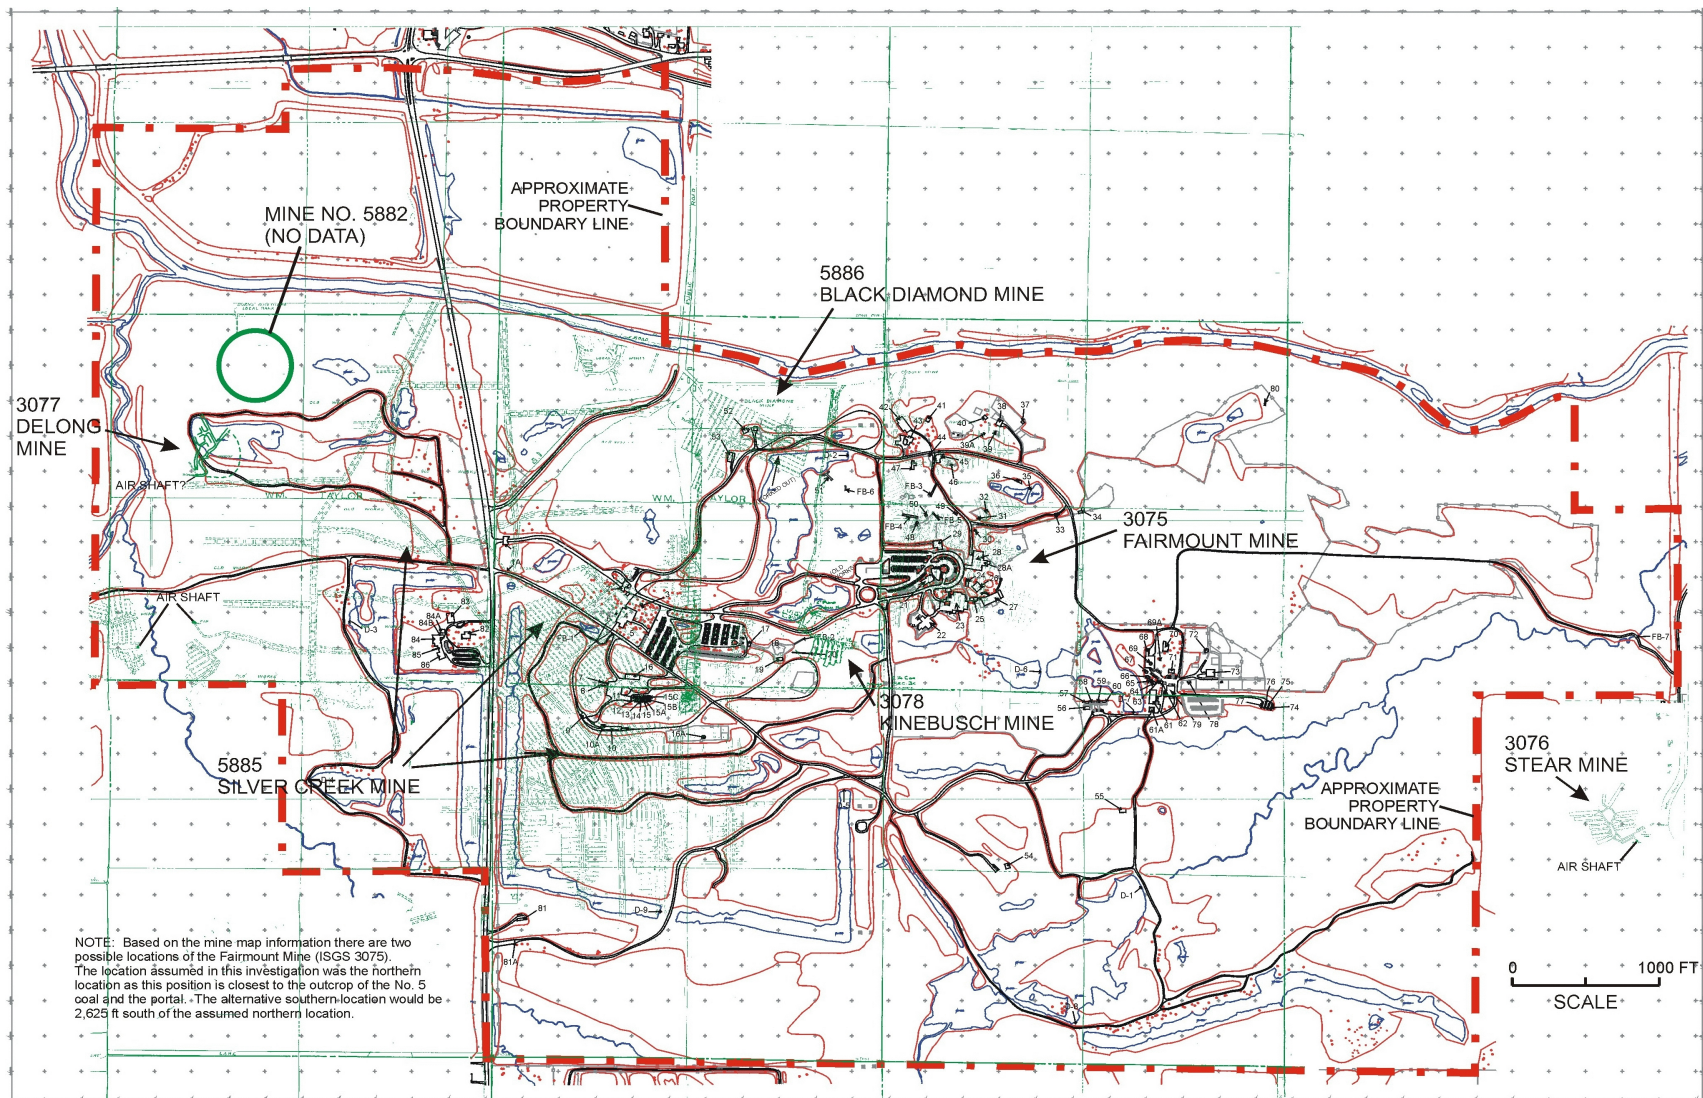
Figure 6. Underground mining beneath Wildlife Prairie State Park based on available records.

As can be seen from Figure 6 most of the western half to two thirds of the Wildlife Prairie State Park appears undermined south of the Kickapoo Creek bluffs except for possibly some extreme southern areas. In other words, little mining of the No. 5 Coal is indicated to the east and south of this location although this should be considered highly suspect given the incompleteness of the mining information. The only known mining in the area to the east appears to have been a small slope mine operation called the Stear Mine which is outside the park boundaries. However, the mine drawing appears to be conspicuously limited in size and consequently the Stear Mine may extend west under the park property.

Overall the mine depth (or depth to the bottom of the No. 5 Coal) generally increases to the south and ranges from about 85-90 ft near the bluffs to 125-140 ft at the south end. The mine extraction height should have been fairly consistent with the coal seam thickness which is about 3.8 ft but can be higher in places since the seam thickness does not afford easy movement of mining operations (i.e. roof and/or floor rock may have been extracted for greater clearance, especially in the main entries).

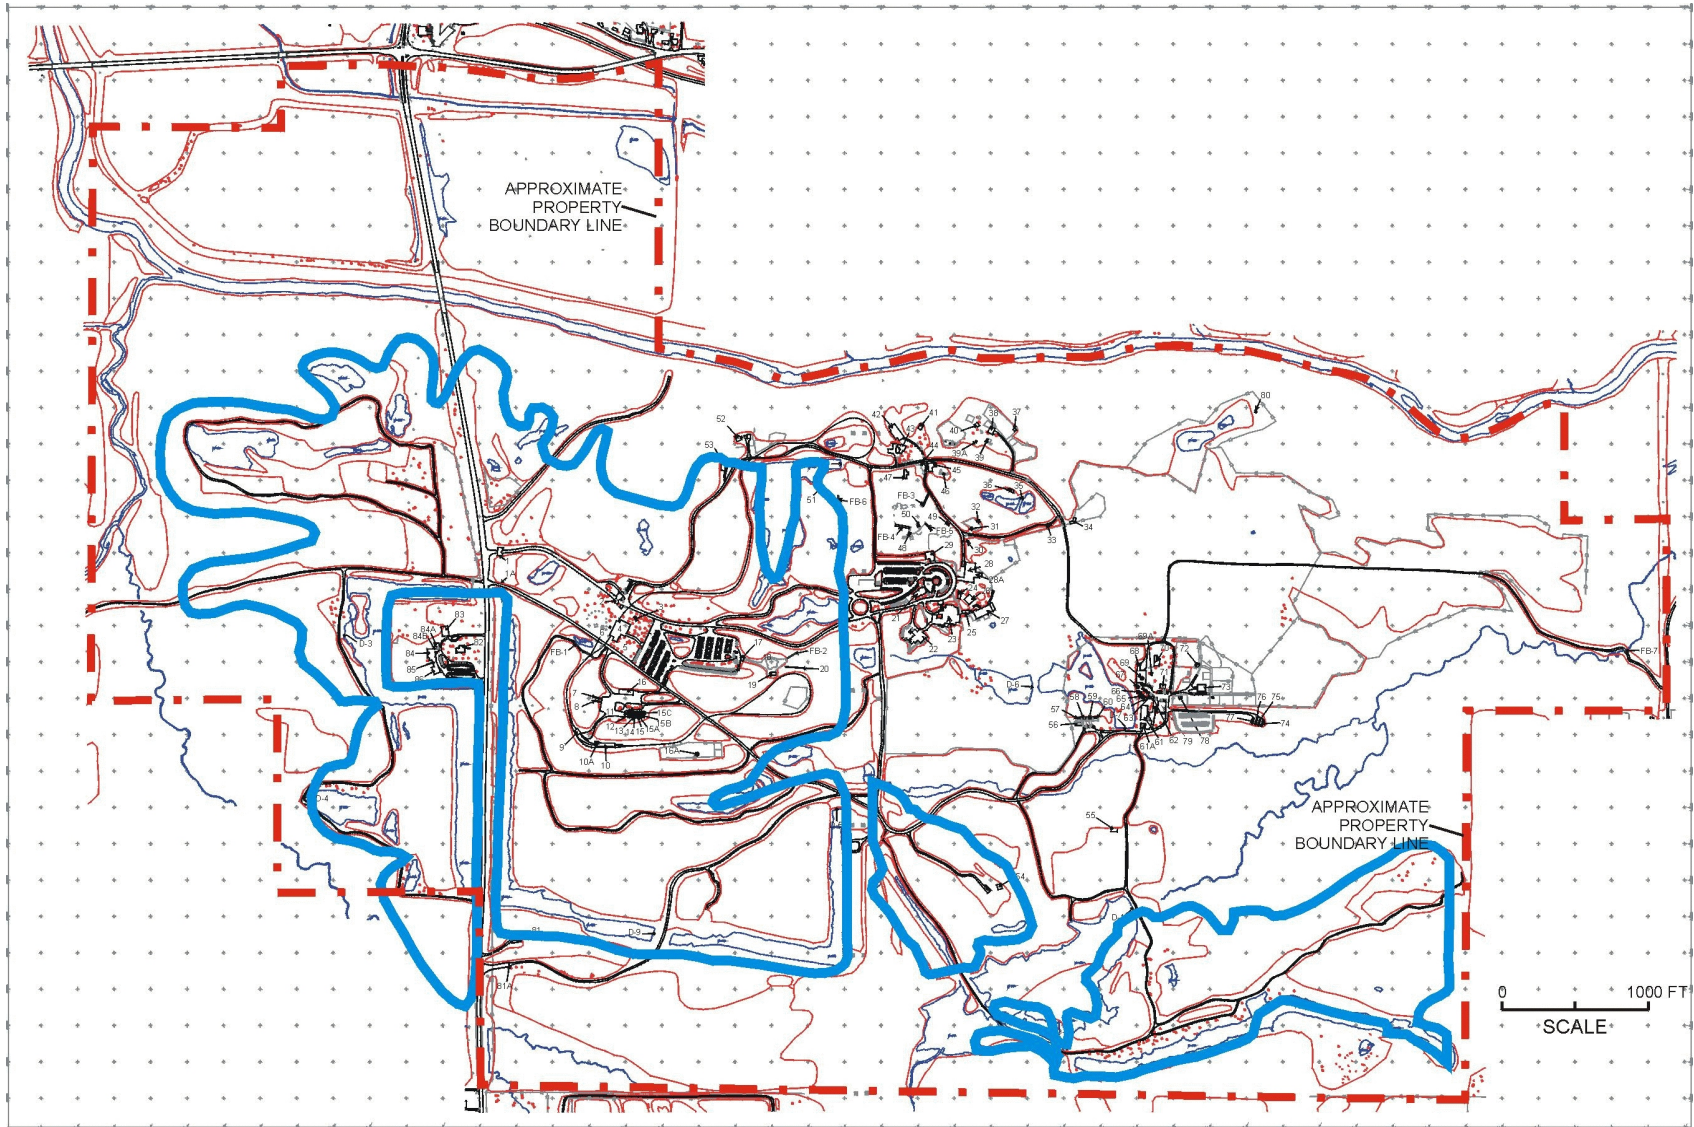
Figure 7. Strip-mined areas at Wildlife Prairie State Park based on Midland Coal Co. strip mine map.

The strip mining, as mentioned above, occurred in the Herrin No. 6 Coal seam (a coal seam above the No. 5 Coal). This strip mine was called the Edwards Mine and operated on the project site from 1952 to 1975. An outline of the stripped mined areas is shown in Figure 7. As can be seen in Figure 7 the strip-mined land exists in the west central and south central parts of the site. Some of the park areas which were strip mined are quite evident by parallel “ridge and valley” topography (spoil ridges or windrows of overburden debris from excavating the coal from beneath). These windrow areas are fairly evident on the site topo and are found in the southern central area of the park. Most of the remaining strip mined areas appear to have been reclaimed to about the original ground contours.

Although most of the No. 6 Coal has been stripped, there are still some areas where it is still present, primarily along the western portion of the southern border and probably in the north central area south of the bluffs. There is a possibility that these No. 6 Coal areas could contain old underground works. Four (4) of the available borings located in the south central end of the park property indicated they intersected old room-and-pillar workings in the Herrin No. 6 Coal at a depth of only about 25 to 30 ft. It appears the coal was probably accessed, prior to stripping this particular location, from the northeasterly sloping ravine just north of the borings where the No. 6 Coal would have outcropped. Therefore, the strip mining may have removed the remnants of pillars. North of this northeast drainage feature the topography again rises and the No. 6 Coal should outcrop in the north slope from which the coal could have been accessed by drift entries and mined out. It is important to note that such old works could extend under park structures (eg. Structures 21 to 29, see Figure 3). It may be also possible that this coal was accessed from the south along the same ravine and developed underground to the west where the No. 6 Coal has not been stripped near the southwest border of the site (see Figure 6).

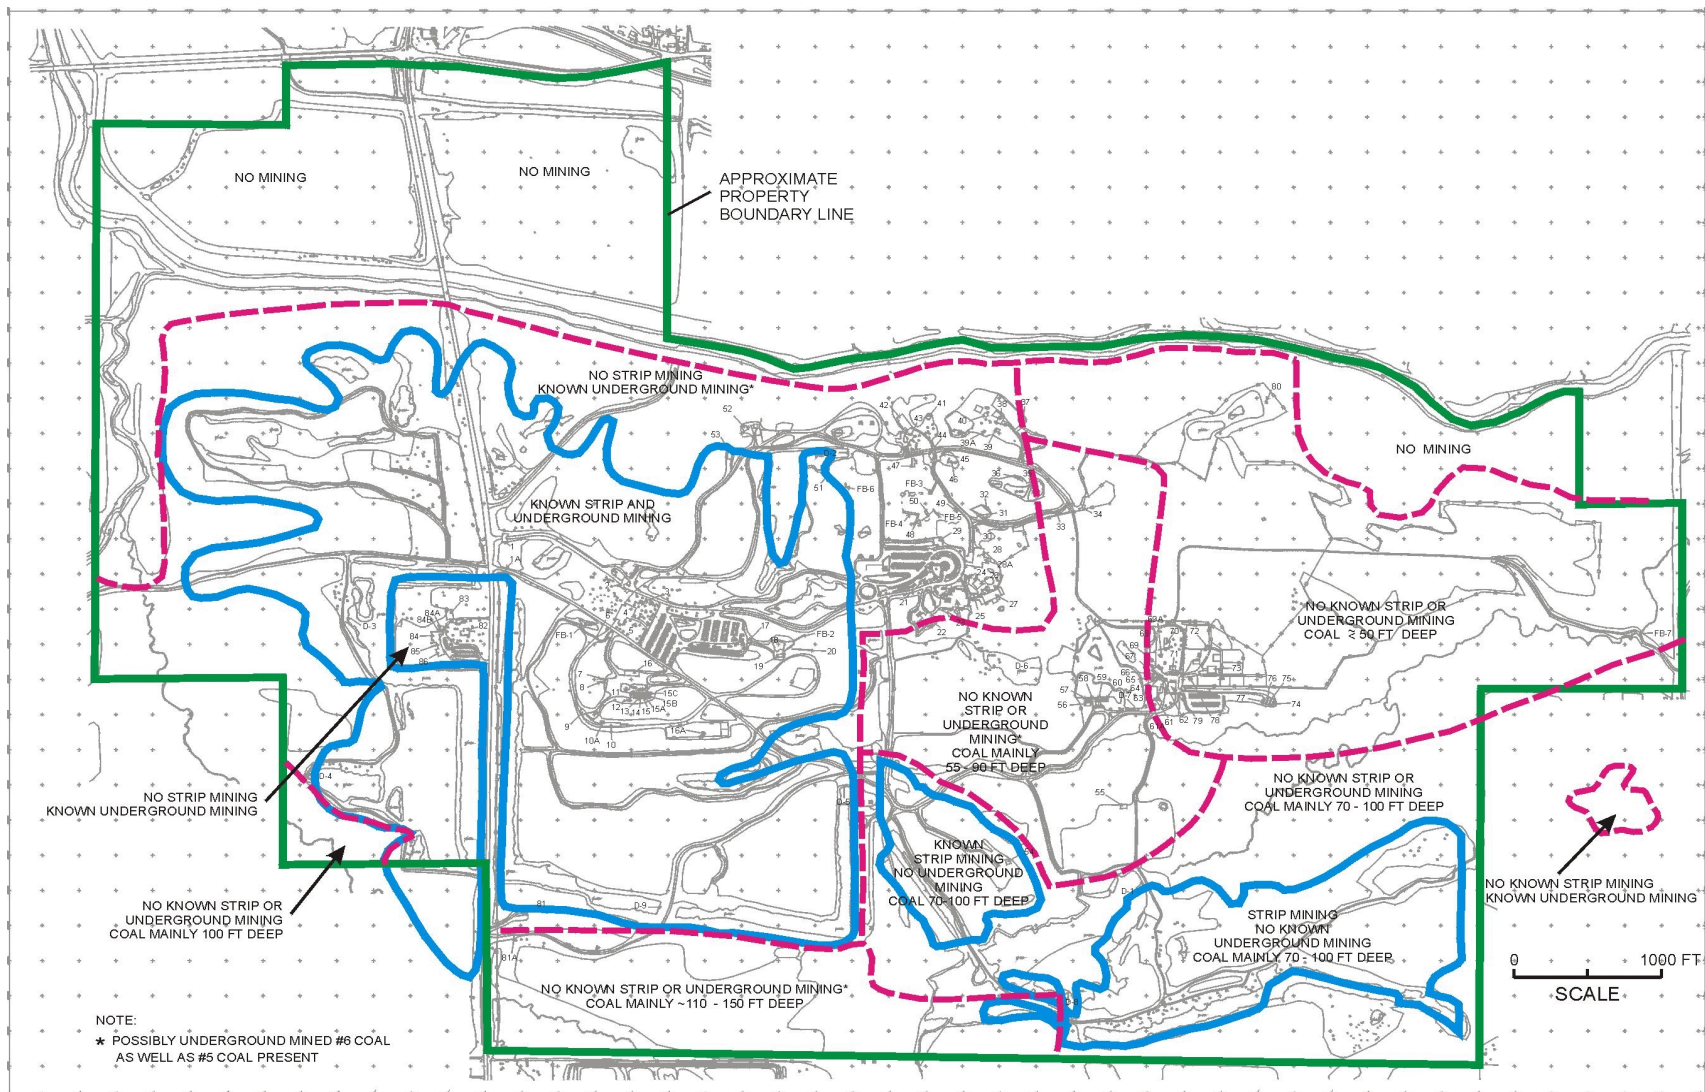
Figure 9. Map depicting approximate limits of various mining scenarios across the site.

A map of the site showing the areas with these various mining scenarios given in Figure 9. It is important to note that the limits as shown in Figure 9 are very approximate. Although available strip-mine data appears to be fairly reliable, mining limits from the maps of the old underground workings are incomplete. Moreover, the possibility of other local mines with unknown location of workings exists.

Based on the limited available No. 5 Coal elevation data the coal depths were also determined where no known mines exist and can be seen in Figure 9. The coal depths were determined to supplement the suspect mine map information. The depth of the coal may have been a limiting factor for mining due to insufficient bedrock cover and possible groundwater inflow problems. Although old localized mines can exist at very shallow depths a possible limiting mineable depth of 50 ft may be assumed. These No Known Mining areas have been discerned and are shown in Figure 9.

All the Critical Structures: Forest Hall/Reptile Hall (22), Prairie Hall (23), Arboretum (27) and Visitor's Center (28), Stone House (82) and Stone Barn (83) are indicated as undermined with the subjacent mine estimated at depths of 85 to 110 ft and are consequently subjected to future pit or sag subsidence. Further, below Structures 22, 23, 27 and 28 the potential exists for the upper No. 6 Coal seam, which would be at a depth of about 60 ft, to contain old localized works. Therefore, based on the available information both pit and sag subsidence can result at critical structure locations.

Based on Figure 9 the best building sites (with the least chance of the effects of mining) are the northeast areas south of the Kickapoo Creek Bluff and of course areas north of the bluffs where the mined-out coal seams are absent. These areas south of the bluffs have no known mining, probably no No. 6 Coal, and No. 5 Coal at depths on the order of 50 ft or less. Other unstripped areas where the coal seam(s) is at greater depths and not reported to be mined may also have not been worked.
