STABILITY MONITORING OF A COAL MINING EXCESS SPOIL FILL¹

X. Zeng, R.A. Rohlf, B. Hippley, and J.D. Reynolds²

Proceedings America Society of Mining and Reclamation, 2002 pp 411-421

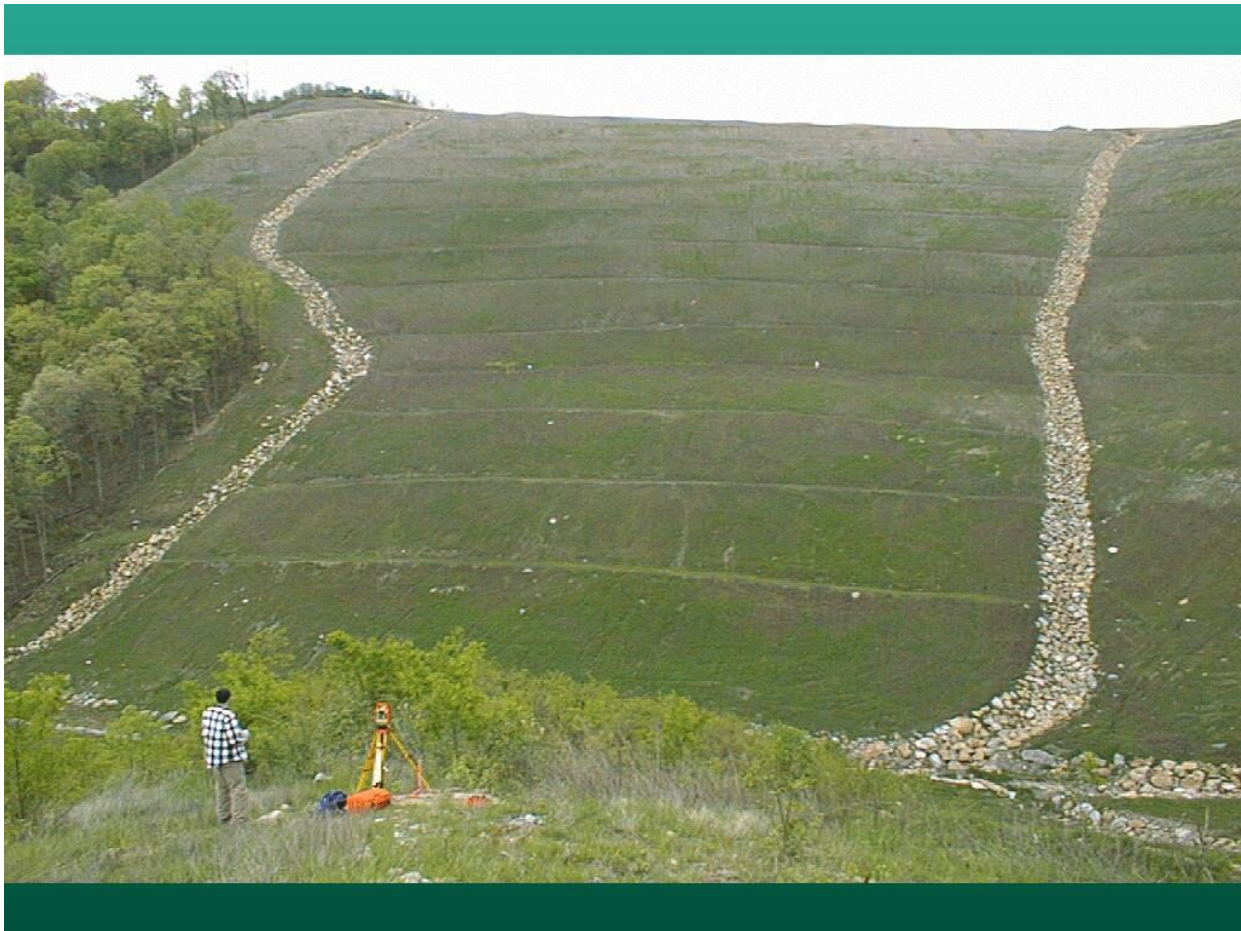
Figure 1. An excess spoil fill in Prestonsburg Kentucky and one of the survey stations.

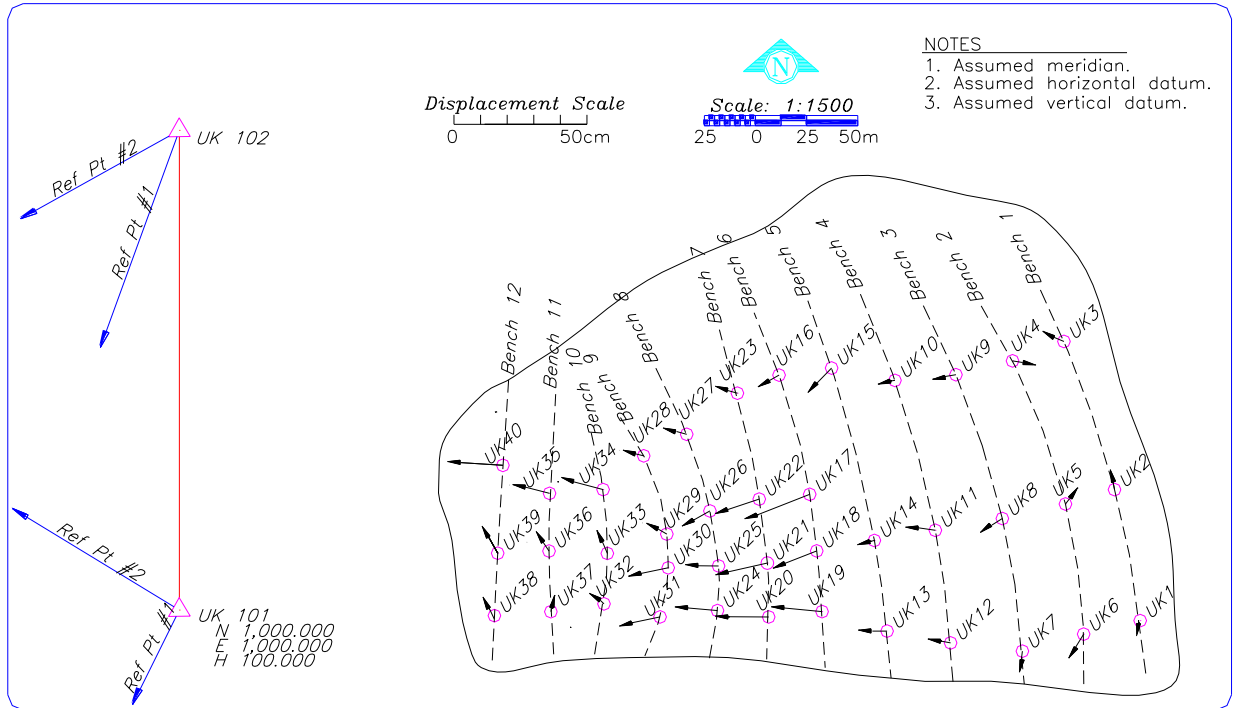
Figure 2. The plan layout of the survey monuments, stations, and recorded displacement during a period of 20 months. (The arrows show the vector of displacement with the scale at the top of the figure)

During the survey period, there was no relative displacement between the two survey stations, indicating that the positions of the stations remained stable. Since we are only interested in the deformation of the survey monuments relative to the survey stations, the meridian, horizontal datum, and vertical datum were assumed for one of the station, which was used as the reference point. The results of the surveys show that there was significant vertical deformation (settlement) and down slope movement within two zones, as shown in Figure 2. The first zone located at the northern end of the 1st, 2nd, and 3rd benches, where the maximum settlement was more than 30 cm and the maximum lateral displacement 20 cm. In fact, surface cracks developed in that zone with one small area of local failure observed. This was near one of the spots where surface water exit was observed during the survey. The second zone located at the southern end of the middle benches (benches 6, 7, 8, and 9) where groundwater seepage was observed throughout the survey period. The maximum settlement was close to 50 cm and lateral movement close to 30 cm. Again, signs of cracks and local failure were observed in this area. The close link between the groundwater table and slope displacement is obvious. In comparison, most other places recorded settlement or displacement of a few centimeters.

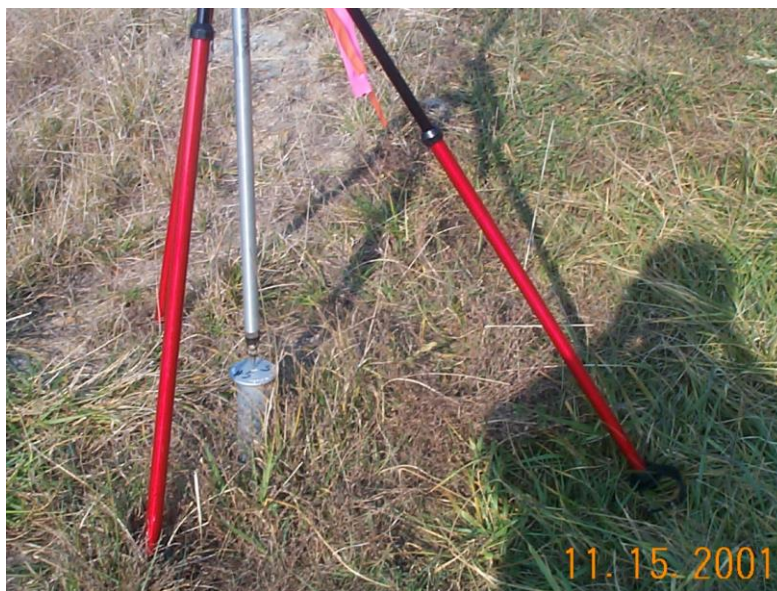
Figure 3. A survey monument buried in soil.

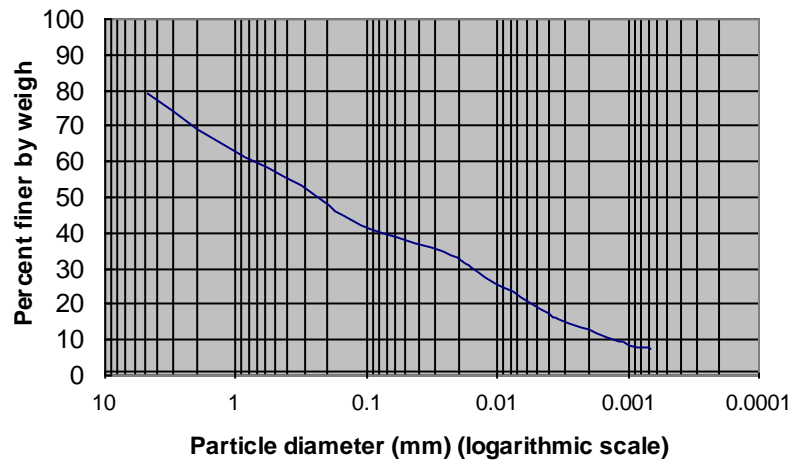
Figure 4. Particle size distribution curve of soil from the 2nd bench.

Based on the results of laboratory tests, the soil is classified as poorly graded clayey sand with gravel and boulders using the Unified Soil Classification System.

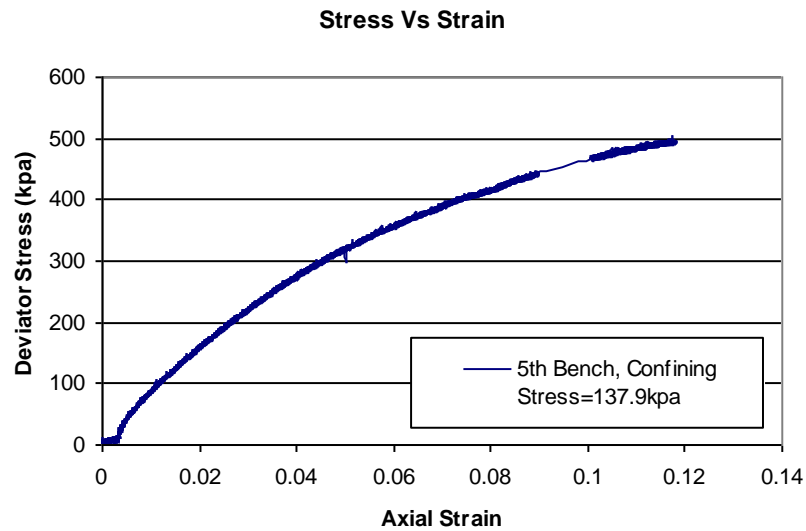
Figure 5. Result of triaxial test on soil from the 5th bench.

The strength of the soil is quite high with a friction angle ranging from 35 to 38 degrees. Moisture samples at the surface, 1 ft., and 2 ft. depth were taken near the top, middle, and bottom

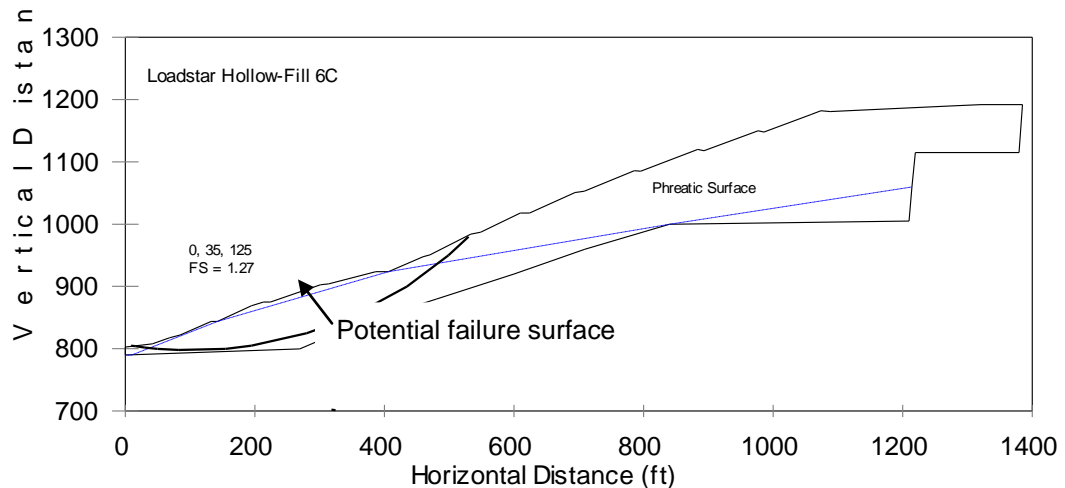
A two-dimensional limit equilibrium stability analysis using soil strength parameters determined from soil sampling ($c = 0$, $\phi = 35^\circ$, $\gamma = 125$ pcf) and a phreatic surface based on the upper seepage points gave a factor of safety of 1.27 for the simplified Bishop method. The fill profile, phreatic surface, and failure surface are presented in Figure 6. Infiltration and continued discharge from coal seams could increase the phreatic surface above the elevation of the current seepage points. A second stability analysis using a phreatic surface closer to the lowest coal seam produced a factor of safety of 0.94 for a moderately deep circle and 1.12 for a deep circle (Figure 7).

Figure 6. Stability analysis at current estimated phreatic surface.

As shown above, a stability analysis using soil strength parameters determined from on-site sampling and a current estimated phreatic surface indicates a factor of safety of 1.27 which is well below the 1.5 factor of safety required by regulation (405 KAR 16:130 Section 1(2)(b)). In addition, the second stability analysis assuming a plausible higher phreatic surface gave a factor of safety of 0.94. Consequently, the long-term stability of this fill is questionable. Stability of this fill is crucial to the Prestonsburg economic development project and downstream Corps of Engineers Dewey Lake. Therefore, continued monitoring of the stability of the fill is very important. With the installment of the survey markers, a continued monitoring is possible. Local failures and crucial zones can be detected early and procedures can be adopted to prevent overall failure.

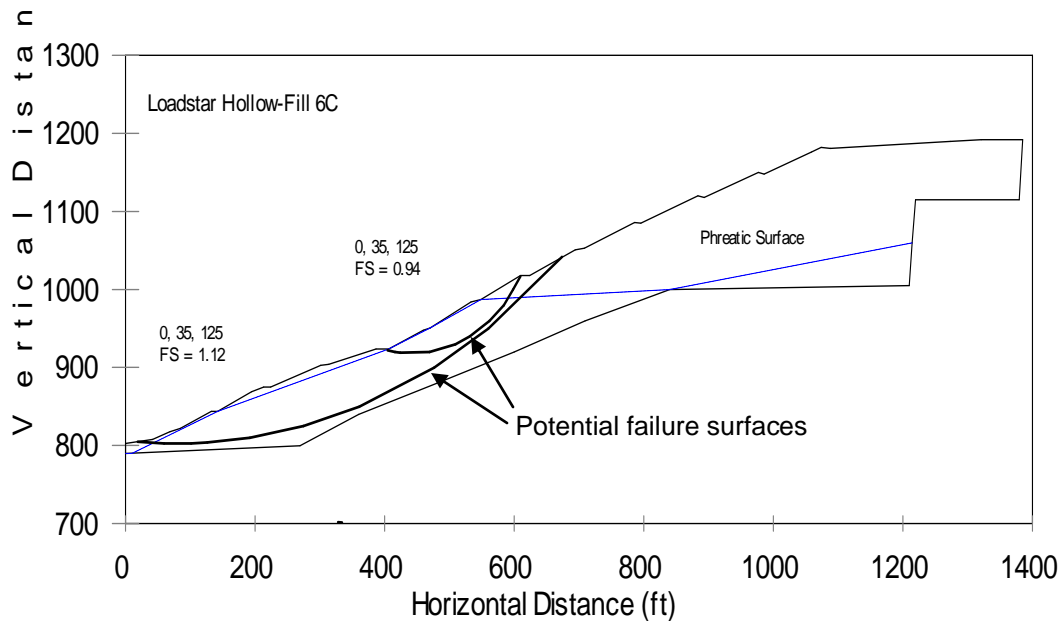
Figure 7. Stability analysis at a higher phreatic surface.
