## RECLAMATION OF A TAILINGS IMPACTED STREAM CORRIDOR<sup>1</sup>

Patrick L. Redmond, George E. Austiguy, and Michael A. Rotar<sup>2</sup>

Proceedings America Society of Mining and Reclamation, 2004 pp 1532-1562

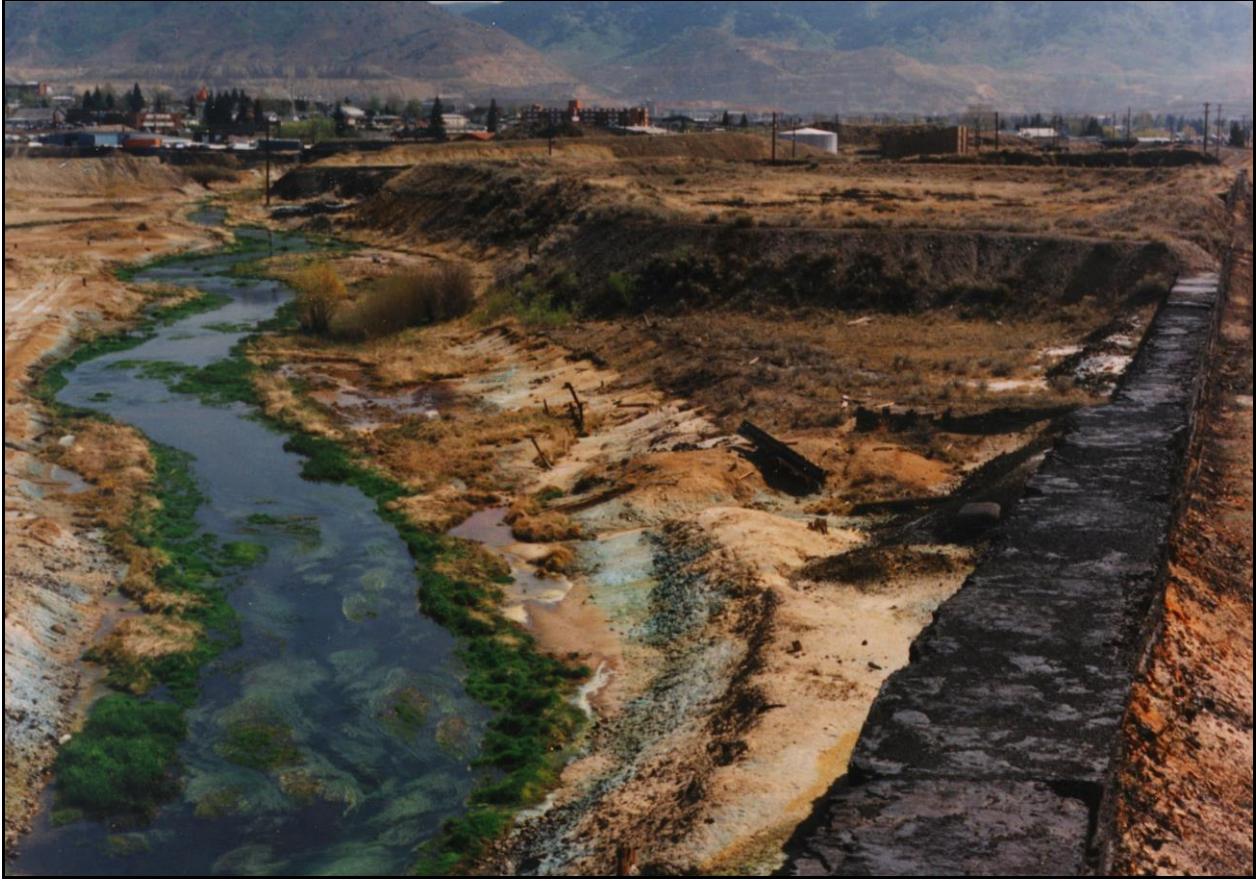
Photo 1. View of Silver Bow Creek within LAO prior to reclamation work.

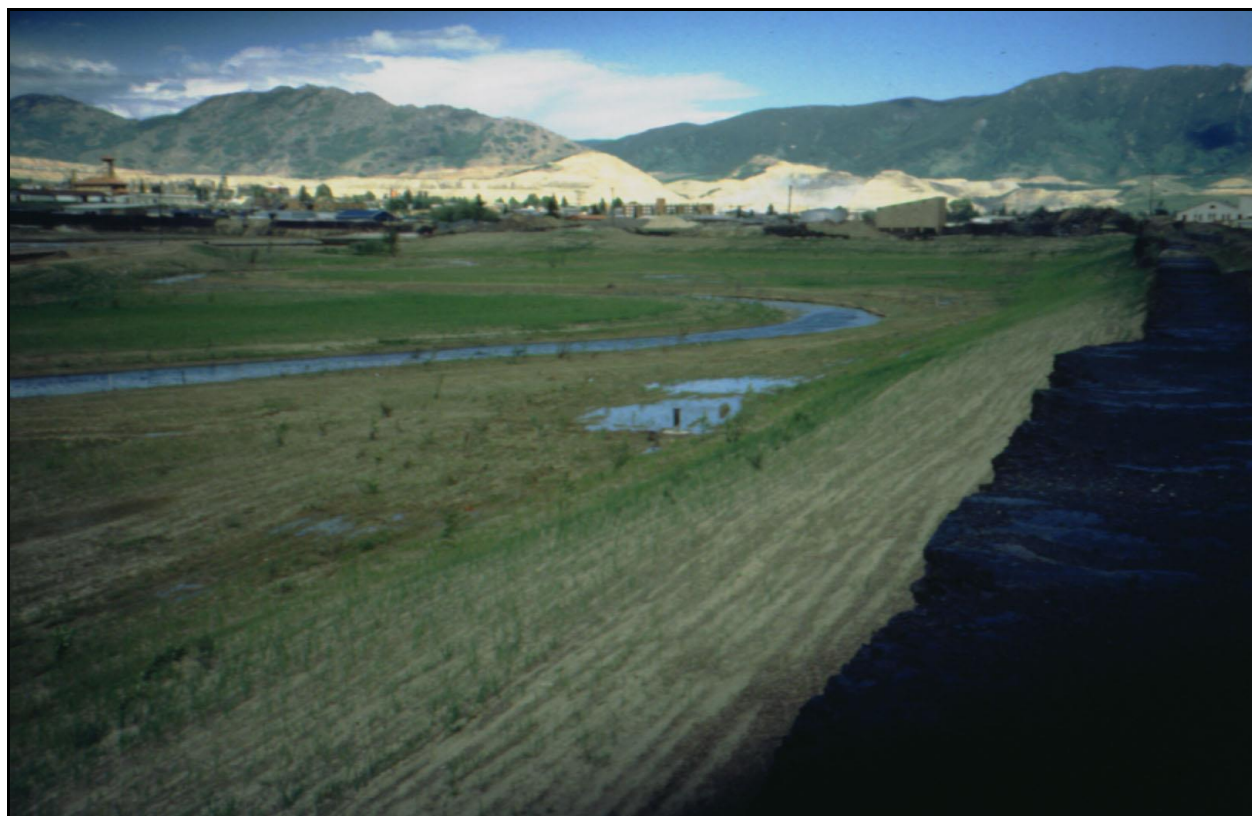
Photo 2. Reconstructed Silver Bow Creek channel and floodplain within LAO.

Full-scale construction activities for Phase I of the LAO ERA began in July 1996. Approximately 1.2 million cubic yards (CY) of tailings and contaminated soils were removed from the site; approximately 250,000 CY were removed in Segment 1, and 920,000 CY were removed in Segment 2. Photo 2 shows the reconstructed Silver Bow Creek channel and floodplain.

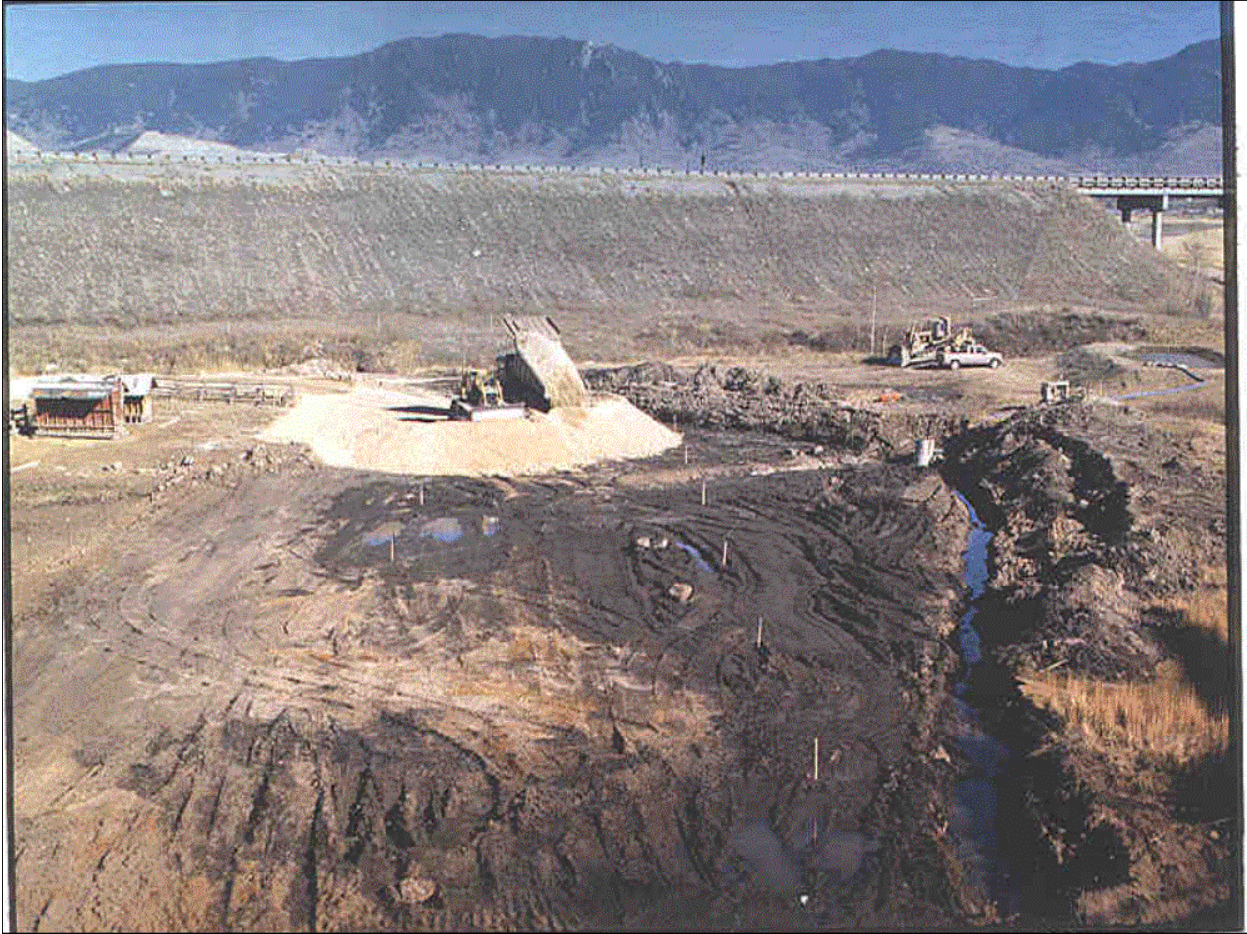
Photo 3. Borrow material being placed over floodplain within SST Operable Unit.

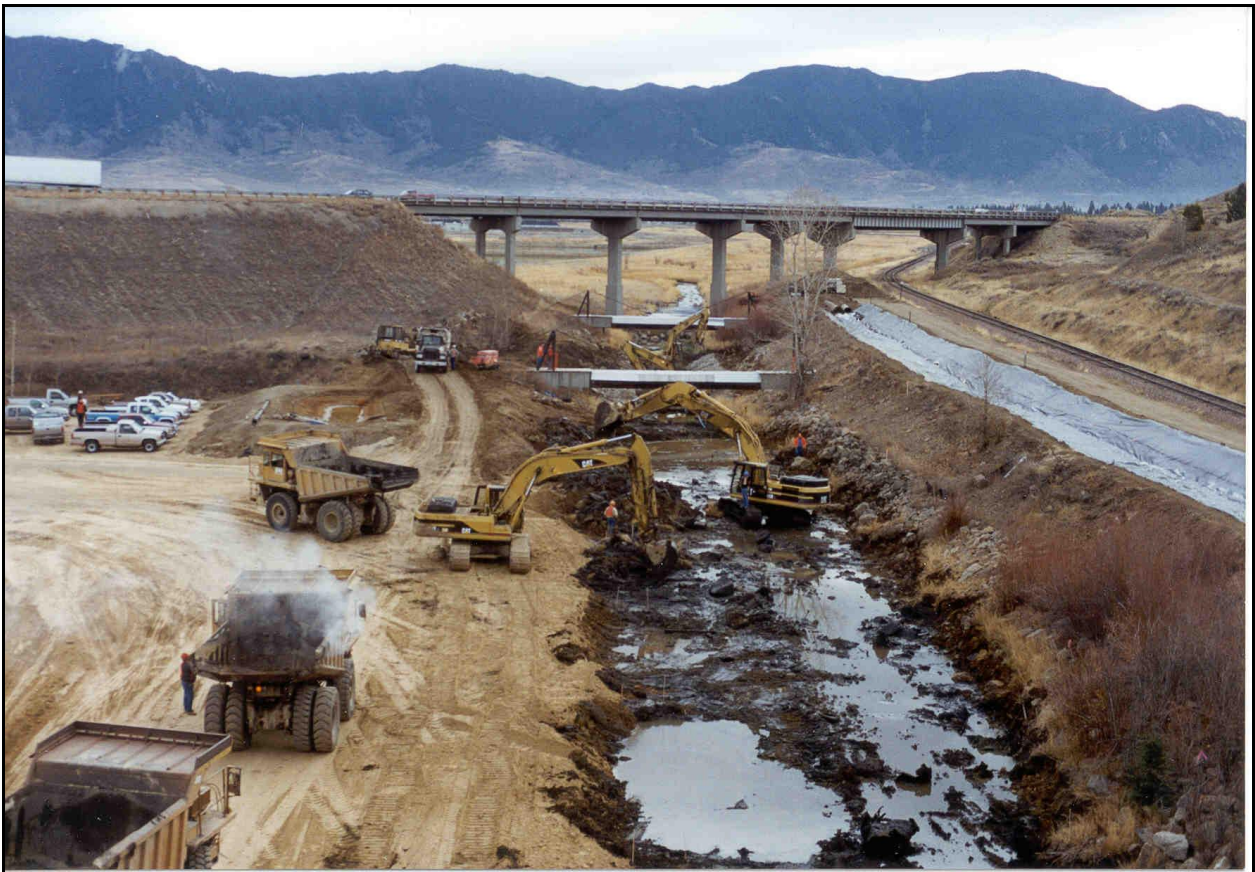
Photo 4. Non-deformable channel excavation with flow in diversion channel at right.

feasible location for the diversion channel was atop a high embankment located between Silver Bow Creek and the Montana Western rail line. The top of this embankment is located 10 to 15 feet above the streambed elevation, therefore providing a substantial challenge for pumping stream flows up to the diversion channel. Stream flows were blocked from the existing stream by constructing a low-head, earthen dam across the channel. The diversion channel extended from the upstream end of the non-deformable channel reconstruction to a point several hundred feet downstream of the non-deformable channel, where it discharged back into Silver Bow Creek (Photo 4).

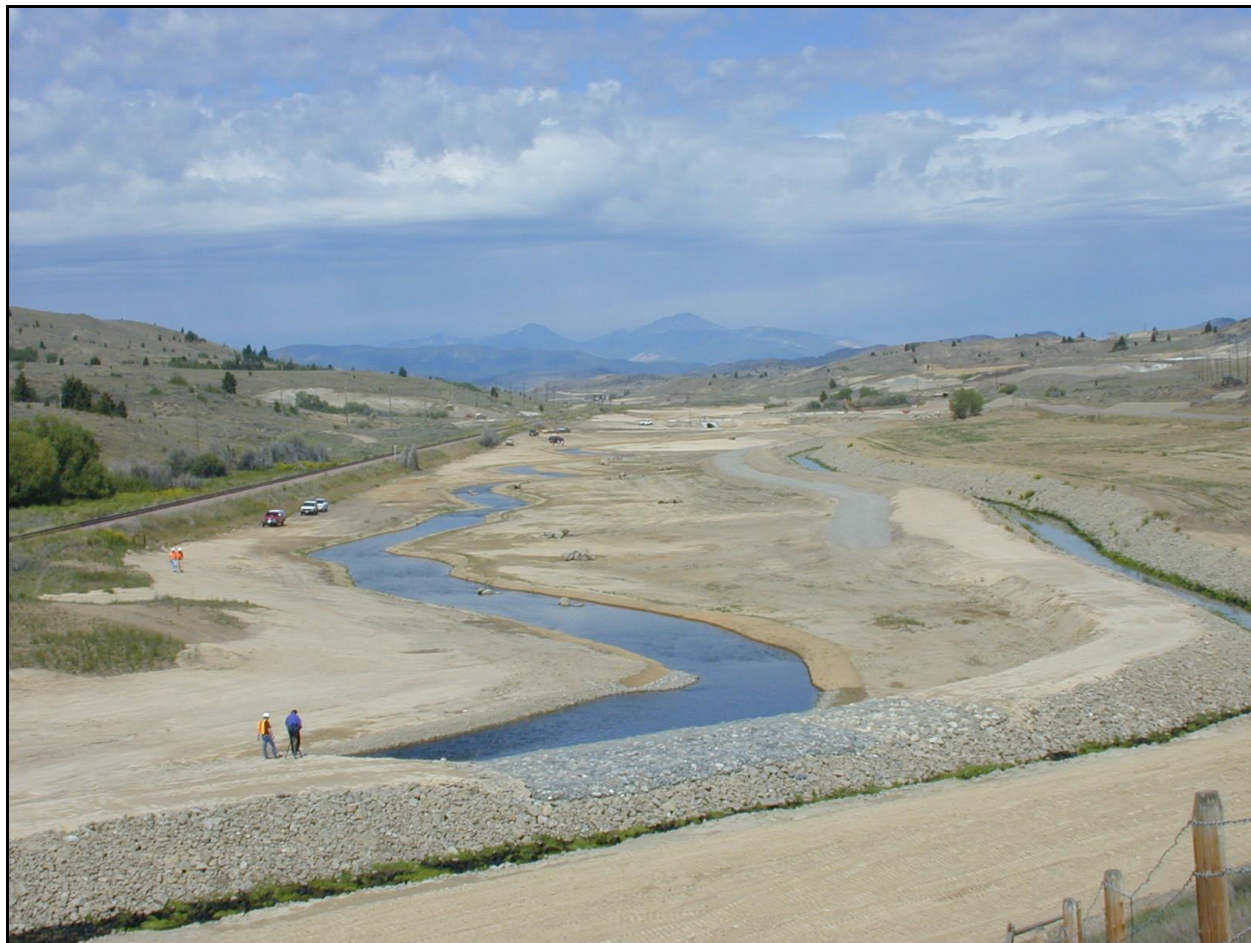
Photo 5. Flow regulation diversion channel (at right), and deformable stream channel (at center).

At the present time, it is anticipated that the diversion channel will remain in place to provide flow regulation for at least several years. Vegetation growth and bank stability in the deformable channel will be monitored closely to determine when flow regulation is no longer necessary. At that time, the diversion channel will be removed and floodplain within its

alignment reclaimed. Photo 5 shows the deformable stream channel and the flow regulation diversion channel.

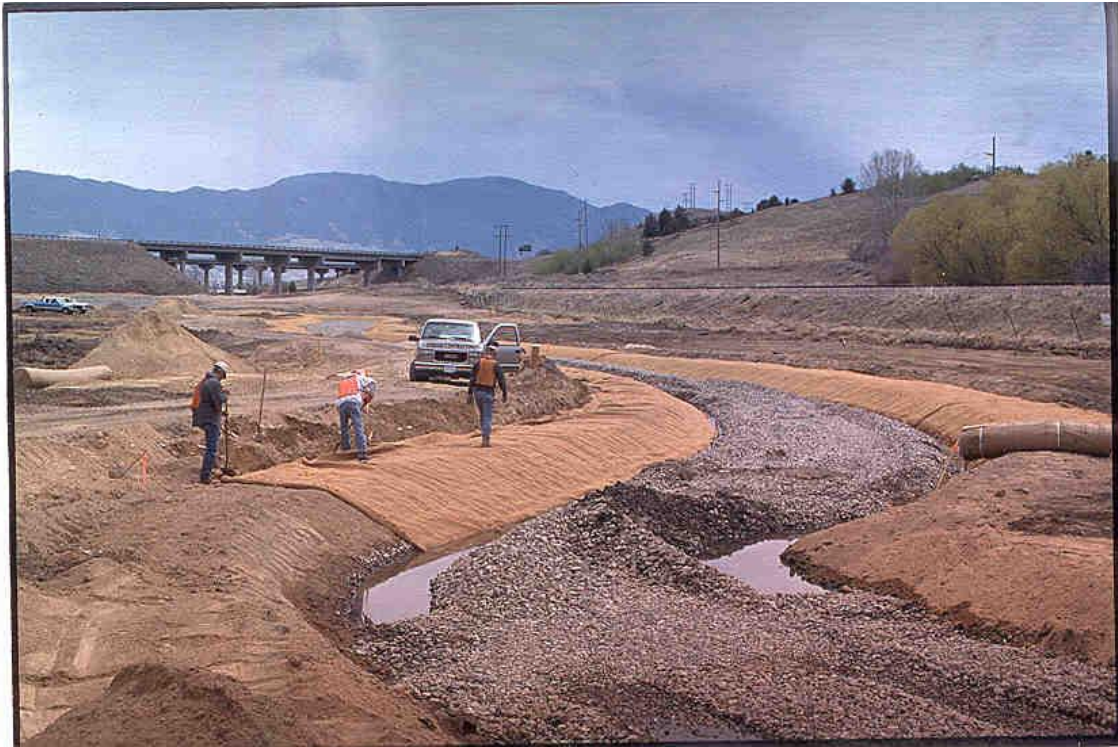
Photo 6. Deformable channel during construction.

Photos 6 and 7 show the deformable channel during construction and immediately following the introduction of flows to the channel, respectively.

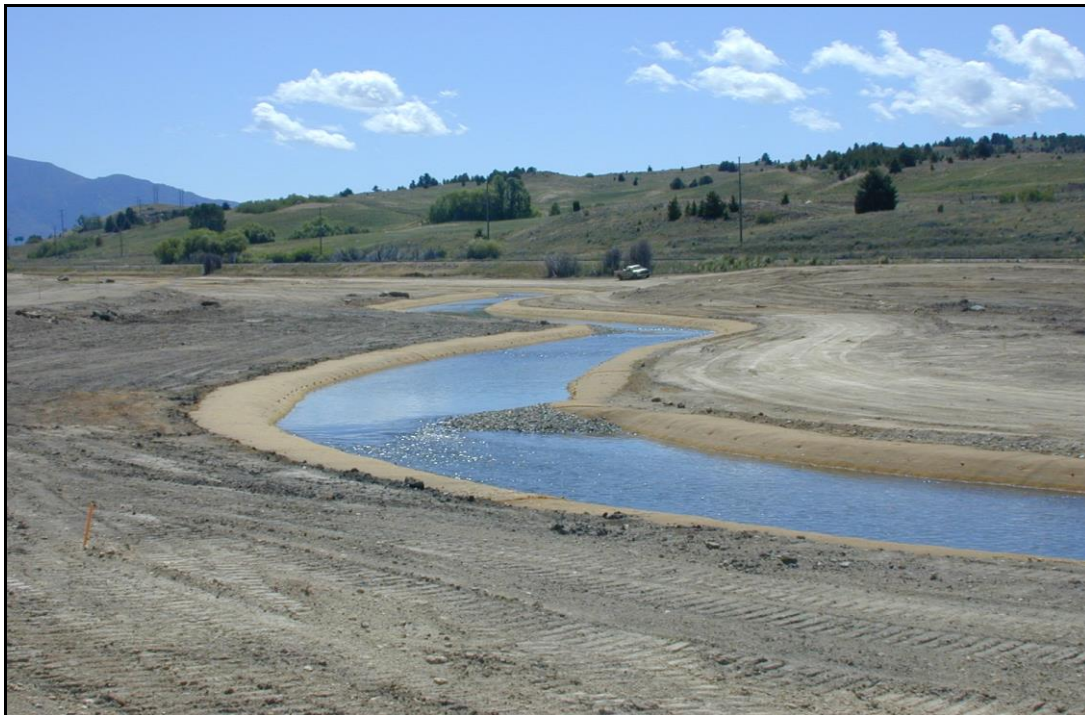
Photo 7. Deformable channel immediately following introduction of flows.
