# ASSURING STABILITY OF MINIMIZED VALLEY FILLS: A REVIEW OF POTENTIAL CAUSES OF INSTABILITY AND AVAILABLE COUNTERMEASURES<sup>1</sup>

Peter R. Michael and Michael J. Superfesky<sup>2</sup>

Proceedings America Society of Mining and Reclamation, 2007 pp 457-491

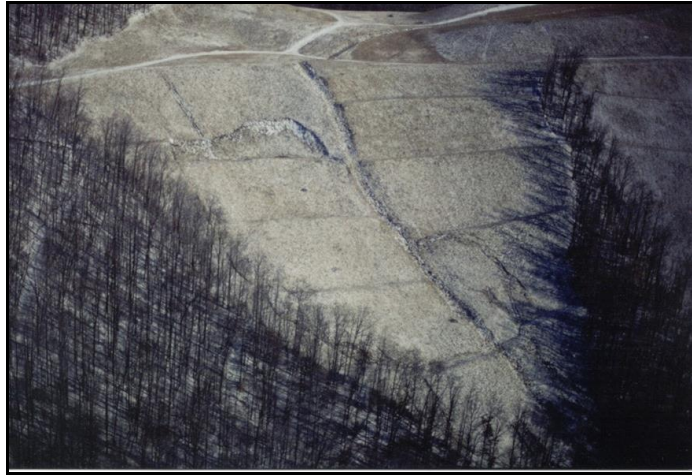
A potential benefit of excess spoil minimization concerning valley fill stability relates to the decrease in soil depth that typically occurs when one traverses from lower to higher elevations up a hollow in steep sloped Appalachia. As a rule we should expect minimized excess spoil fills to be founded on soils that are shallower than those underlying un-minimized fills. All else being equal, this should add stability to the former fill type. However, the limited amount of data we have on valley fill stability indicates that generally thinner soil layers beneath minimized fills does not completely compensate for the effect of steeper foundation slopes. Most natural soils at valley fill sites are composed of colluvium above weathered rock and they tend to thicken downslope towards base level. However, deep soils can occur locally in higher elevations where weak rock types (e.g. mud rocks like shale and claystone) are exposed. Also, in many past and future cases of major fill instability resulting from weak foundations, the thickness of the soil may not be an important factor. Natural landslides in steep-sloped Appalachia are commonly translational as opposed to rotational in nature and this seems also to be true of at least some of the slope movements on valley fills. Translational mass movements of almost entire fill structures can occur above a continuous veneer of relatively thin soil-like foundation material. Figure 10 is an example of translational movements on an excess spoil fill. A separate land slip occurred on each side of the center drain. The one to the reader’s left has a well developed scarp near the crest of the fill outslope and the bottom of the slip is located at the fill toe.

Figure 10: Translational Land Slips on a Durable Rock Fill.  
(Aerial photo taken in December 1999 during  
the EIS fill stability study).

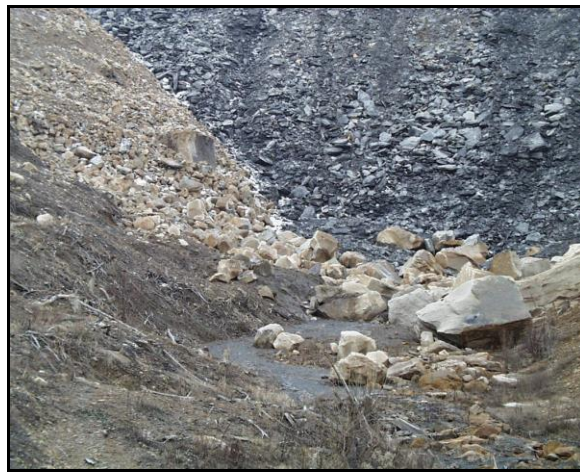
considered to lack underdrains. A similar exercise was performed by KYDMRE and OSM personnel during the Kentucky stability evaluation. Four of 29 durable rock fills visited had “questionable” underdrains. A contrast between effective and ineffective gravity segregation is illustrated in Fig. 11. The photograph shows a unique toe area of a durable rock fill under construction in which two distinct rock lithologies (brown sandstone and black shale) are end dumped from different positions at the crest of the fill outslope. Gravity segregation of coarse sandstone particles at the fill toe is evident. This is not the case with respect to the shale particles.

Figure 11: Comparative Effectiveness of Gravity Segregation between Sandstone and Shale Particles at Toe of Durable Rock Fill Under Construction. (Photo taken in spring 2000 during the EIS stability study).

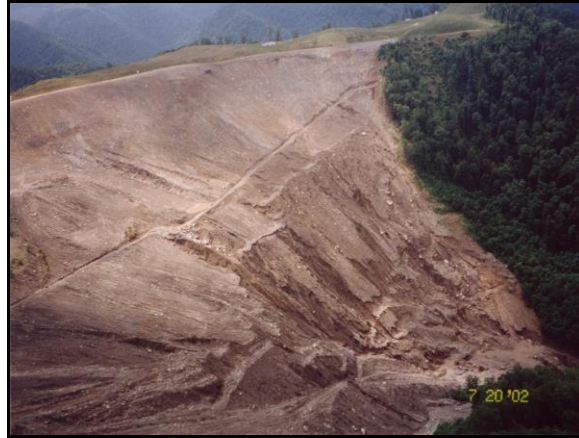
Some of the most dramatic cases of fill-associated erosion, wash-out sedimentation, and localized flooding took place during the last five years in West Virginia (Fig. 12 and 13). These events followed high-intensity rainfall and occurred in small watersheds containing unreclaimed or partly unreclaimed valley fills. Temporary surface drainage

structures were not in place or adequate to handle the high discharge flow. Consequently large volumes of water cascaded over the fill outslopes; causing sloughing and erosion of un-compacted spoil, breaching of sediment ponds, and downstream flooding. The most severe instance occurred in Lyburn, Logan County WV on July 18, 2002 when heavy rains occurred while the face of the fill was being regraded to final configuration.

Figure 12: Erosion and Sloughing on Fill Face from Uncontrolled Storm Runoff.

OSM investigations of these major washout events indicated that future impacts from heavy precipitation can be minimized by: (1) timely and phased reclamation; (2) proper installation and maintenance of surface drainage; (3) proper location of the fills; (4) minimization of additional disturbance of the surrounding area; (5) building in extra sediment and flood storage facilities; and (6) following proper fill certification procedures. However, it is important to note that at least most of these measures should also be used to minimize more gradual erosion over a fill face over an extended time

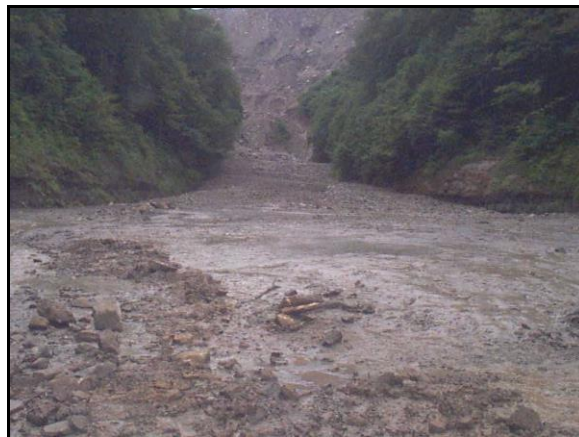
Figure 13: Post-Storm Mudflow and Outwash from Unreclaimed Durable Rock Fill with Inadequate Surface Drainage Control.

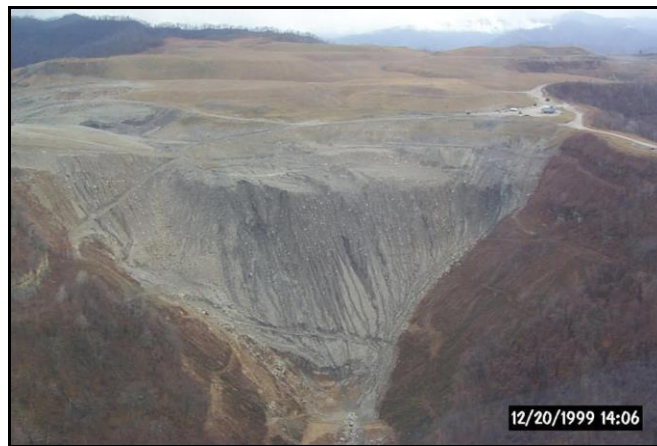
The EIS stability study noted that some durable rock fills were abandoned for long periods of time following partial construction. It found eight cases of unreclaimed durable rock fills where end-dumping or regrading-and-seeding work had not occurred for a year or more (Fig. 14).

Figure 14: Durable Rock Fill Lacking Contemporaneous Reclamation.

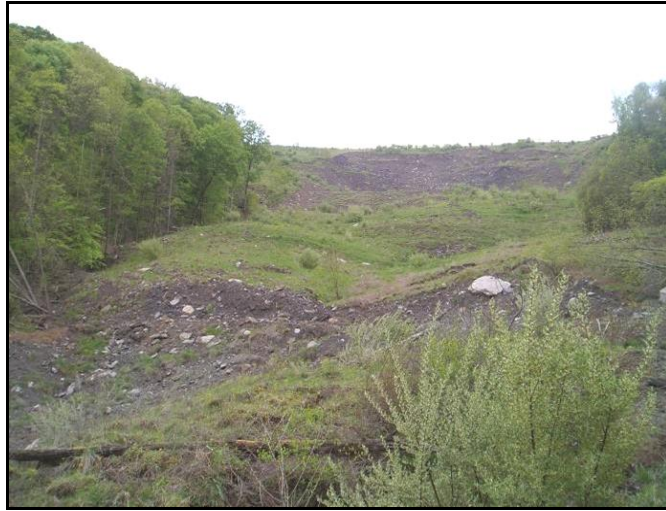
Fortunately, since the completion of the EIS stability study, we know of only one more mass failure in a valley fill (Figure 15). However, the case is emblematic of future instabilities that could occur on improperly constructed fills resting on steeply inclined natural slopes. It is the second time a major failure has occurred on a bond-forfeiture mine site. At the time this paper was written, work was underway to remediate the fill (henceforth called Fill 1). OSM investigated the fill failure in 2005.

Figure 15: General View of Landslide on Durable Rock Fill, Looking Upslope from Toe. (Photograph taken in April 2005).

Not counting tension cracks in otherwise intact portions of the fill face, the landslide affected approximately 90 to 95 percent of the structure. The crown-to-toe length was approximately 354 meters (1,160 feet); the maximum width between side scarps, about 183 meters (600 feet); and the vertical drop and lateral transport distances were approximately 61 and 79 meters (200 and 260 feet), respectively. In addition to the 61-

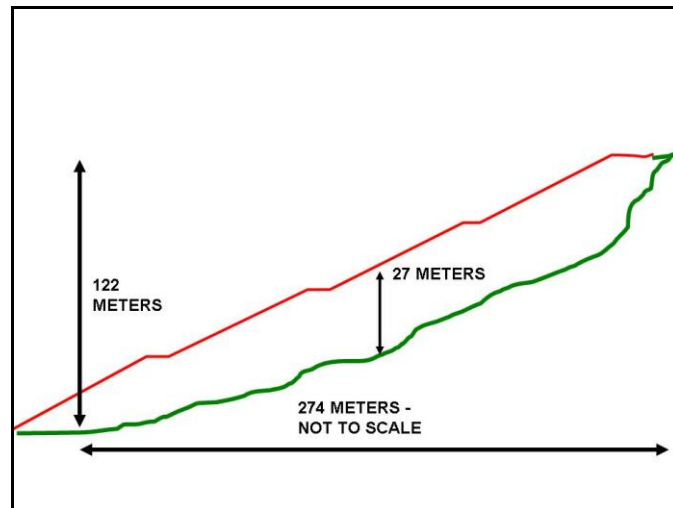
Figure 16: Schematic Cross Section of Fill 1 Prior to Failure. The steep foundation of the fill results from its construction from the crest of the natural slope and its minimized length.

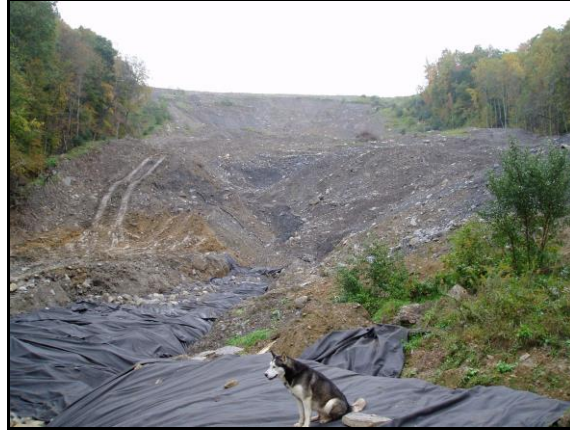
The spoil materials exposed in the landslide scarps were poorly sorted, exhibiting a roughly even volumetric distribution of clay-to-gravel grain sizes. Assuming that the relative amount of gravels and boulders in the observable spoil was roughly indicative of the amount of durable rock present, an OSM investigator estimated to percent durable rock by volume to be somewhere between 30 and 40 percent. There was no evidence of gravity segregation of particle size in the exposures of the spoil. The low percentage of durable rock and absence of gravity segregation were apparent during a site visit in April 2005. As Fig. 17 illustrates, those observations were confirmed at depth after the toe region of the fill was excavated for underdrain installation.

Figure 17: Particle Size Distribution at the Toe of Fill 1. The photograph was taken by KYDEP during new underdrain installation in October 2006.

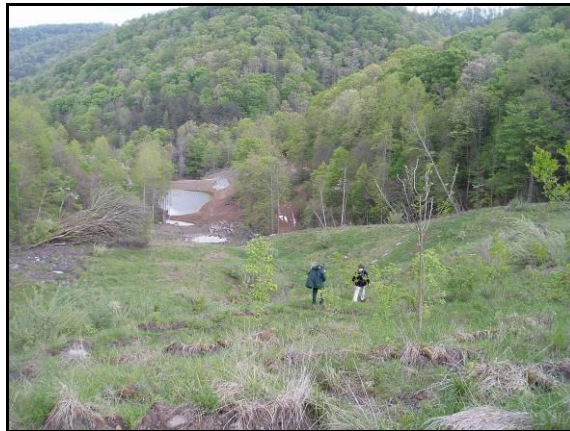
Evidence of another potential factor behind the failure was found just beyond the toe of the slide: a thick sequence of colluvium and deeply weathered bedrock, exposed by the construction of a new settlement pond and haulage road, may be indicative of weak foundation conditions beneath the fill (Fig. 18 and 19).

Figure 18: View of Toe and Settlement Pond from the Outslope of Fill 1. Exposure of thick colluvium and weathered bedrock occurs to the right of the pond. (Photo taken in April 2005).

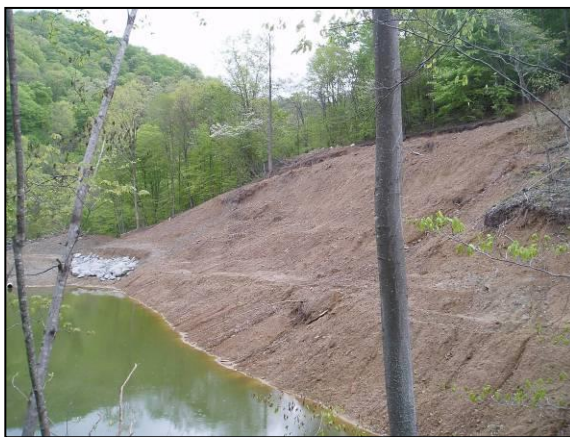
Figure 19: Close-up of Colluvium and Weathered Bedrock Near Toe of Fill 1. (Photo taken in April 2005).

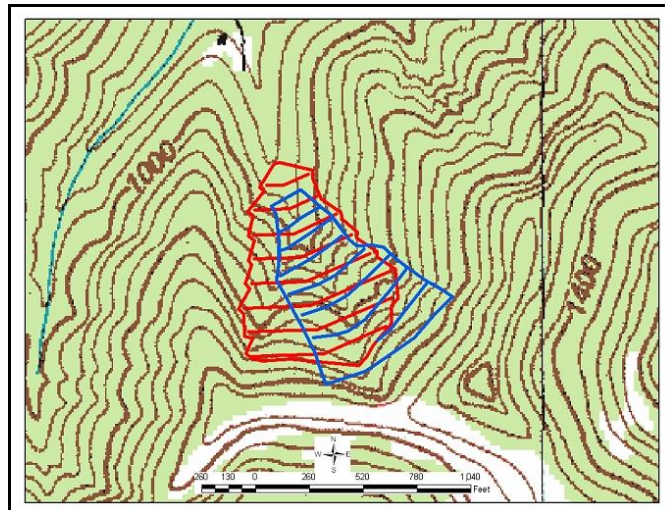
The engineer’s construction certifications, extending from September 29, 1997 to January 8, 1999, indicate that end-dumping was completed by December 31, 1997. Final certification, post terracing, diversion-ditch construction, and revegetation, was first submitted by the mining company on December 4, 1998. The KYDNR returned the certification “...due to deviations from the proposed design” (January 1, 1999 mine inspection report). The “deviations” involved about a 46-meter (150-foot) sideways shift in fill location, from as-designed to as-built, within the hollow (Fig. 20). The final certification, with new stability analyses for the as-built fill, was resubmitted on January 8, 1999.

Figure 20: Shift in Fill 1 Location from As-Designed (Red) to As-Built (Blue).
