CASE STUDY ON THE REMEDIATION OF THE DEFUNCT COAL MINE ARBOR COLLIERY, IN MPUMALANGA SOUTH AFRICA¹

Chris Waygood², Mike Palmer, and Rod Schwab

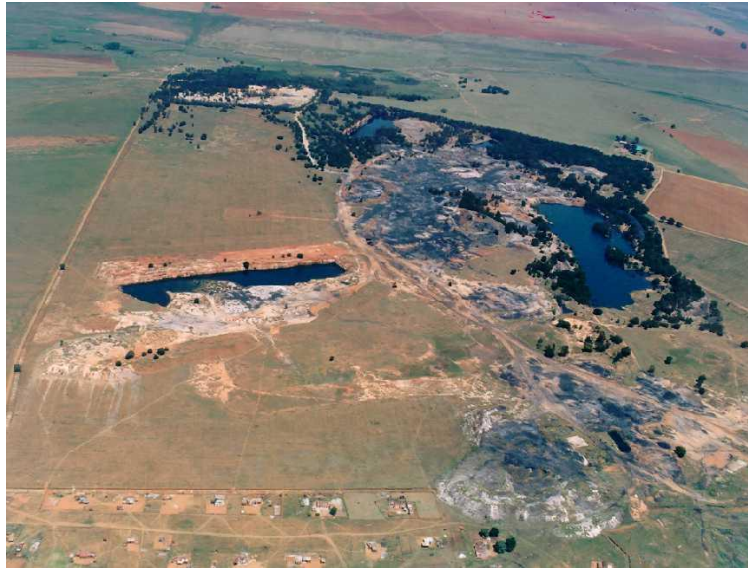
Figure 2: Aerial view of Arbor Mine

An aerial view of the mine is shown in Figure 2. Various pits can be noted, and sampling of water within the pits indicated acidic conditions in the pits (pH of between 2 and 3), elevated sulfate levels (between 106 and 1353 mg/l) and elevated metals (Fe ranging from 0.2 to 17.6 mg/l; Mn ranging from 2.3 to 2.8 mg/l; and Al ranging from 9 to 102 mg/l).
