DECOMMISSIONING OF TAILINGS AND WASTE ROCK AREAS AT STEKENJOKK, SWEDEN $^{\rm 1}$

Per G Broman and Torbjörn Göransson²

Abstract: The zinc-/copper deposits at Stekenjokk were discovered in 1918. Operations started in 1976 and continued until October 1988. The operation left a 110 ha tailings and clarification pond, a minor open pit, waste rock dumps and surface installations mainly comprising a head frame with ore bins and a combined concentrator, workshop and office building.

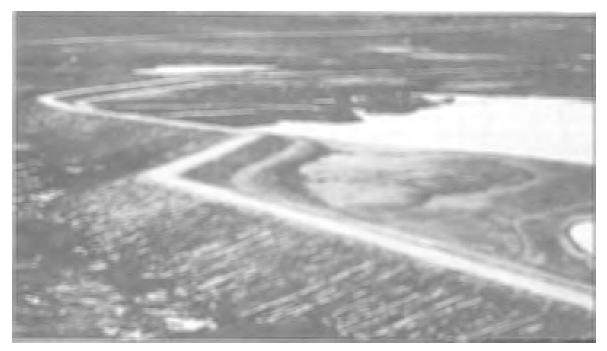
Figure 6. The completed downstream dike.

The work was initiated in the summer of 1990 and was completed by late summer 1991. The work on the dikes, mainly the nearly 2-km-long downstream dike, provided an excellent opportunity for eliminating the existing sulfide bearing waste rock dumps (see figure 6). Large amounts of sulfide free waste rock were required to raise the dike and reduce its slope to a 1:3 proportion. An erosion-inhibiting, breakwater shelf was set in place on the dike's inner side. Here, large amounts of sulfide-bearing waste rock were deposited to ensure safe underwater disposal during a long period. The breakwaters were constructed using similar type waste rock and, preferably, such material that required underwater deposition for safe, long-term disposal. The breakwaters were constructed somewhat in a checked pattern, which covered the shallow part of the future lake (see figure 7). The tailings were excavated and removed using the breakwaters as working and transport surfaces for excavators and hauling vehicles. The tailings' ground water level proved to be higher than originally calculated, resulting in water saturation of the tailings surface occuring prior to the final depth being reached. Driving vehicles over such material was impossible. In this instance, the area's plentiful supply of crushed waste rock turned a drawback into an advantage. By using waste rock, the surface could actually be made sufficiently stable for trafficability. Approximately 100 hectares, or one-tenth of the surface, were thus covered with waste rock. About 90,000 m³ of tailings were excavated from other locations, hauled to the lower-lying areas, and deposited.

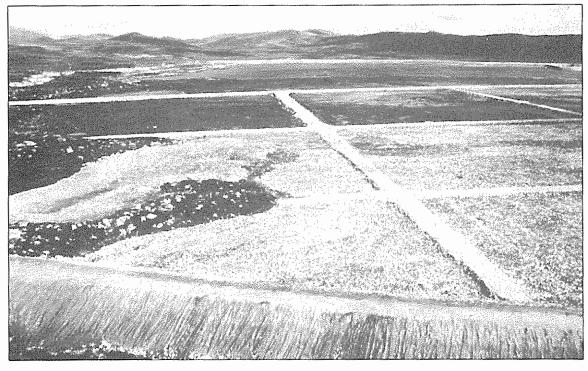
Figure 7. Breakwaters in the shallow part of the lake.

The water has risen to a level covering the adjoining land area on the lake's western shore. The surface of the water remains undisturbed, except when strong winds blow, wherein the waves are broken along the breakwaters. In the event of a 1,000-year drought, the breakwaters would be visible, even during a calm. To the casual onlooker, this lake is indistinguishable from any other in the area. Eventually, normal biological life should develop in the lake.

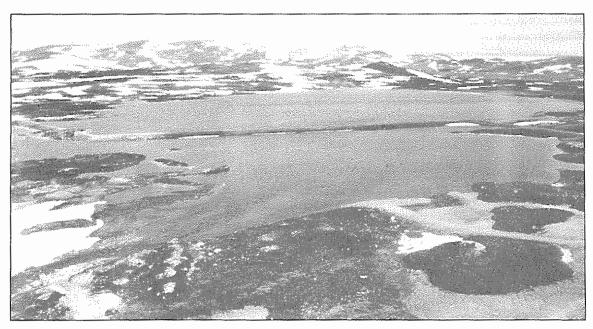
Figure 8. The tailings pond following flooding (the photo's middle and background). Shown in the foreground is the raw water pond.

Figure 8 shows the area when completed.

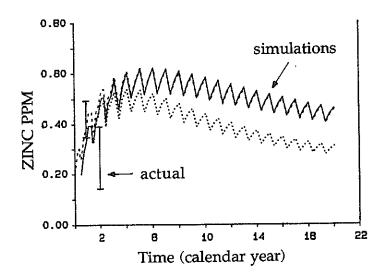
The simulations of the lake's water quality development are shown in figure 9. In the figure, the anticipated development of the zinc content, under two assumptions, is shown. The simulations assume that a maximum zinc load of about 800 kg will be transported by overflow from the lake annually. This is the same level as when operations were underway. Ultimately, this transport will decline to very low levels.

The effect of the decommissioning will be followed by means of a monitoring program which primarily is focused on a 5-year period. Results to date have been positive. The zinc contents from samples taken from spillway water are also illustrated in figure 9 and are well within the anticipated range.
