Investigation Of Surface Effects From Mine Subsidence In Mountainous Terrain.

By Clyde DeRossett

Proceedings America Society of Mining and Reclamation, 2000 pp 137-143
DOI: 10.21000/JASMR00010137

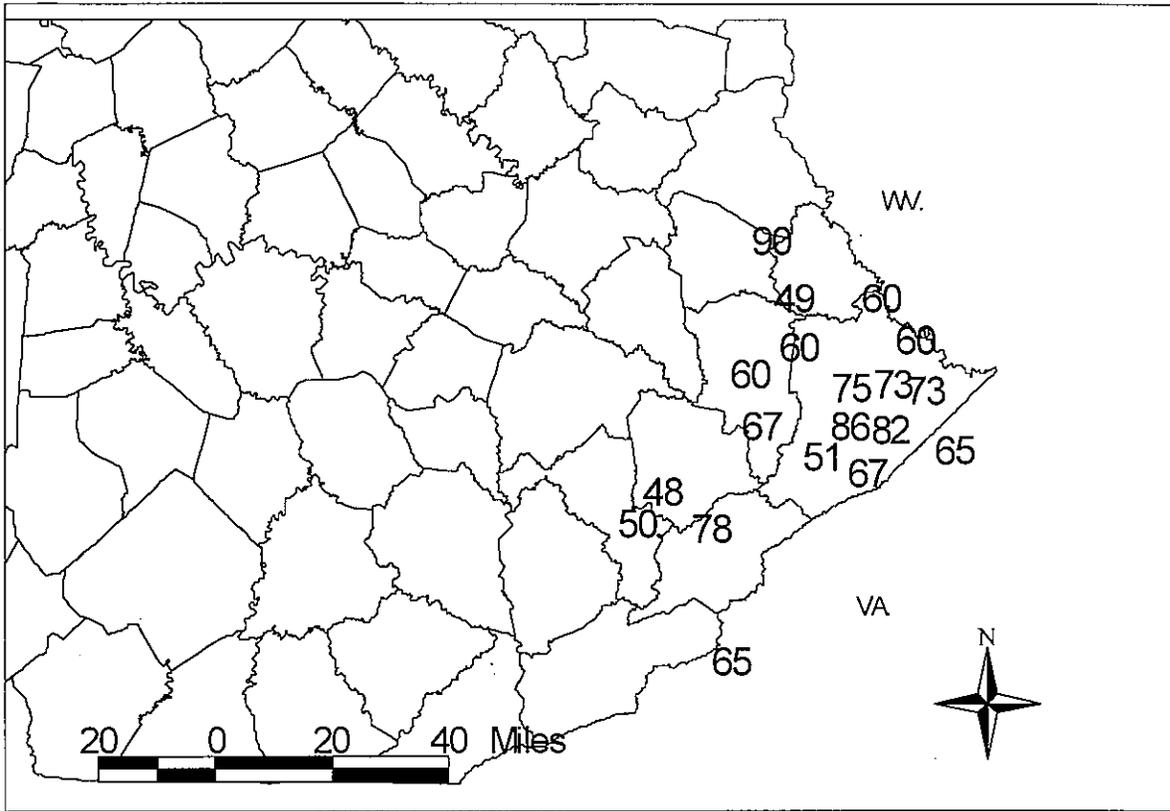
A database of surface fractures in eastern Kentucky is shown in Figure 1. The data set consists of 21 cases located throughout the eastern Kentucky coal region. This is an enlargement of a database done several years earlier and this trend is supported by additional data collected. Study of the database revealed several factors that illustrate some of the differences between mine subsidence in the mountainous terrain of eastern Kentucky as compared to more level land. The clearest trend in the data set is the tendency of surface fractures to occur on the uphill side of the retreat mining area (the "pillared area"). Only one of the cases has a fracture located on the downhill side of the retreat mining area. Two of the cases have fractures inside of large areas of retreat mining. This trend was also noted by subsidence research done in eastern Kentucky (Minns 1996). It is also interesting to compare the seam height to occurrence of the surface fractures. The mean height of the seams is 65 inches with all of the data being in the range of 48 to 90. To put this data in perspective it should be noted that 47 percent of all the mines in eastern Kentucky reported a seam height below 40 inches (1998 Kentucky Department for Mines and Mineral data).

Figure No. 1. Location and Seam Height (in inches) for Surface Fractures in database.

and amount of subsidence were used to predict the value. The surface fracture database seems to correlate with this data especially given the fact that so much of the mining in eastern Kentucky coalfields is done in thin seam mines. The dataset indicates that fractures tend to occur in coal mines with a greater mine void height which provide the greater surface subsidence (Figure No. 3). Higher than predicted horizontal displacement and large fractures located on the uphill side of pillared areas also indicate another phenomenon that needs to be considered. Downslope movement of the mountain will result in a compressional stress at the base. This compressive stress can impact structures located on the surface. This phenomena has been documented by others (Lin et al 1987, Khair and Molesky 1988) and has been observed in several cases investigated by the author. The trend of the fractures occurring on the uphill side, with fewer fractures found on the downhill side of the mountain indicates that compressional stresses are likely. It also is good practice when investigating subsidence damage claims to check the location of the uphill side of retreat mining area for evidence of surface subsidence. Absence of any surface fractures however, cannot be taken as proof of no mine

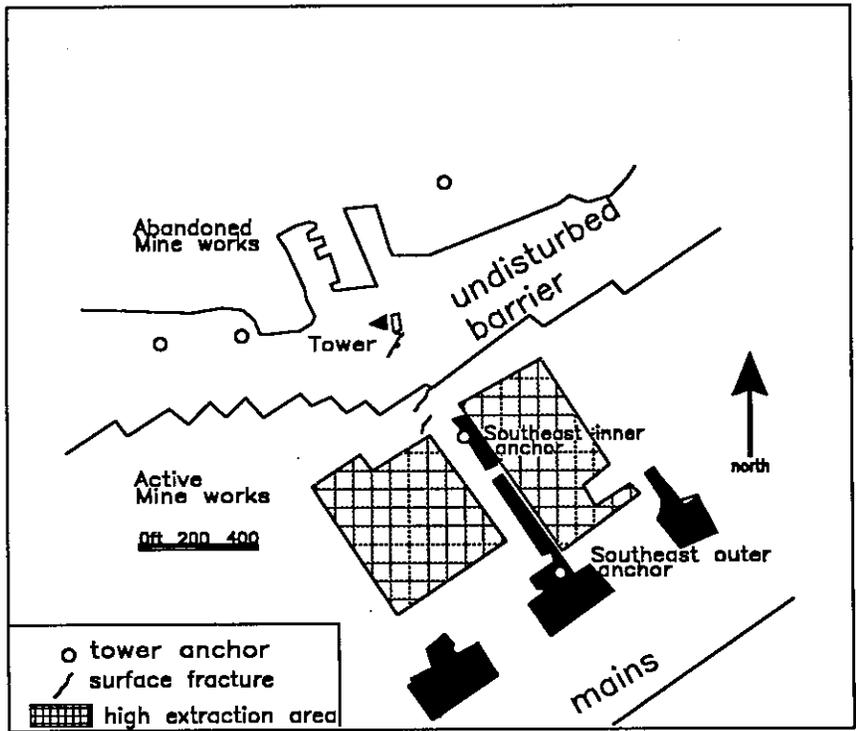
One of the most important parts of many of our investigations is the collection of surface features and mine information for the area. The tower is situated in relation to the mine works as shown in Figures No. 4a and 4b. Several surface fractures were present, with the closest 90 feet from the base of the tower. Several others were reported at the site and reconnaissance showed evidence of more subsidence. Four surface fractures were initially reported to be present at the site. Three of the surface fractures were mapped as shown in Figure No. 4a.

The abandoned Hazard no. 4 seam mine was examined to determine to what extent its expected influence was near the tower. This was done by looking at the radius of influence of expected subsidence from the mine works. Both 15 and 27-degree angles were used to construct the extent of the influence at the site. These two angles were chosen because the 15-degree angle is often used in designing a subsidence protection plan and VPI database of subsidence cases would support the peak tensile strain to occur within that range. The 27-degree angle was used, as this was the projected angle-of-draw given for super critical conditions given by the VPI database (Agioutantis et al. 1987). As discussed above, the extent of the radius of influence normally accepted in level terrain may not

Figure No. 4a Hazard no. 4 Mine works.

The active mineworks were examined to determine the possibility of surface subsidence affecting the tower. Location of the mine works to the tower was close enough to have affected the tower and high extraction mining was done in the area. It was also noted that mining in the area occurred in July to September, this matches the occurrence of the surface fractures that first appeared in September of the same year. The location of the inner anchor (the anchor closest to the tower) was located over or near a barrier pillar shown on the mine map.

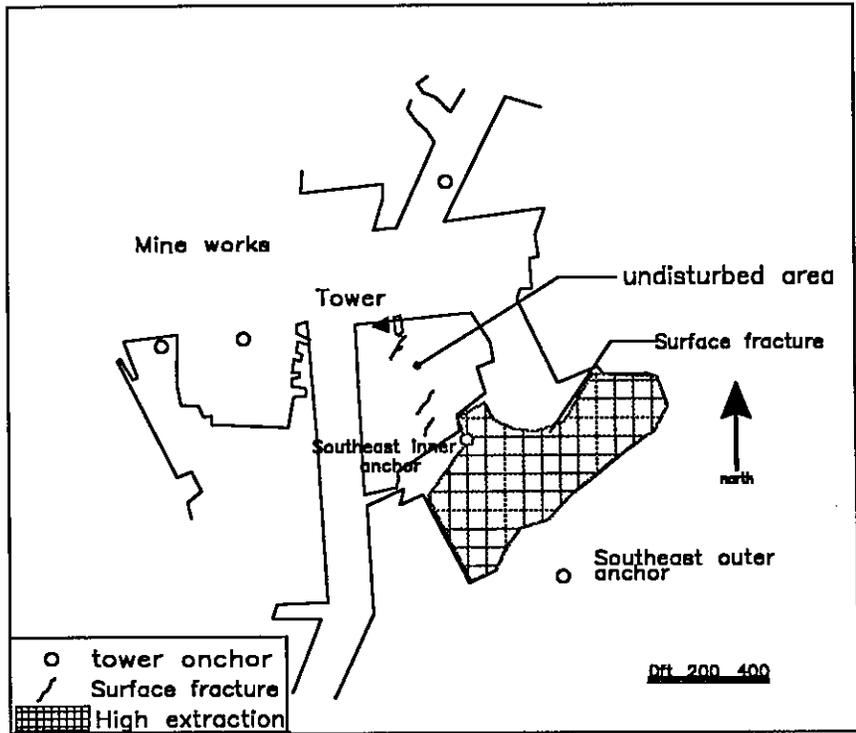
Figure no. 4b Abandon mine works in the Hindman seam.

The third mine was located approximately 600 feet above the active Hazard no. 4 mine (about 300 feet below the tower) and had mine works over the area of the tower and the surface fractures (see Figure No. 4b). These mine works were shown to have the mine pillars intact and the pillars were substantial enough to have supported the overburden. Review of the mine map showed pillaring operations only in small areas. The radius of influence for this area would not extend to the fracture closest to the tower. The fourth fracture found in the woods away from the tower plotted at the edge of the pillared area. This would be at a location that we typically locate these fractures. This would give some validation to the mine map accuracy.

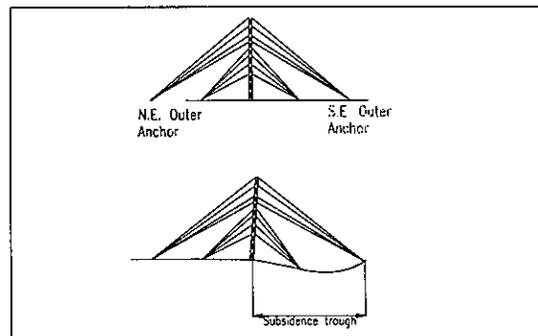
A subsidence model SDPS (developed by VPI for the OSM tips program) was used to analyze the potential of the active Hazard no. 4 seam mine to create strain values sufficient to create the surface fracture on the surface. Default values of subsidence factor, strain factor, and angle of break were used. The predicted subsidence at the southeastern inner anchor was approximately 7 inches. Maximum strain values given near the tower was 0.0016 about the threshold of where some surface damage would be expected. (Agioutantis et al 1987). As mentioned earlier, this predicted value would be expected to be lower than actual field values due to the location of the anchor on the uphill side of the high extraction areas. Analysis for the area near the outer southeast anchor showed a surface subsidence of 3 inches. The maximum subsidence given by the model was a little greater than 14 inches. Comparing this to the information concerning the adjustment of the anchors supports the model prediction that a greater amount of subsidence is occurring at the inner anchor. Information from the tower adjustments and the model indicate that Figure No. 6 was a valid conceptual model of the surface deformation in the area.

Figure No. 6. Conceptual model of ground movement at tower.
