# RELEVELING AND BEHAVIOR OF STRAP RETROFITTED DAMAGED TEST FOUNDATIONS EXPOSED TO MINE SUBSIDENCE<sup>1</sup>

by Gennaro G. Marino, Ph.D., P.E.<sup>2</sup>

**Abstract.** Test foundation walls were constructed in an area of planned subsidence. These crawl space-sized block bearing walls were located in the tension zone of a longwall panel. The test walls were 12.2 m (40 ft) long and were vertically loaded on top with soil bins to simulate the house weight. As the longwall proceeded past these test foundations subsidence movements damaged the test structures. Using a steel strap retrofit and applying a cementitious surface coating, the foundations were structurally and aesthetically repaired. The repaired test foundations underwent significant subsequent subsidence as an adjacent longwall was mined beneath. The response of the repaired foundation is summarized. The second part of the paper describes releveling another set of the damaged test foundations after the first subsidence event by using an innovative procedure. First the straps were applied to the block bearing walls and then with wall jacks the top of the walls were successfully made level. This releveling procedure is ou

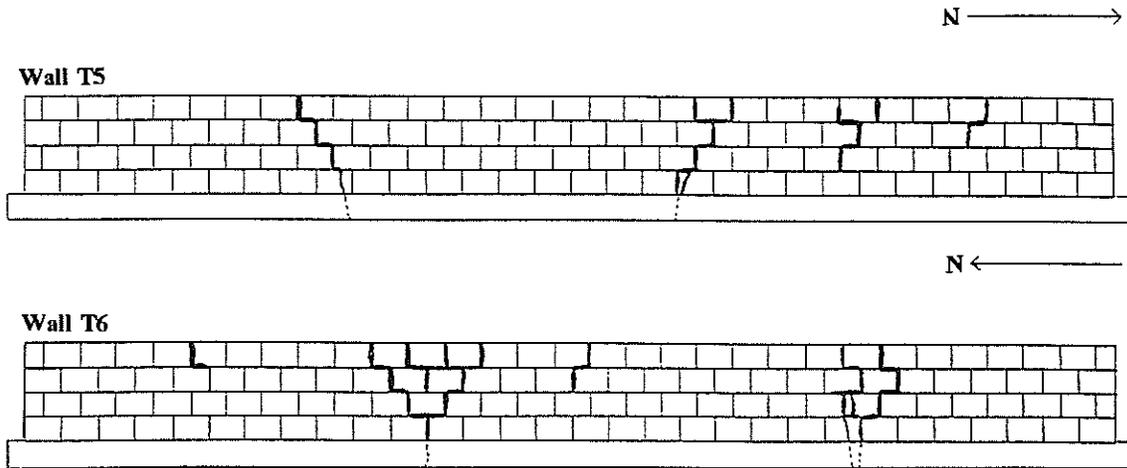
FIGURE 3 MAIN CRACKING IN FOUNDATION T5 AND T6 (MAY, 1991)

The strap retrofit system used in the field test is illustrated in Figure 4. For test foundation T5, the strap retrofit was applied to both the east and west sides, and for T6 a strap was applied only to the east side. The total cross-sectional area of the steel was the same, however, for both walls. The purpose of attaching straps to both faces of wall T5, and only one face of wall T6 was to evaluate single strap performance and compare it to the performance of the wall with reinforcing straps on both faces. It was important to evaluate single strap performance, because if the larger single reinforcing straps perform adequately, the necessary reinforcement can be applied entirely to the interior wall faces. This procedure modification would be more cost efficient than applying straps to both sides especially where excavation would be required. Also note as shown on Figure 4, the amount of steel applied to the wall surfaces increased towards the middle of the walls. This increase in steel was calculated based on the increased bending moments estimated from the expected hogging-like subsidence movement resulting from when the southern panel is mined.

There were five main steps taken in retrofitting the damaged test foundations. First, the steel required for the repair was determined. Second, the first stage of repair was done and the walls were cleaned. This included filling open wall cracks in the expected zone of compression with mortar. By doing this large wall deflections due to crack closure were prevented. Shear strength was restored to the walls by grouting reinforcement into the cells of the concrete blocks in areas exhibiting diagonal shear cracks. Cleaning the walls was then completed, thus enabling the epoxy and fiber-cement to adhere to it. Third, the steel reinforcing straps were prepared for attachment. Fourth, the external reinforcing straps were attached to the walls to increase wall bending capacity. Fifth, a surface finish of fiber-cement was applied to the walls to improve the retrofit

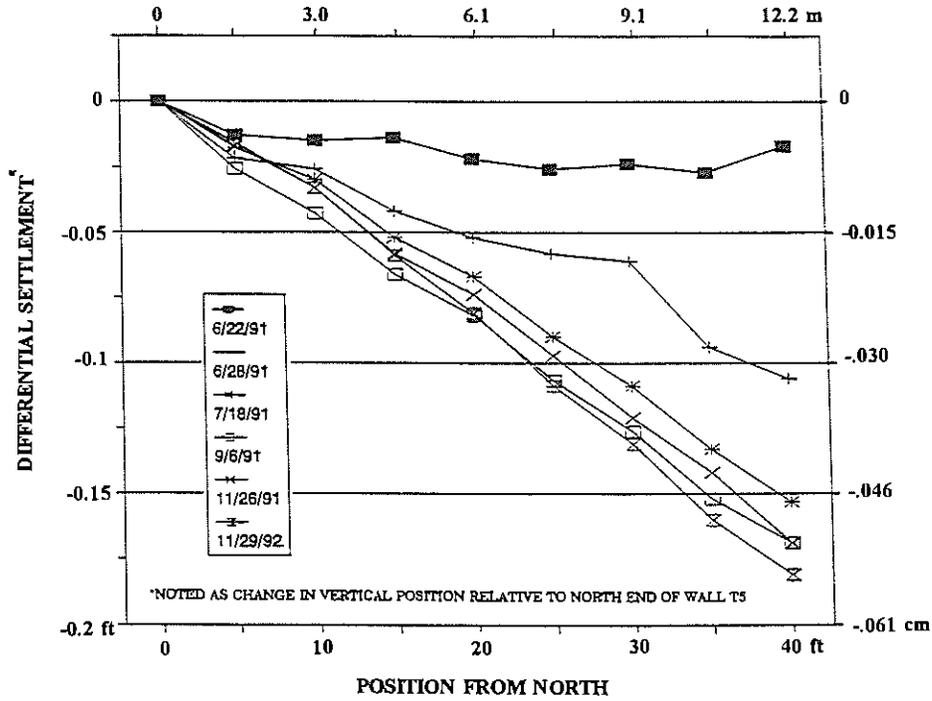
Based on the survey data taken during subsidence, the wall and footing settlement profiles for each retrofitted foundation are similar (even though steel was placed on only one side of T6 compared to both sides of T5). Furthermore, these profiles show the foundation walls and footings undergoing a more definitive hogging curvature with time. To demonstrate these points, foundation settlement measurements for T5 relative to the positions on 14 May 1991 are shown in Figures 5 and 6. Note only selective profiles are shown for clarity.

FIGURE 5 DIFFERENTIAL SETTLEMENT OF RETROFITTED WALL OF FOUNDATION T5

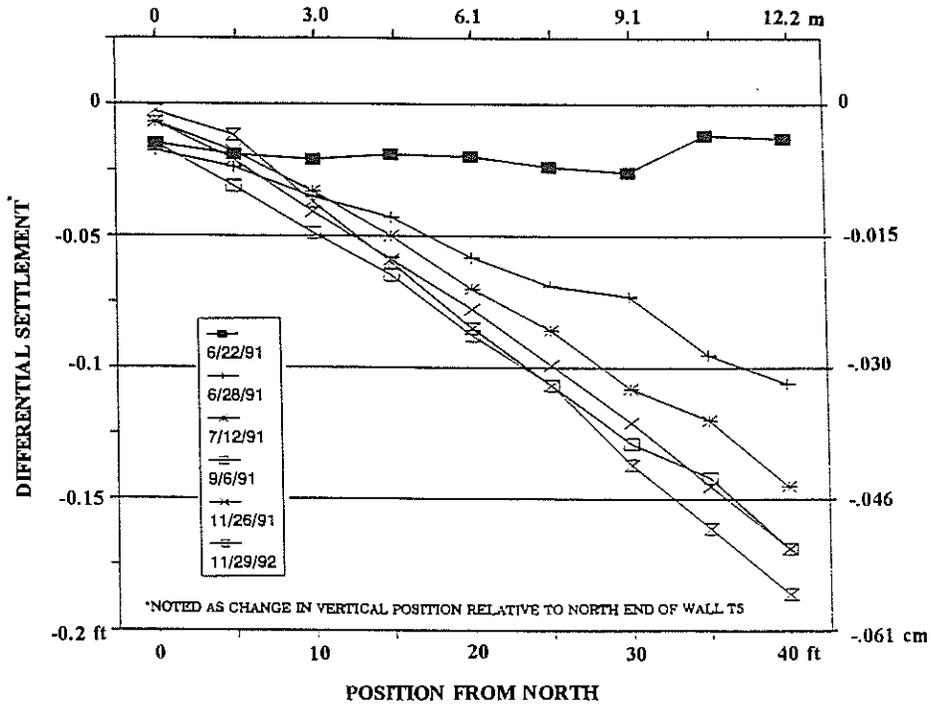
FIGURE 6 DIFFERENTIAL SETTLEMENT OF FOOTING OF FOUNDATION T5

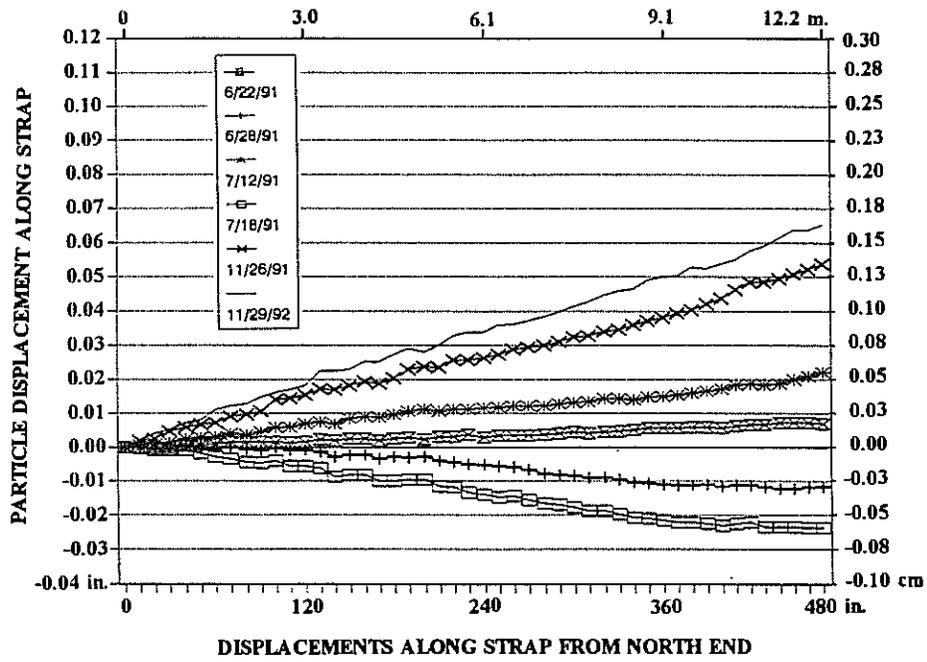
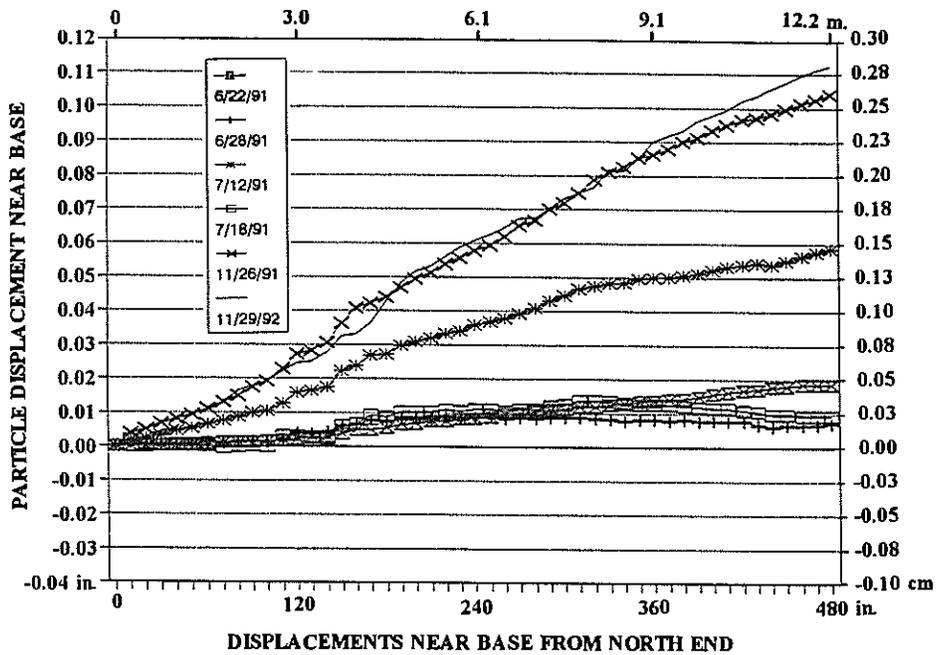
As can be seen in Figure 7 little overall change in strain (as determined by the slope of the line) occurred between November 26, 1991 to November 29, 1992. Changes in the average longitudinal strain over this period of time ranged from about  $-2.0 \times 10^{-5}$  to  $3.0 \times 10^{-5}$ . Even peak average strains during the entire test period were small and were  $2.4 \times 10^{-4}$  in tension and  $-4.8 \times 10^{-5}$  in compression. Even though these strain values may appear low compared to the increase in the angular distortion (or deflection) of the walls (see Table 2), they are actually greater than values that would be predicted by the classical curvature-bending strain relationship (Popov, 1968) which is:

FIGURE 7 RELATIVE PARTICLE DISPLACEMENTS ALONG EAST FACE OF RETROFITTED WALL OF FOUNDATION T5

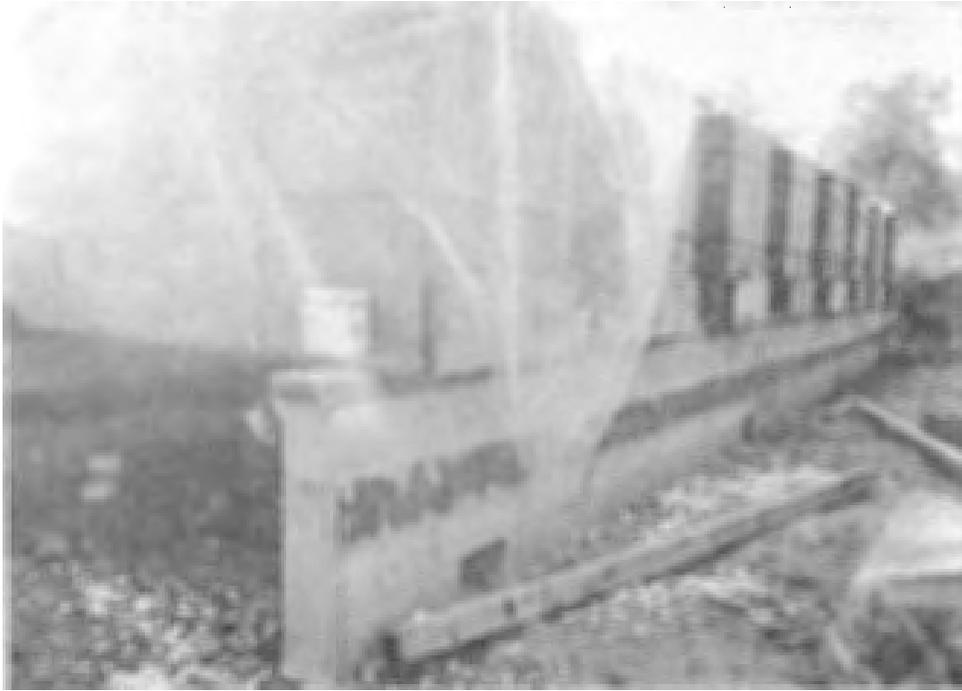
FIGURE 10 ALL JACK WINDOWS KNOCKED OUT

Structural preparation similar to that conducted on Foundation T5/T6 was performed on T3/T4. (Note here, however, vertical steel straps were used in lieu of grouted-in rebar for shear strength repair. This was the first attempt at using vertical straps on the walls for shear strength repair.) Windows for the jacks were knocked out in the lower course of block at the prescribed places along the walls (see Figure 10). Bottle jacks were then inserted in the windows (see Figure 11).

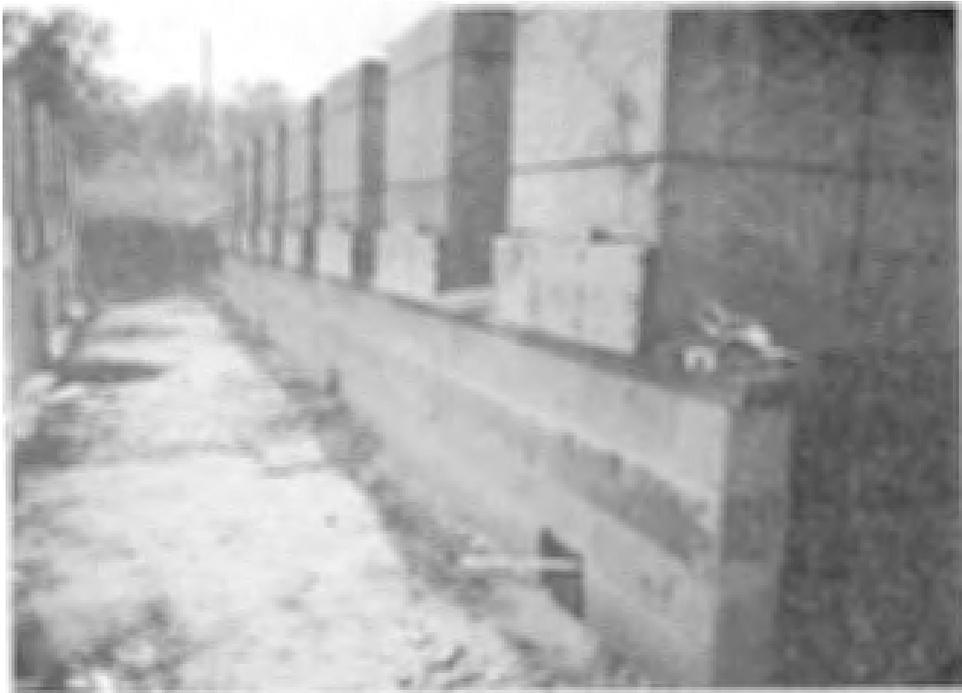
FIGURE 11 JACKS INSERTED IN WINDOWS

The jacking process was conducted in three stages: 1. uniformly lifting walls 2.5 cm (1 in.); 2. rotating walls to level positions; and 3. adjusting jacks to straighten the top of the walls (see Figures 11 to 13). The main purpose of Stage 1 was to provide sufficient separation as to allow the north ends of the walls to rotate as the lower south ends were jacked upwards.

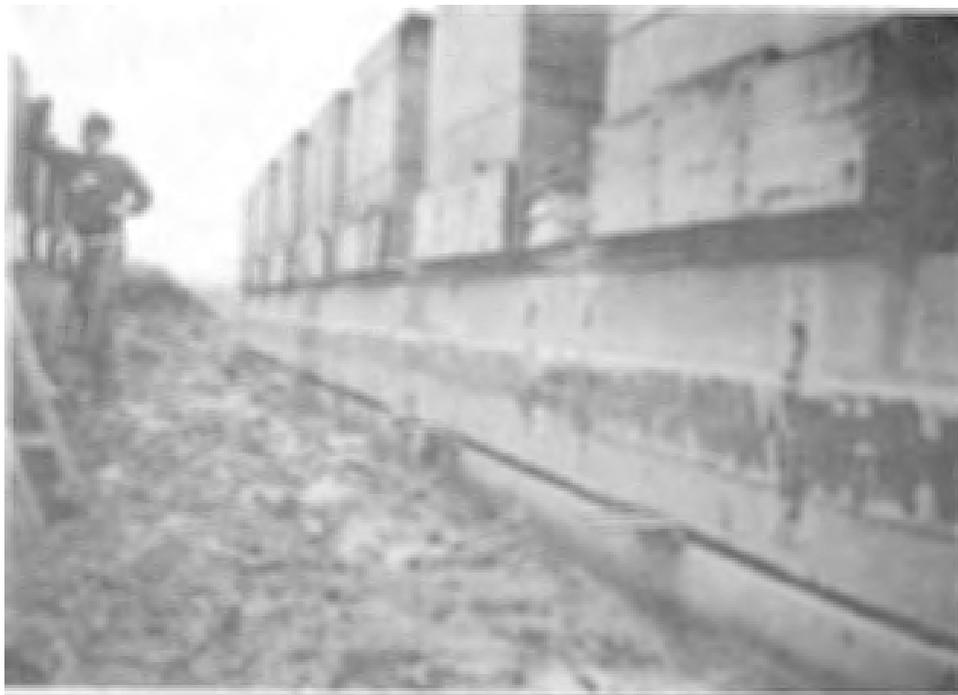
FIGURE 13 FINAL JACKED POSITION OF WALL

Although the walls were level end-to-end it was discovered that the middle of the walls were about 3.8 cm (1.5 in.) higher. This was determined by stretching strings from one end to the other at the tops of the walls. The tops of the walls were then straightened out by adjusting the jacks until both strings were coincident with the tops of the walls (see Figure 13). With the walls now straight the jacking was complete. The induced mortar joint separations were supported with additional shims and the jacks were removed.

After all the jacking was complete and the walls were straight and level, the most stressed point measured in the steel (based on Whittemore gauge measurements) reached only about 20 percent of its yield strength.
