MONITORING OF A HOUSE DURING MINING SUBSIDENCE

G. Lin¹, E.C. Drumm², R.M. Bennett², L. Powell³

Proceedings American Society of Mining and Reclamation, 1996 pp 184-203

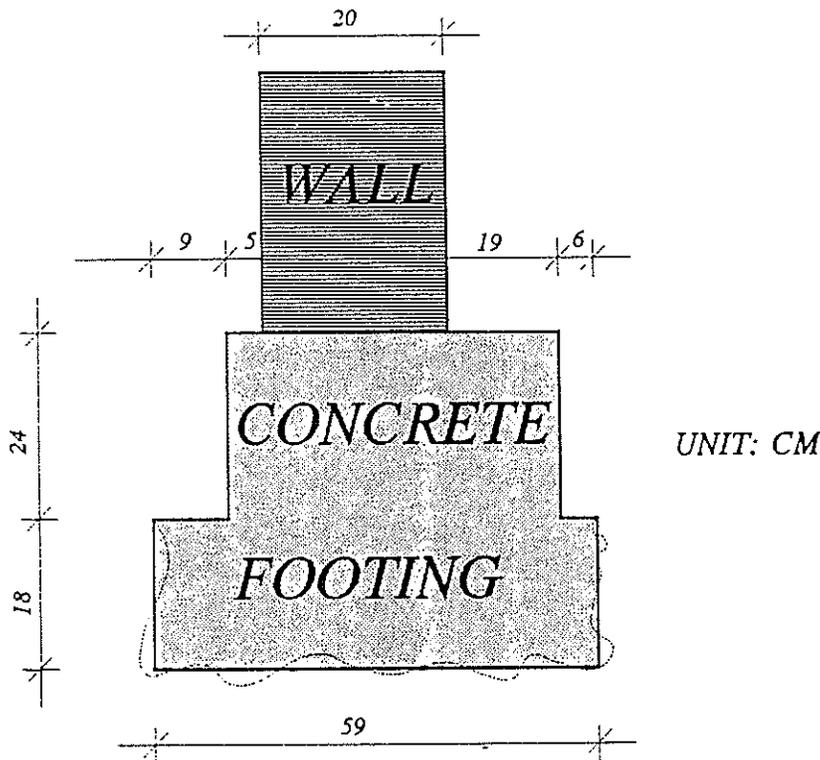
Figure 3 Typical Section through the Foundation

The main structure was supported on continuous unreinforced concrete strip footings about 0.6 m wide as shown in Figure 3. Although the footings along the four sides were connected at the corners, they were not at the same

elevation. The footings at the south and west sides were poured approximately 20 cm higher than the footings at the north and east sides. A wooden beam, consisting of three nominal 50 by 200 mm boards, ran longitudinally down the center of the house. The beam was supported on six evenly spaced isolated concrete footings of approximately 0.6 m square. Wood joists spanned between the top of the foundation and the main beam. The house was anchored to the foundation with 9 mm L-shaped anchor bolts at 2 m on center. The sill was a 50 mm by 150 mm board with 18 mm holes for the anchor bolts. There was evidence of some rot in the sill.

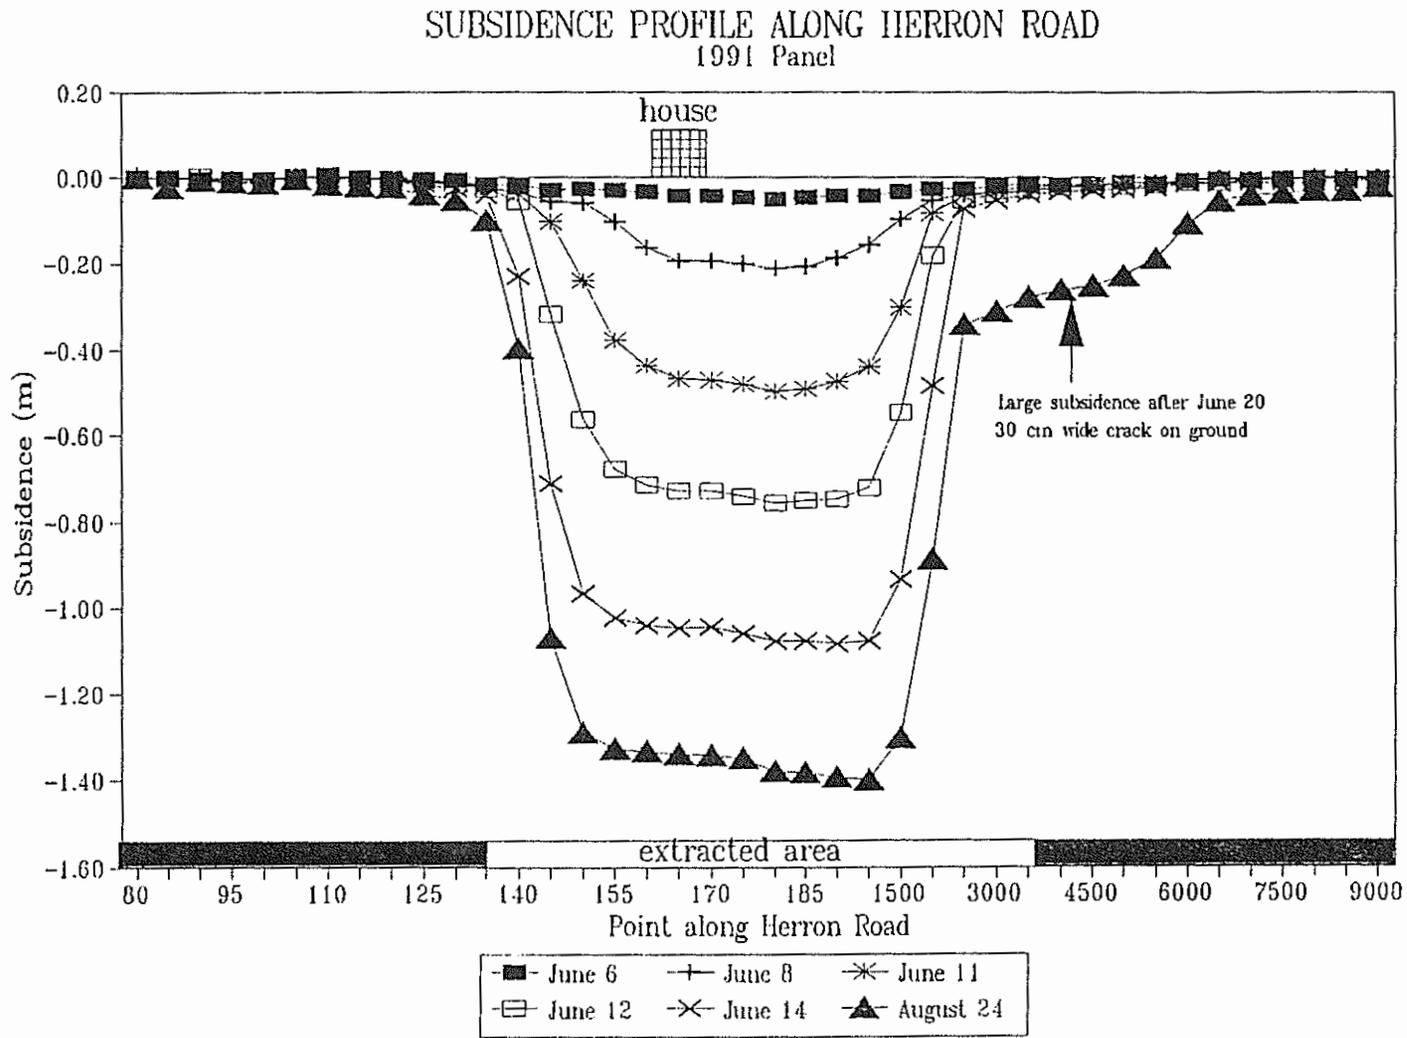
Figure 4 Subsidence Profile Perpendicular to Mining Direction along a 700 m Survey Line

Survey monuments along the access road to the house were monitored during the subsidence event. Figure 4 shows the subsidence profile along the road over a horizontal distance of about 700 m. The relative location of the house is also shown. Figure 4 indicates that a maximum subsidence of about 1.4 meters was measured in the location of the house.

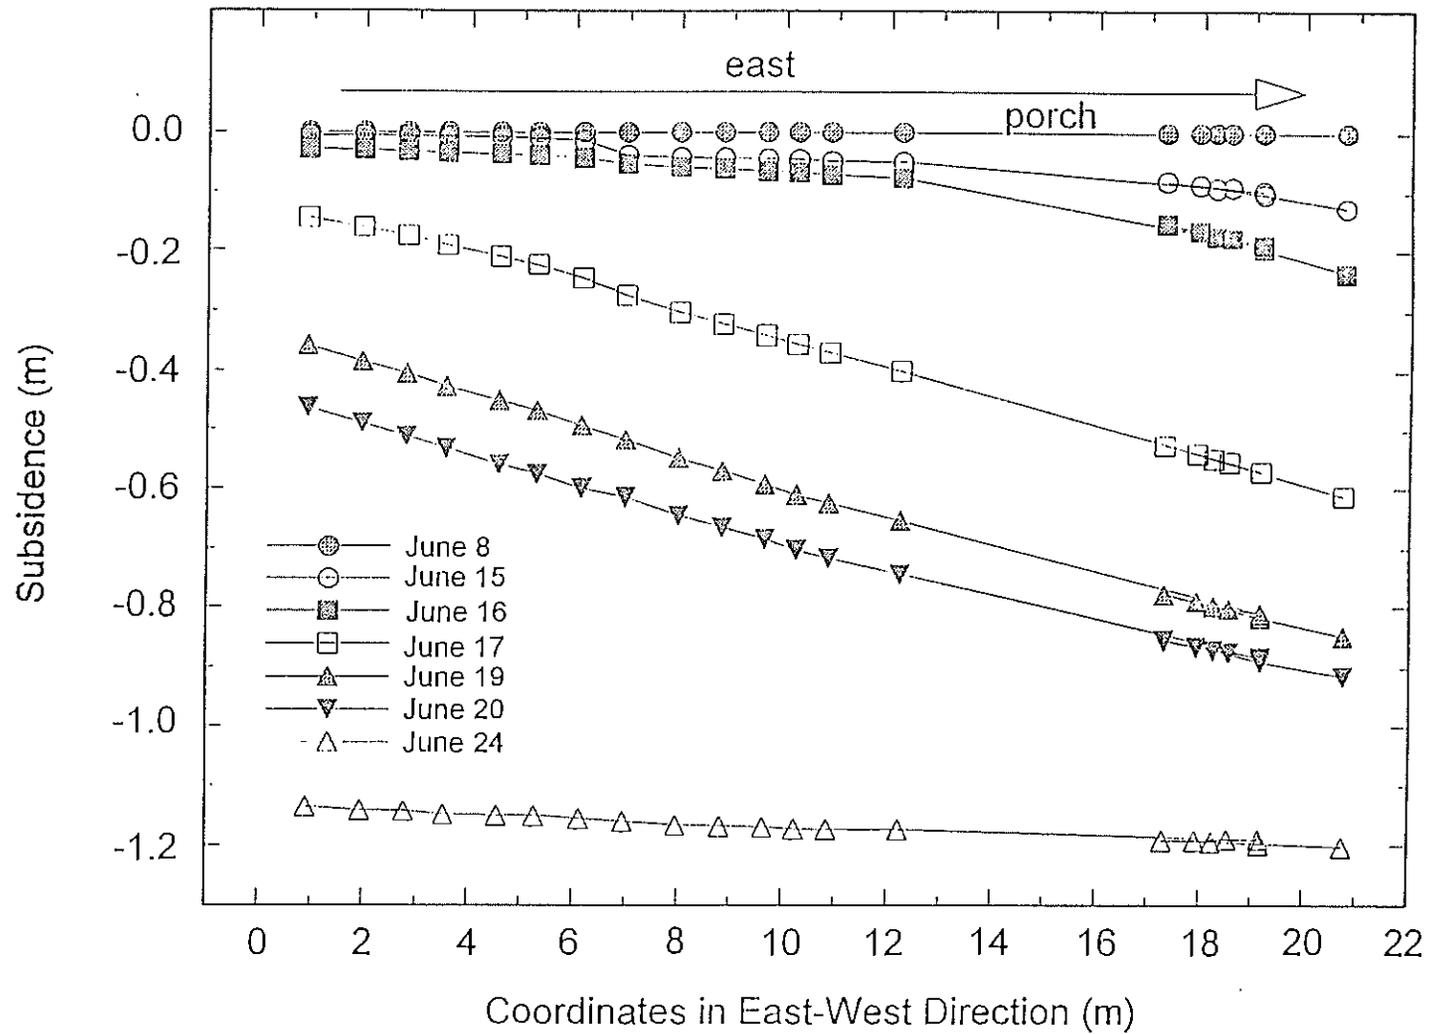
Figure 5 Subsidence of the Ground near the House

Figure 5 depicts ground subsidence along the mining direction and ground deformation at different phases of the subsidence event. The large span in the east half of the curves corresponds to the rigid front porch. The curves indicate that subsidence started at the east end and moved from east to west. The subsidence profiles on June 15 and 16 indicate that the ground subsided considerably more at the east end than at west end, and suggest the east half of the ground was in tension. On June 17, the tension wave on the ground surface reached the western end of the structure, and the eastern half experienced near constant slope. The entire ground around the house was in compression as the subsidence profiles were slightly concave-upward. The ground returned to almost level by June 24, as the mining face moved well beyond the house. The maximum subsidence around the house was approximately 1.2 m, while the the maximum subsidence in the mining panel was approximately 1.4 m. As anticipated, the subsidence around house was caused primarily by the dynamic subsidence moving in the east- west direction; the subsidence perpendicular to the mining direction was negligible.

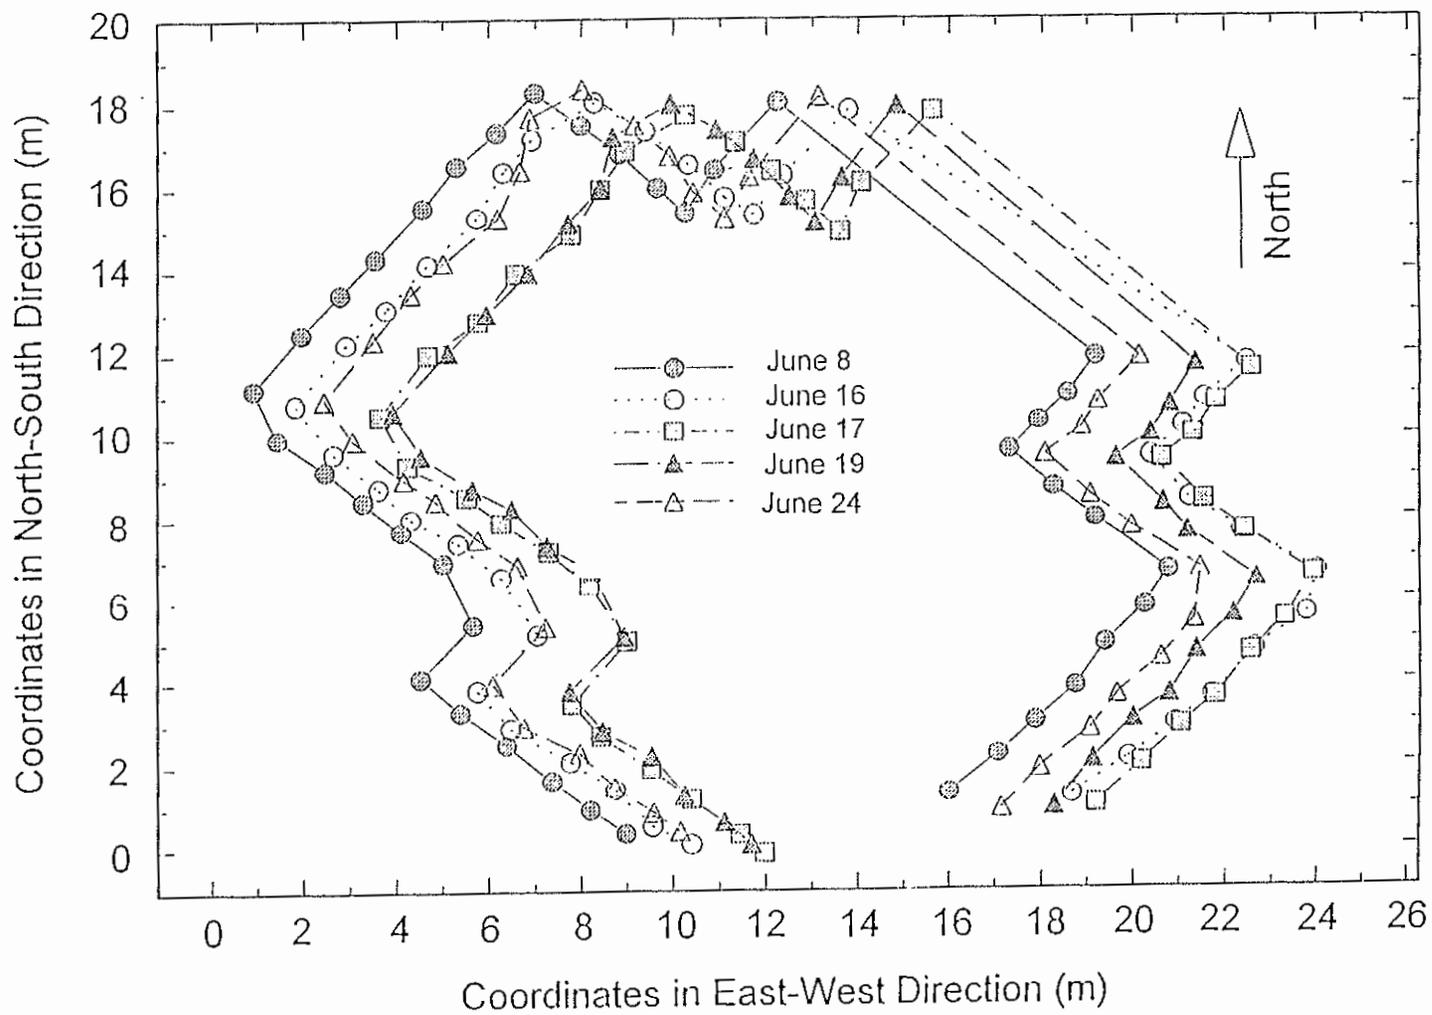
Figure 6 Horizontal movement of the Ground around the House

The horizontal ground movements in Figure 6 were magnified twenty times for clarity. The ground first moved eastward, then moved westward back to the initial position, with the movements in the north-south direction being negligible. Between June 8 and June 16, the ground at the east end moved the maximum amount (0.164 m) while the ground at the west end only moved about one-third of the maximum (0.046 m). This differential movement perpendicular to the mining direction was negligible.

The horizontal ground movements in Figure 6 were magnified twenty times for clarity. The ground first moved eastward, then moved westward back to the initial position, with the movements in the north-south direction being negligible. Between June 8 and June 16, the ground at the east end moved the maximum amount (0.164 m) while the ground at the west end only moved about one-third of the maximum (0.046 m). This differential movement of 0.118 m

subjected the house to tension. On June 17, the east end remained almost in the same position while the west end moved to almost the maximum amount (0.139 mm). On June 18 and 19, the east half of the ground started to move back westward while the west part continued to move slightly eastward, subjecting the house to compression.

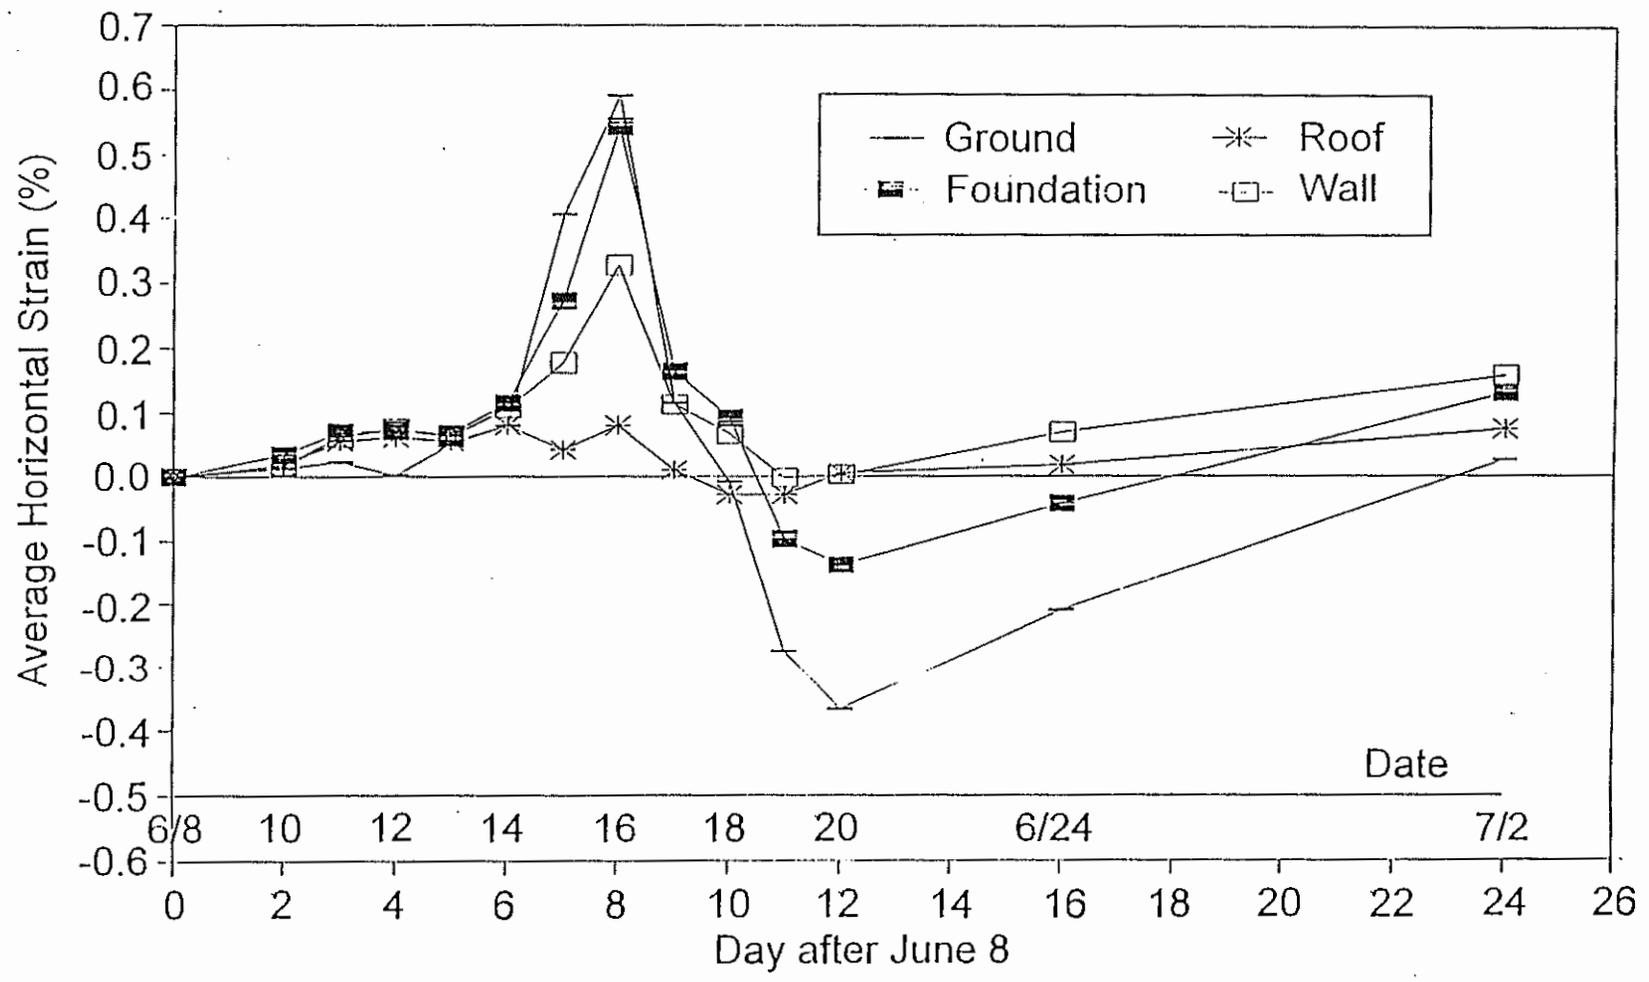
Figure 8 Average Horizontal Strain of the Ground, Foundation, Wall and Roof

transmitted to the superstructure components than compressive strain. The maximum tensile strain of the foundation was very close to the tensile strain of the ground, while the maximum compressive strain of the foundation was only about one-third of the maximum compressive strain of the ground. Both tensile and compressive strains decreased substantially from the foundation to the roof. Both the wall and the roof sustained virtually no compressive strain along the mining direction, which suggests there were relative movements between the foundation and the superstructure.

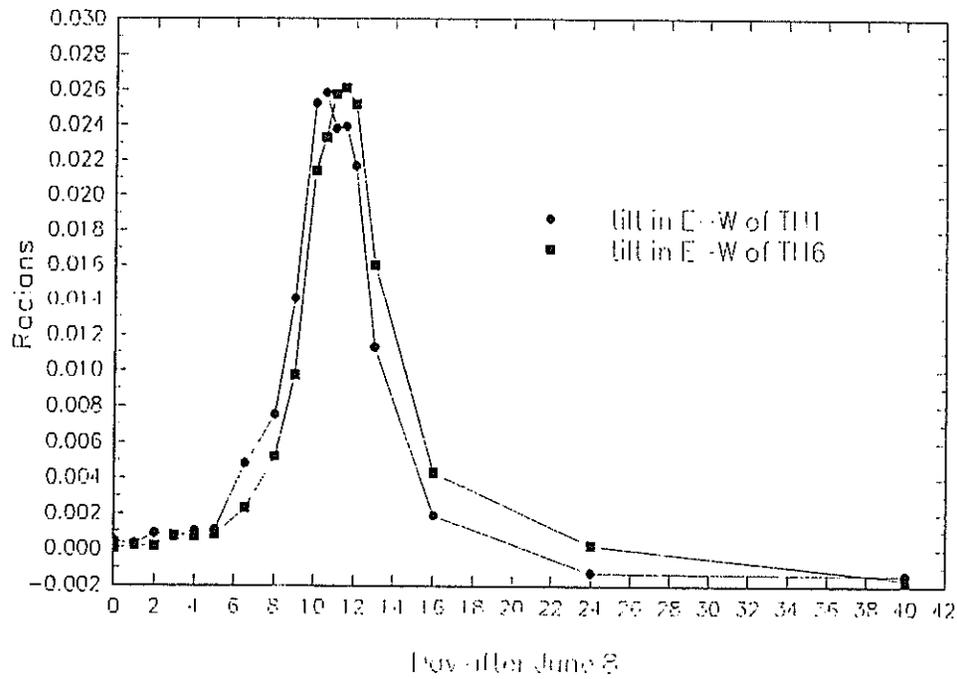
Figure 9 Measured Tilt of the East and West Corners of the House

Tiltplates were installed at numerous locations around the floor of the house. The tiltplates (SINCO 1985) permit the measurement of structural tilt in two orthogonal directions. Figure 9 illustrates the East-West tilt measured at two locations (tiltplates TH1 and TH6) over a period of 40 days. It is noted that the maximum tilt occurred about June 18 at the eastern most plate, TH1, while the maximum tilt occurred about 2 days later on the western tiltplate, TH6. There was very little tilt measured at either location in the North-South direction perpendicular to mining.

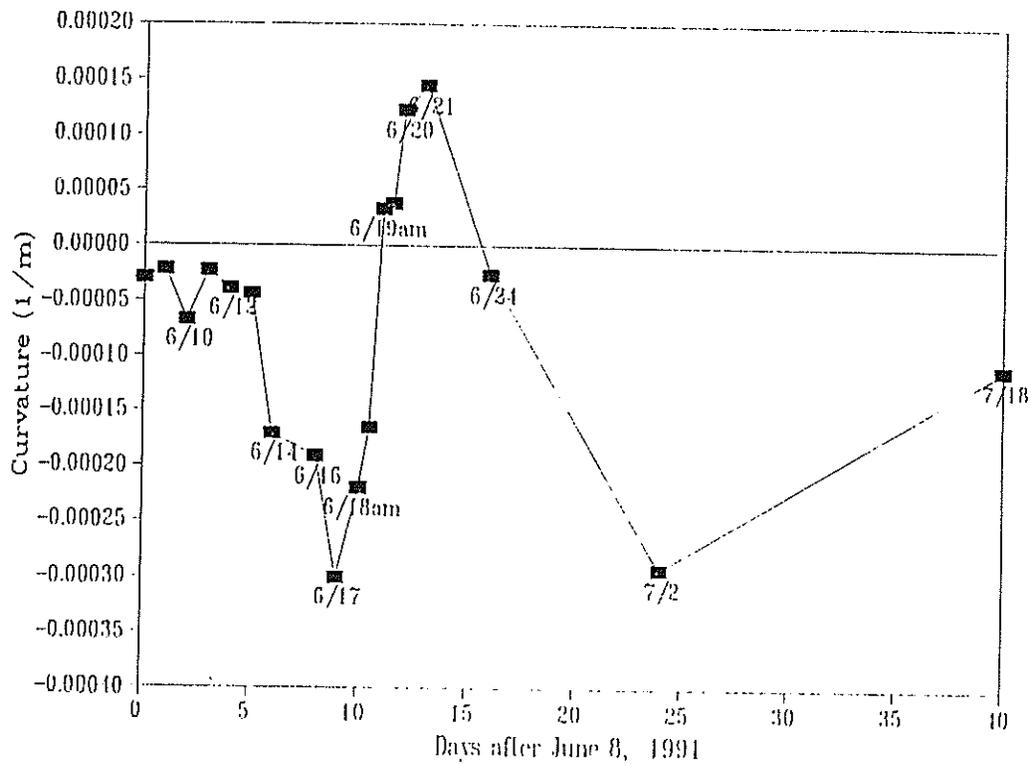
Figure 10 Calculated Curvatures along the House Diagonal

The gradient of the tilt with respect to horizontal distance is the curvature, which is useful for the comparison of structural damage. A linear regression of the tiltplate data was performed to determine the curvature along the diagonal of the structure. Figure 10 shows the curvature of the house floor over time. During the tension phase (about June 17) a convex-upward or negative curvature of 0.0003 m^{-1} was recorded. On June 21, a concave-upward or positive curvature of 0.00015 m^{-1} was recorded. A second negative curvature of about the same magnitude as the first was recorded on July 2.

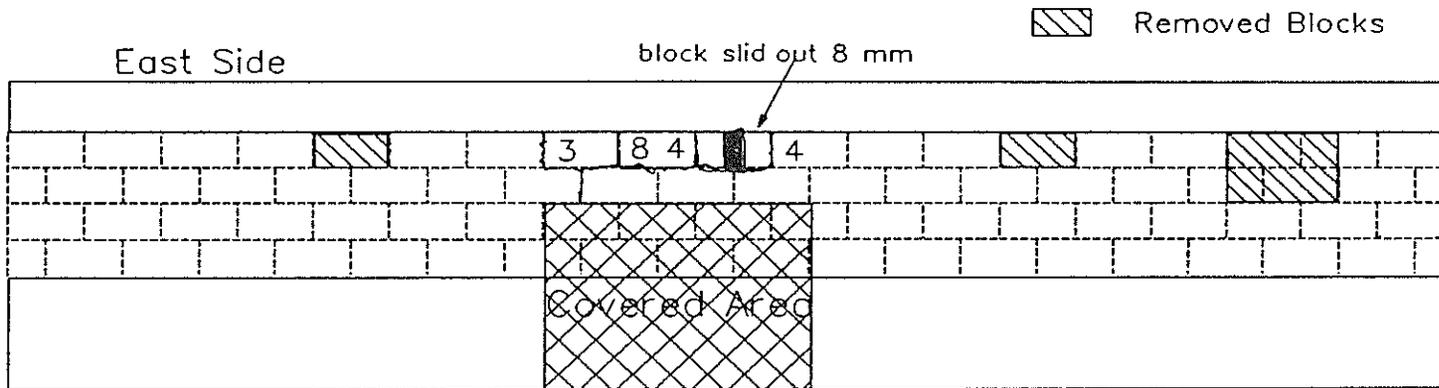
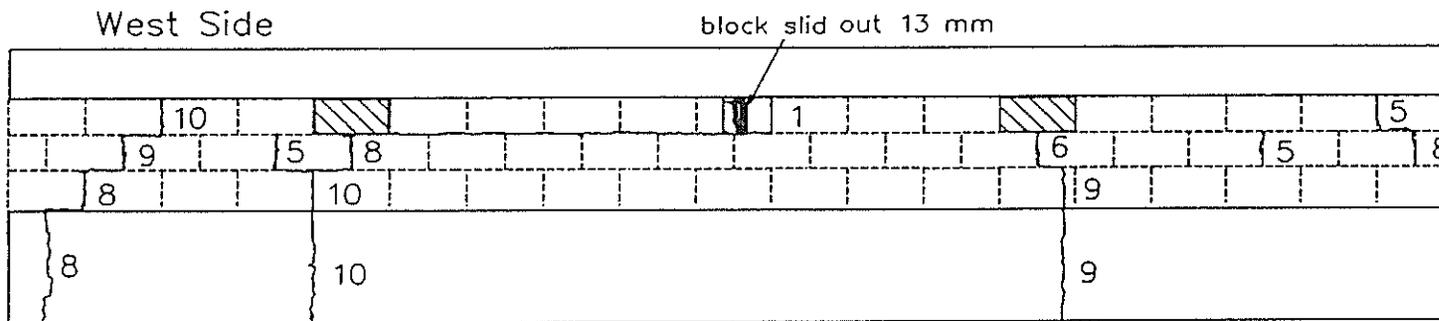
Figure 14 Location and Widths of Final Cracks (Front and Rear of House)

Figures 14 and 15 show the location and residual crack width in the concrete footings and block walls. The residual crack width was considerably smaller than the maximum crack openings developed during the tension phase of the subsidence event, and ranged from 3 mm to 10 mm. The cracks typically extended up through the masonry wall, generally in a stair step fashion and slightly increasing in width. No cracks were observed in the east side footing, but a large portion of the footing was covered by a utility box. Cracks were first found on the east side of the masonry wall on June 15, and by late afternoon six cracks were found in the masonry wall.

The development of the crack on the east section of the front wall, Figure 14, can be used to illustrate the effects of subsidence on the house. This crack started on June 15 and by the morning of June 16, the blocks on the sides of the crack moved apart about 25 mm both in the direction of the wall plane and perpendicular to the wall plane. On the morning of June 17, the cracks closed to about 10 mm in both the in-plane and out-of-plane directions. The crack decreased to about 2 mm in both directions on June

18. Subsequently, the crack reopened in the wall plane and had a residual width of about 10 mm. This process of tension, compression and a second tension has been described previously (Geddes 1977) and was also observed in a nearby series of test foundations (Lin et al. 1994). Due to the high compressive stiffness of the structure and yielding of the soil, the full compressive deformations from the soil are not induced into the structure. As the ground returned to a state of zero tension, it induced a second tension in the structure.

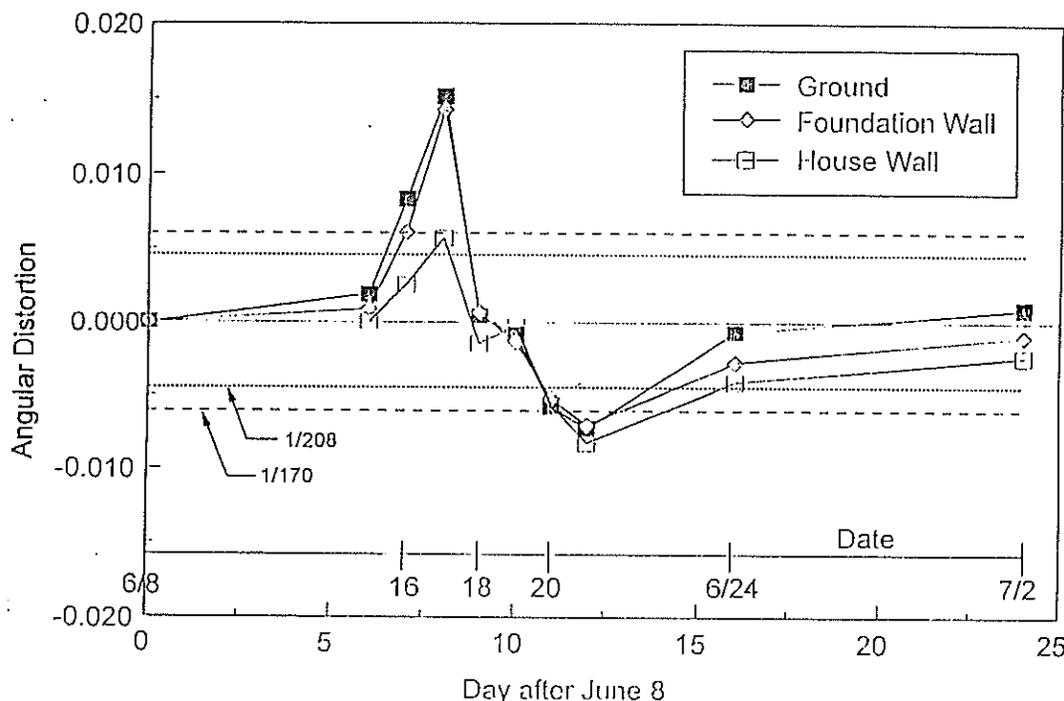
Figure 16 Angular Distortion of Ground, Foundation Wall, and House Wall

It appears that the superstructure damage was primarily due to differential vertical movements, and secondarily due to horizontal movements. The structural deformation and damage were quantitatively described in terms of angular distortion. Angular distortion is the change of slope between two points divided by the horizontal distance between the two points. Figure 16 shows the angular distortion of the ground, foundation wall, and house wall immediately above the foundation wall. The angular distortion decreases moving from the ground up to the foundation, and continues decreasing with elevation into the structure. The change in angular distortion is indicative of interaction between ground, foundation and the superstructure.

The calculated angular distortions are relatively consistent with the limits of angular distortion suggested by others corresponding to certain levels of structural damage. Bjerrum (1963) suggested an angular distortion of 1/500 as a safe limit for no cracking. Cracking was observed in the house

foundation when this limit was exceeded. Marino (1985) suggested that a house with a crawl space that had an angular distortion exceeding 1/208 would require foundation repair. Once the house foundation cracked, it essentially followed the ground movements, resulting in high angular distortion of much greater than 1/208 and complete failure. Wahls (1994) indicates that cracking for plywood or fiberboard on wood frames occurs at an angular distortion between 1/60 and 1/170. Angular distortions greater than 1/170 were observed during the investigation, but only minimal cracking was noticed. However, serviceability problems such as inoperable doors were experienced.
