# CONTINUOUS LIFT PIERS: DAMAGE REPAIR AND RESPONSE DURING SUBSIDENCE<sup>1</sup>

**Abstract:** A series of test foundations damaged during a longwall mining operation were left with permanent tilt, curvature, and substantial cracking. Two of the foundations were releveled using continuous lift piers. The continuous lift piers removed the tilt and curvature and significantly reduced the width of the foundation cracks. Following the releveled of the foundations, an adjacent longwall panel was mined, resulting in additional subsidence, although of smaller magnitude. The response of the releveled foundations was monitored and compared with the response of a footing that was not releveled. Although the continuous pier system does not strengthen the structure and distortion was observed during the second event, the system permitted the deformations to be removed in a few hours.

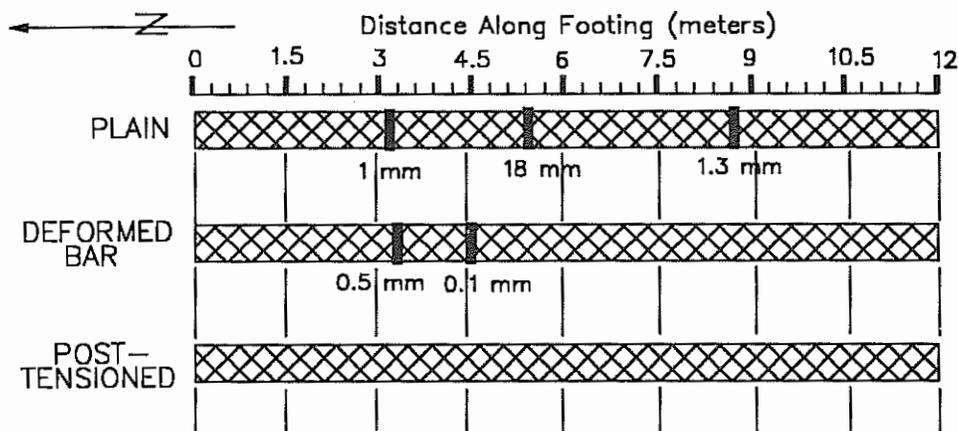
The maximum subsidence from the first panel measured at the panel centerline was 1.43 m, while the subsidence in the maximum tension zone near the test foundations ranged from 0.1 m toward the edge of the panel to 0.3 m toward the centerline of the panel. Footing deformation was measured with a precision survey level and tiltmeter. The maximum differential settlement of the plain concrete footing was 0.170 m, which resulted in an average tilt of 0.0139 radians. The reinforced concrete and post-tensioned concrete footings sustained similar deformations. Figure 3 compares the cracks observed in each of the three footings. The plain concrete footing suffered the most damage, cracking in three locations with the maximum crack being 18 mm wide. The post-tensioned footing did not crack and the deformed bar reinforced footing developed small cracks. The block walls

cracked at the locations over the footing cracks, and the wall cracks were slightly wider than the footing cracks. The deflection ratio (DR) is defined as the maximum footing deviation from a straight line divided by the foundation length. Values for deflection ratio and average curvature for the test footings and surrounding soil are summarized in table 1.

Figure 3. Cracks in foundations due to first subsidence event.

After subsidence, the plain concrete and reinforced concrete footings were relevelled using a system of continuous lift piers (Atlas Systems, Inc. 1990). Once installed, continuous lift piers permit the foundation to be raised or lifted over a wide range, with a high degree of control. The system also permits additional adjustments to the foundation should ground movements occur in the future. The Atlas pier system is a proprietary system (Atlas System 1990), and the installation is described in terms of this method. Other systems with similar capabilities exist, but have not been demonstrated on subsidence-damaged structures.

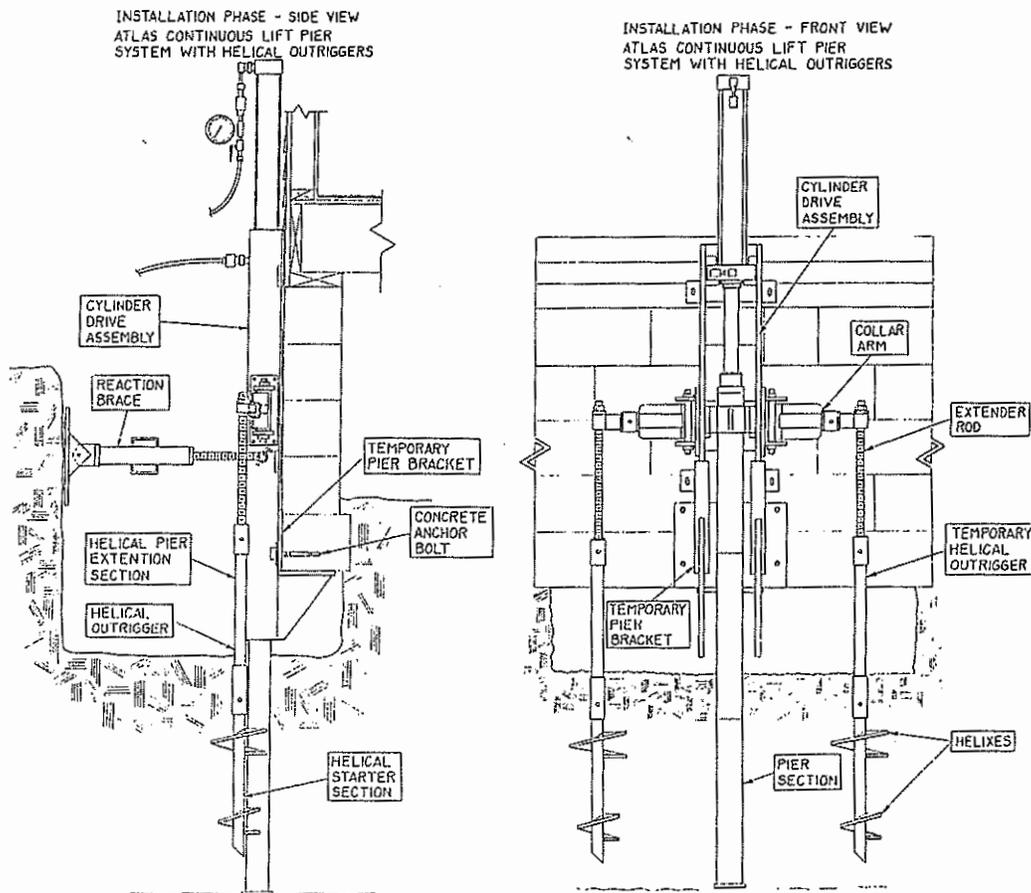
Figure 4. Installation phase-continuous lift pier system with helical outriggers.

The footing is excavated at the pier locations to provide access to the sides and bottom. If cracks exist in the footings, steel angles or plates are bolted to the footing to maintain continuity across the cracks during the leveling process. A temporary pier bracket is then bolted to the footing, as shown in figure 4. The cylinder drive assembly is then installed to hydraulically push the pier sections down to a firm bearing strata. If the firm layer is deep or nonexistent, friction must be developed along the mini-piles. To provide adequate reaction for the hydraulic driving forces, supplemental weights can be added to the foundation, or reaction can be obtained from helical outriggers as shown in figure 4. For the test foundations, five continuous lift pier systems were installed on each of the two foundations. The pier sections were pushed to the firm strata at a depth of about 7 m from the original ground surface. Reaction for the pier jacking was provided by supplemental weights added to the top of the foundations.

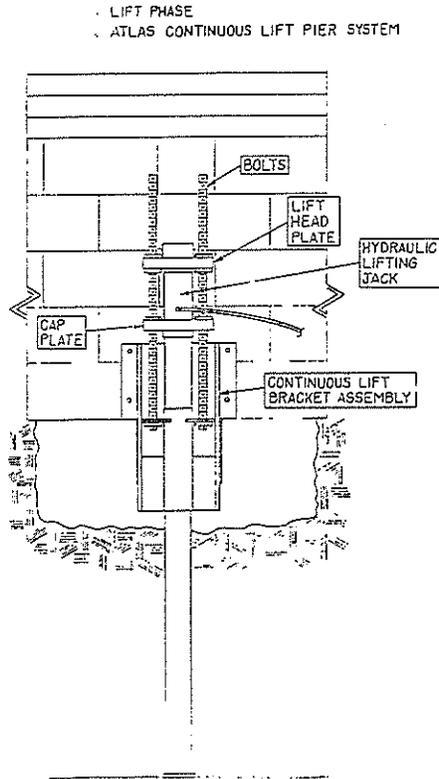
Figure 5. Lift phase-continuous lift piers.

After the pier is in place, the supplemental weights, cylinder drive assembly, outriggers, and helixes are removed, and the temporary pier bracket is replaced by the continuous lift bracket assembly (fig. 5). A hydraulic lifting jack is installed at each pier location, and the jacks connected to the hydraulic pump through a manifold. The manifold system permits the simultaneous adjustment of each of the piers to prohibit additional structural distress and ensure that the foundation is relevelled.

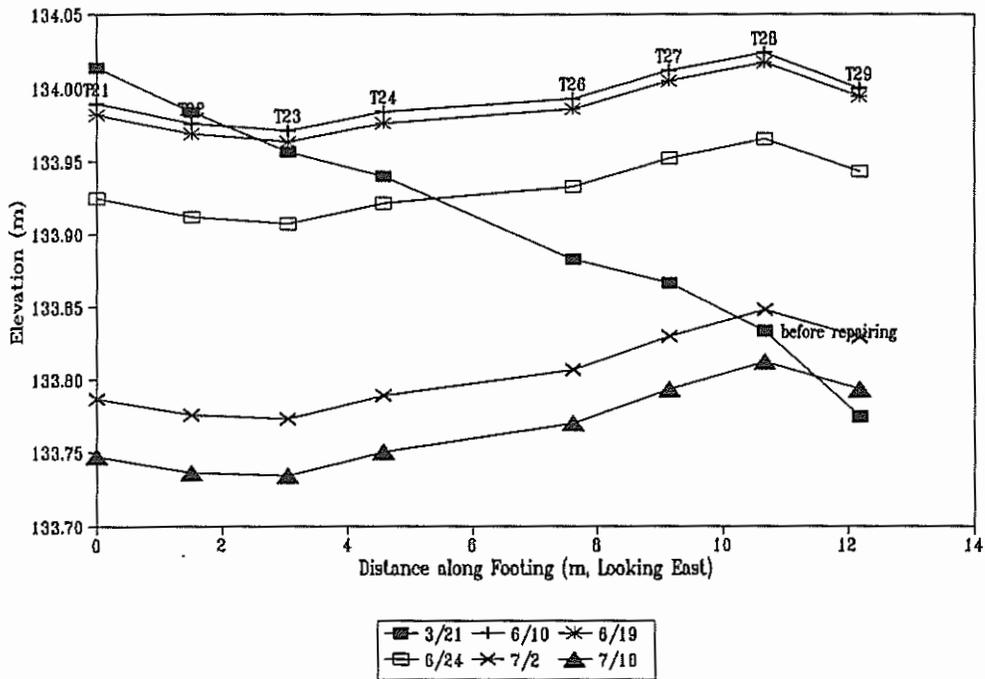
Using the manifold system, the footings were systematically raised and the foundations leveled. The maximum differential settlement before leveling was 0.24 m measured on March 21, as shown in figure 6. After leveling, June 10, the foundation was essentially level, with the south end slightly higher than the north end. The maximum difference was 0.0524 m on June 10. The footing could have been completely leveled, however, adjustments were made until the sill plate was level within 3 mm. Crack widths in the footings and block walls decreased after leveling. The adjustment heads were left in place to facilitate leveling after the second subsidence event. However, if additional ground movement is not expected, the lifting heads can be removed to restore the original foundation appearance. A significant advantage of the continuous lift pier system is that if additional deformation occurs, the footing can be relevelled or adjusted. The installation and releveling were completed in two days. If the helical outrigger system had been used to provide the reaction, the installation period would have been significantly shorter than that required with the supplemental weights.

Figure 6. Elevation profile of reinforced concrete footing before and after leveling.

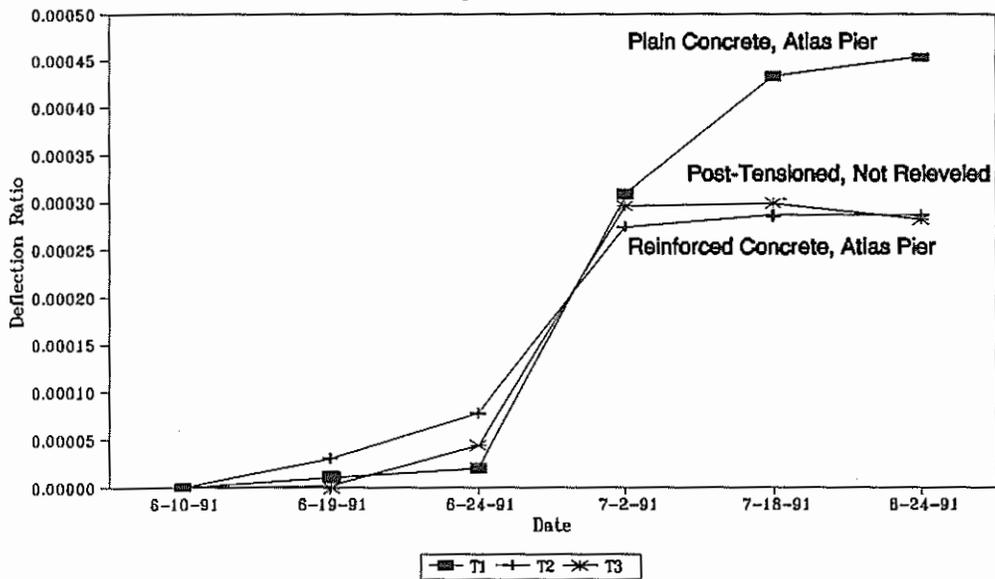
The variation in the deflection ratio over time is shown in figure 7 for each of the three footings. All three footings experienced a significant increase in DR during the second subsidence event, but the reinforced concrete and post-tensioned footing deformed less than the plain concrete footing (table 2). This difference was observed during the first (1990) subsidence event also, except the deflection ratios were much greater, about -0.002. It can be concluded that since the continuous lift piers did not increase the structural rigidity of the footings, they did not improve the resistance to deformation during subsidence. However, since the reinforced footing with continuous lift piers and the post-tensioned footing without continuous lift piers responded in a similar manner, the continuous

Figure 7. Foundation deflection ratio during second subsidence event.

One of the most significant advantages of the Atlas continuous lift pier system is that after installation, the position of the structure can be adjusted repeatedly. The tilt and deformation left in the foundations after the second subsidence event were removed in 1993, restoring the foundation to level. Since the lifting heads were left in place, the releveling process was completed in about two hours, simply by reinstalling the jack and manifold system. Provided adequate travel is provided in the original installation, there is no limit to the number of times the structure can be relevelled.
