PRELIMINARY INVESTIGATION OF INFLUENT DISTRIBUTION IN A VERTICAL FLOW SYSTEM¹

Darcy Peart and Charles Cooper, P.E., P.L.S.²

Proceedings America Society of Mining and Reclamation, 2000 pp 427-437

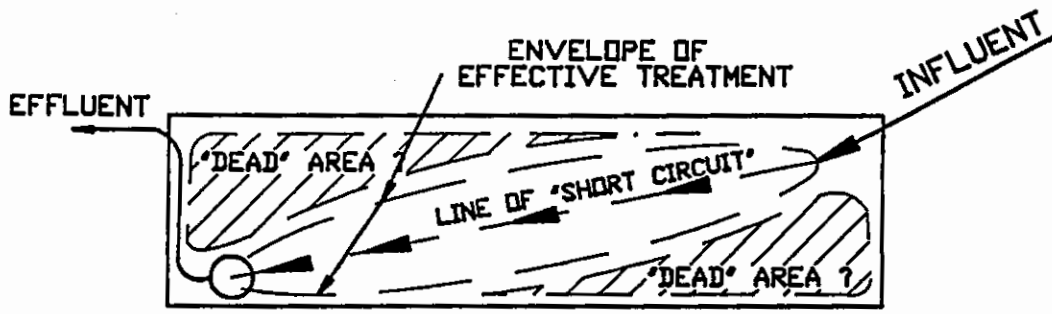
CASE 1

SCHEMATIC SECTION OF TYPICAL VFS
SHOWING SHORT CIRCUITING

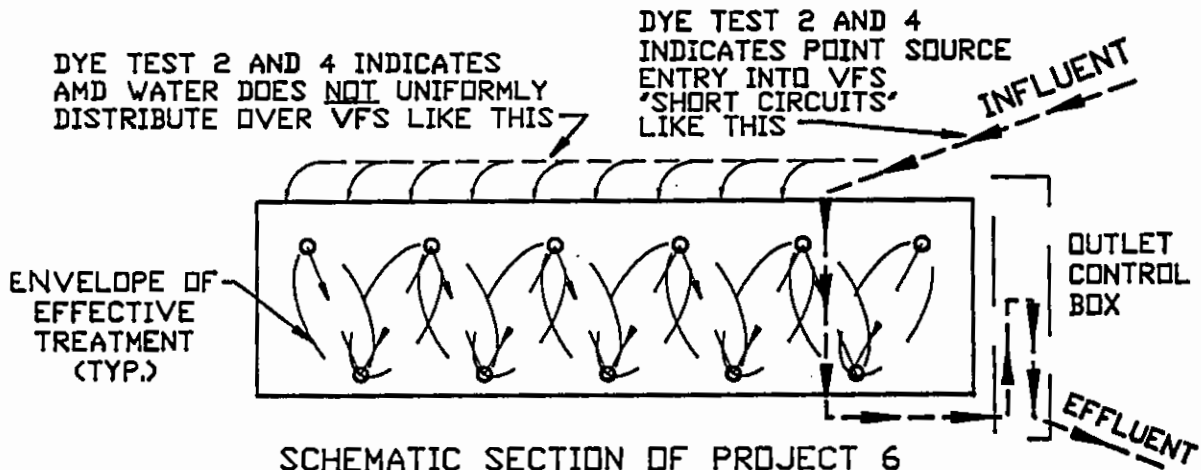
CASE 2

would lead to "short circuiting" of a substantial portion of the passive treatment fill media. Case 2 shows the condition intended to simulate with Dye Tests 2 and 4, which indicates substantial short circuiting. Case 3 depicts our interpretation of the results of reasonably uniform distribution of the influent AMD as per Dye Test 3.

SCHEMATIC SECTION OF PROJECT 6
VERTICAL FLOW SYSTEM

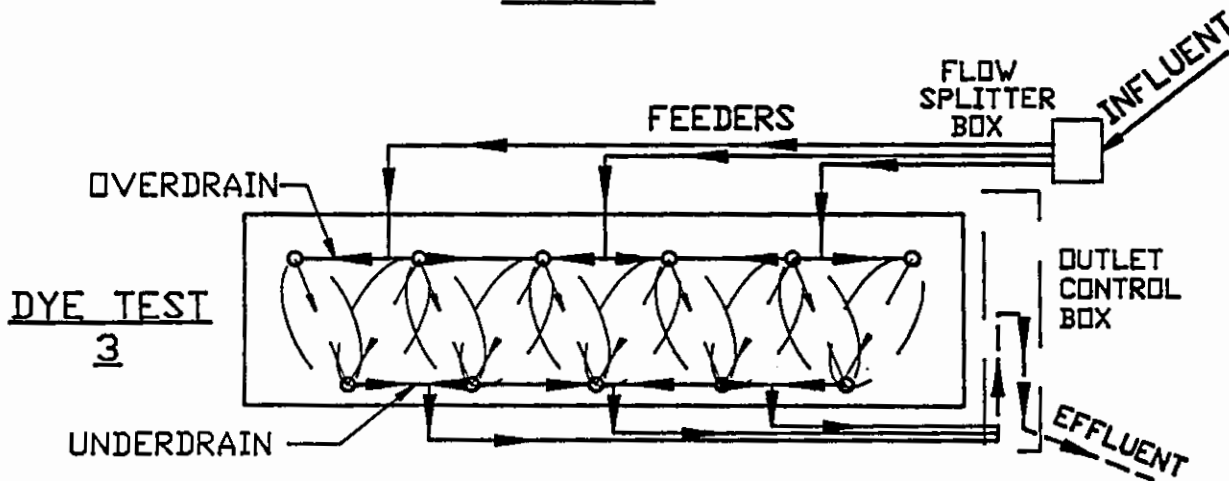
CASE 3

SCHEMATIC SECTION OF PROJECT 6
VERTICAL FLOW SYSTEM

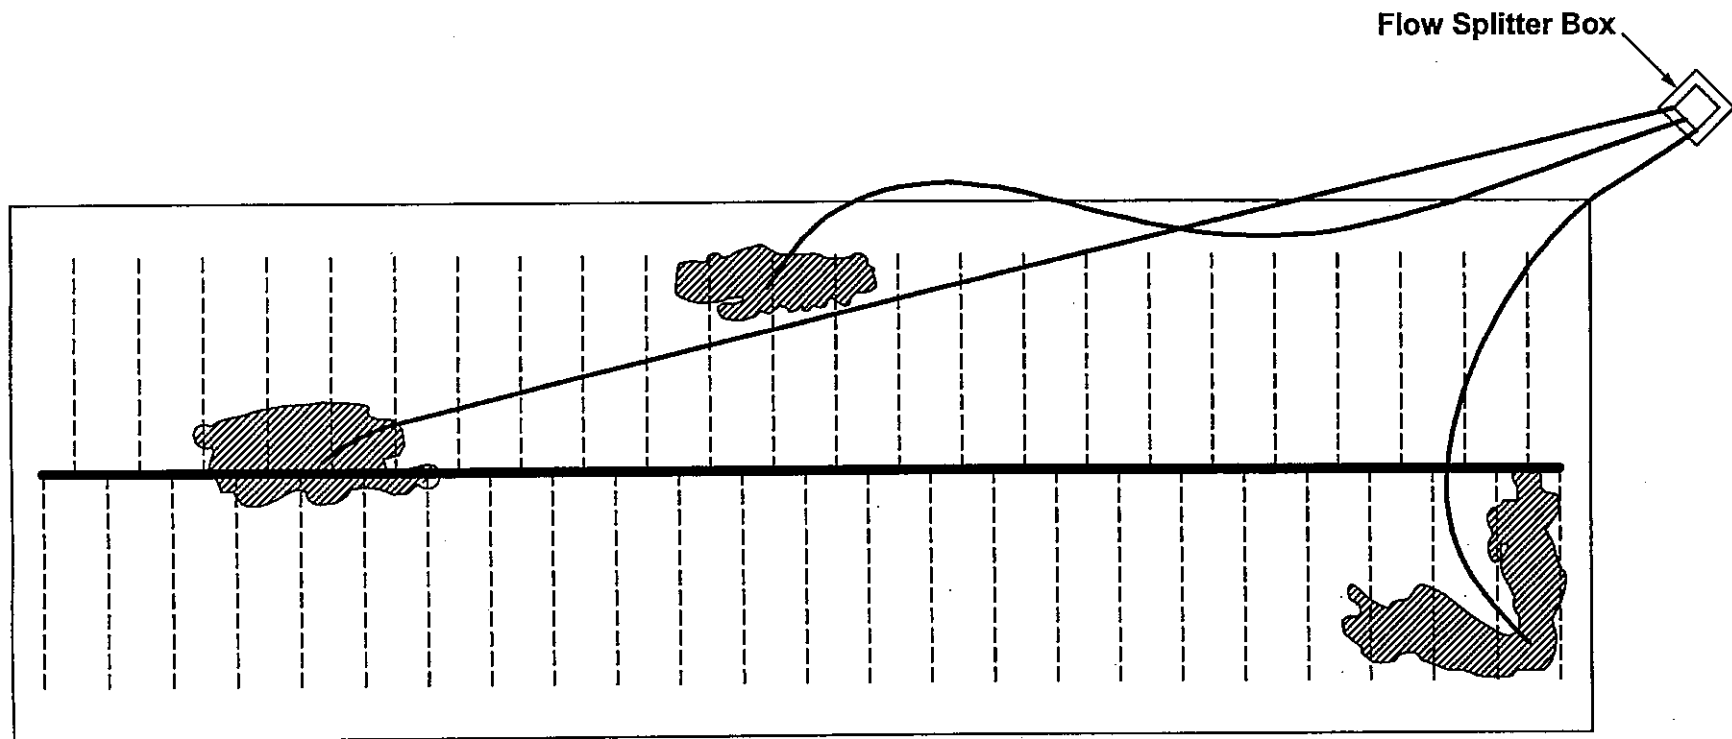
Figure 4. Schematic of Dye Test 1 illustrating disconnected feeder pipes from header pipe.

The results of Dye Test 1 are shown in Figure 4. This test was performed on September 14,

1998 with the 2" (5.08 cm) black poly-plastic feeder lines disconnected from the 2" (5.08 cm) PVC header due to prior clogging of the perforated 3/4" (1.91 cm) laterals. We were in seasonally low flow (15.6 gpm) and there was also a low water cap level in the VFS pond. Some exposure of vegetation on the surface of the compost-limestone was visible. The test began on 9/14/98 at 14:50 (2:50 PM) as iridescent red dye tablets were added at the flow splitter box. The filamentous iron bacteria and iron precipitate, which is probably responsible for clogging the 1/4" (0.64 cm) perforations in the 3/4" (1.91 cm) laterals, were clearly visible in the Flow Splitter Box (FSB). At 20 minutes, approximate 8' (3.44 m) plumes had developed at the feeder pipe ends. At 1 hour 26 minutes the plumes were approximately 16' (4.89 m) to 18' (5.49 m) in diameter, although some dye represented residual staining after dispersion of the dye. After dye addition was discontinued, and thereafter for the rest of the day, an approximate 8' (3.44 m) diameter clear area developed at the ends of the three feeders surrounded by 20' (6.09 m) to 25' (7.62 m) of residual dye staining. Therefore, it was concluded that the influent water was forming a plume of only approximately 8' (3.44 m) in diameter then coursing downward and short circuiting. This assumption was substantiated by subsequent dye testing. It should be noted that no dye was ever observed in the effluent of the vertical flow system. The dye apparently adheres to the soil-type fill material and the color dissipates there.

Dye Test 1
 (at 3-2" feeder ends: 15.6 gpm)
 9/14/98: 15:15 (1 hour 26 min)
 Approximately 16-18' plumes at feeder ends

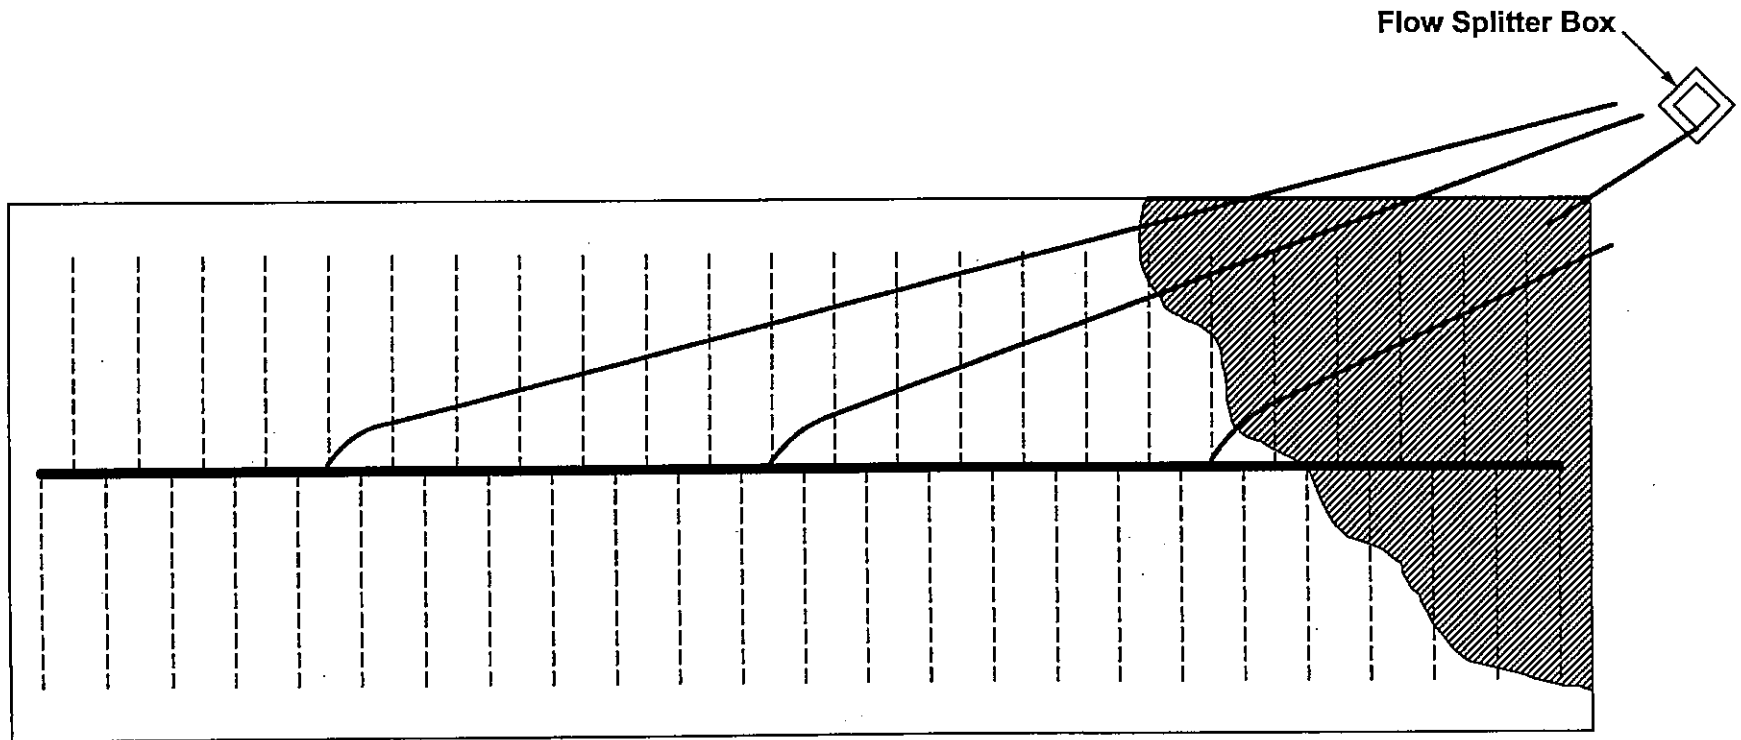
Figure 5. Schematic of Dye Test 2 illustrating single point of influent.

This test was performed on September 23, 1998 and is shown on Figure 5. The center 2" (5.08 cm) black poly plastic feeder pipe was disconnected near the Flow Splitter Box, with the other two FSB outlets plugged.

This test was intended to simulate channel or pipe influent into the VFS at a single point, as is reportedly accepted in some designs. If the supposition of uniform dispersion is correct, we would expect to see relatively uniform dispersion of the dye throughout the VFS.

At approximately 1 hour 10 minutes the dye has extended to its approximate maximum. It is reasonable to assume that much of the dispersion was due to the momentum of the influent water from the feeder pipe. The results of this test therefore imply substantial short-circuiting under these influent conditions.

Dye Test 2
 (single feeder @ SE cor VFS; 12.8 gpm)
 9/23/98; 12:12 PM (1 hour 10 min)
 Plume expanded to approximate maximum-
 42' on north side and 45' on west side

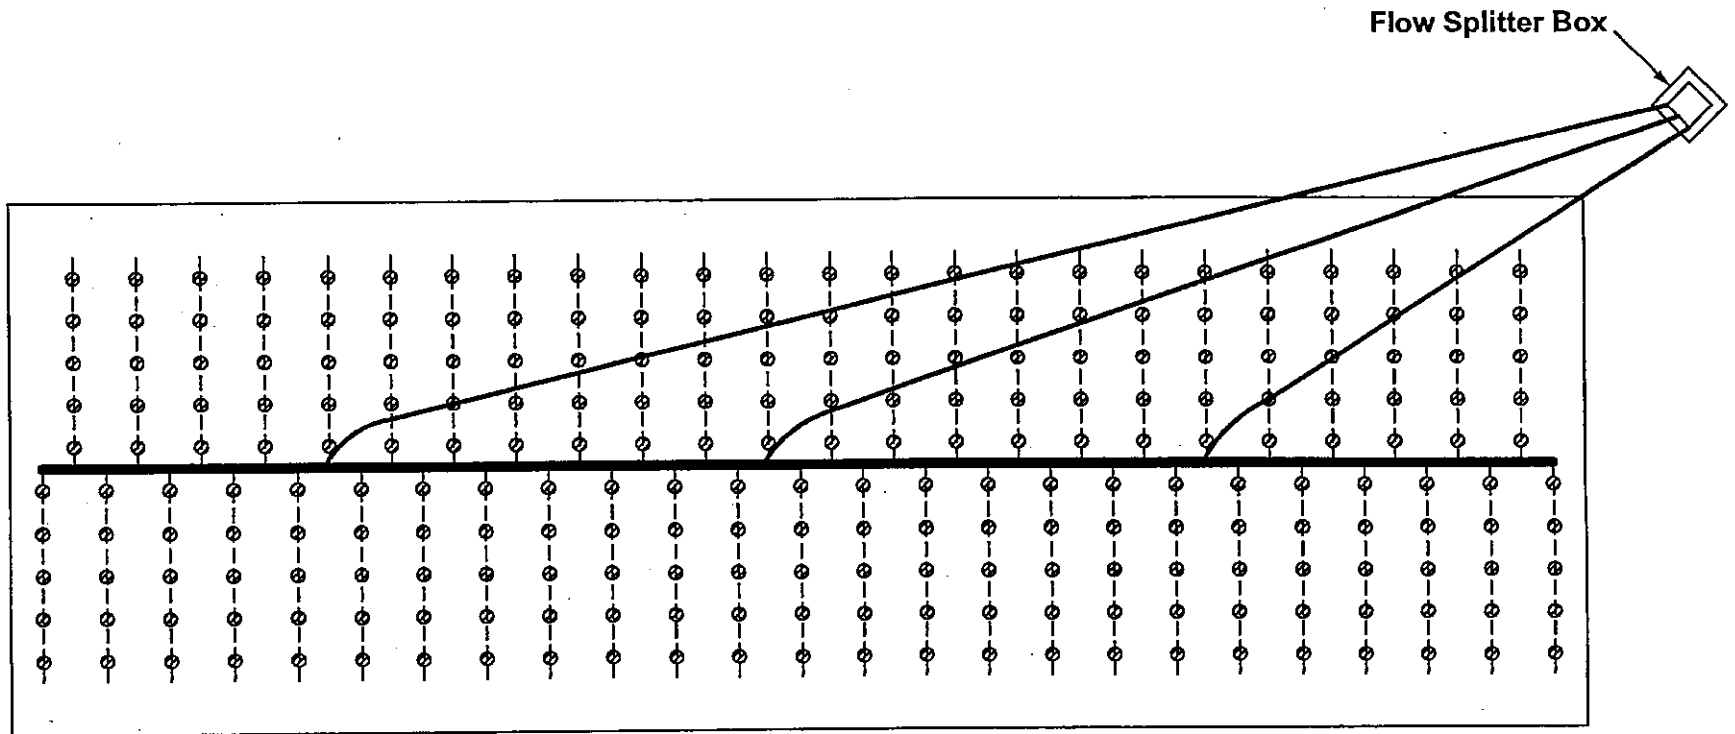
Figure 6. Schematic of Dye Test 3 illustrating distribution through cleaned overdrain.

On September 21, 1998 the 3/4" (1.91 cm) perforated PVC laterals were disconnected, removed and readily cleaned by rodding with a fish wire. The iron and/or iron bacteria precipitate was protruding and clogging the 1/4" (0.64 cm) perforation hole. Gas, probably carbon dioxide, was also observed bubbling through crevices in several places in the compost-limestone fill material from an unidentified type of crust, possibly aluminum precipitate, developing on top of the fill medium.

With the 3/4" (1.91 cm) laterals cleaned and reinstalled, and the level of the water cap raised to its design depth of approximately 1' (0.3 m), Dye Test 3 was conducted on October 14, 1998, as shown in Figure 6. In this test we distribute the AMD through the overdrain as designed. Within a few minutes, the dye began to appear at the 1/4" (0.64 cm) holes nearest the 2" (5.08 cm) header, and in less than 10 minutes, the dye appeared to be flowing evenly and uniformly through all the 1/4" (0.64 cm) hole perforations. It had been presumed in the design that flow might be greater at the holes nearer the 2" (5.08 cm) header pipe due to velocity head loss along the length of the laterals. However, the flow through the holes was quite even and uniform along the entire length of the individual laterals. It should be noted that the flow during the experiment was quite low (12.9 gpm) compared to the springtime flows of 30 + gpm, although it is probable that the overdrain, when clean, also functions quite adequately at the higher flows.

Dye Test 3
(through cleaned overdrain; 12.9 gpm)
10/14/98; 10:50 (10 min)
Dye appears at 1/4" holes at lateral ends

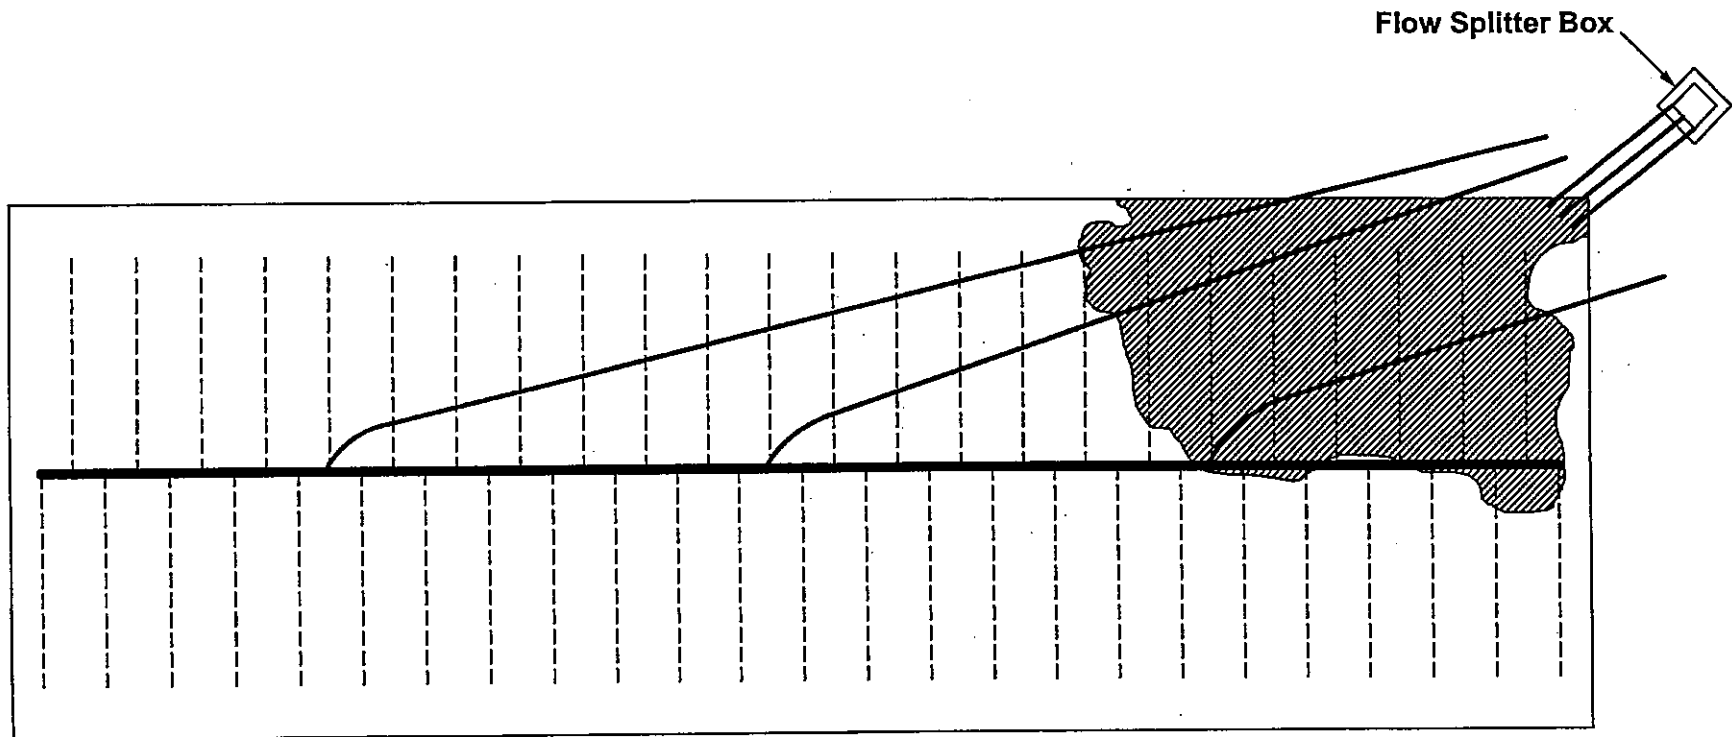
Figure 7. Schematic of Dye Test 4 illustrating influent through all three feeder pipes disconnected at SE corner of VFS.

There had been some concern that the low level of the water cap during Dye Tests 1 and 2 might be impeding the distribution of the AMD over and through the Vertical Flow System. Therefore, Dye Test 4 was conducted on October 21, 1998 with the level of the water cap at the normal depth of approximately 1' (0.3 m) as shown in Figure 7. The three 2" (5.08 cm) black poly-plastic feeder pipes were disconnected directly below the Flow Splitter Box. Again, this test is intended to simulate a channelized or piped influent at a point entrance into a vertical flow system. The red dye tablets were added at the Flow Splitter Box as in the previous tests. The results of Dye Test 4 were quite similar to Dye Test 2, with the plume being somewhat smaller, perhaps due to the reduced velocity and momentum of water because the flow was split among all three feeders.

Dye Test 4
 (all 3 feeders @SE cor VFS; 12.5 gpm)
 10/21/98; 11:38 (53 min)
 Dye extends 48' to north, 30' to west
