SUBSIDENCE RESISTANT REPAIR OF A BLOCK BASEMENT

Abstract: A one story house was damaged by mine subsidence movement. The house is located in a small subsidence sag and is experiencing differential settlement and compressive ground strains. Instead of waiting for the ground movements to eventually stop, The Illinois Mine Subsidence Insurance Fund developed a permanent repair scheme that was implemented at the same time damaging mine subsidence movement was affecting the structure. This repair provided a significant structural resistance against the anticipated residual mine subsidence movement and was aesthetically acceptable to the homeowners. The repair consisted of epoxying vertical and horizontal steel straps and then applying a cover coat of fiber-cement on the unreinforced concrete block basement walls. The repair scheme was relatively untried, but had been successfully researched. This paper provides information on the mine subsidence movement/damage, the design concepts of steel strap/fiber-cement repair, construction details, performance and costs. Other applications of the use of the steel strap repair method are also discussed for releveling of a building and/or correcti

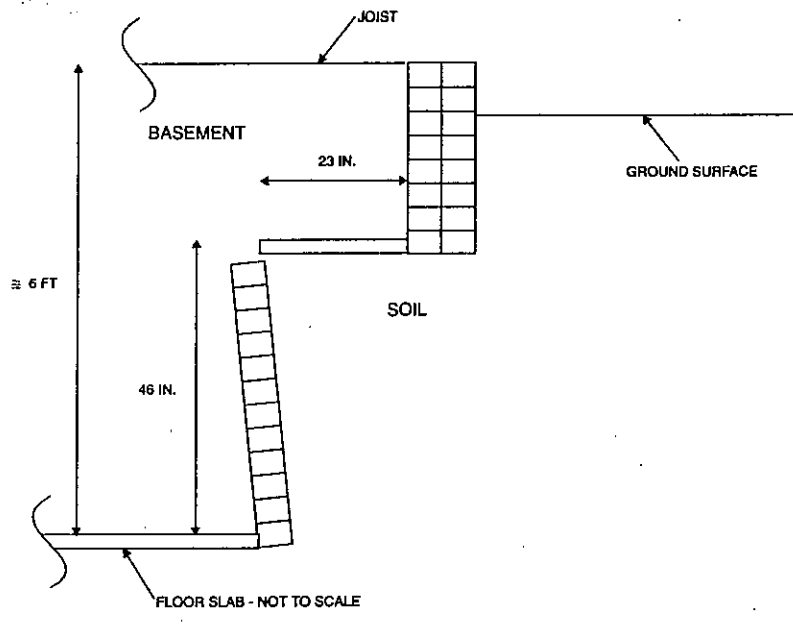
FIG. 1 CROSS SECTION OF SHELF WALL

The original structure had a brick shelf wall basement on the north, west and south walls (shelf 46 in. high and 23 in. wide) (Fig. 1.). A short section of the north and south sides as well as the east side had vertical concrete block walls (9-block high). The mine subsidence damage in the home was primarily compression (inward movement) on the basement walls. All of the walls showed a typical compression damage pattern. Horizontal moment cracks formed along the tops of the shelf walls and 2 ft below the top of the east block wall. The cracks were open 1/16 to 7/16 in. and were offset 3/8 to 2-5/8 in. Inward movement ranged between 0.6 to 7.3 in. Diagonal cracks were present in the corners. A summary of the basement wall damage is given in Table 1. A substantial portion of the compression damage predated the mine subsidence movement and was caused by earth pressures and hydrostatic loads in the plastic soils behind the walls.

The permanent repair of the basement walls consisted of removal of the original brick shelf walls and a section of the block wall, replacement with 8-in. concrete blocks, and strap retrofit/ fiber-cement support of all basement walls. The east wall was saved and the joint connections along the north and south walls were inclined in order to properly interface the concrete blocks. The floor joists and sill plates were cribbed and supported on wood beams and columns while the brick walls were torn down and replaced. The perimeter area adjacent to the home was excavated to a depth of approximately 5 ft deep in order to construct the block walls and footings.

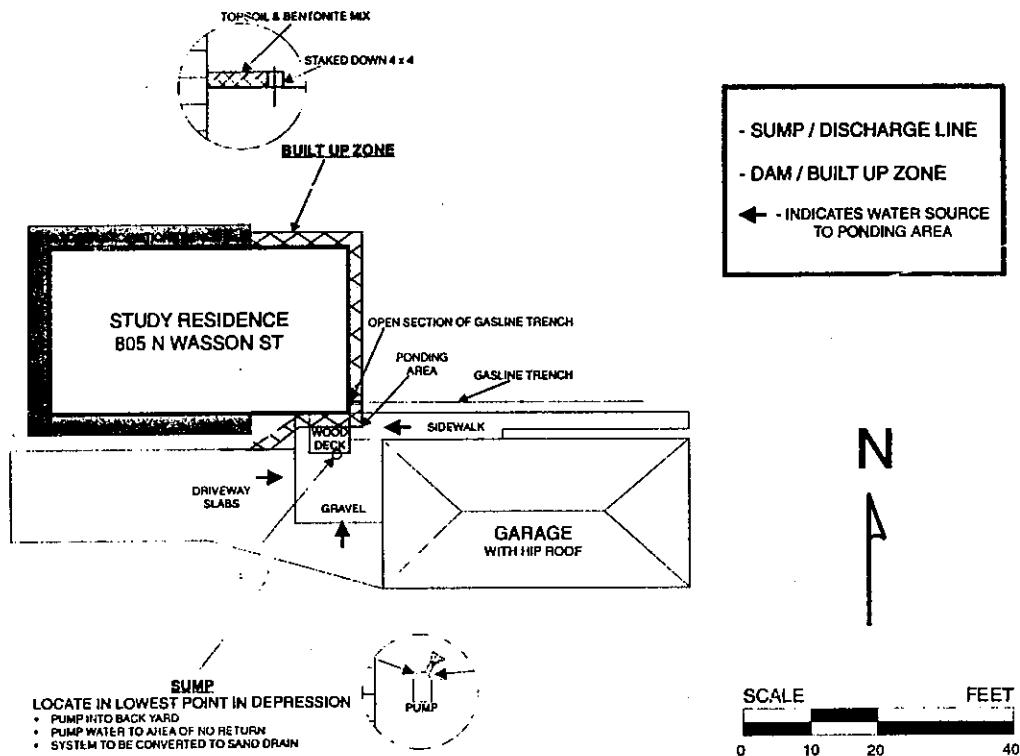
FIG. 8 PLAN MAP SHOWING THE LOCATION OF PONDING AREA AROUND STUDY RESIDENCE - STREATOR, ILLINOIS

Differential settlement related to mine subsidence movement caused water to pond near the southeast corner

of the basement. The original block walls became wet and had to be dried prior to injecting the epoxy behind the straps. The area around the basement was built up and a sump installed to prevent water seepage into the basement (Fig. 8). The sump was later tied into a perimeter drain that was placed in the open cut portion of the basement walls.
