ABANDONED MINE LAND RECLAMATION - UNIQUE  
PRDJECTS IN WEST VIRGINIA<sup>1</sup>

Neil A. Robinson<sup>2</sup>

**Abstract.** The Abandoned Mine Lands Program (AML) in West Virginia has completed reclamation on 215 projects at a total construction cost of \$90 million. Typical projects encountered daily by the AML staff including mine portal sealing, coal refuse pile regrading and extinguishment (if burning), landslide correction, subsidence abatement, and mine drainage control. Some of these projects require a different reclamation approach than is commonly used on typical AML projects. This paper provides information concerning the abatement and correction of several AML projects that required different approaches. One site consisted of a burning coal refuse pile covered with asbestos which had to be handled and disposed of in a specific manner. The use of a coarse sand aggregate was utilized to extinguish a deep mine seam fire on a project in Kistler, West Virginia. Two projects required special water handling and treatment facilities. Transforming a hazardous burning coal refuse pile into an extension of a state park campground facility was the reclamation objective of one AML

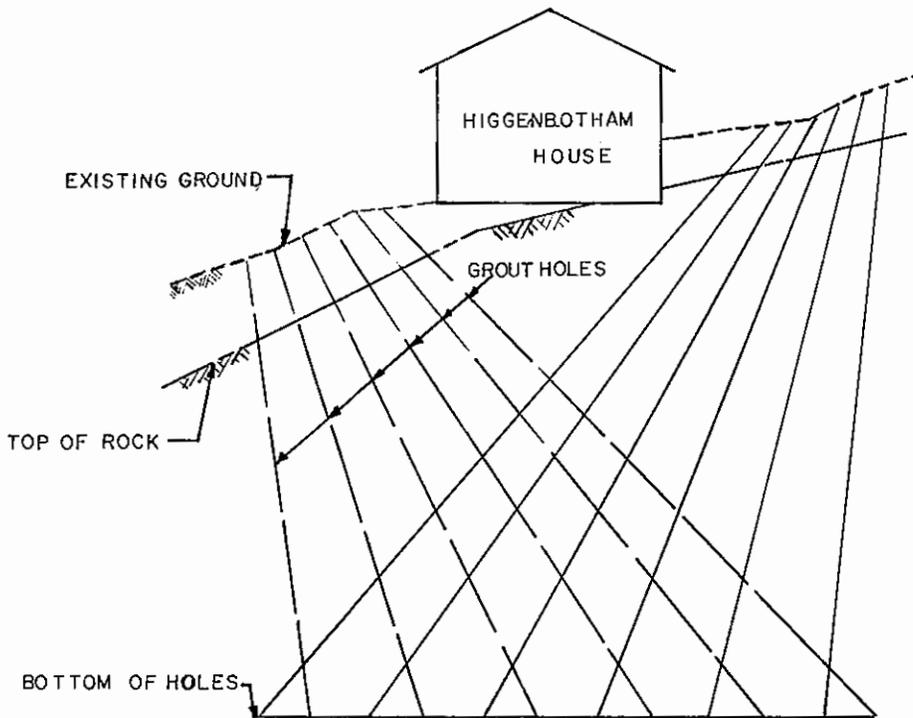
The Higgenbotham residence in northern West Virginia was experiencing severe structural distress. Concrete block basement walls contained several vertical and horizontal cracks from hairline up to 1/2 inch in width. The family room floor had sunk at one end and the interior doors would not close.

An abandoned deep mine causing the structural damage was located approximately 385 feet below the house. An exploratory borehole was drilled next to the Higgenbotham residence to the mine level. Results of this drilling provided evidence of subsidence due to the highly fractured geologic material that the borehole encountered.

The method used to stabilize the Higgenbotham home was referred to as fractured rock reinforcing. With this method an attempt is made to tie the fractured rock strata together so that it will respond as a single unit during a subsidence event. This design does not attempt to eliminate settlement but it does eliminate abrupt differential settlement that results in structural damage due to mine subsidence.

Six rows of 4 inch diameter holes were drilled on either side of the house at spacings of 12 feet between rows and 3 feet between holes. The holes were angle drilled beneath the house ranging from 4.5 degrees to 51 degrees from vertical forming an interlocking pattern (see Figure 1). The bottom elevations of all holes were the same. Hole depth varied from 50 to 90 feet depending on the ground surface elevation from which it was drilled. Number 10 deformed reinforcement

Figure 1. Higgenbotham grout borehole locations.

bars (rebars) with centralizer were placed in the hole. A grout mixture was then pumped to fill the holes around the rebar. Extensometers were installed prior to the start of construction to monitor ground movements, before, during and after the work conducted at this site.

Rock reinforcing was completed in August 1989 after approximately 90 days of construction at a total cost of

\$99,500.00. Construction was slowed due to rainy weather and encountering water in some boreholes at the 40 foot depth. Water in the boreholes was remedied by grouting the boreholes from the bottom and displacing the water.

According to reports, no additional structural distress to the Higgenbotham residence have been observed. Therefore, it is assumed that the reinforcement technique was successful.
