# ACID MINE RECLAMATION IN SPOTSYLVANIA COUNTY, VIRGINIA, USA: USING WATER CHEMISTRY AND VEGETATION RE-ESTABLISHMENT AS A MEASURE OF SUCCESS<sup>1</sup>

Robert G. Sobeck, Jr.<sup>2</sup>, James E. Perry, Allen Bishop, and Edward Epp

Proceedings American Society of Mining and Reclamation, 2008 pp 1039-1069

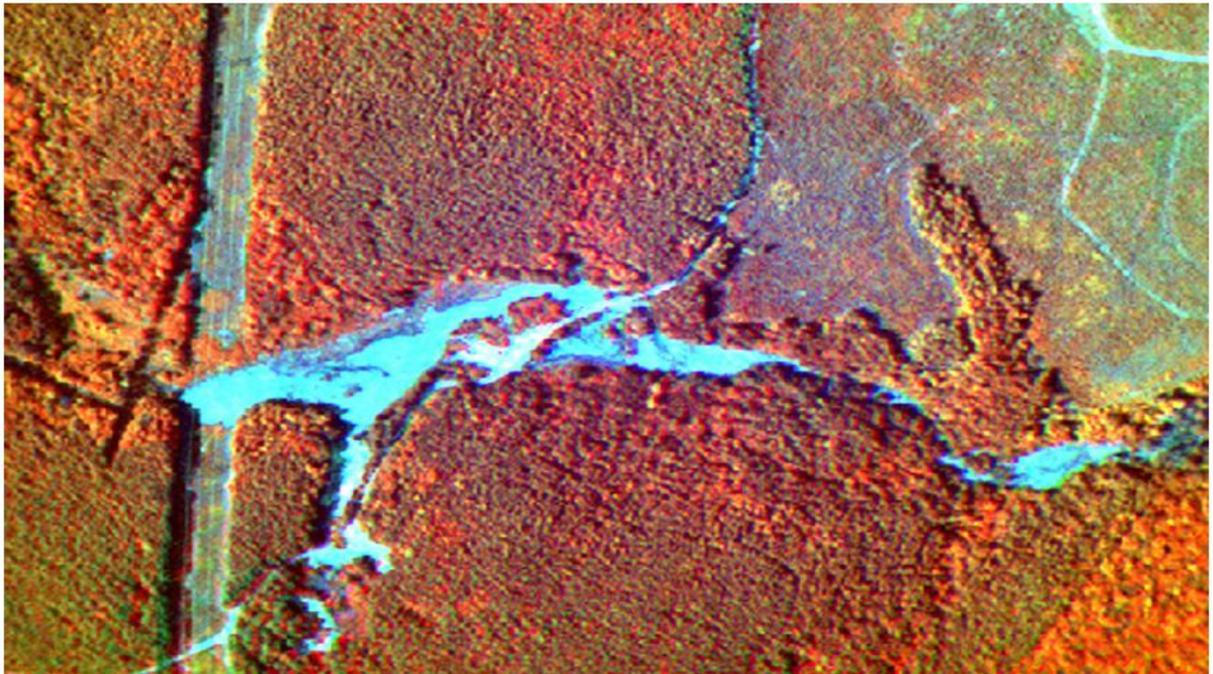
Figure 3 is a spectral photograph of the Valzinco site that relates certain wavelengths of light energy to acid conditions along the riparian parts of the stream. The aqua-blue color of the photograph correlates to low pH of water in the vegetation and soils of the watershed (Anderson, 1999). The white areas, transecting the light blue valley in the center of the figure, represent the approximate alignment of the constructed dam at Valzinco.

Figure 3. Aqua-blue in the spectral reflectance photo represents AMD effects in Knights Branch.

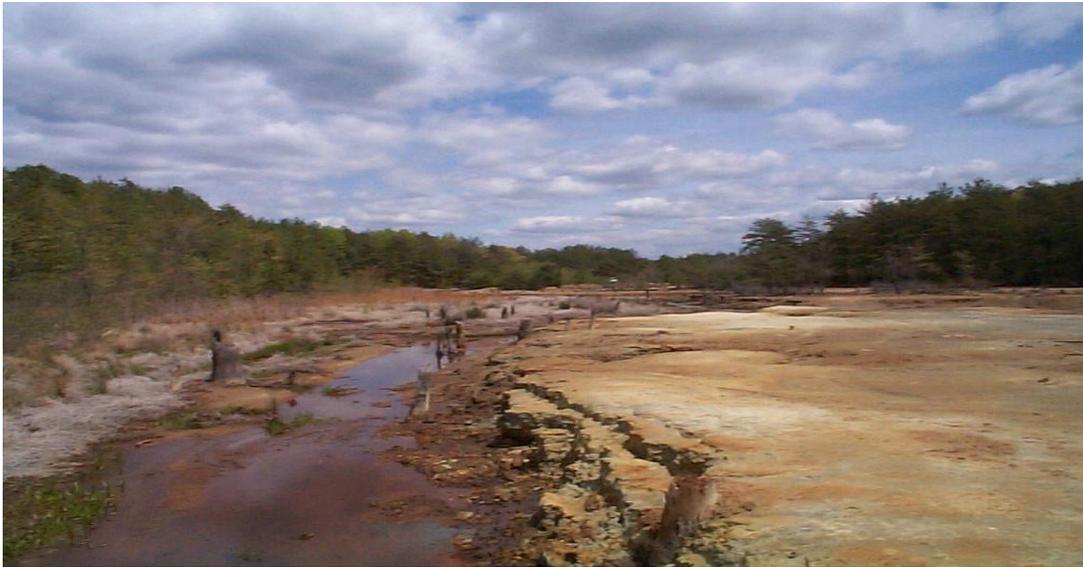
Figure 6. Valzinco mine spoils and saprolite sediments above the dam in Knights Branch.

As can be seen in Figs. 6-8, vegetation was sparse to non-existent. Small pockets of soft rush (*Juncus effusus* L.) and golden club (*Orontium aquaticum* L.) occurred along the periphery. Only the golden club, an aquatic plant that inhabits running water, appeared to occur in a perennial state while the soft rush did not occur in the same spot from year to year. On the northwest edge of the restoration site (see Fig. 6, left) was a small wetland area dominated by cotton grass (*Eriophorum virginicum* L.), an acid-loving plant listed as a species of special concern in Virginia (Townsend, 2007) and rice cut grass (*Leersia oryzoides* (L.) Sw.). Southern-bog cranberry (*Vaccinium oxycoccos* L.), also an acid-loving plant listed as a species of special concern in Virginia (Townsend, 2007). Woody species rarely survived for more than a year on the spoils and were usually represented by only their standing-dead remains (see Figs. 6-8).

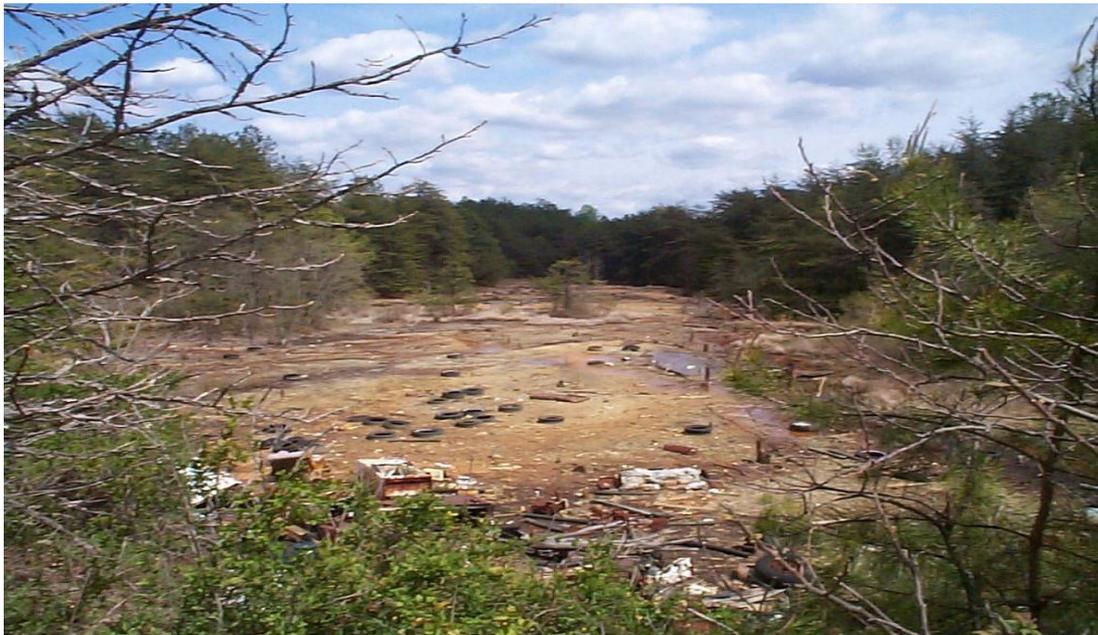
Figure 7. Valzinco mine spoils and saprolite sediments transported below the dam in Knights Branch towards sampling station VLZN-3.

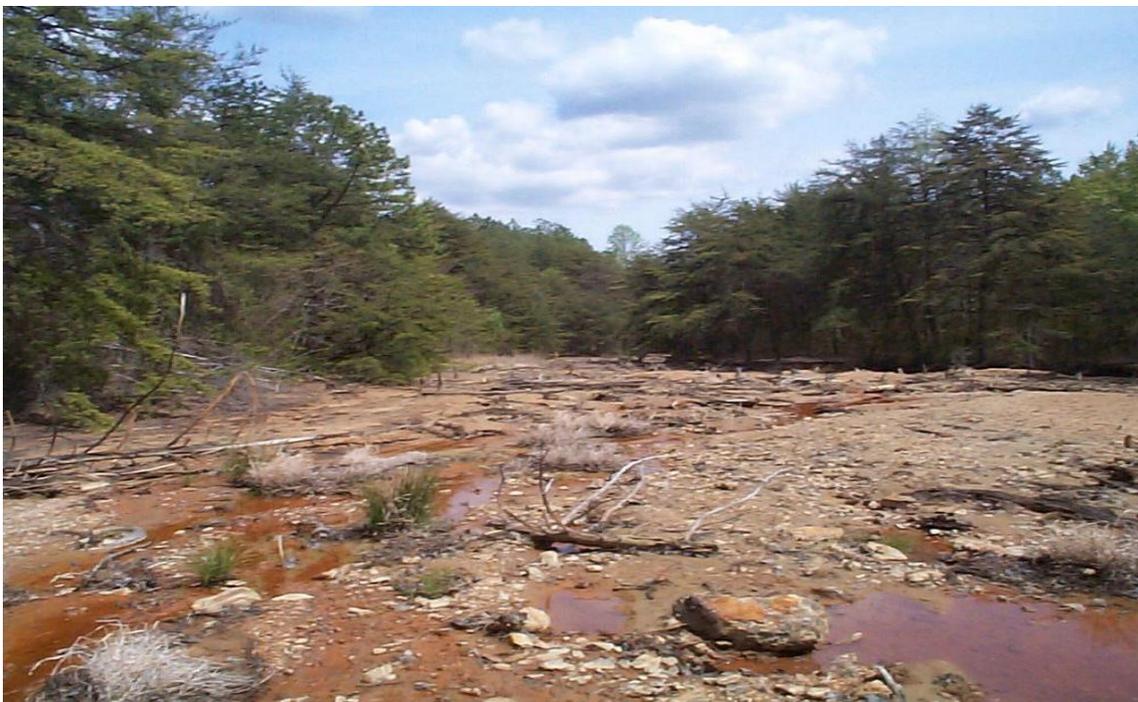
Figure 8. Mass transport of Valzinco spoils and watershed sediments out of Valzinco valley.

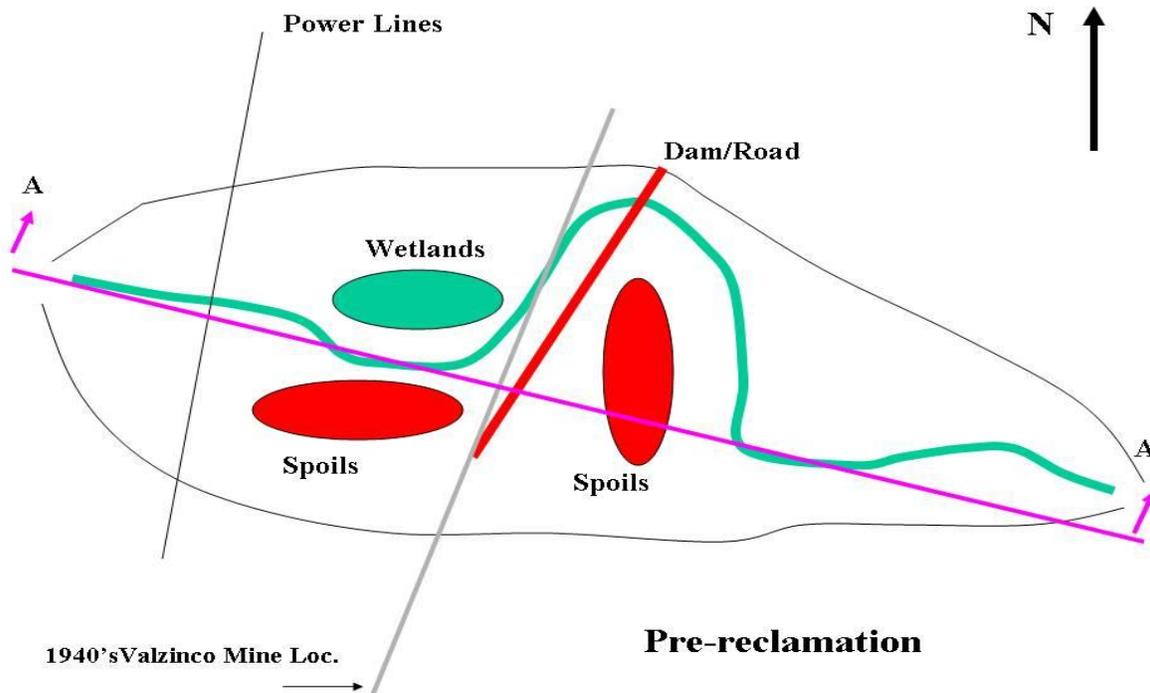
Figure 9. Position of stream channel after mining operations ceased at Valzinco.

As depicted in Figs. 9 and 10, the spoils mass was greater than 3 meters deep on the upstream side of the dam at Valzinco and the downstream spoils were typically above the water level of Knights Branch when flows were below bankfull-stage. The environmental objectives of reclamation design at Valzinco were as follows and shown conceptually in Fig. 11:

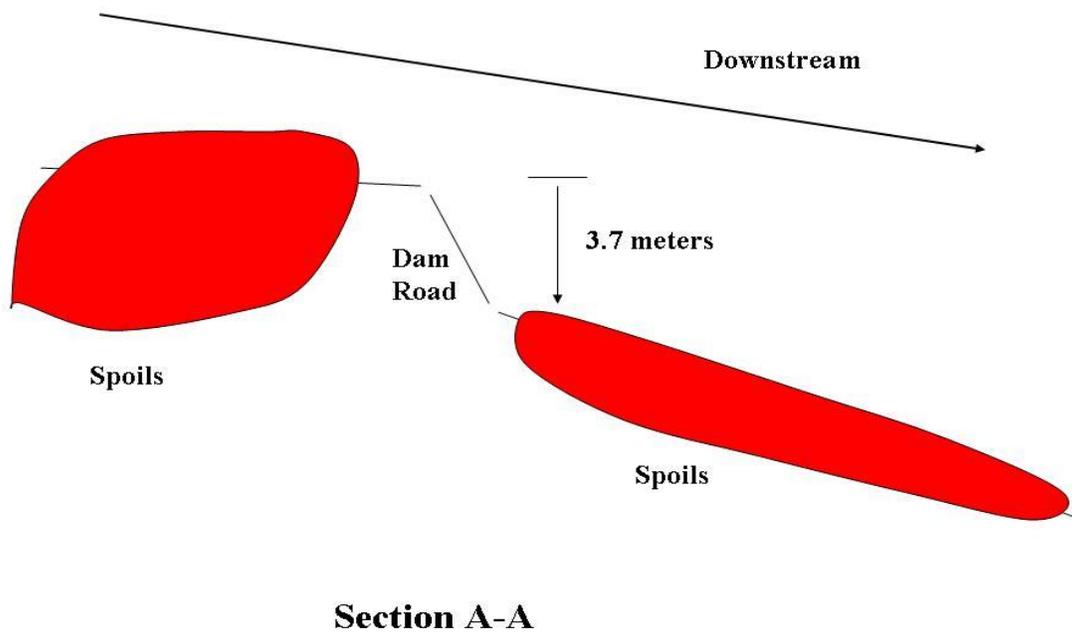
Figure 10. Depth and extent of spoil mass along Knights Branch in Valzinco valley.

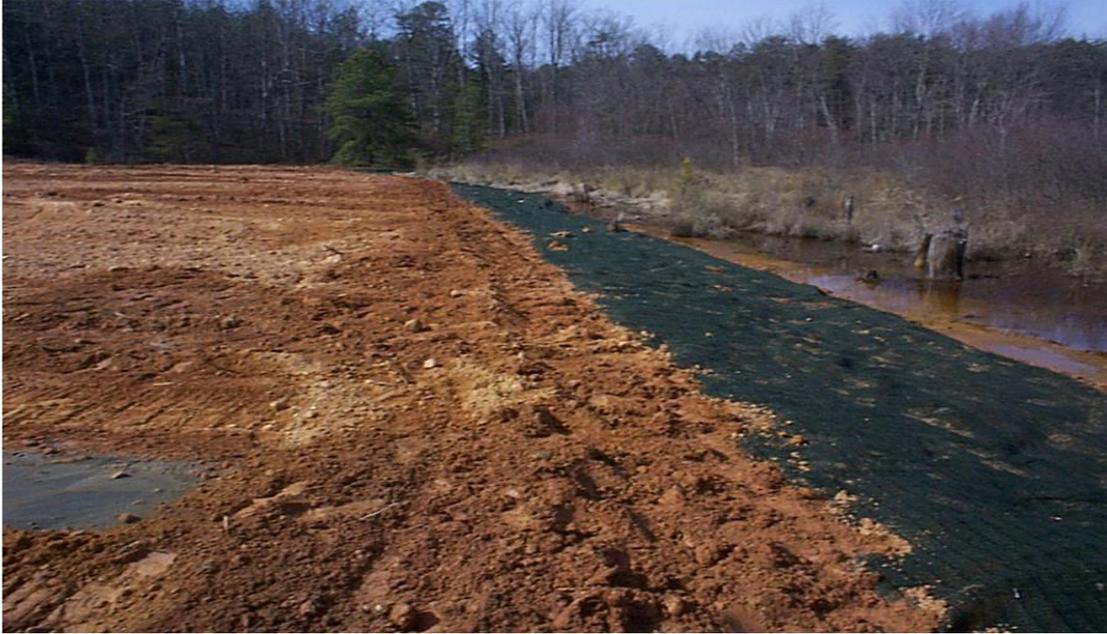
Figure 14. Covered spoils under soil cap contiguous to Knights Branch approaching Wetlands Cell 1.

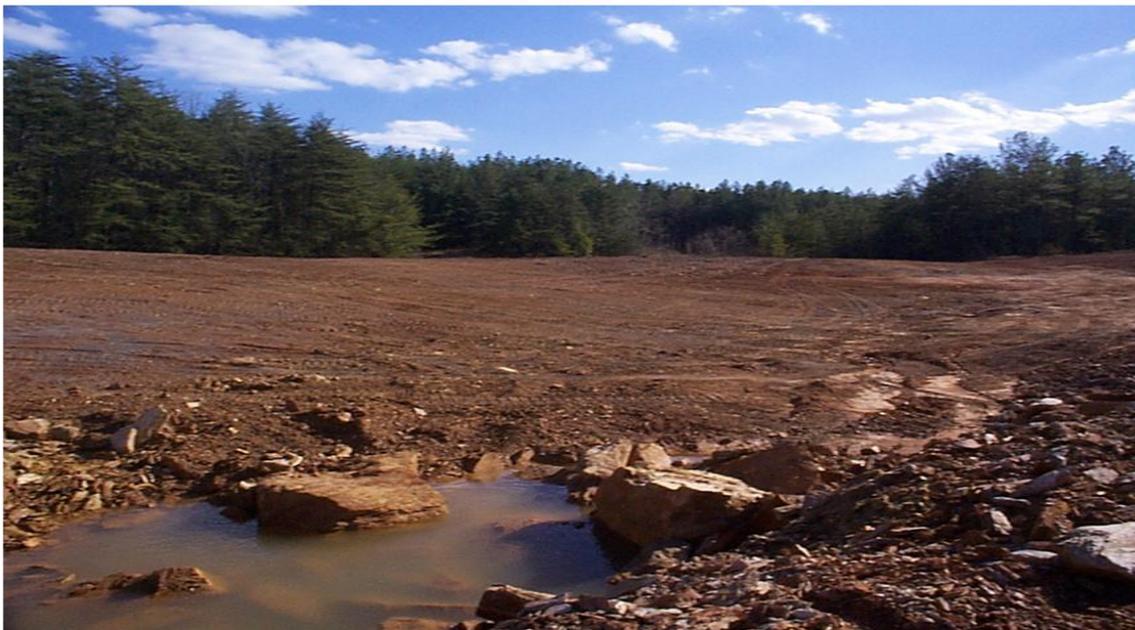
Figure 15. Soil cap over landfill containing wet-excavated spoils with microbial inhibitor applied.

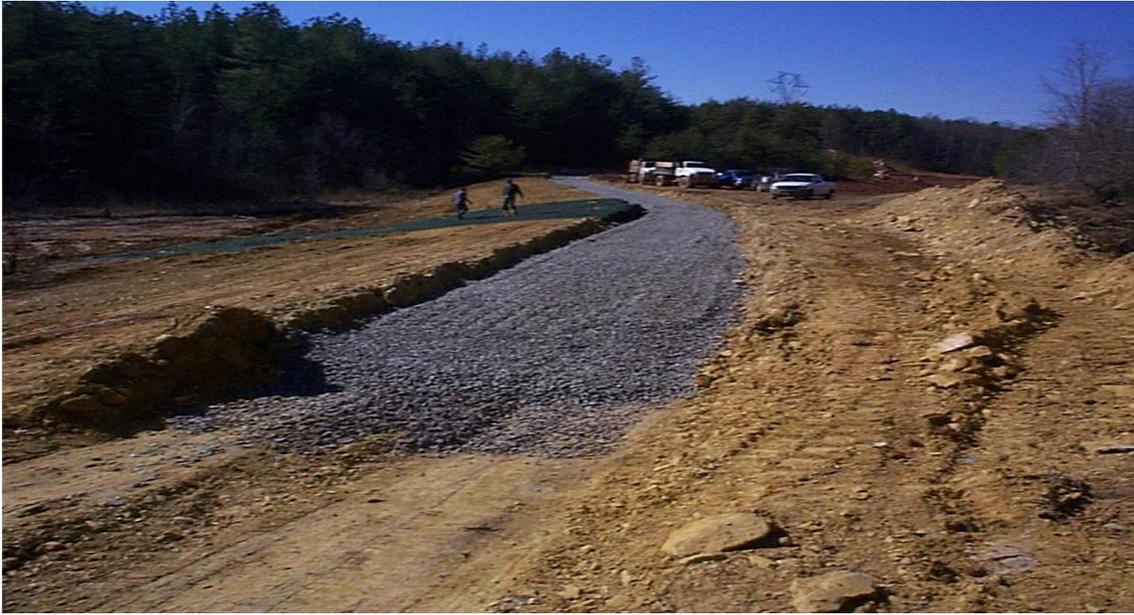
Figure 16. New 46 meter spillway cut into dam structure and reggraded dam face with vegetation mat on 5:1 slope.

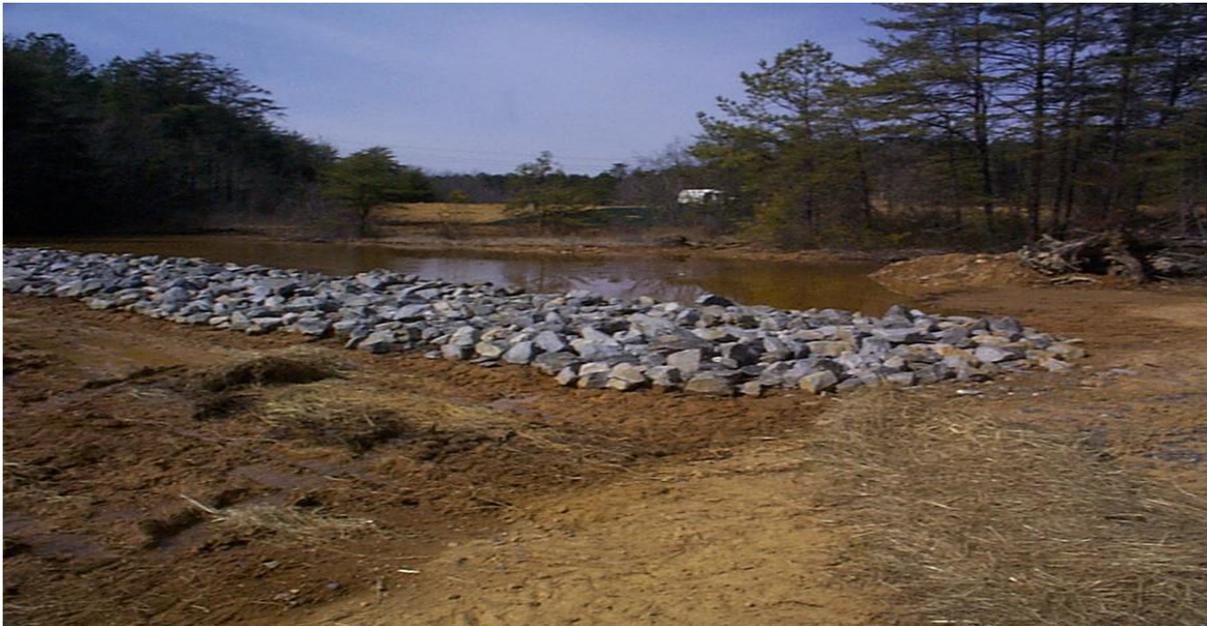
Figure 17. Berm 1 is in foreground forming Wetlands Cell 2; the new spillway over the dam shows in the background.

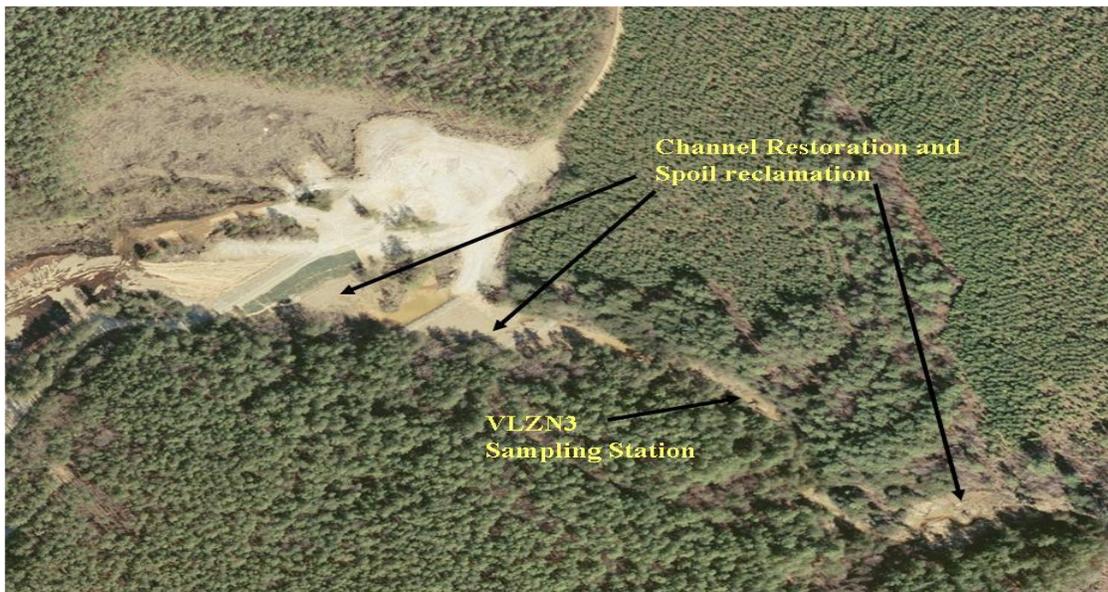
Figure 18. Phase II establishes a southern channel for Knights Branch from the dam through Wetlands Cell 2.

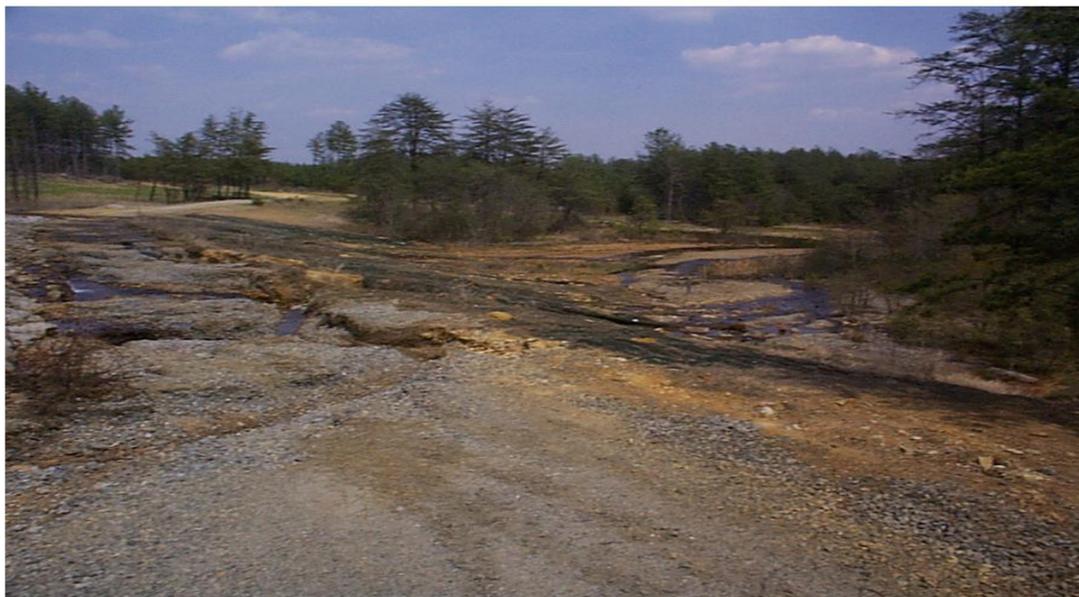
Figure 20. Channel development over the dam (2003) along the south side of the watershed and location of Phase II step-pool structure.

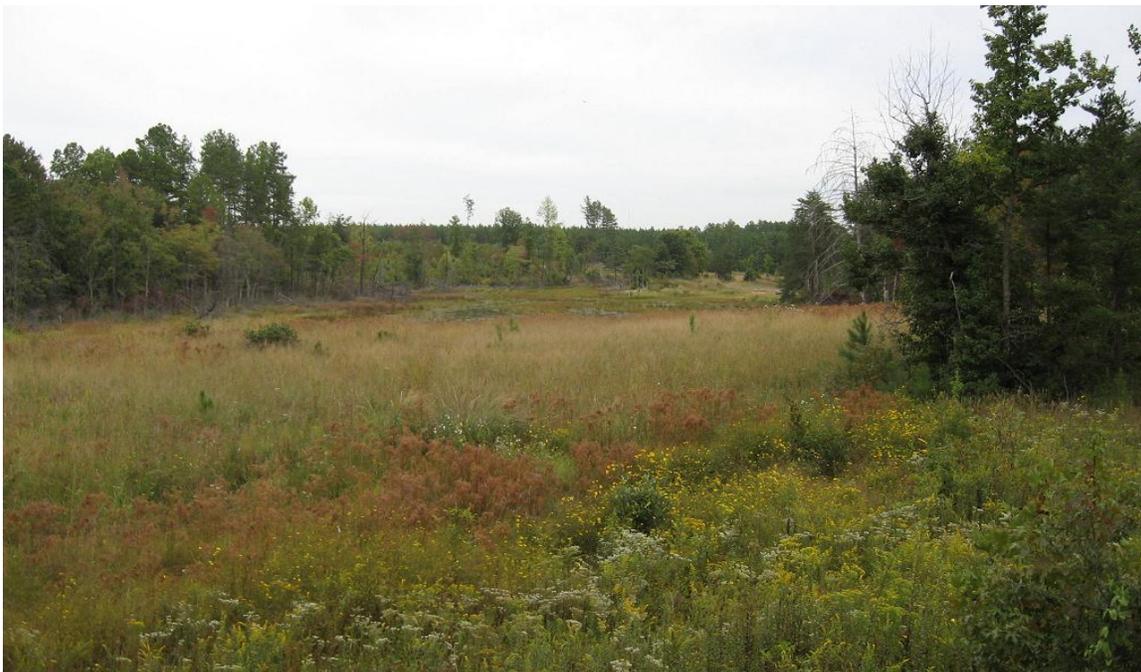
Figure 21. Former spoils area upstream of the dam and surrounding Wetlands Cell 1.

The vegetation community of Cell 1 was dominated by spike rush (*Eleocharis obtusa* (Willd.) Schult., IV = 25.1) and bladderwort (*Utricularia gibba* L., IV = 22.2) (Figures X1-X2, Table 5). Where water was greater than 10cm deep, bladderwort coverage often exceeded 100%. Average cover for the cell was 74.7%. The annual weakstalked bulrush (*Schoenoplectus purshianus* (Fernald) M.T. Strong) was seasonally common with in the cell (IV = 10.6). This was a surprising find as it is usually found in alkaline systems with a mean pH of 7.1 and range of 6.7 to 8.3. Bare ground, treated as a species in our cover data, was also dominant with IV = 29.0.

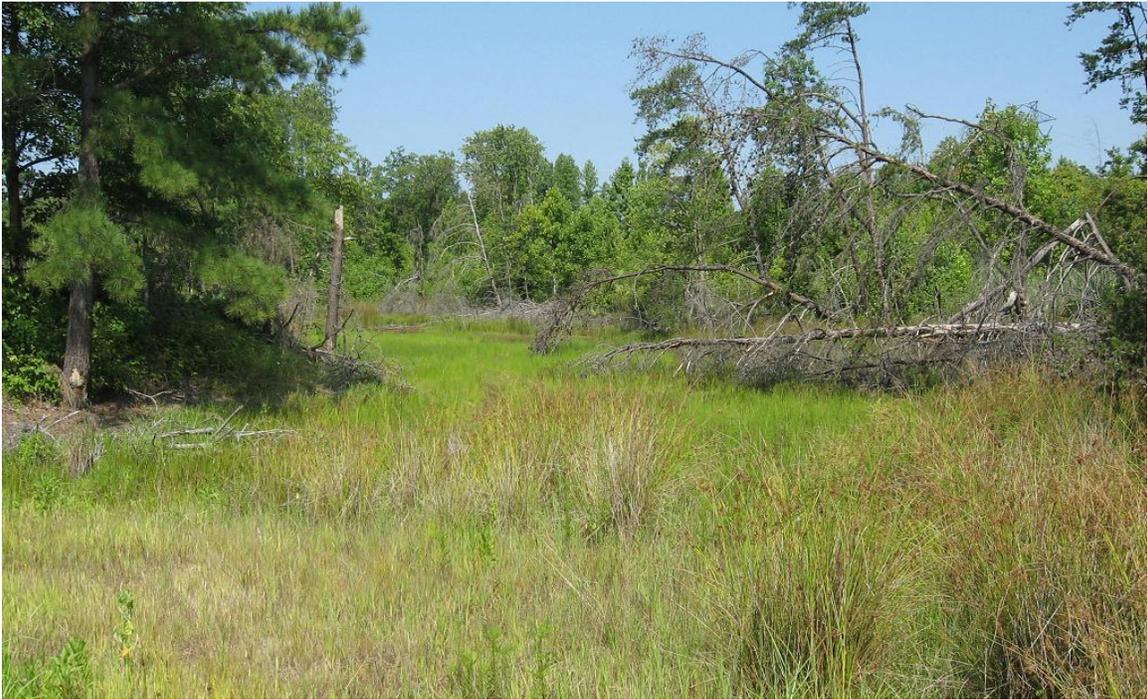
Figure 22. Former location of Knights Branch channel at northern end of dam.

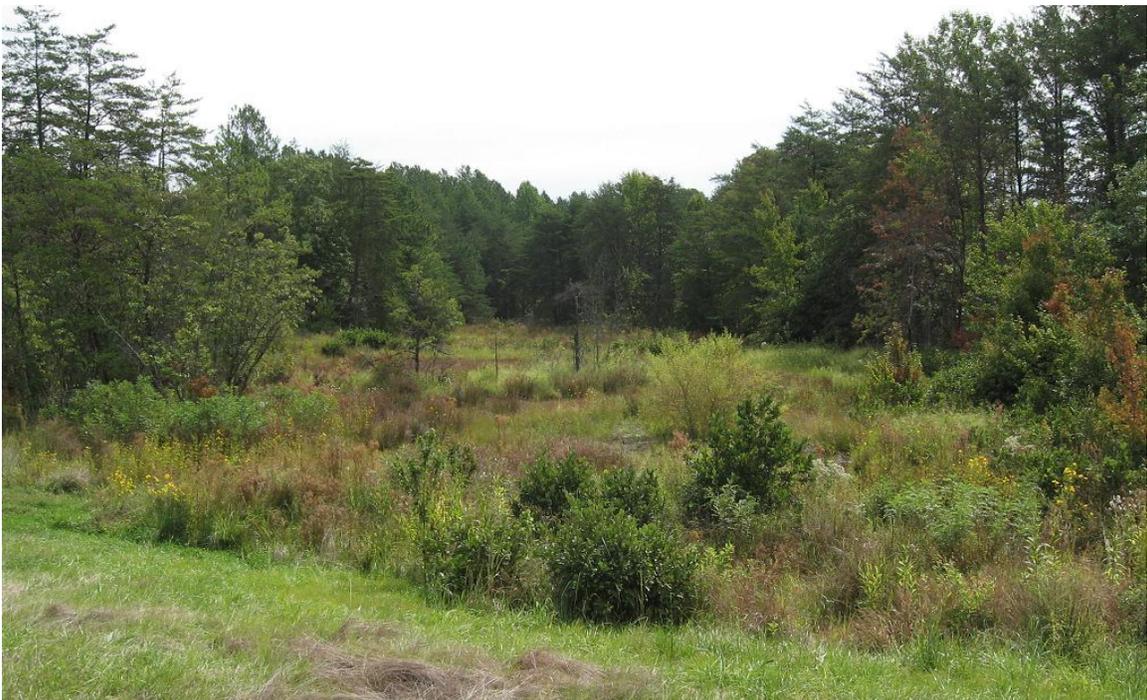
Figure 23. Knights Branch below the dam and reconstituted channel to the right.

The bulrush and spike rush dominated the vegetation community of Cell 2 (IV = 27.3 and 23.9, respectively) (Fig. 23, Table 5). There was less standing water on the site compared to Cell 1. Average cover for the cell was 75.7%. Bare ground was also dominant with IV = 24.9. Many woody shrubs were established within the cell (although, not encountered in our quadrats) and included such species as buttonbush (*Cephalanthus occidentalis* L.), highbush blueberry (*Vaccinium corymbosum* L.), spice bush (*Lindera benzoin* (L.) Blume), and hazel alder (*Alnus serrulata* (Aiton) Willd.). Several trees, including American sycamore (*Platanus occidentalis* L.) black willow (*Salix nigra* L.), river birch (*Betula nigra* L.), and red maple (*Acer rubrum* L.), had reached an age of 2 to 3 years old and appear to be healthy and robust.

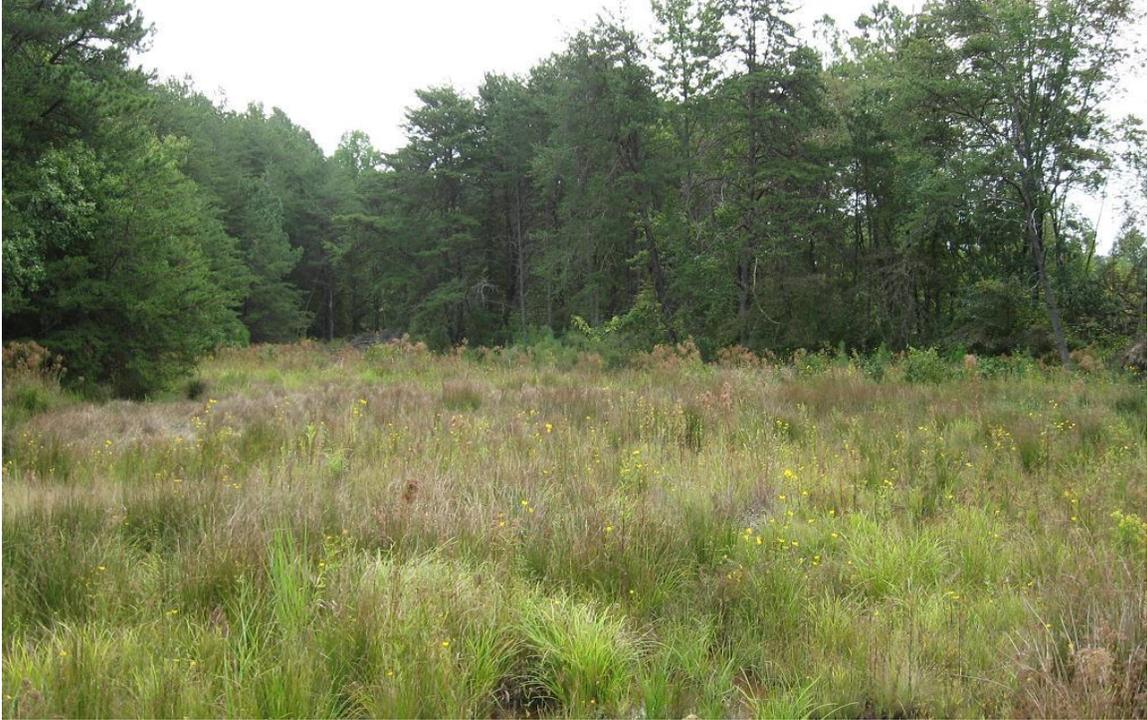
Figure 24. Downstream limit and wetlands of the Valzinco valley below the dam
