# **Geomorphic Reclamation of Abandoned Coal Mines near Raton, NM**

#### The Swastika Mine and Dutchman Canyon Reclamation Project

Design and Construction Oversight

Presented By: Kate Malers, P.E.: Water & Earth Technologies (WET)

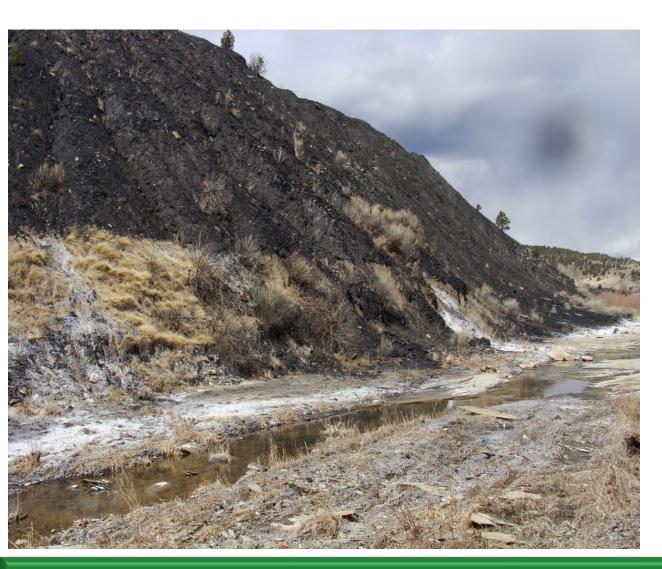
- Unstable coal waste slopes collapsing into the stream
- Infiltration leaching contaminants from the coal waste pile and conveying them to the stream channel
- Coal waste eroding into the stream during runoff events

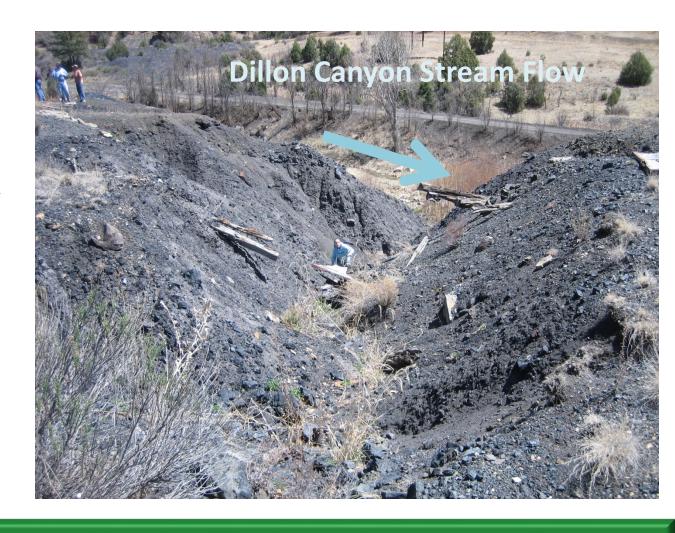
In those locations where runoff from the mountainside above the waste pile crossed the pile, very deep gullies eroded through the coal waste.

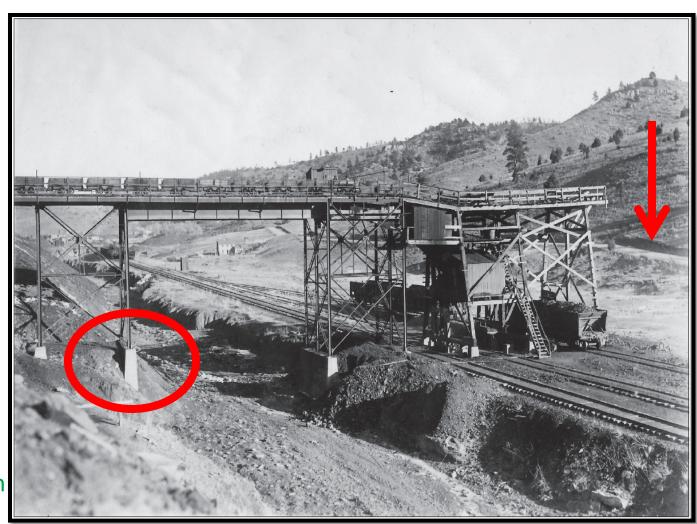
- The stream was straightened to accommodate coal handling facilities
- Channelization reduces stream gradient and increases flow velocities
- High flow velocities erode the channel bed and banks, destabilizing the stream

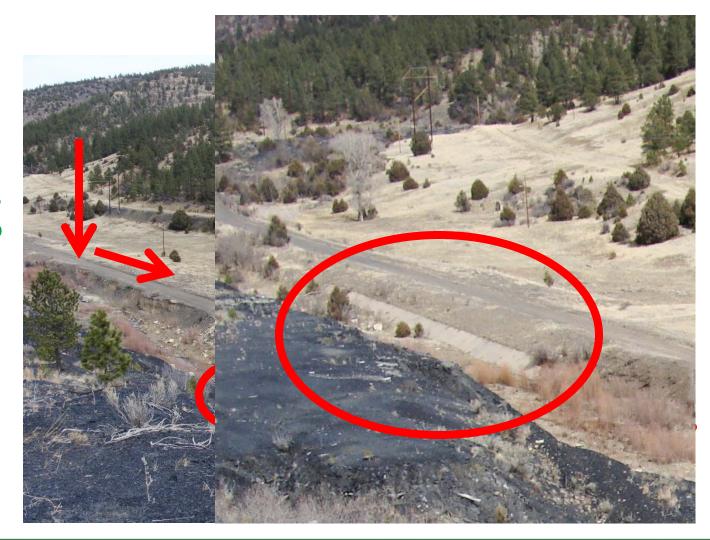
- Channel bed degradation propagates from the disturbed reach
- Bank erosion works towards the return to a meandering stream alignment
- However, bank erosion is undesirable because it undercuts the coal waste pile and the road

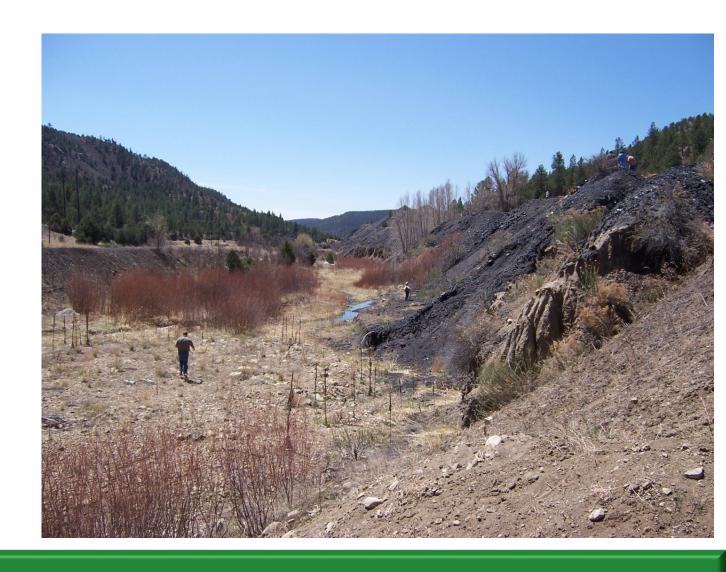
The large capacity channel conveys flood flows inchannel, without the benefits of floodplain inundation:

- Zones of shallow, slow overbank flood flow and deposition
- Bank storage
- Flood peak attentuation
- Riparian habitat benefits

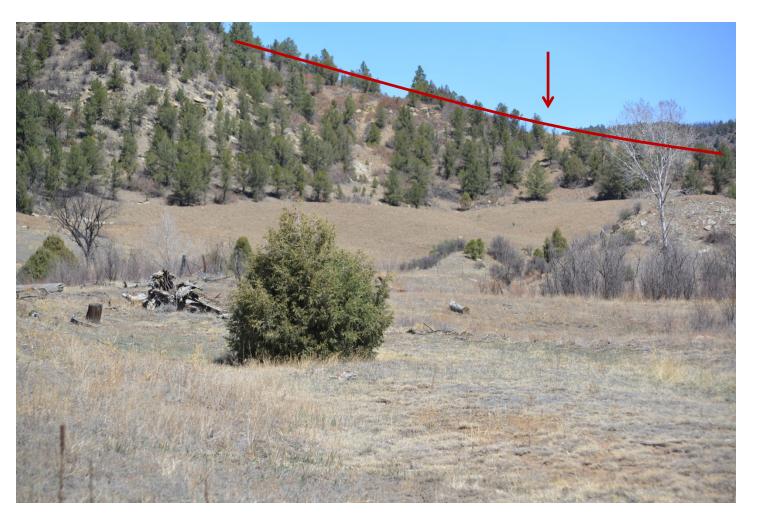
South
Combination
Soil
Borrow/Coal
Waste
Repository
with wood
straw mulch

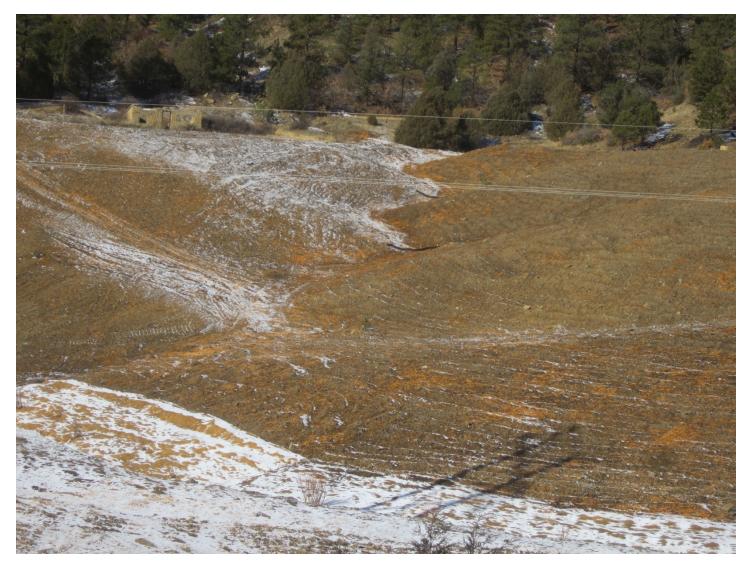
Geomorphic Landform and Integrated Drainage Channel

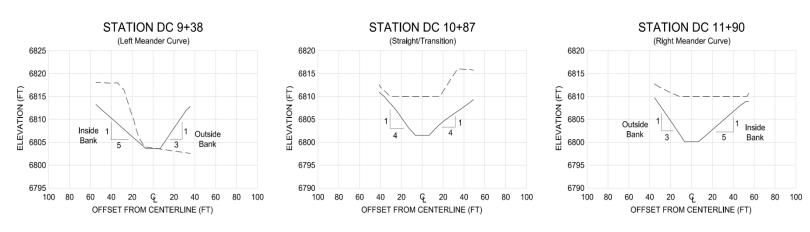
Typical channel cross section geometry, transitioning from steeper to flatter side slopes depending upon the location in the meander pattern

Steeper slopes on the outside of meanders are protected with a heavier TRM product (green) in the completed restoration
