EVALUATION AND RESTORATION OF PASSIVE TREATMENT SYSTEM PERFORMANCE IN PENNSYLVANIA

Presenter: Ryan M. Mahony

Additional Authors: D.A. Guy, C. F. Denholm, T. P. Danehy, C. A. Neely, S. L. Busler, M. H. Dunn

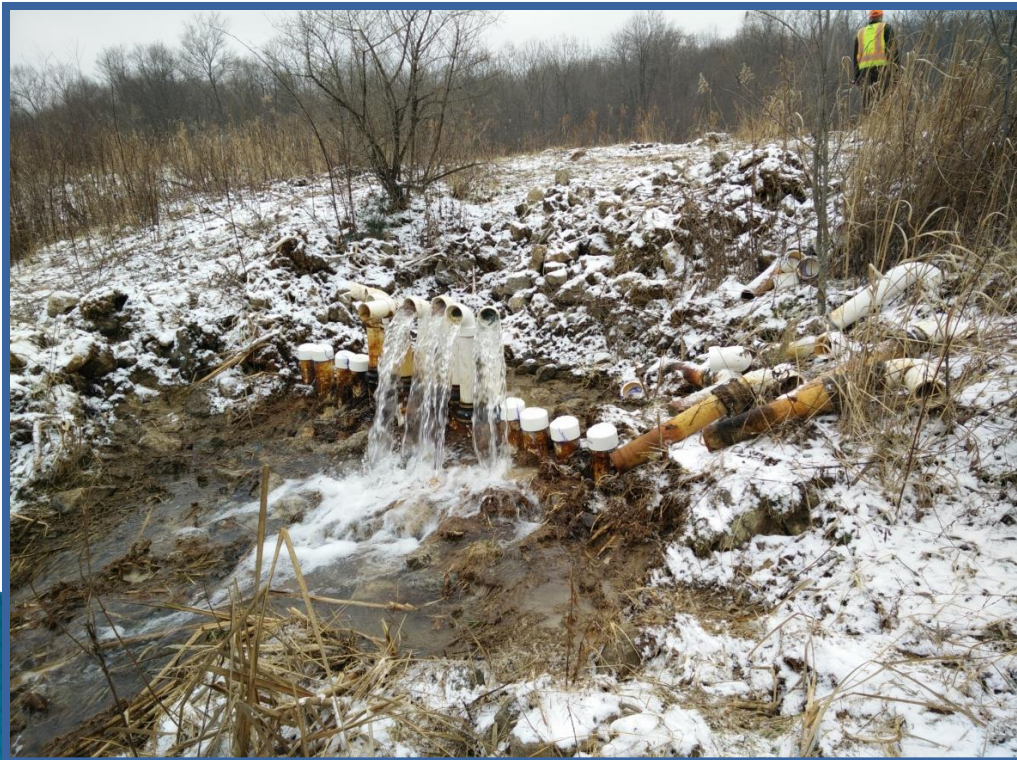
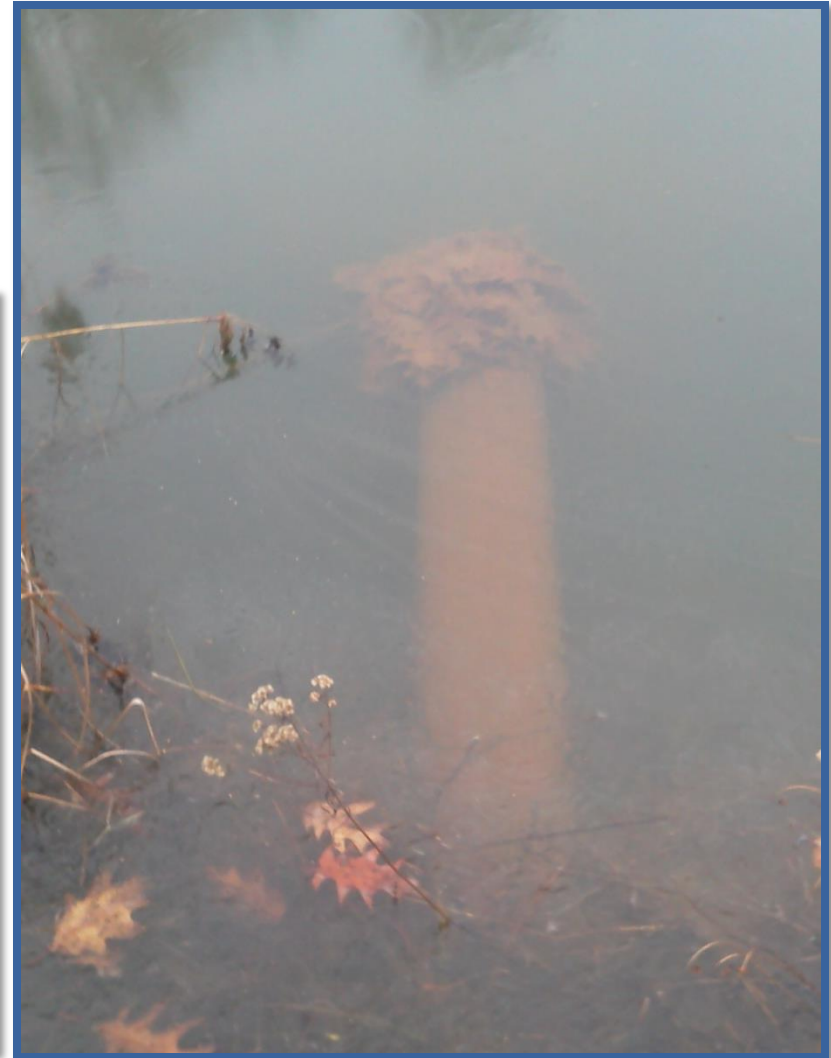
- ▶ Multiple issues noted during site visit by SRWC
- ▶ Forebay pipe inlet clogged
- ▶ VFP performance decreased

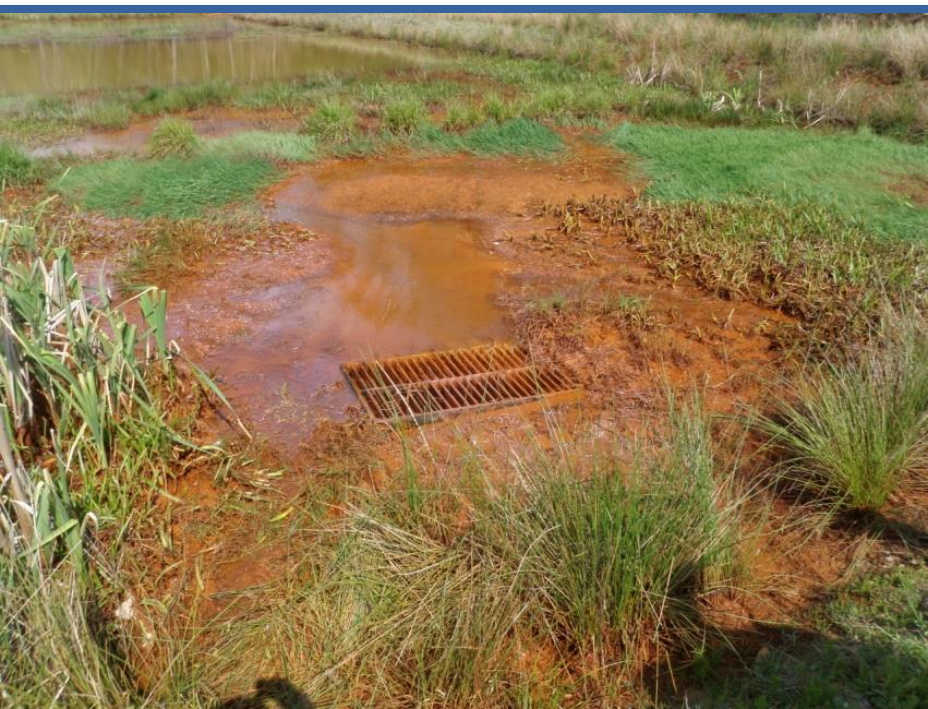
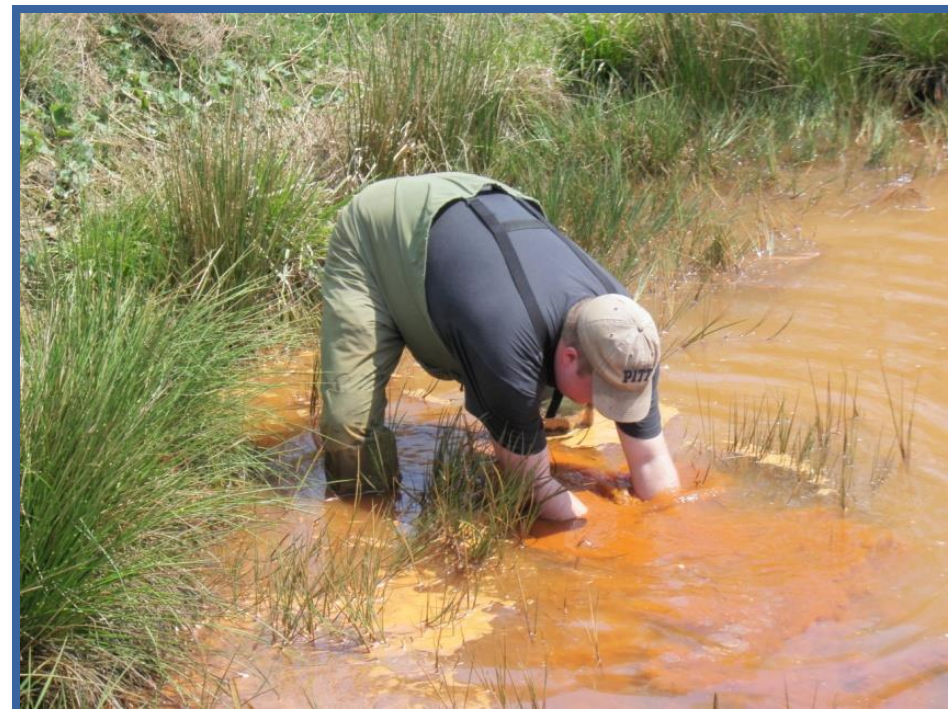
- ▶ 8" pipe flows 100' under road, blocked multiple times
- ▶ SRI assisted ICCD and the Evergreen Conservancy in clearing the blockage using a clean out tool
- ▶ Iron precipitation also reduced flow

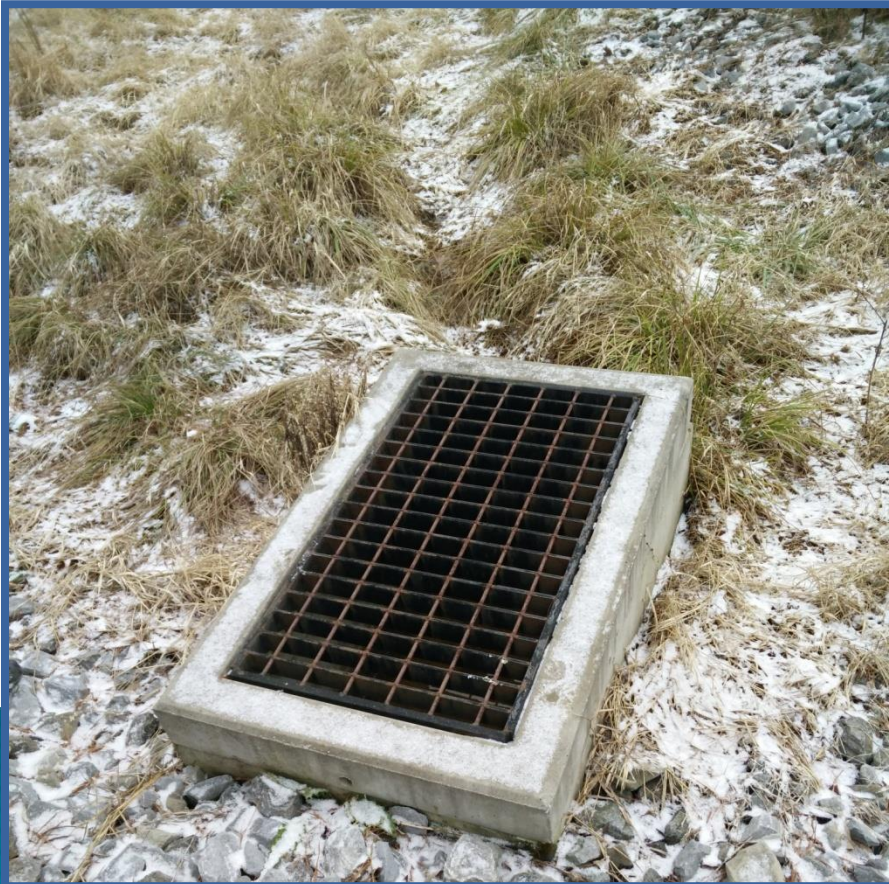
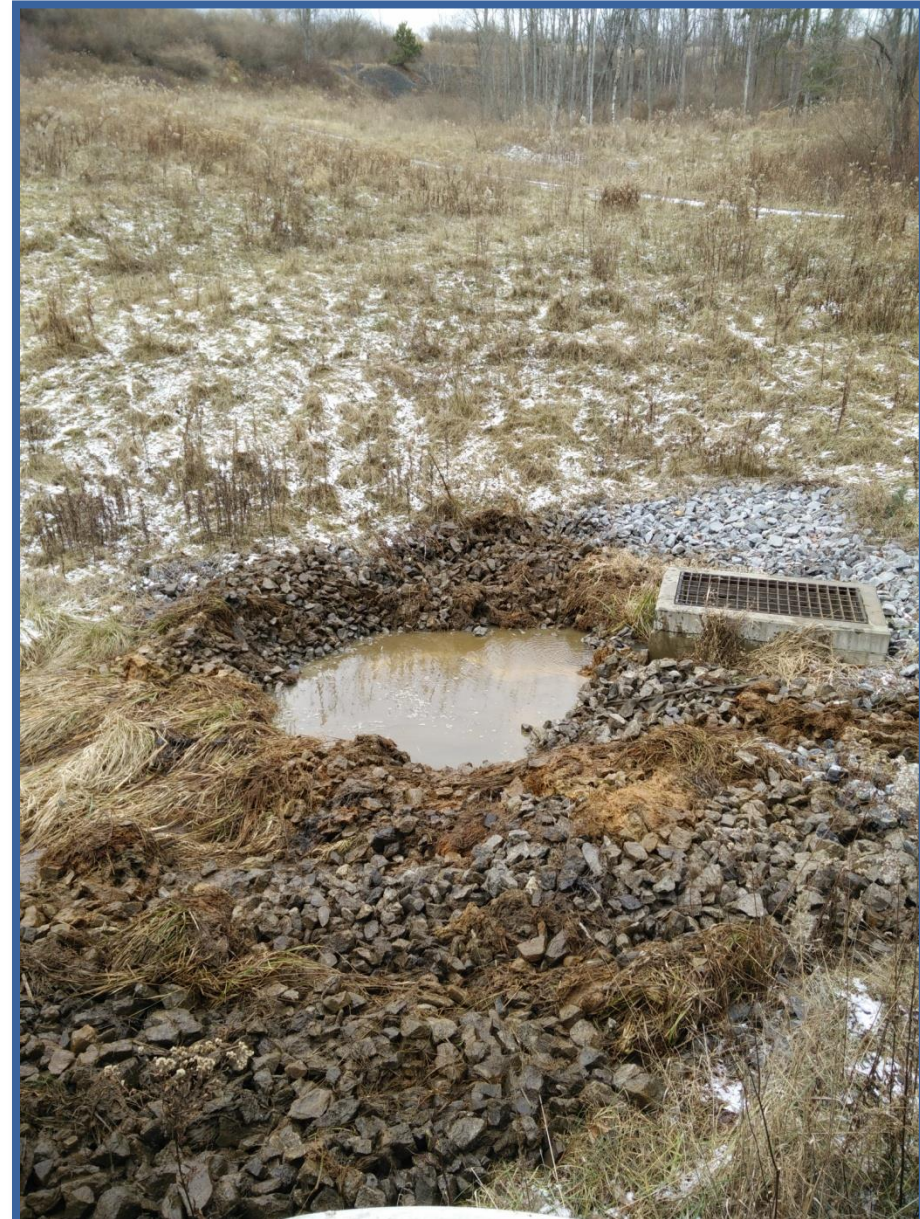
- ▶ Box outlet clogged
- ▶ Vegetation removed, outlet depth increased
