TREATMENT SYSTEM RESTORATION AND POWER GENERATION IN THE SLIPPERY ROCK CREEK WATERSHED

Presenters: Ryan M. Mahony & Daniel A. Guy

Slippery Rock Watershed Renaissance Initiative

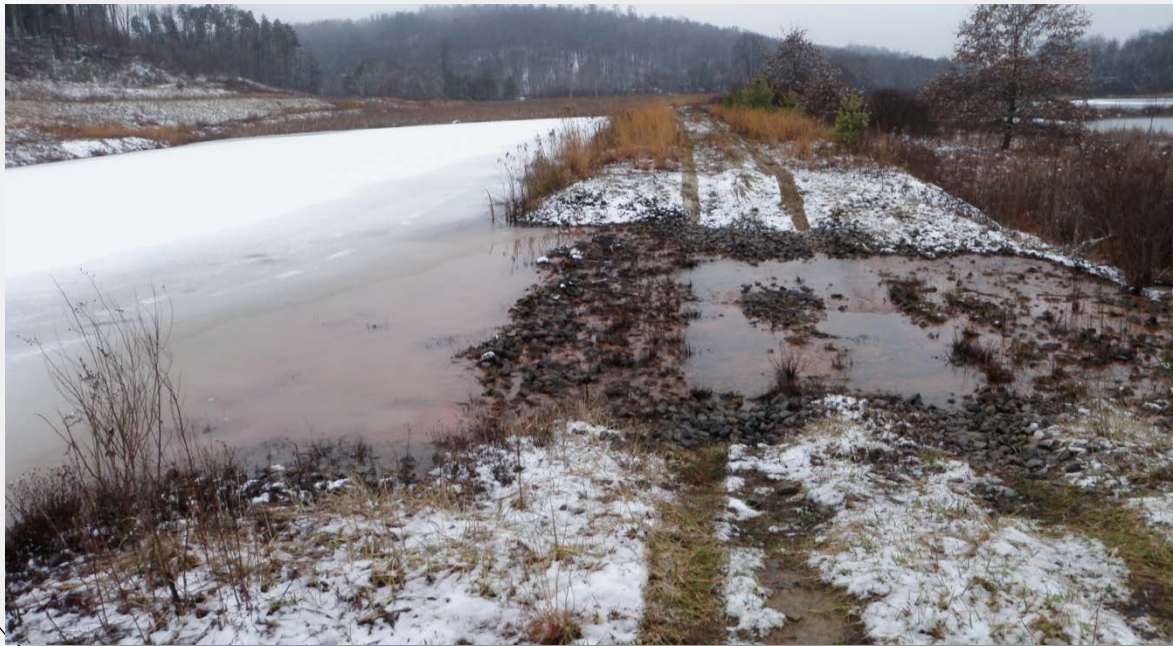
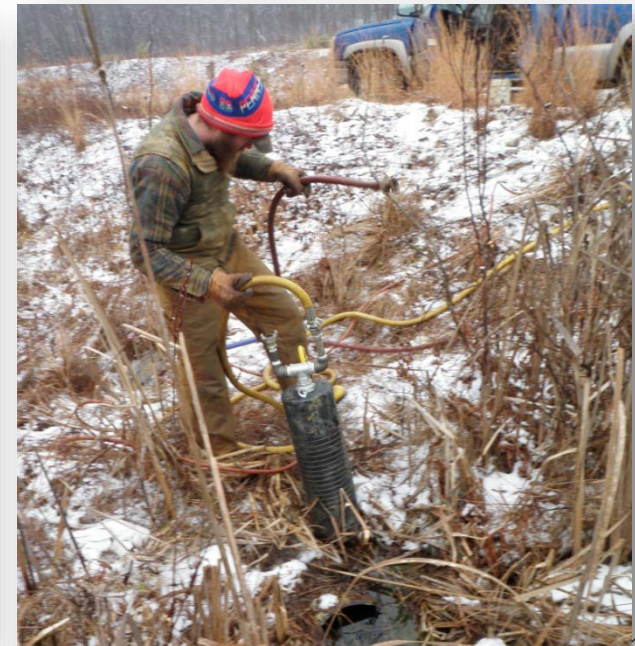
- In 2013, horizontal flow limestone bed (HFLB) became plugged
- Attempted backflushing, little improvement
- Stirring of HFLB recommended

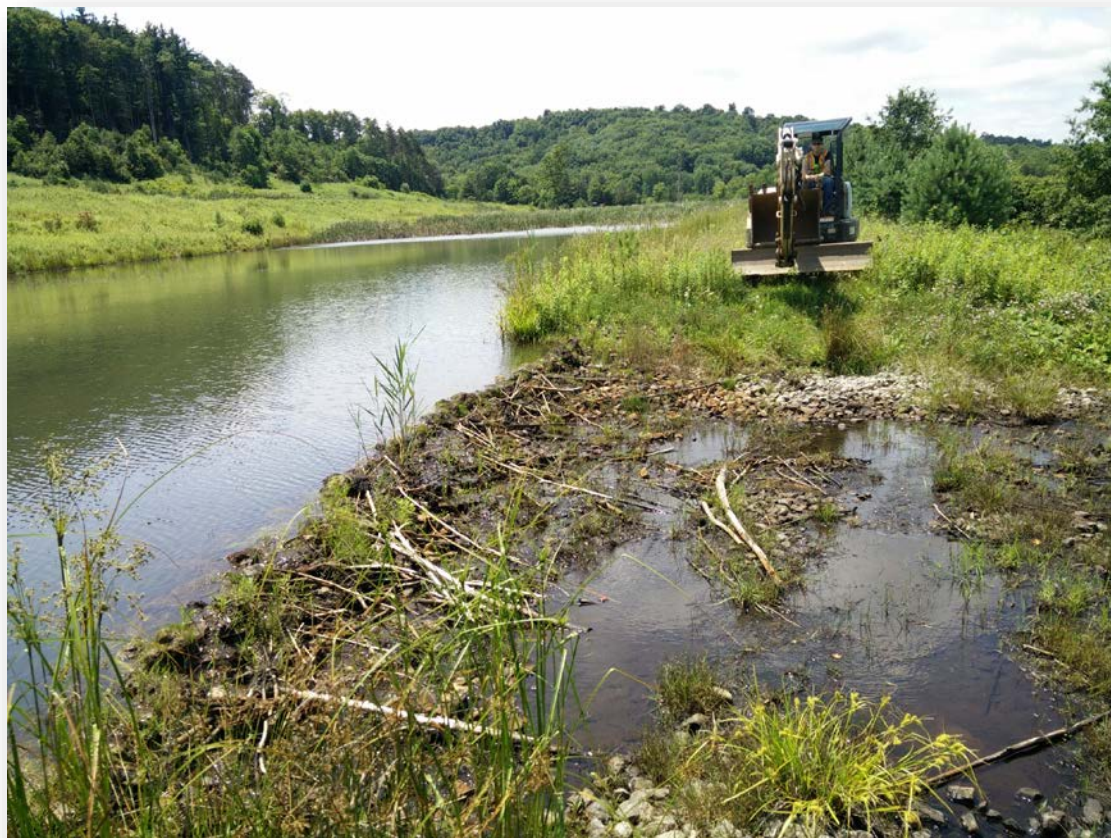
Beaver dam located at
emergency spillway

- Beaver activity abatement
- Include sludge pond when designing site layout if large amounts of sludge are expected to be produced

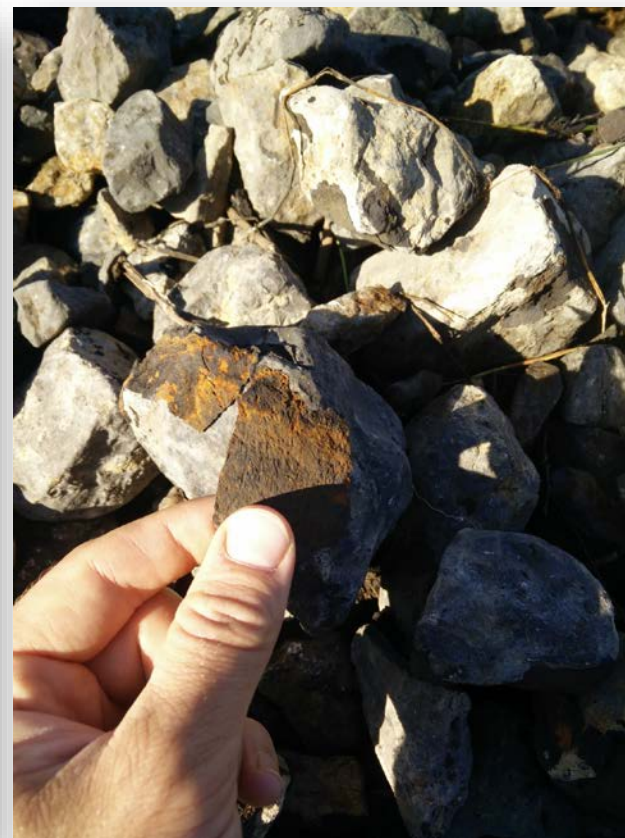
Fe & Mn 'flakes' on
spillway limestone

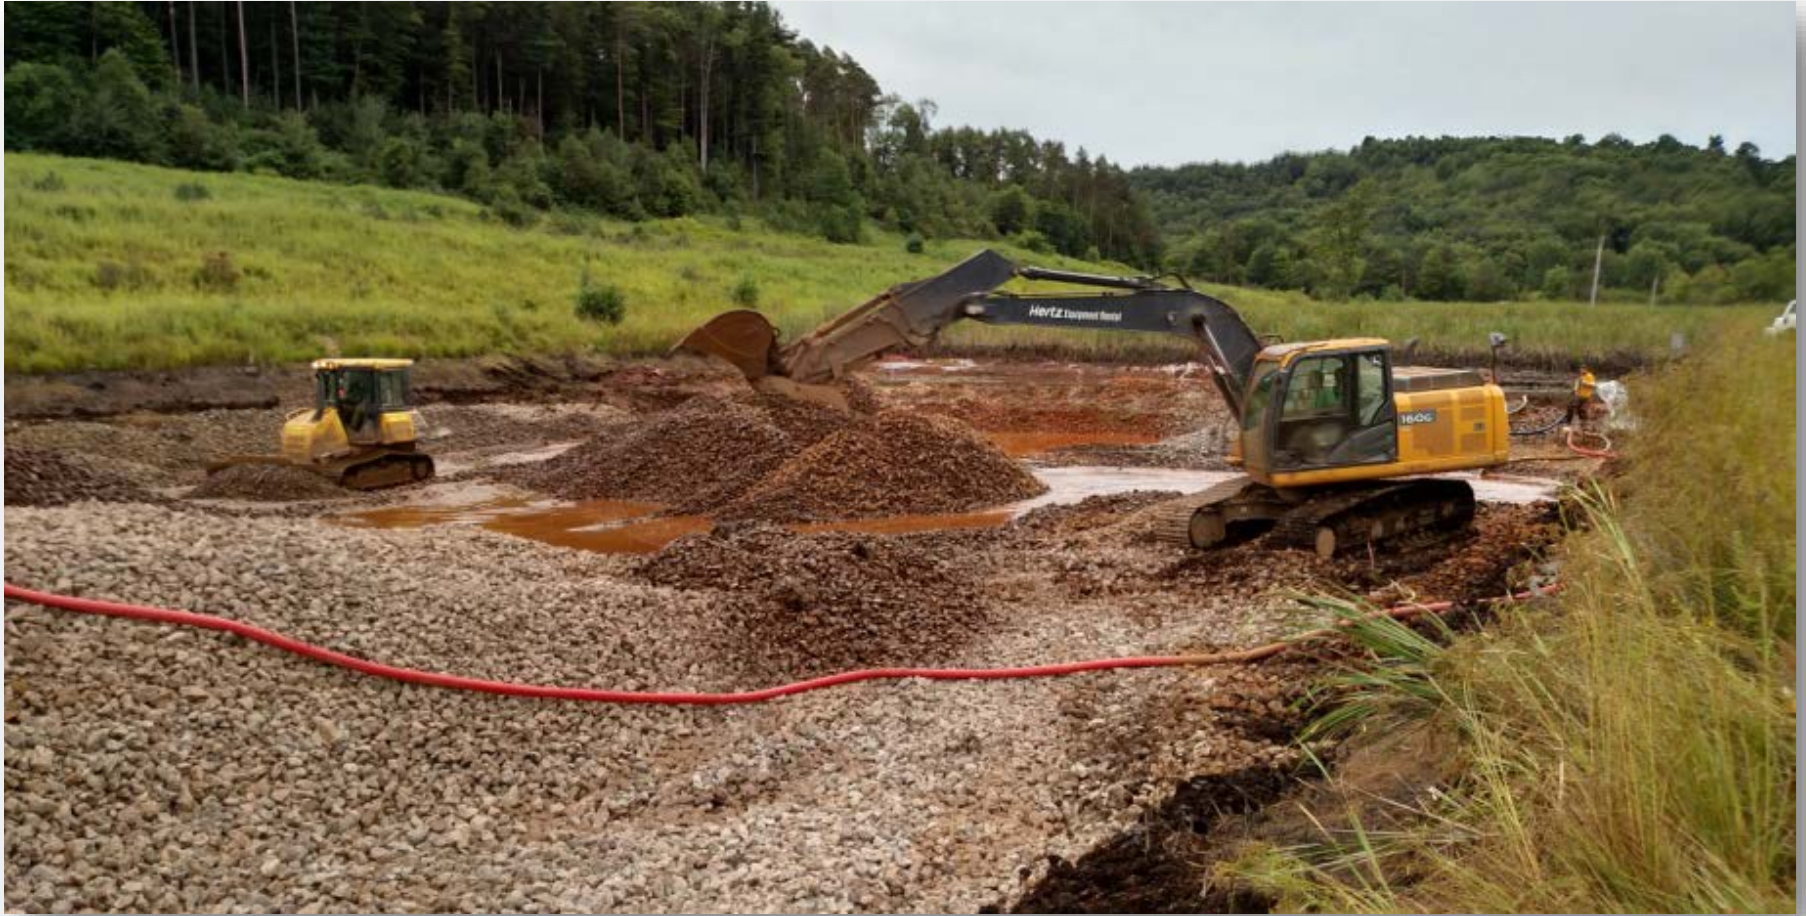
Bulldozer used to keep sludge from settling while pumping

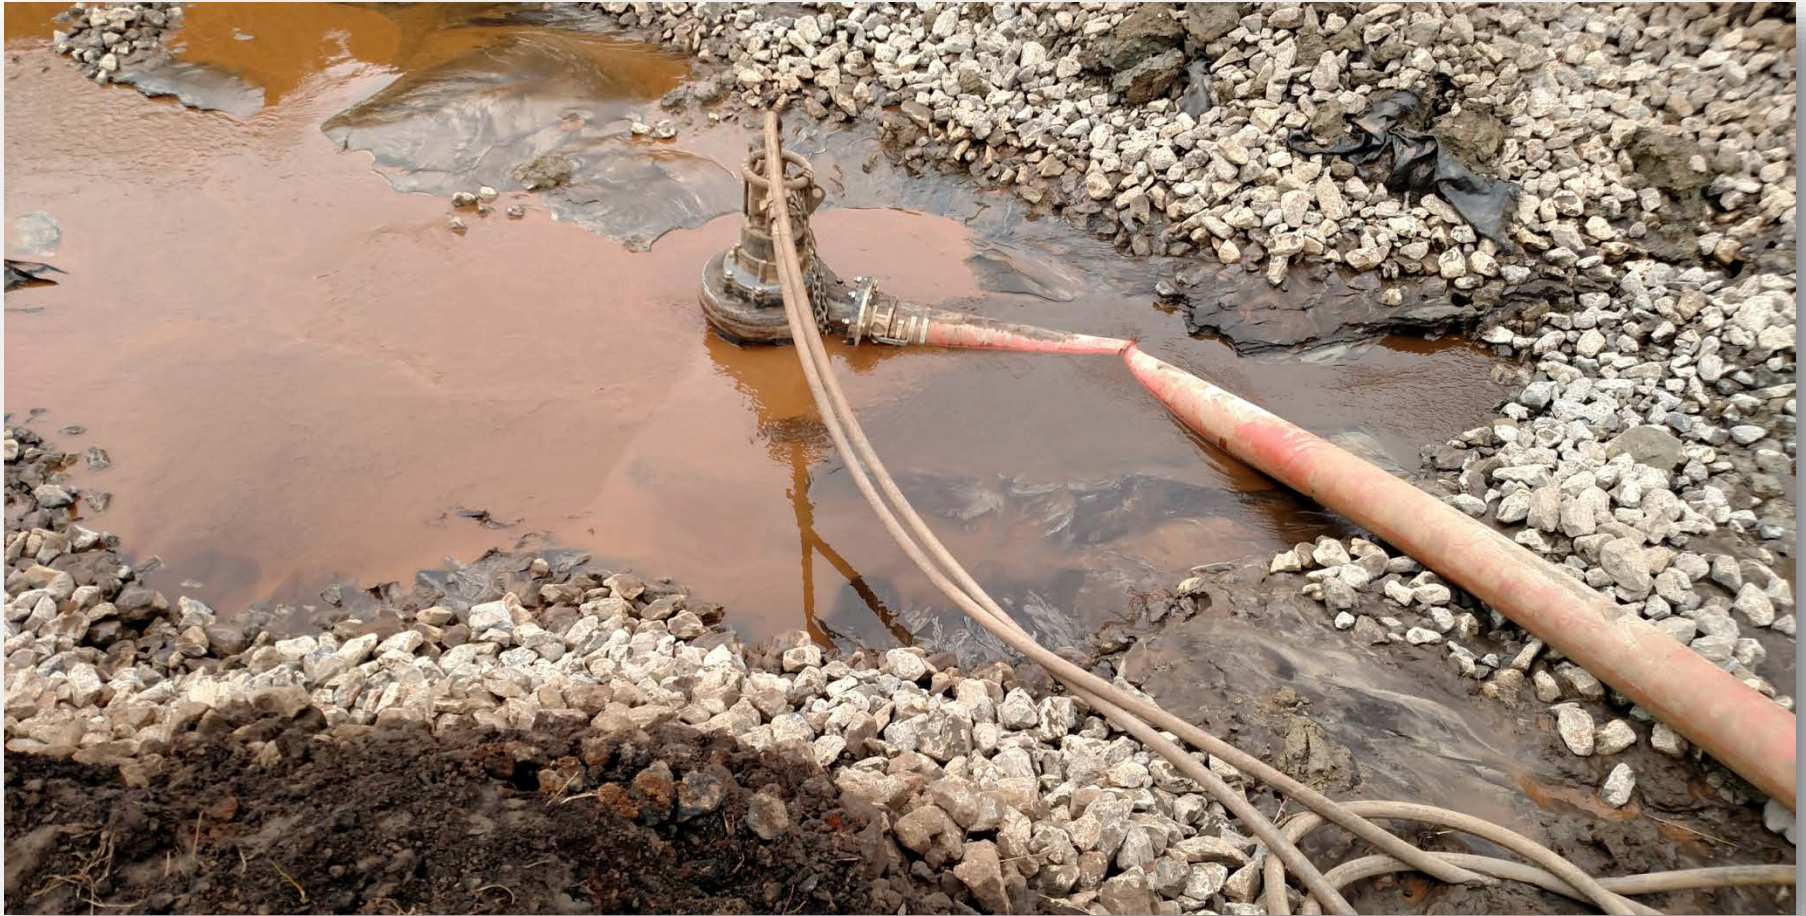
Water pumped to a sludge pond via 6" hydraulic pump

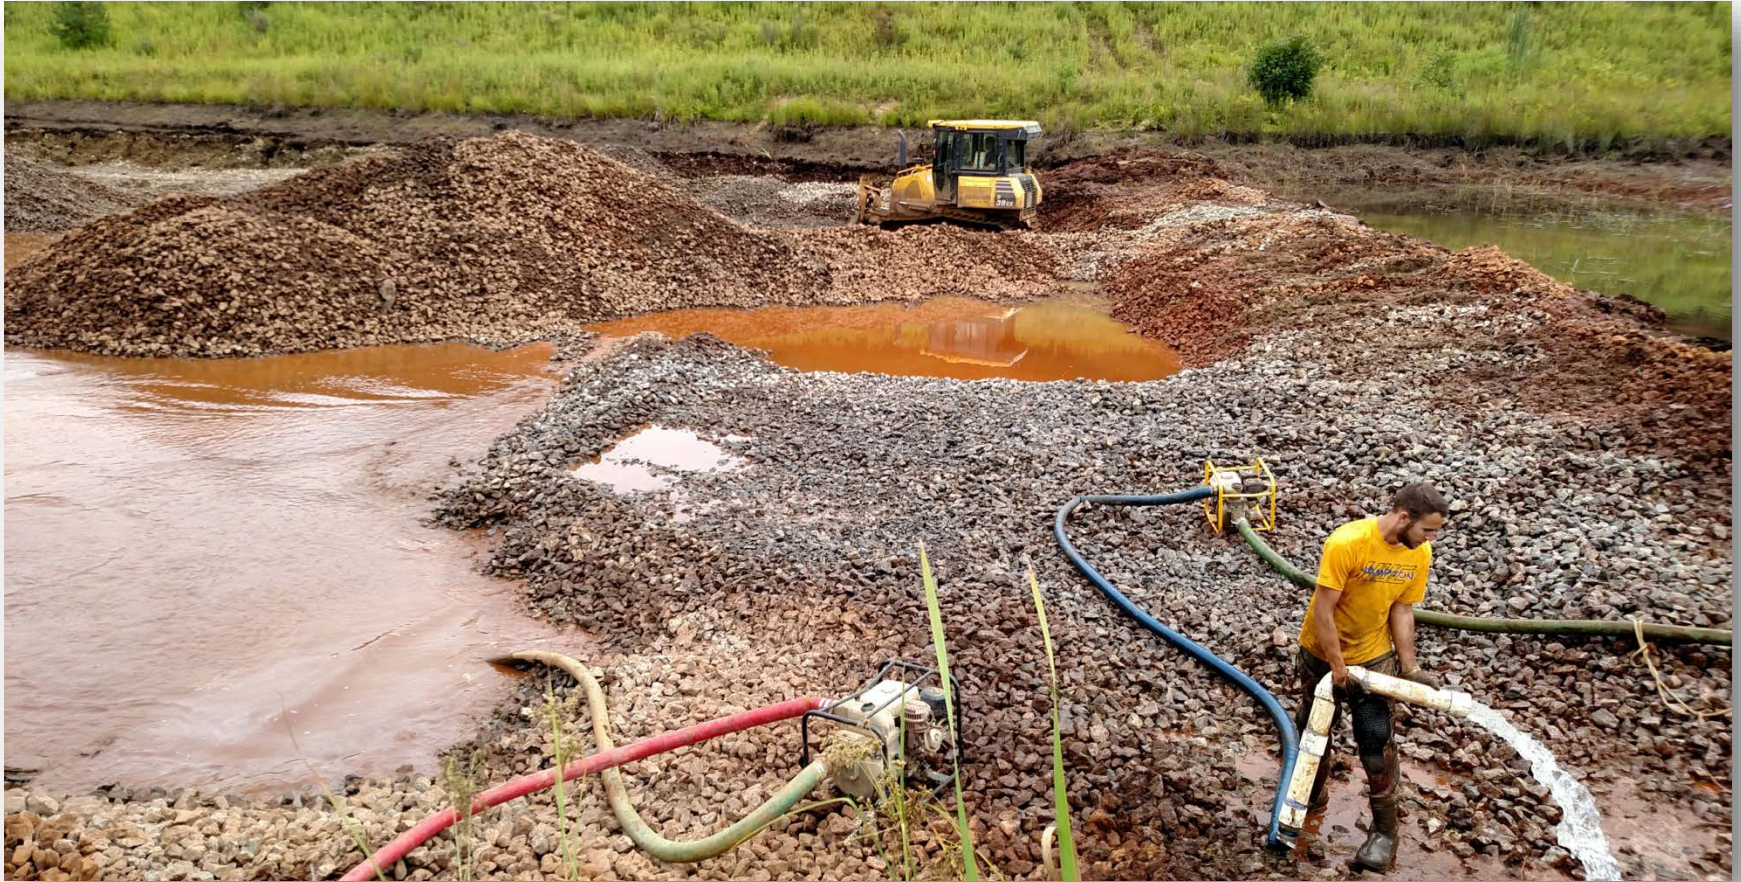
Limestone was cleaned further with a water pump after the initial sludge layer was removed

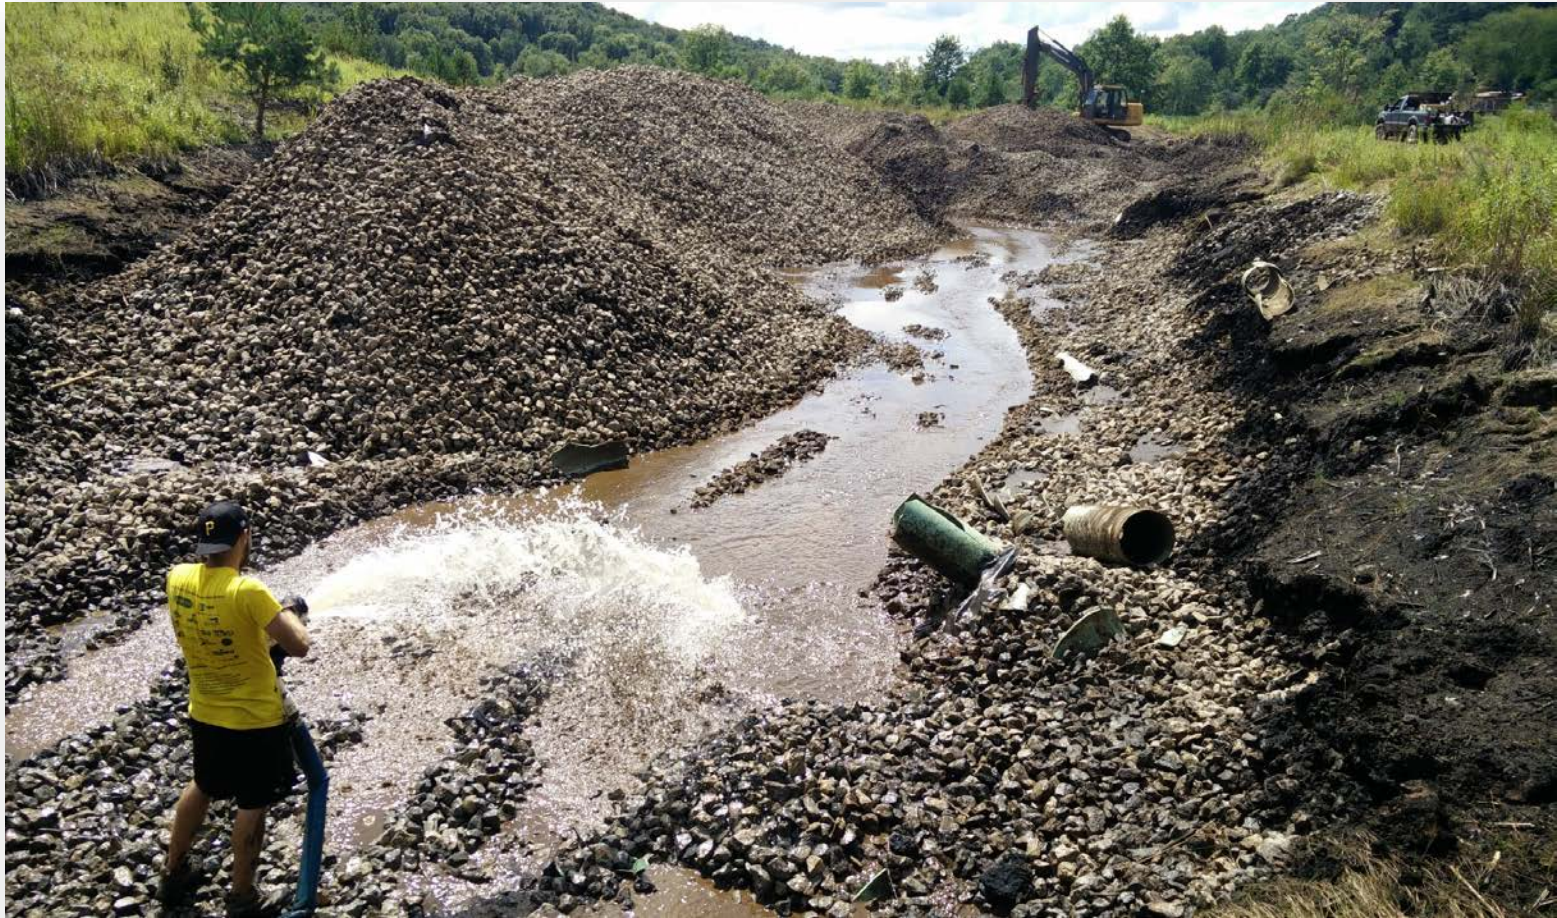
Limestone was cleaned further with a water pump after the initial sludge layer was removed

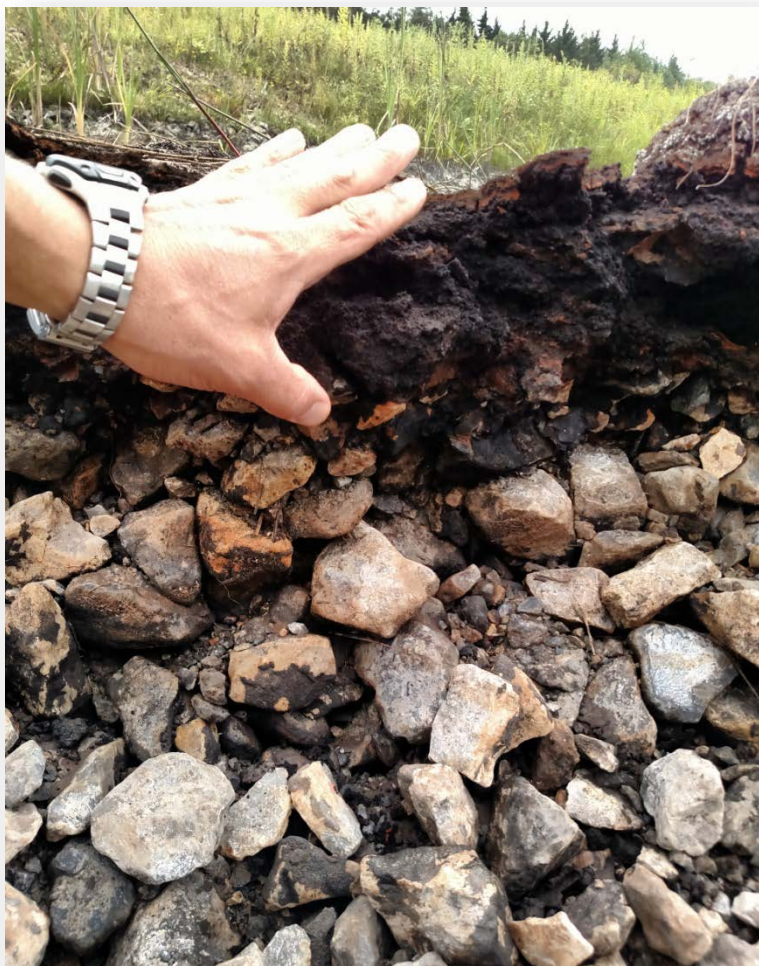
Sludge/stone layering prior to cleaning

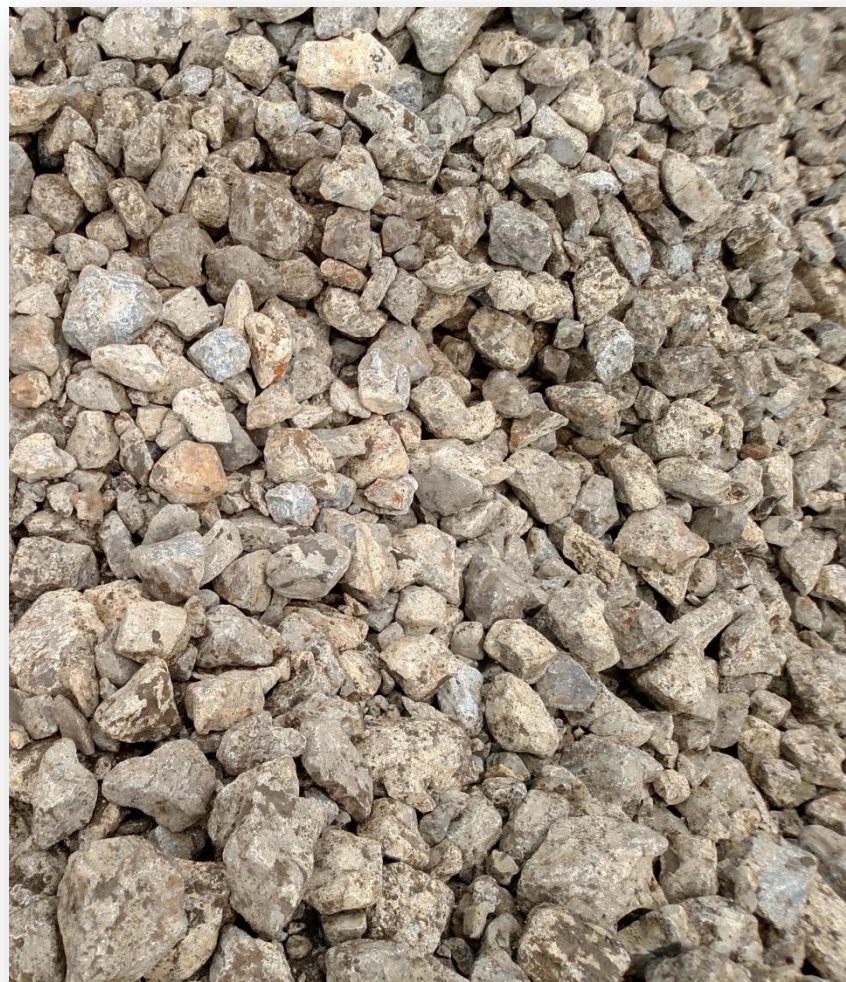
Limestone after cleaning

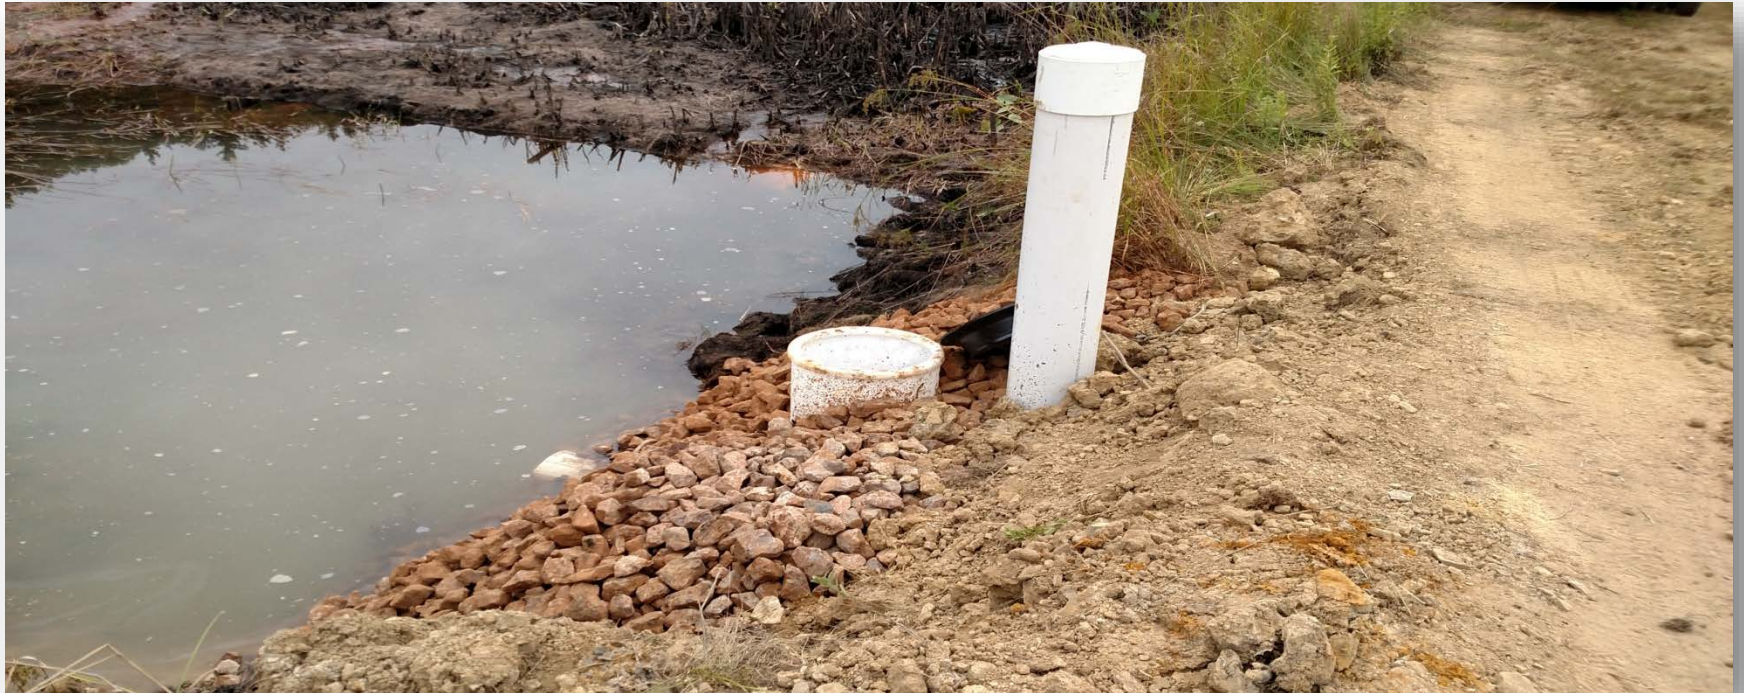
A bypass valve was installed upgradient of the HFLB to simplify future maintenance activities.

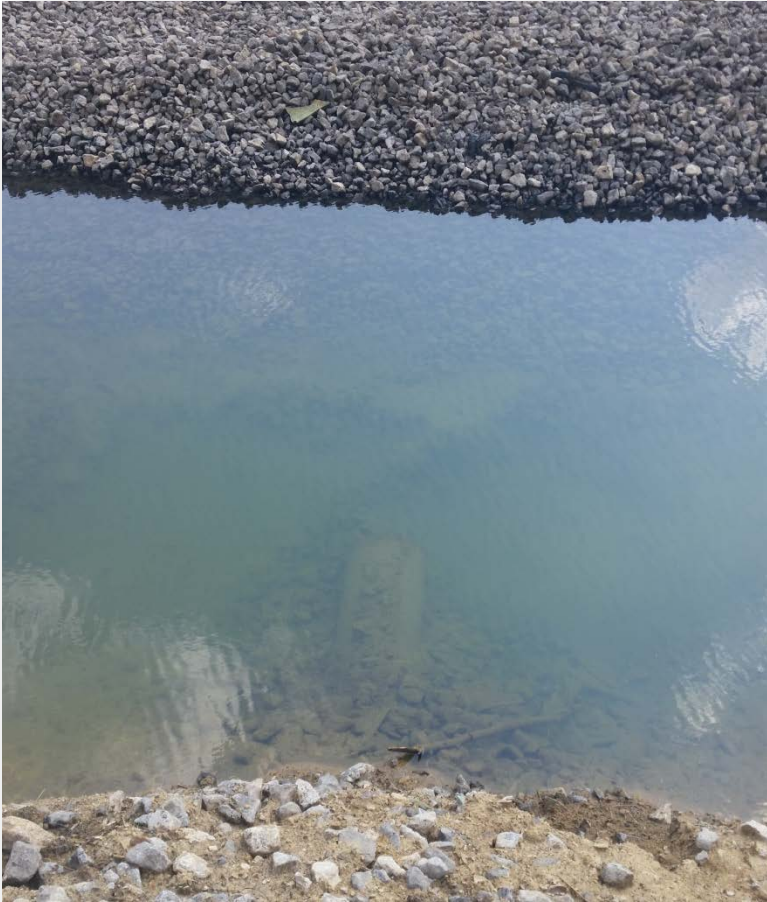
HFLB underdrain manifold replaced by outlet pool

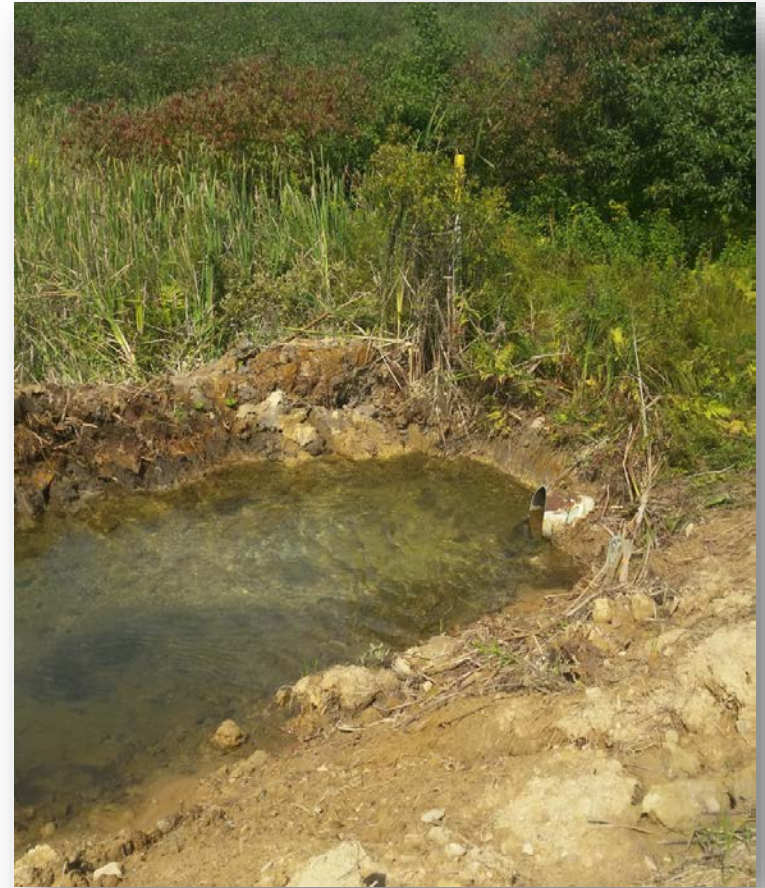
System outlet cleared of vegetation and outlet pool constructed.

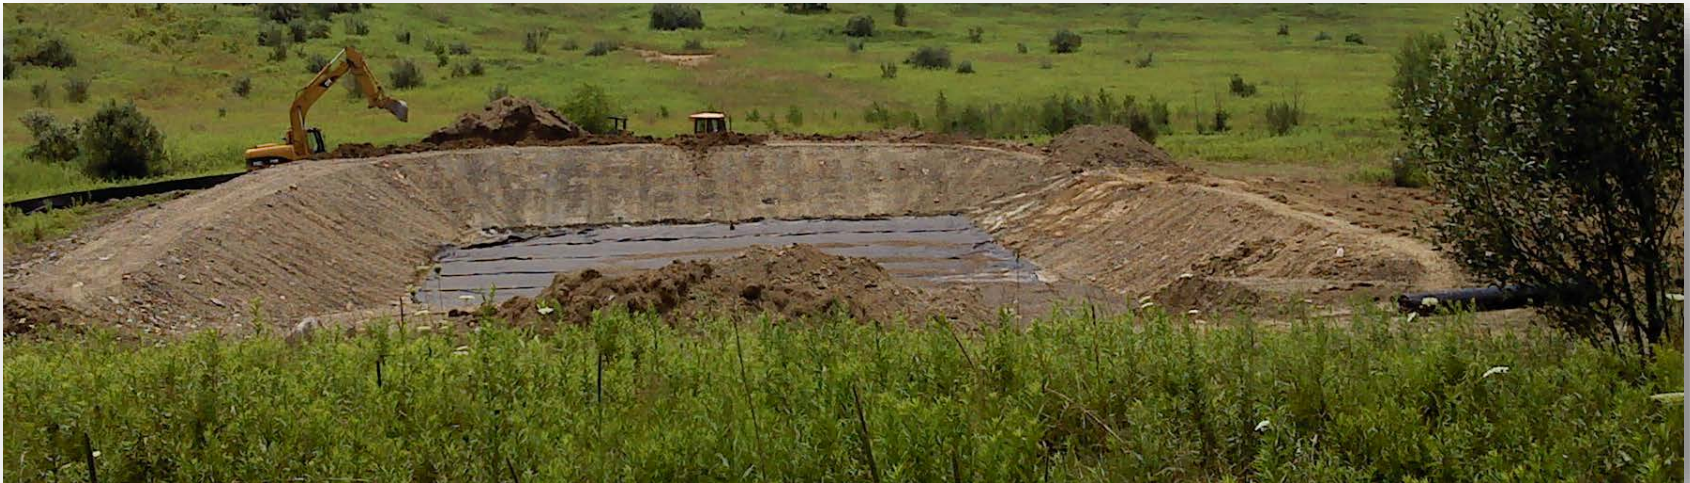
- After construction, issues with water retention in wetlands
- Constructed on previously mined land
- Best available on-site material compacted & used to construct components

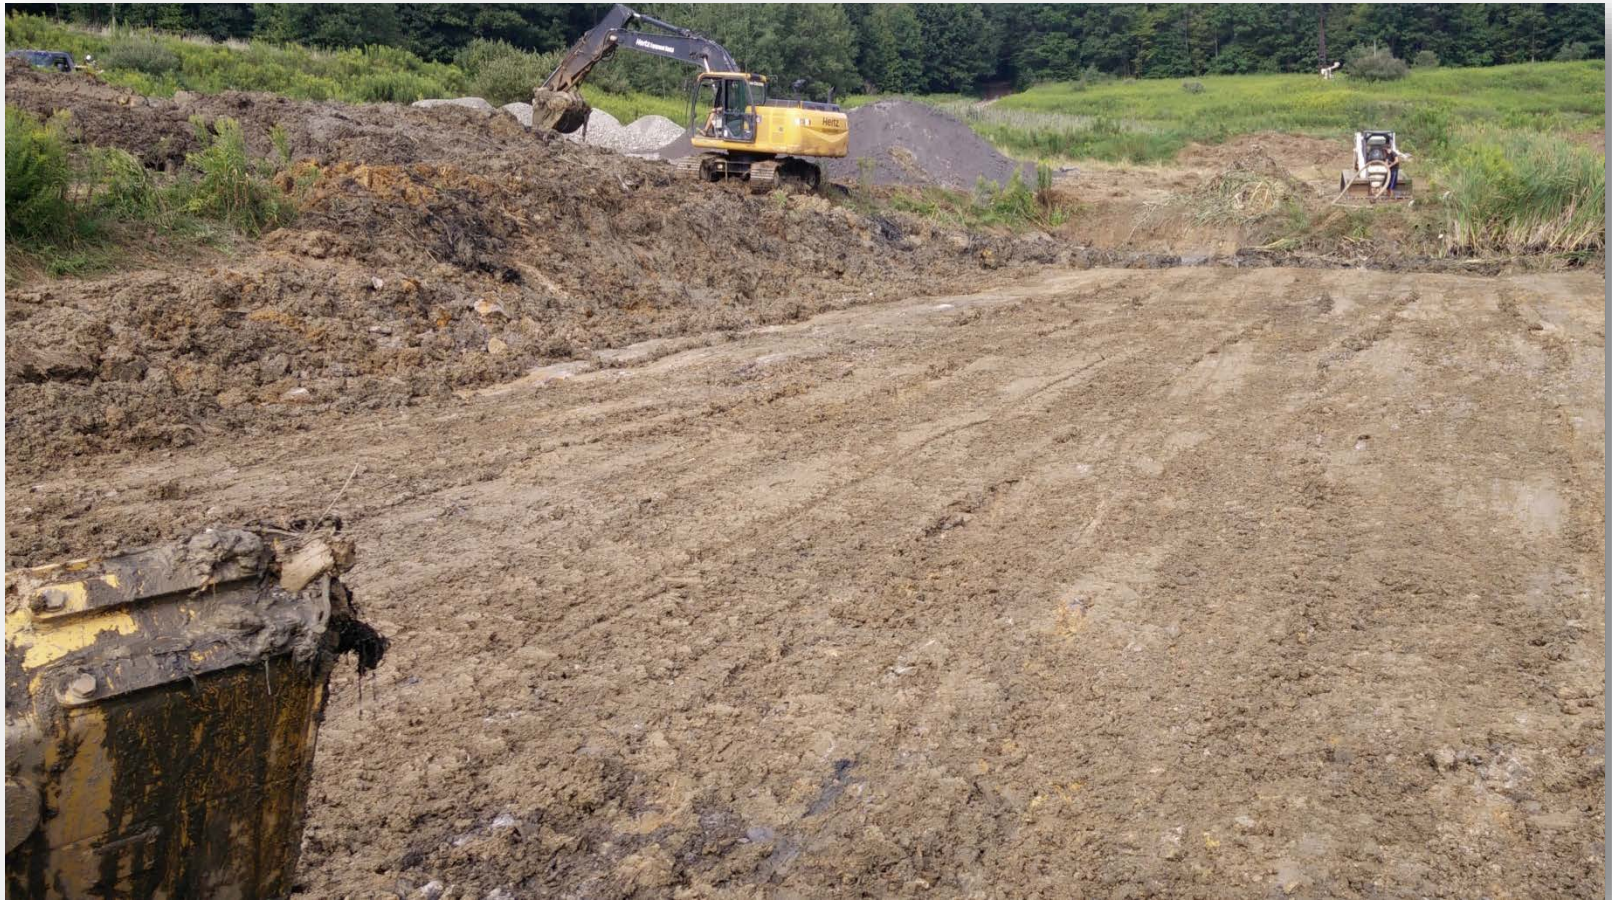
- Wetland substrate removed and stockpiled

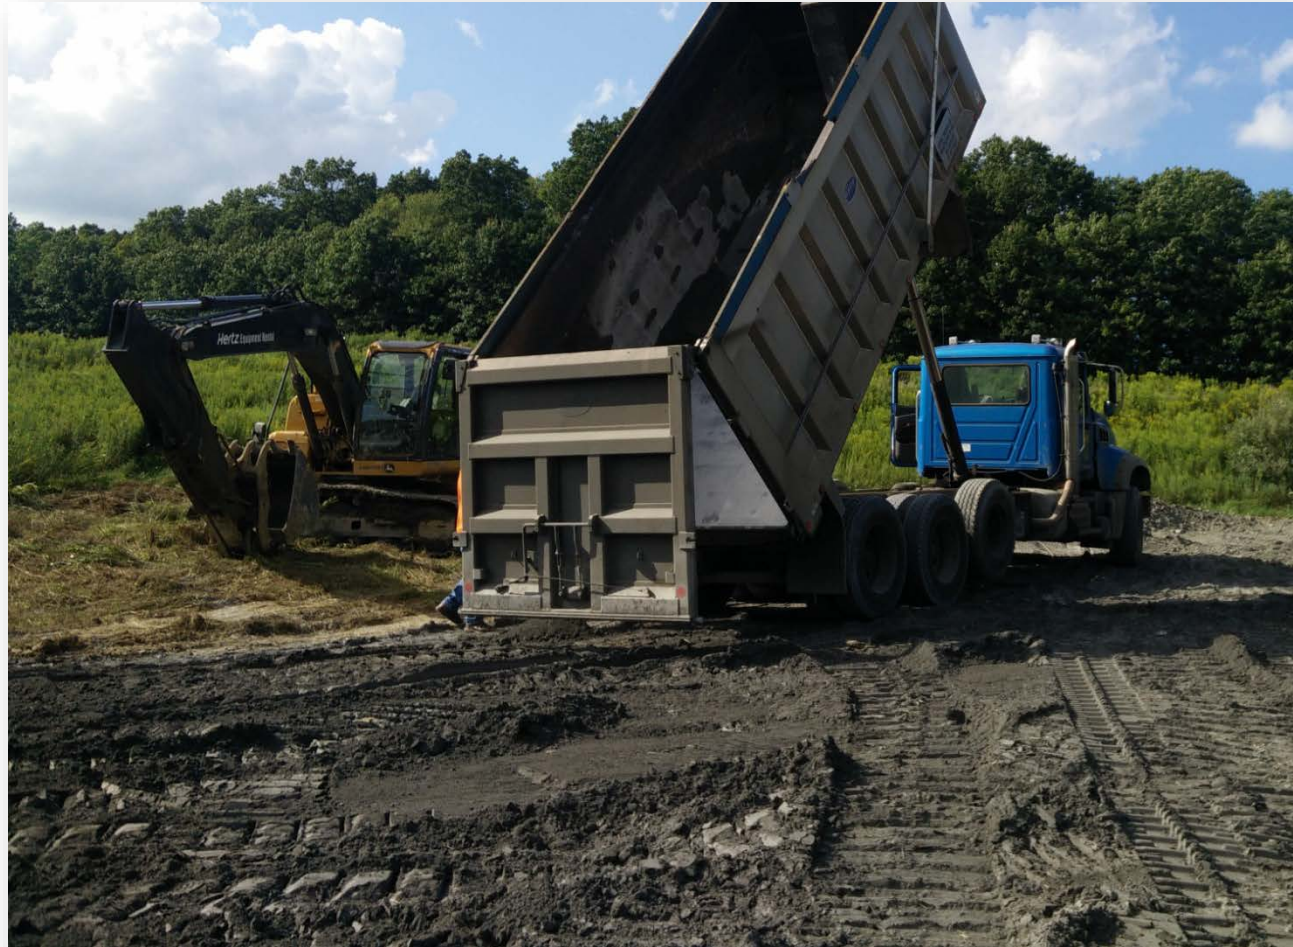
- Harsco Mineral CSA used as lining material

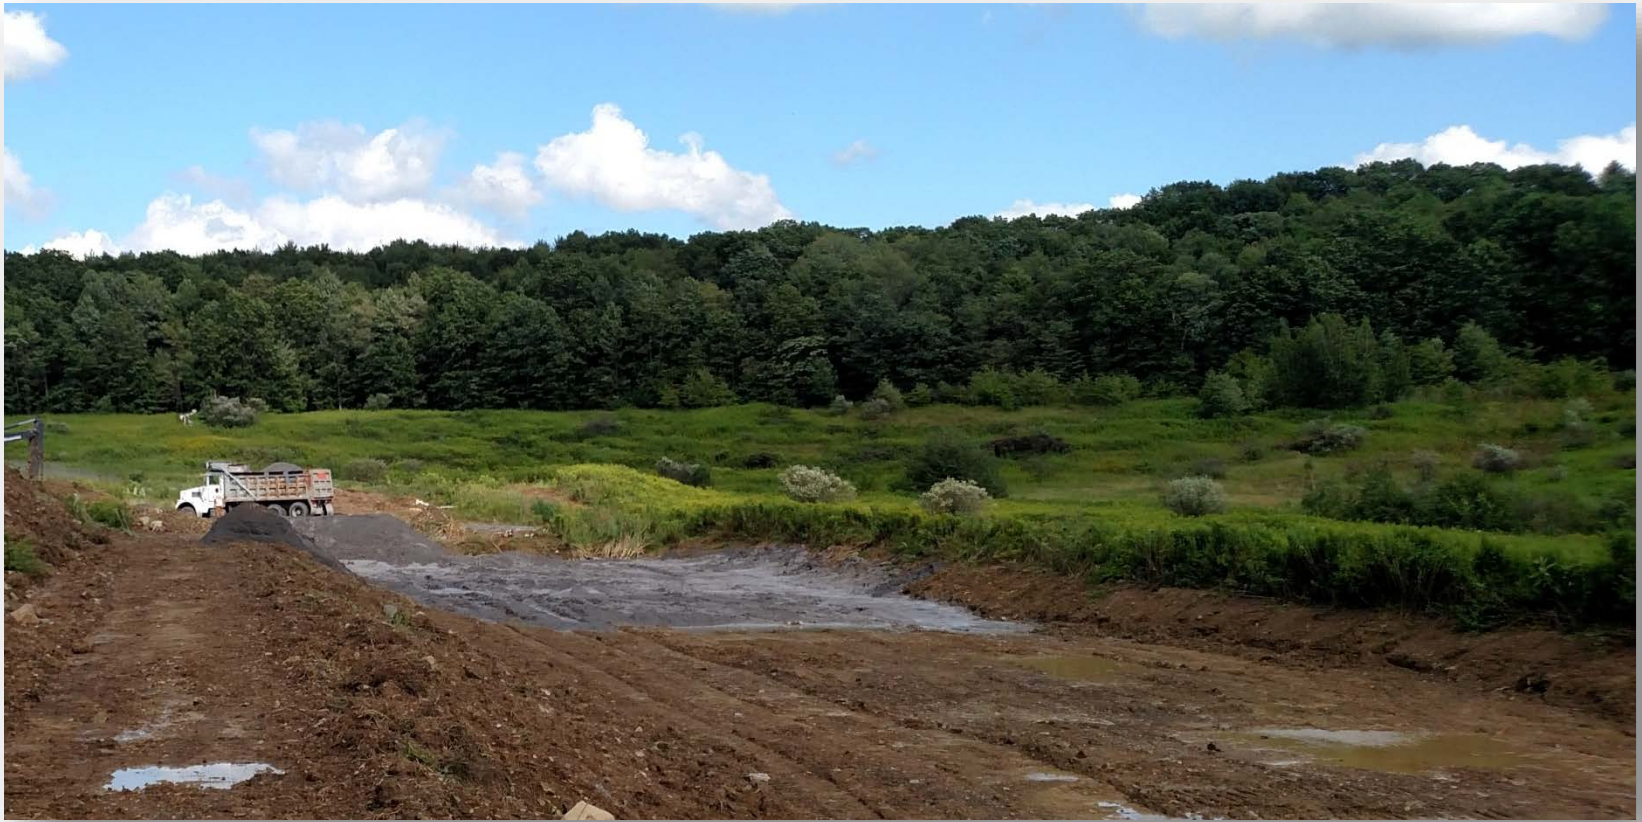
- Harsco Mineral CSA used as lining material

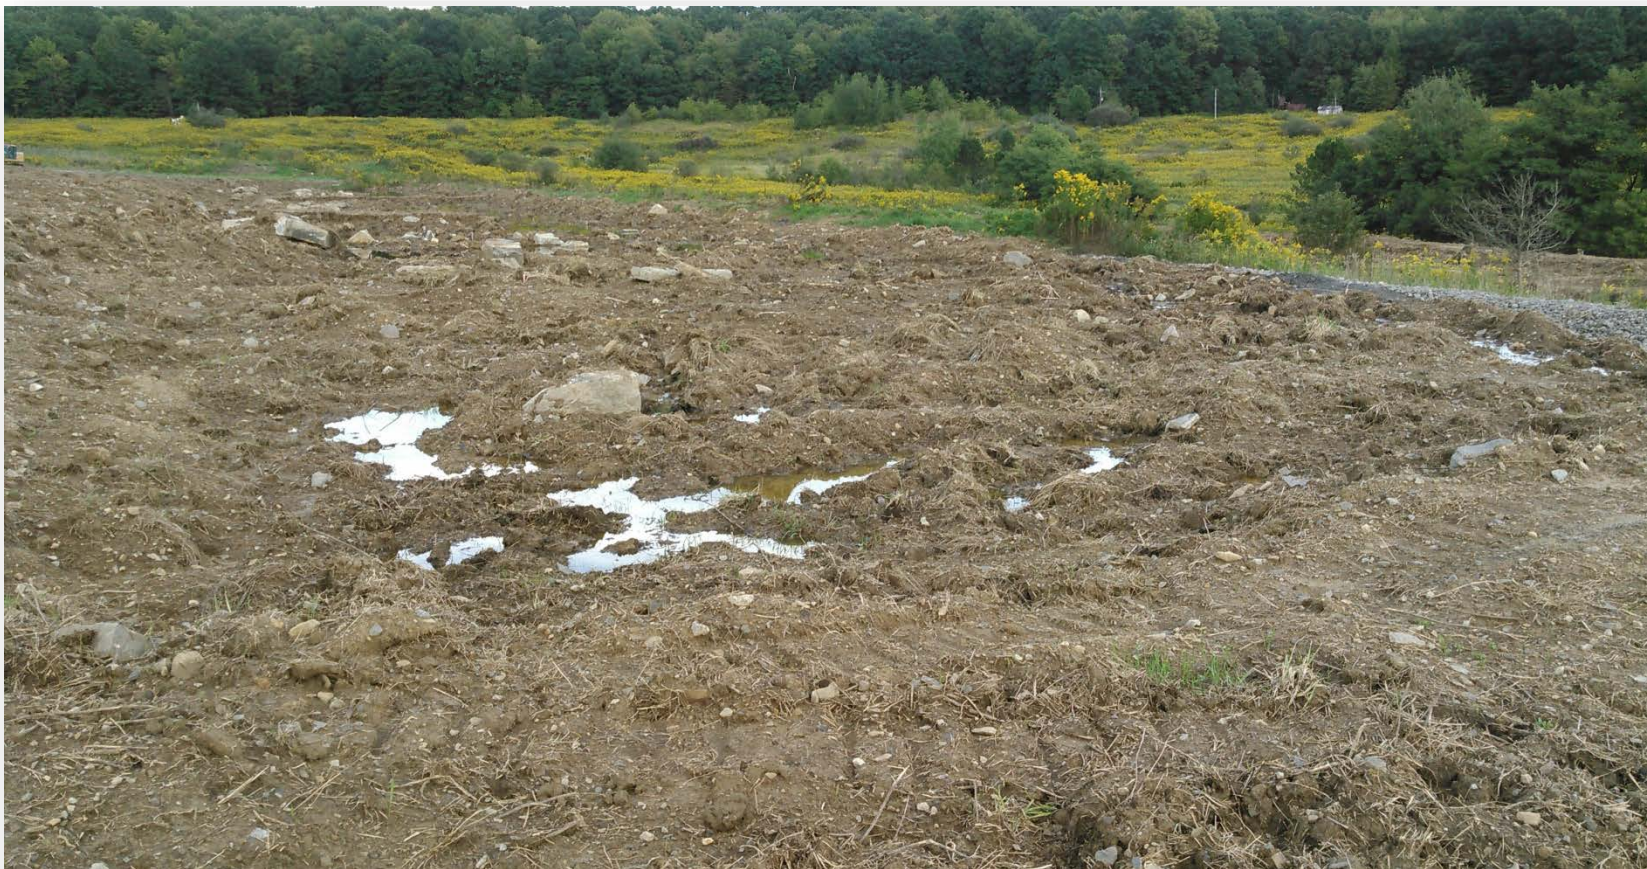
- Wetland substrate redistributed

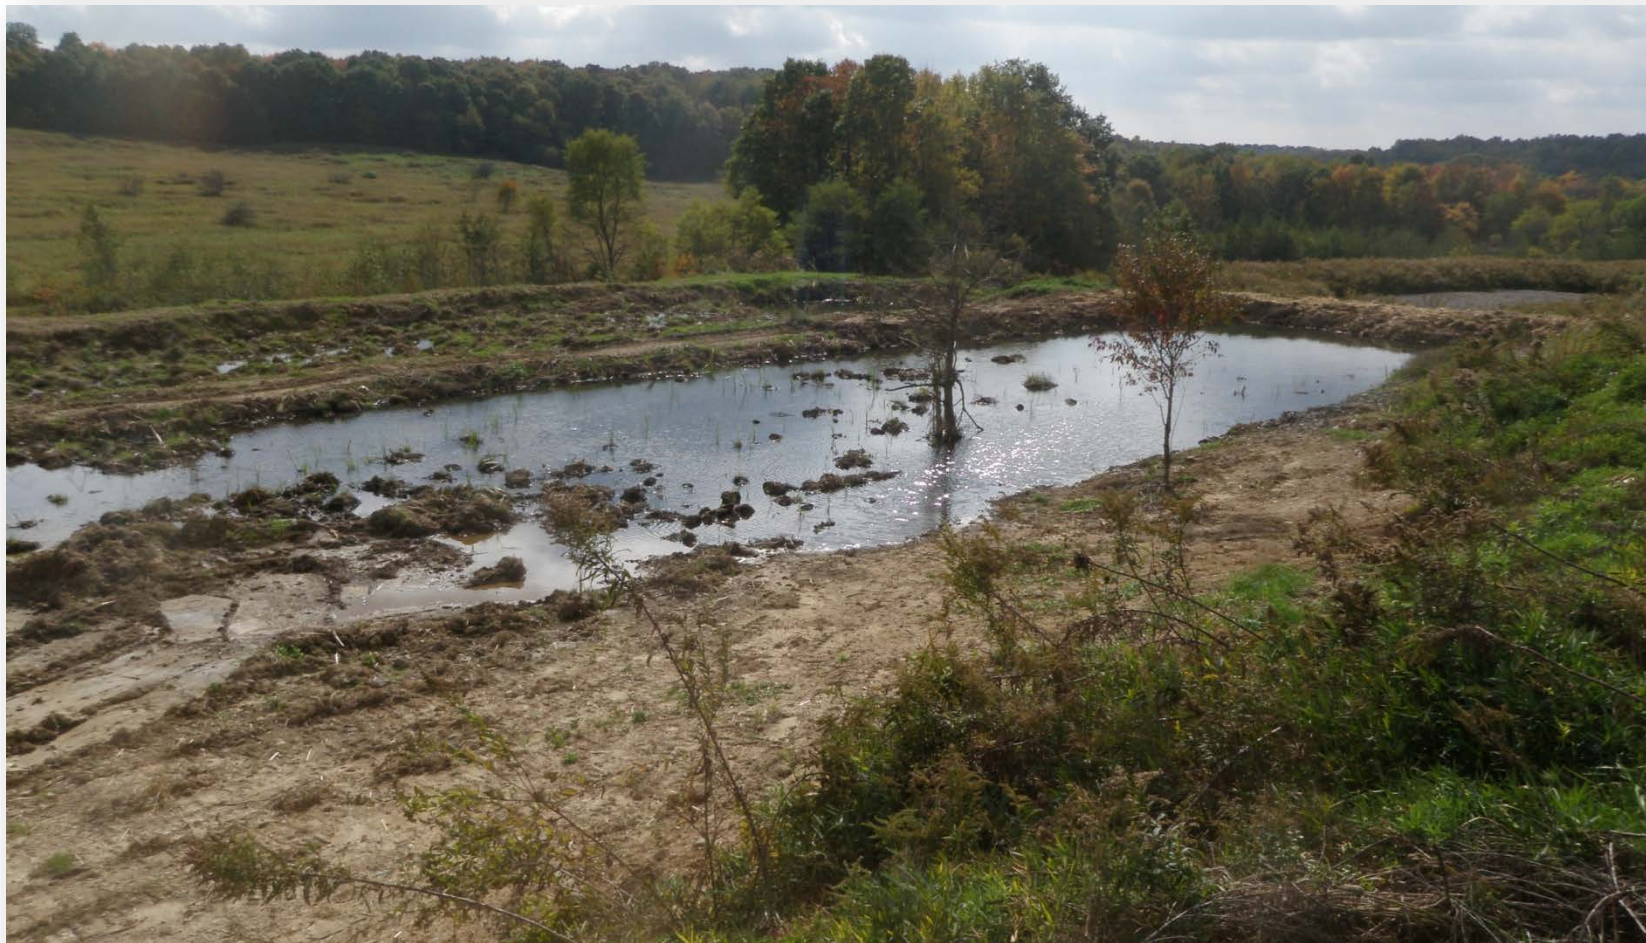
- Water redirected to wetland cells

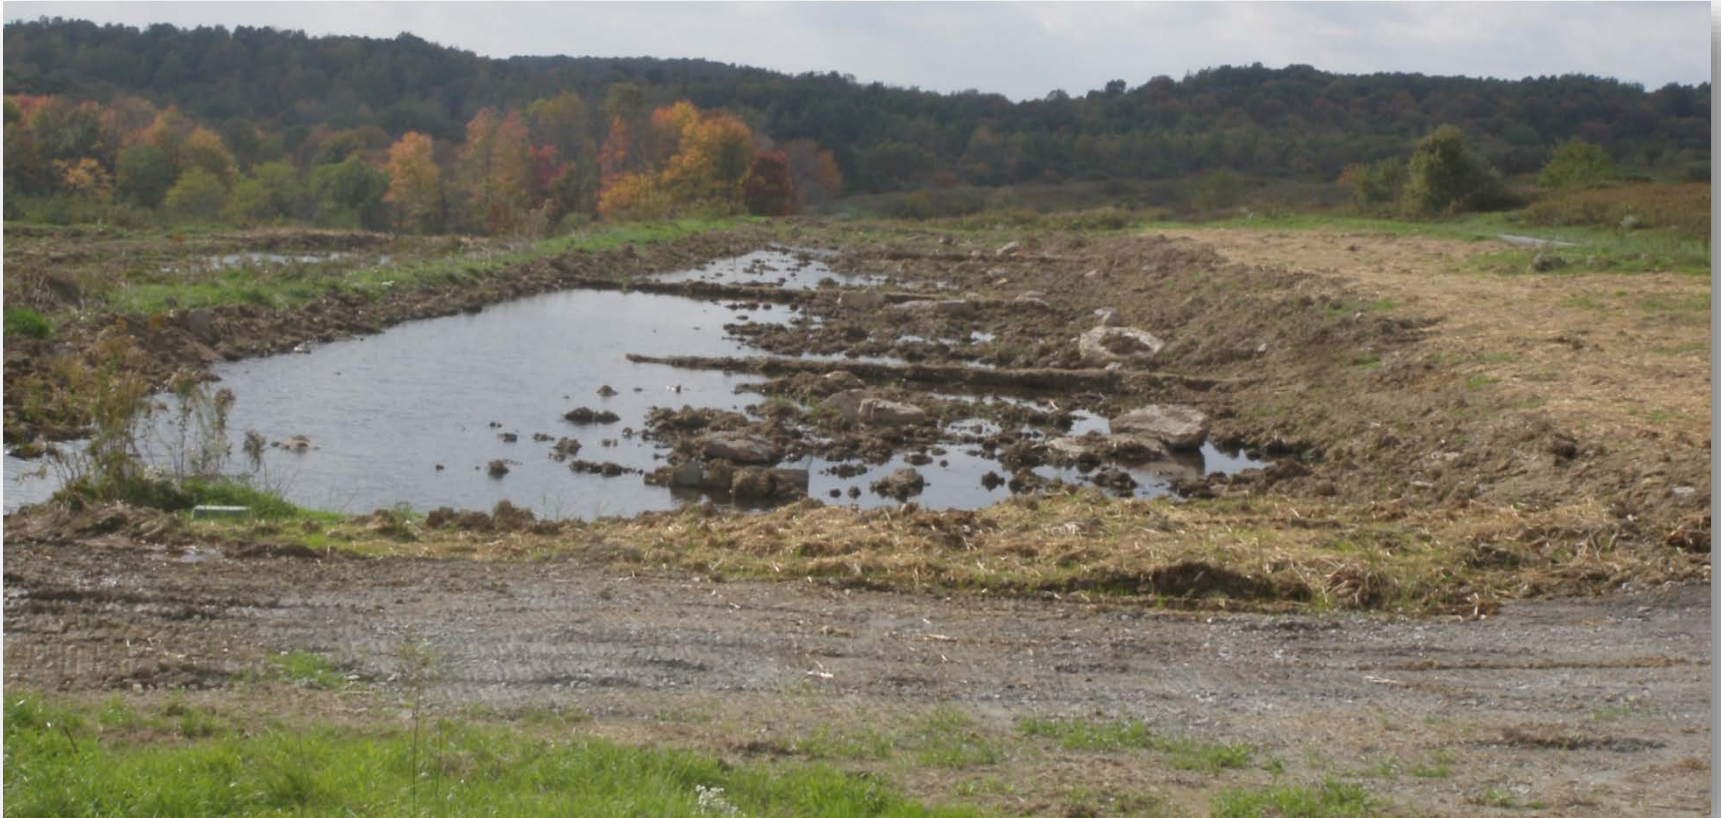
- Water redirected to wetland cells
