TREATMENT SYSTEM RESTORATION AND POWER GENERATION IN THE SLIPPERY ROCK CREEK WATERSHED

Presenters: Ryan M. Mahony & Daniel A. Guy

Slippery Rock Watershed Renaissance Initiative

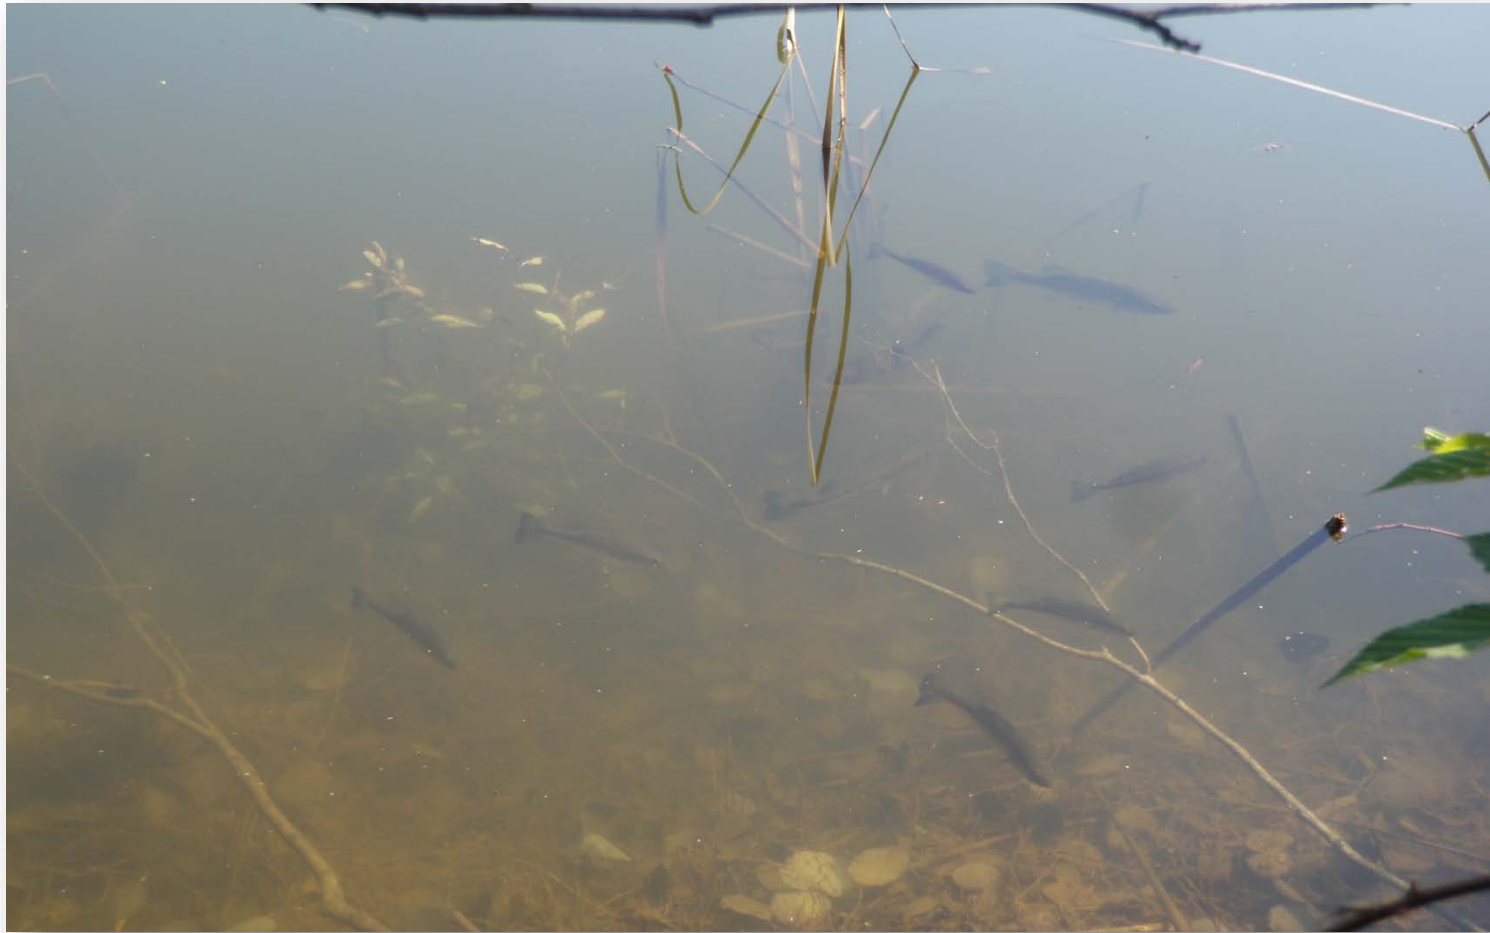
- Fish present in sediment basin

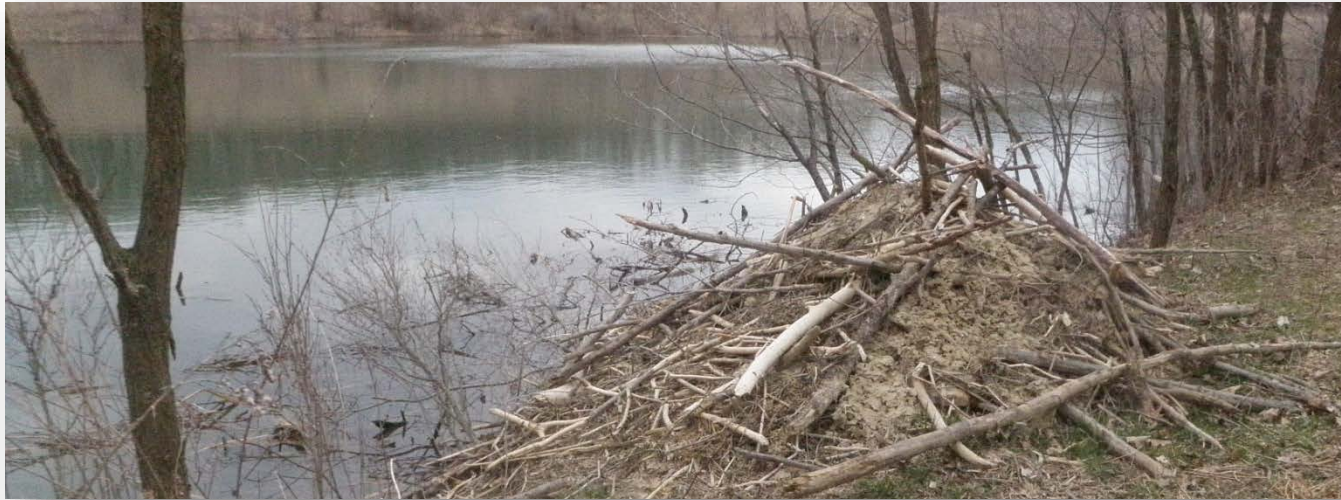
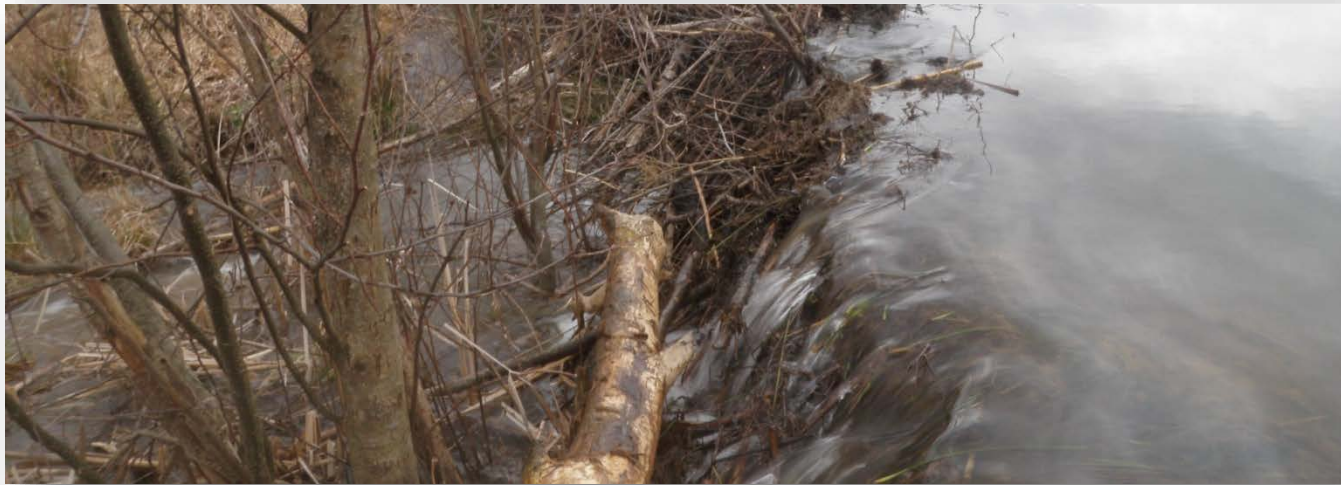
- Issues with beaver activity at sediment basin

- Reduce potential for water leakage by using liners if known issues exist
 - building on mine spoil, rocky/sandy substrate
- Beaver activity abatement

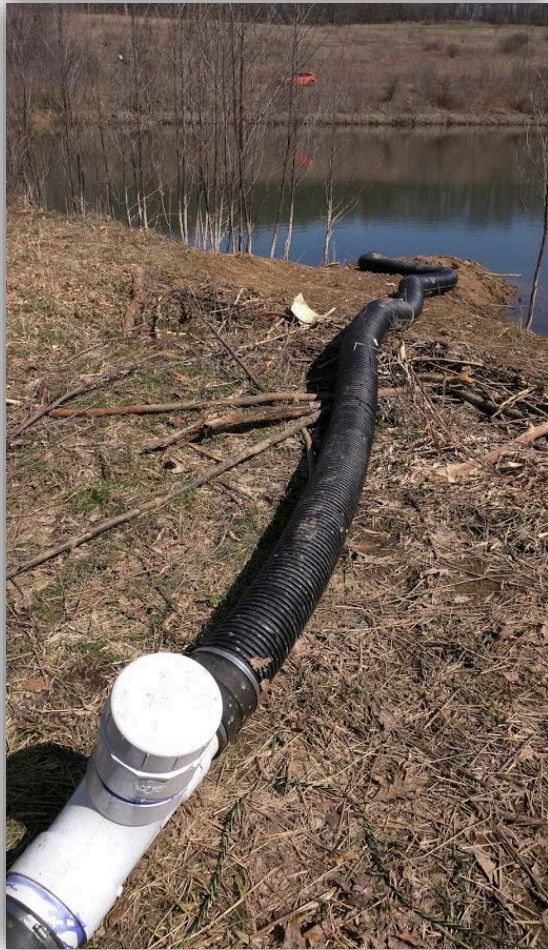
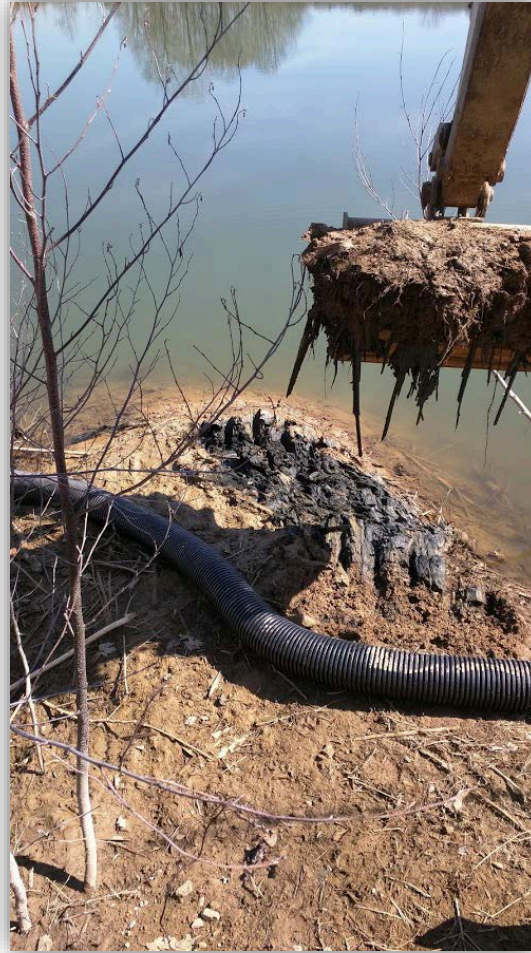
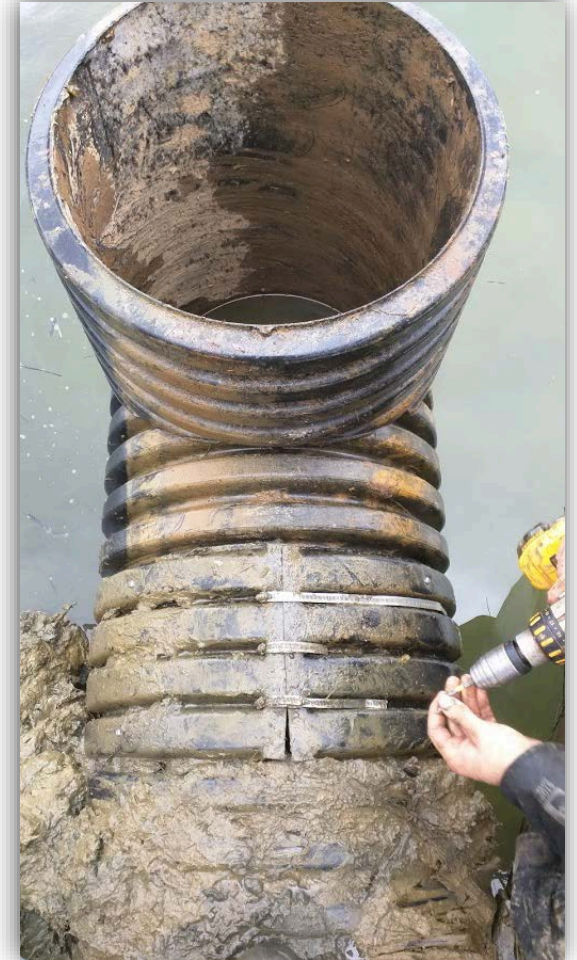
- Issues with beaver activity at sediment basin

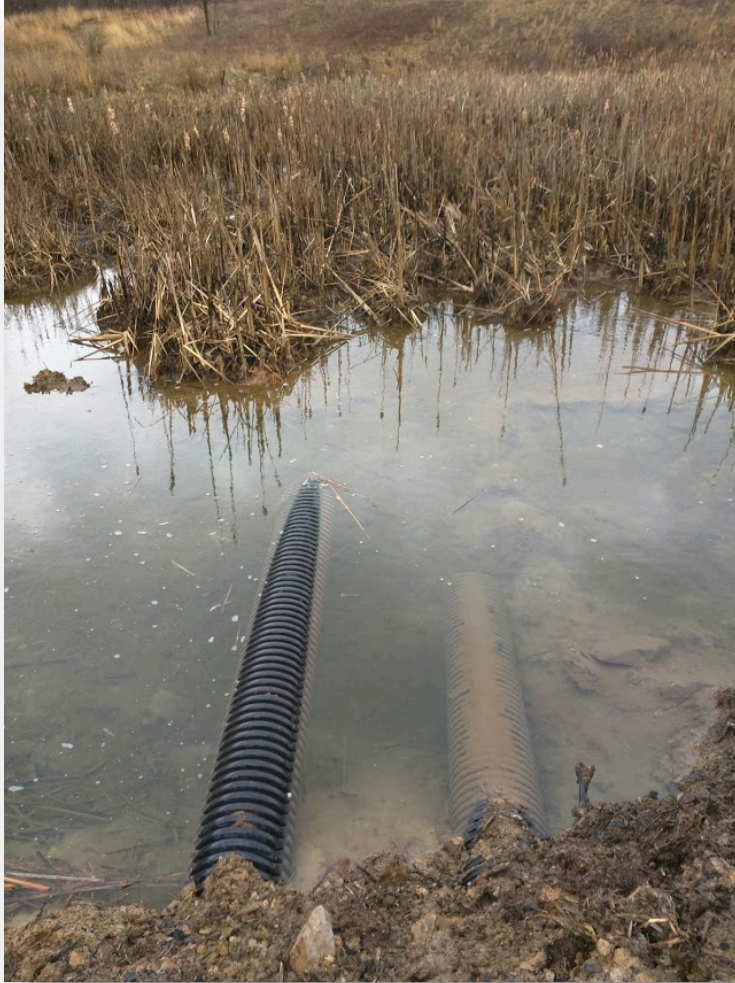
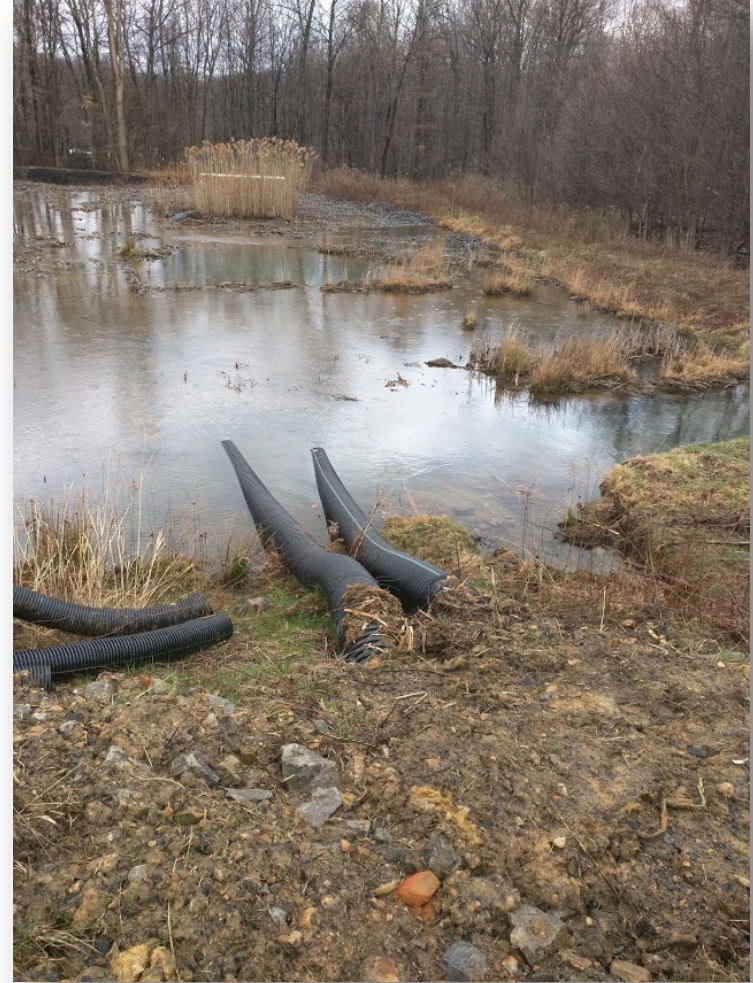
“The Beaver Deceiver”

- DeSale Phase II beaver dam issues
