# Slippery Rock Creek Stream Bank Stabilization

Daniel Guy
Geologist
Stream Restoration Inc.

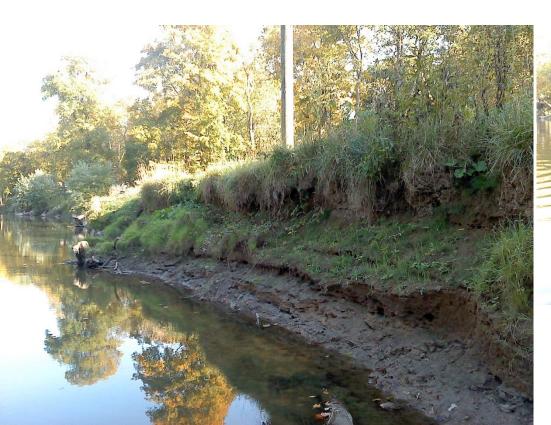
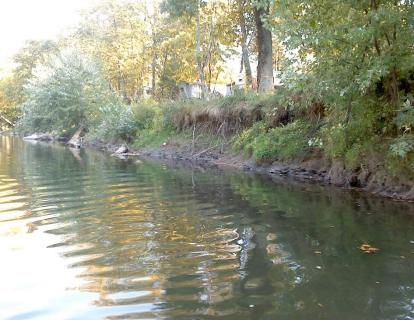
- Major loss of property
- Under cutting and slumping
- Utility pole and utility line concerns

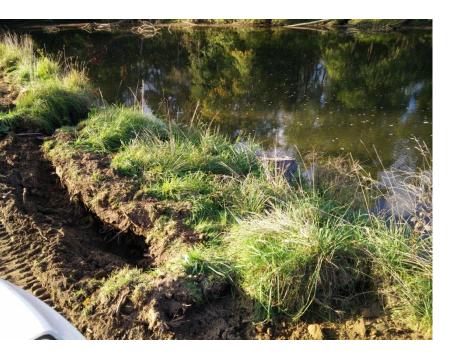
Photo to the right: Before the bulk of the construction could begin a power line had to be moved back from the stream bank. The photo to the left shows slumping that occurred due to the large amount of undercutting from the stream.

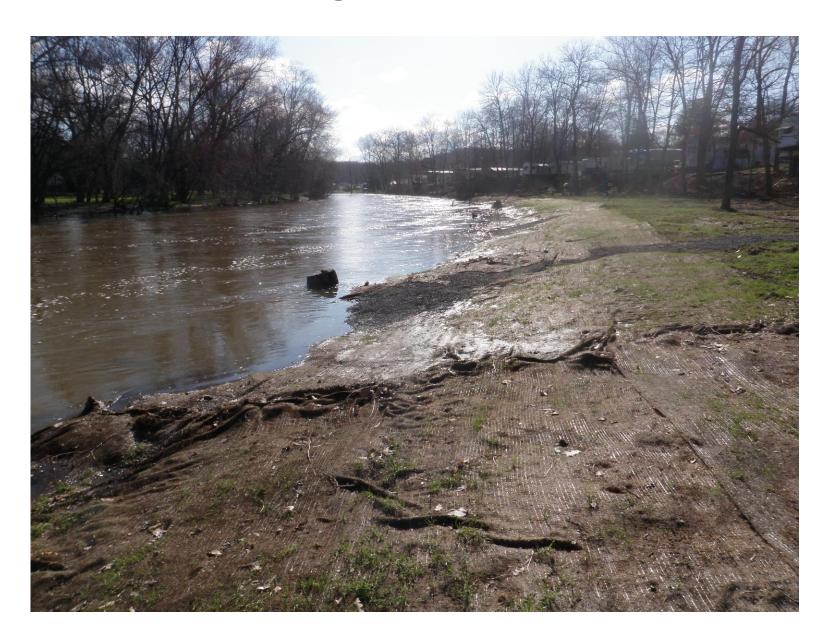
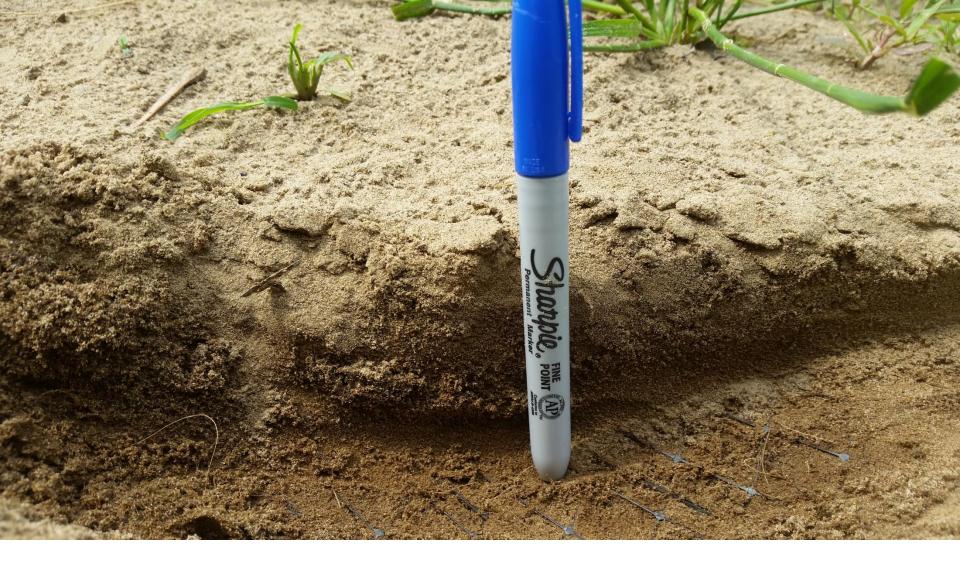
After the flood waters subsided there were areas with up to 3in of deposited sand and silt. The lower water velocities due to the rip rap, coconut fiber blanket, and vegetation allowed for deposition of sediments instead of erosion.

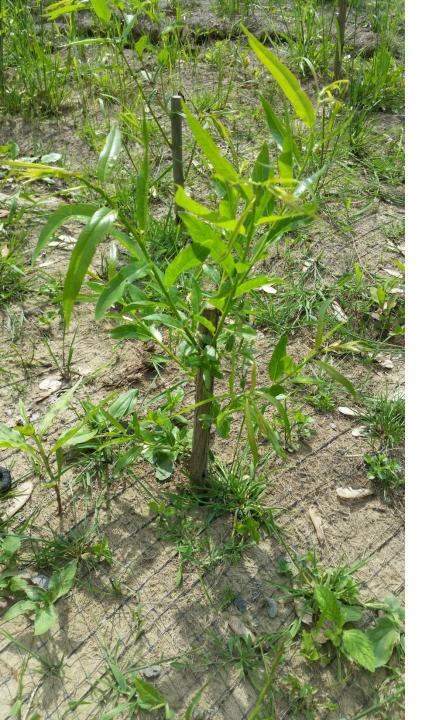
Live stake growth after 2 months was extensive with an estimated survival rate greater than 95%

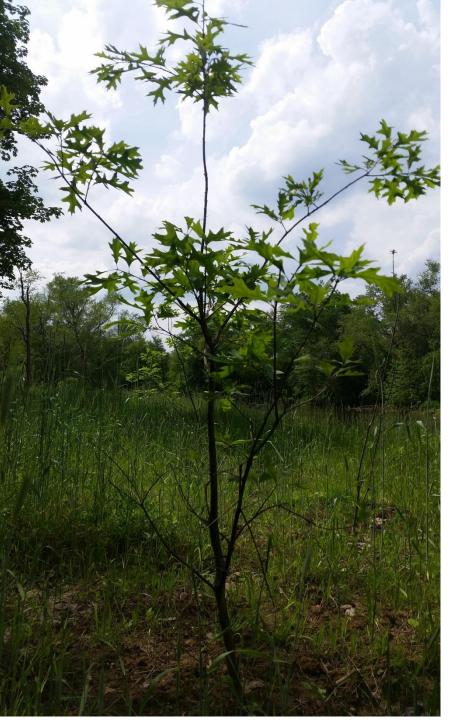
Planted tree budded and produced leaves and show good potential for the future.

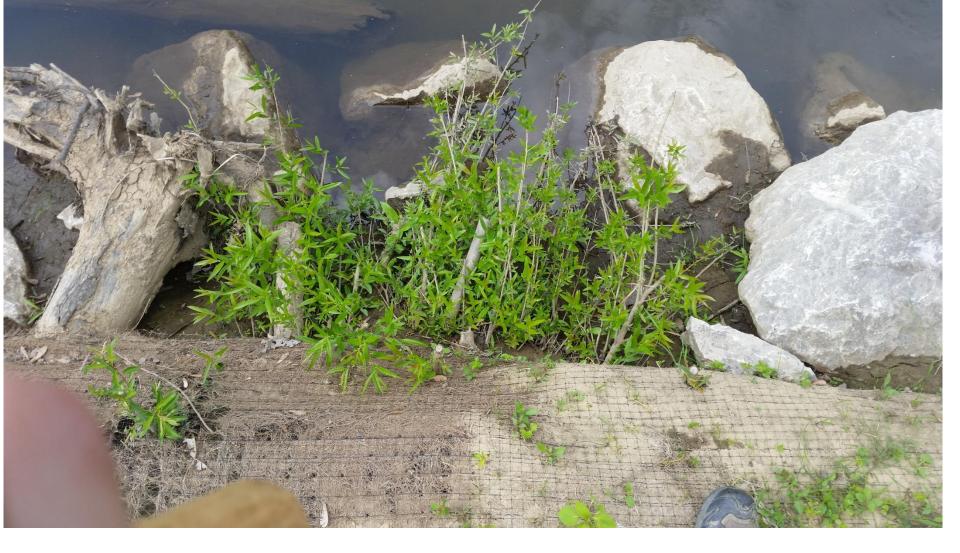
Brush layering was placed in various locations during construction and show growth at every location when laying was placed.

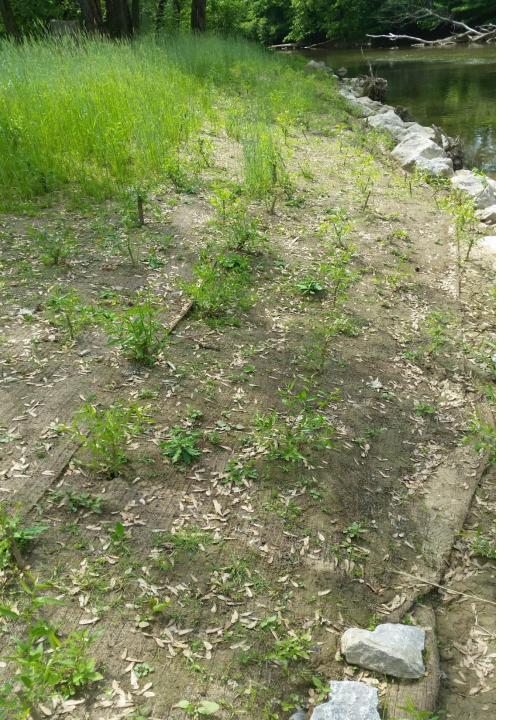
Live stake growth along the toe with tall grasses up the bank.
