# Geotechnical-Geophysical Void Mapping and Foamed-Sand Backfilling of the Rapson Coal Mine, Colorado Springs, Colorado – Case Study

Kanaan Hanna, Jim Pfeiffer & Steve Hodges, *Zapata Incorporated*  
Al Amundson, *Colorado Division of Reclamation, Mining and Safety*  
Richard Palladino, *Cellular Concrete Solutions*  
Tom Szynakiewicz, *Hayward Baker*

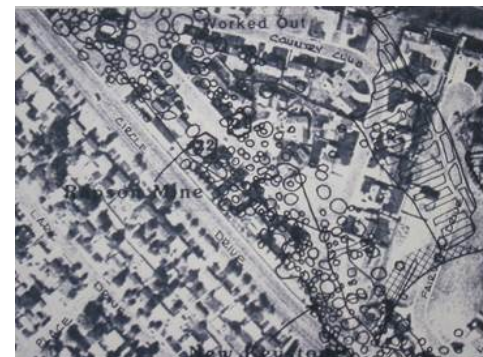
Historic subsidence

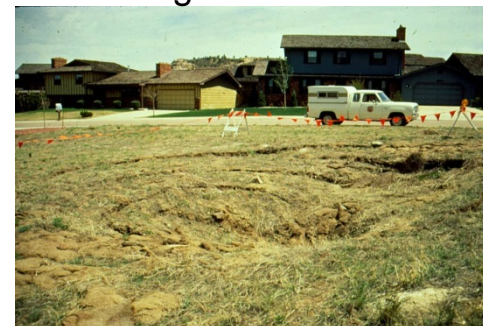
Trough subsidence

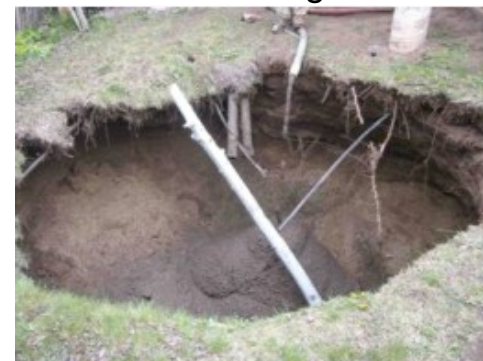
Sinkhole mitigation

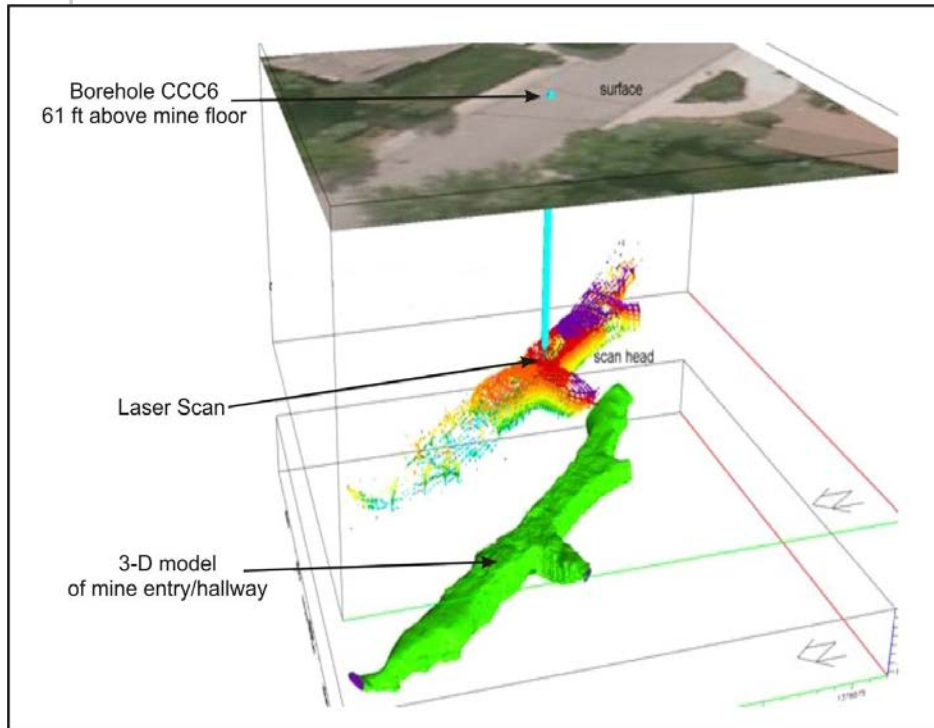
Laser 3-D model of haulageway (main entry)  
Borehole CCC6

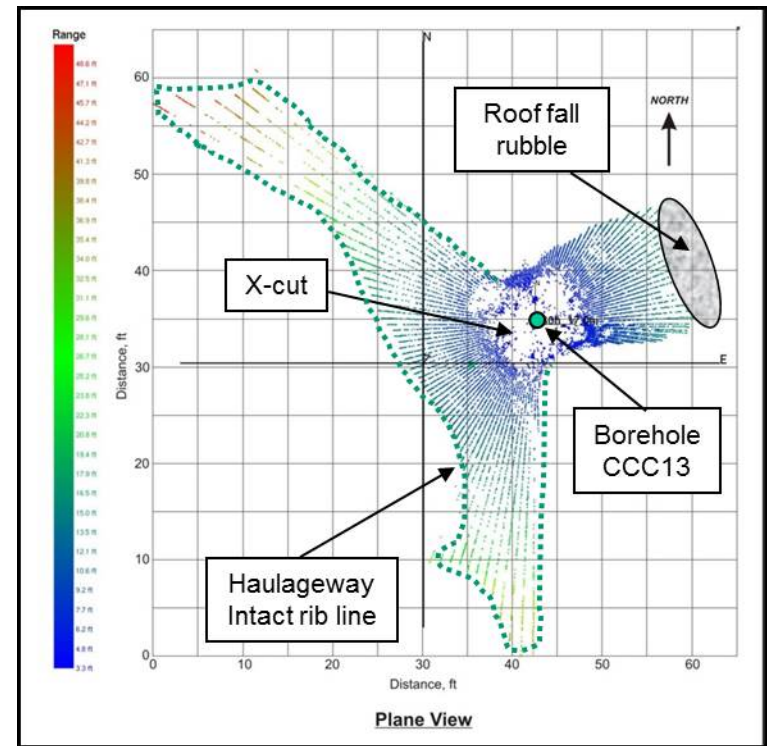
Laser 2D interpretation plan view  
Borehole CCC13

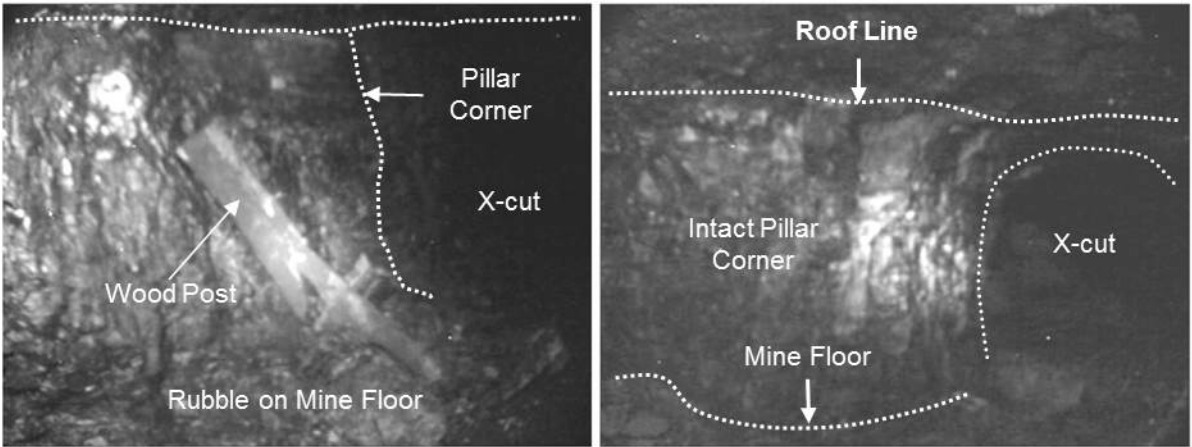
## Video images interpretation – Borehole CCC6

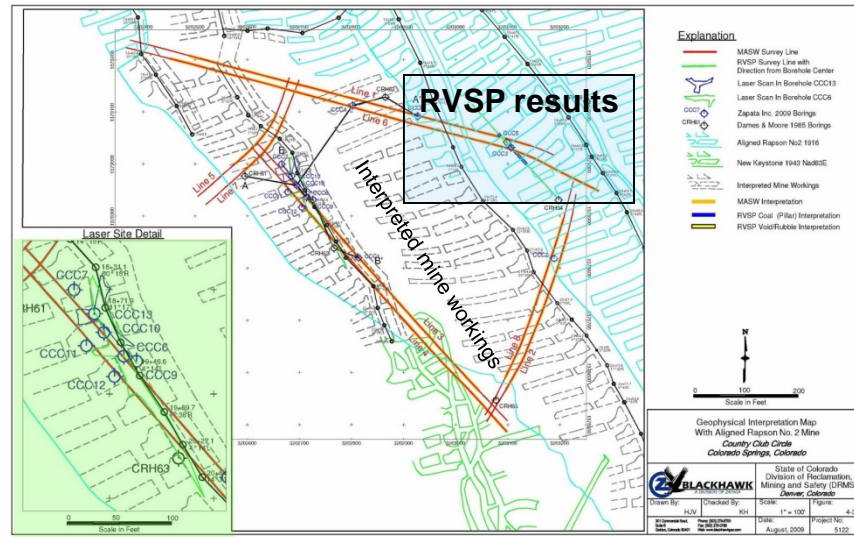
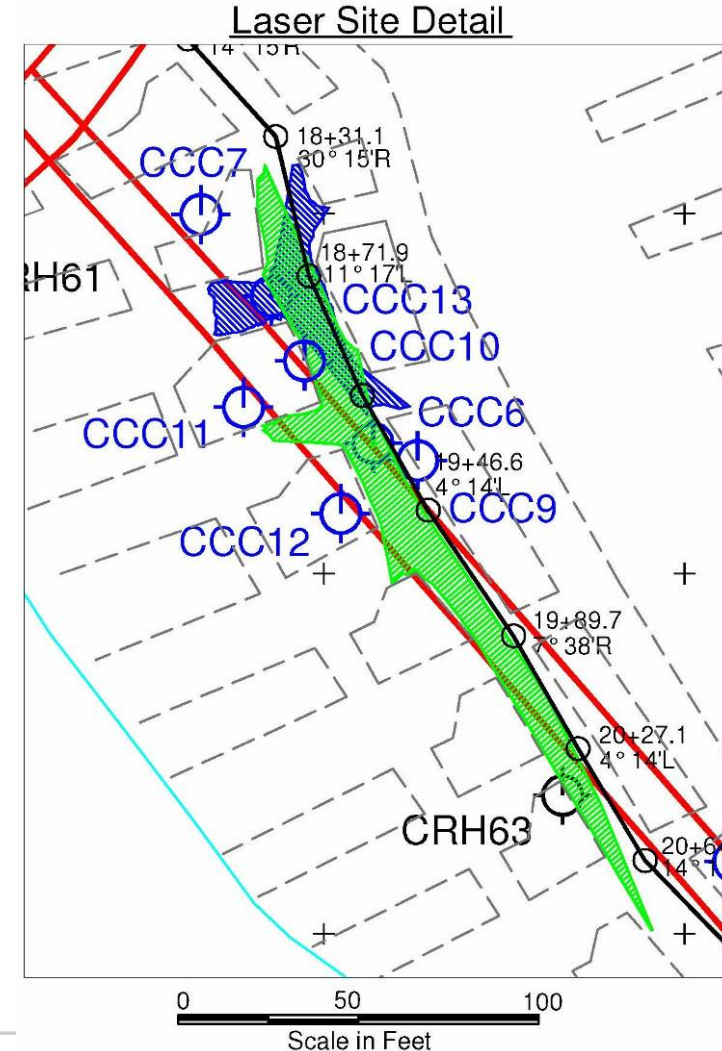
- RVSP results: The position of the mine workings in the north-northeast was shifted 25 ft north.
- Laser results: The position of the re-constructed haulageway was shifted 25 ft south and 17 ft west

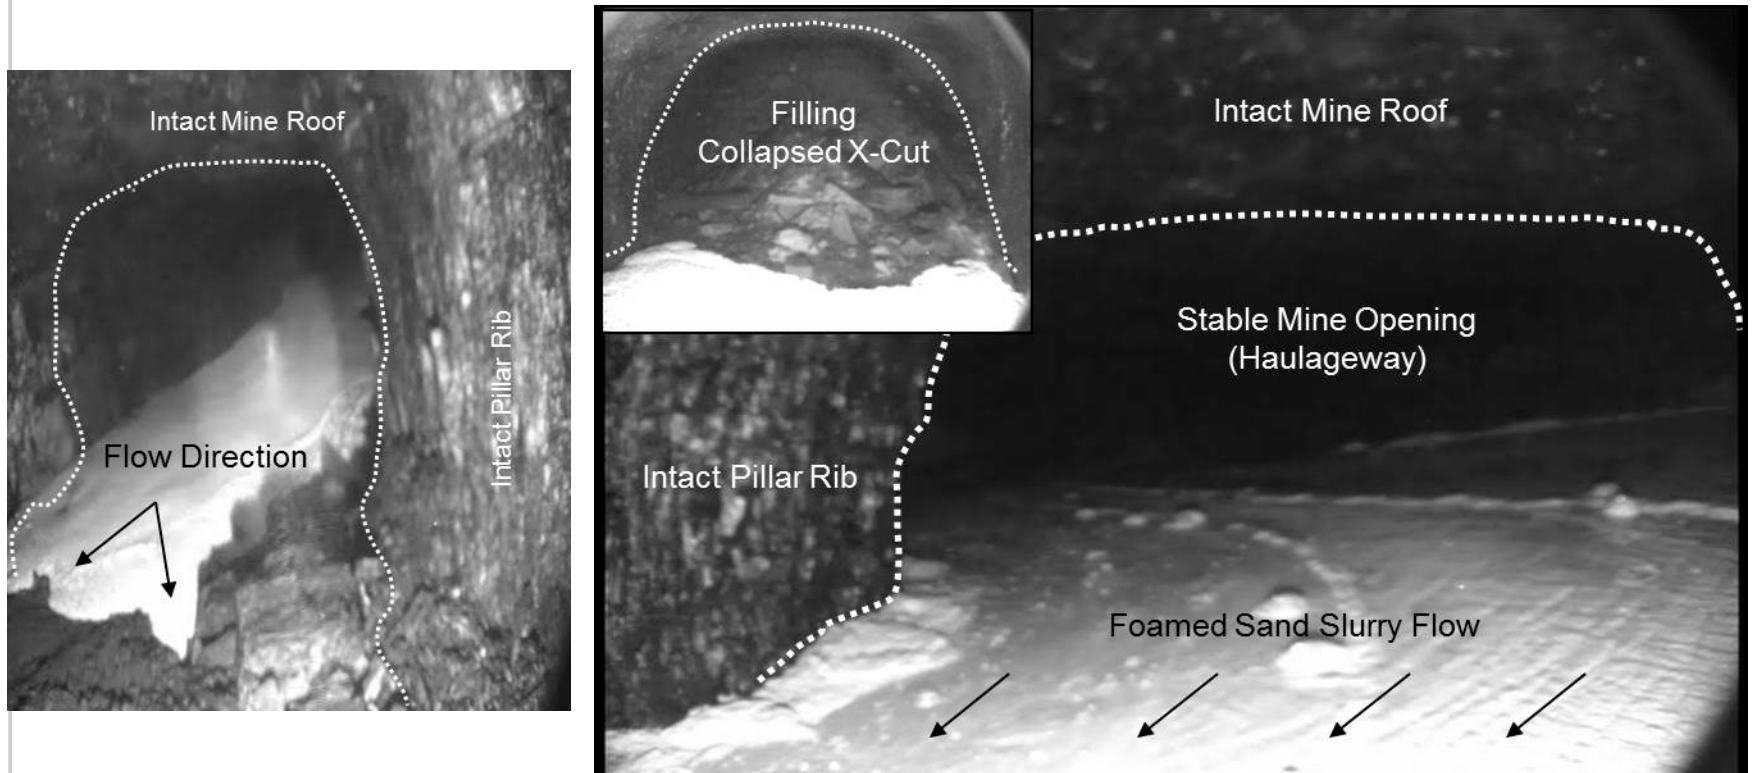
## Video images from CCC13 of foamed sand slurry backfilling in Borehole CCC6
