Passive System Rehabilitation of a High Flow Acidic Coal Mine Discharge

Presenter: Ryan M. Mahony

Maiden Passive Treatment System Background

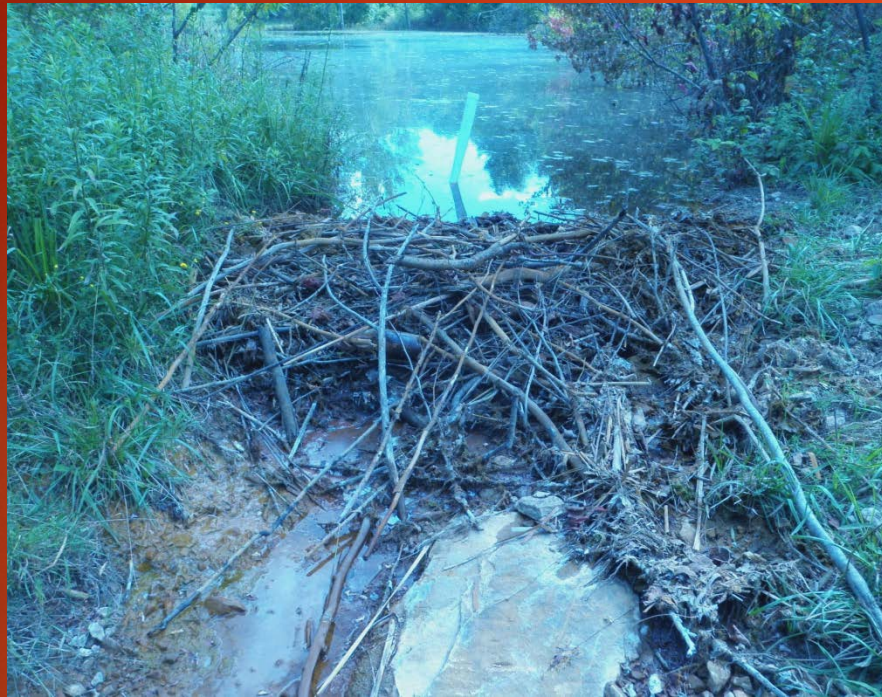
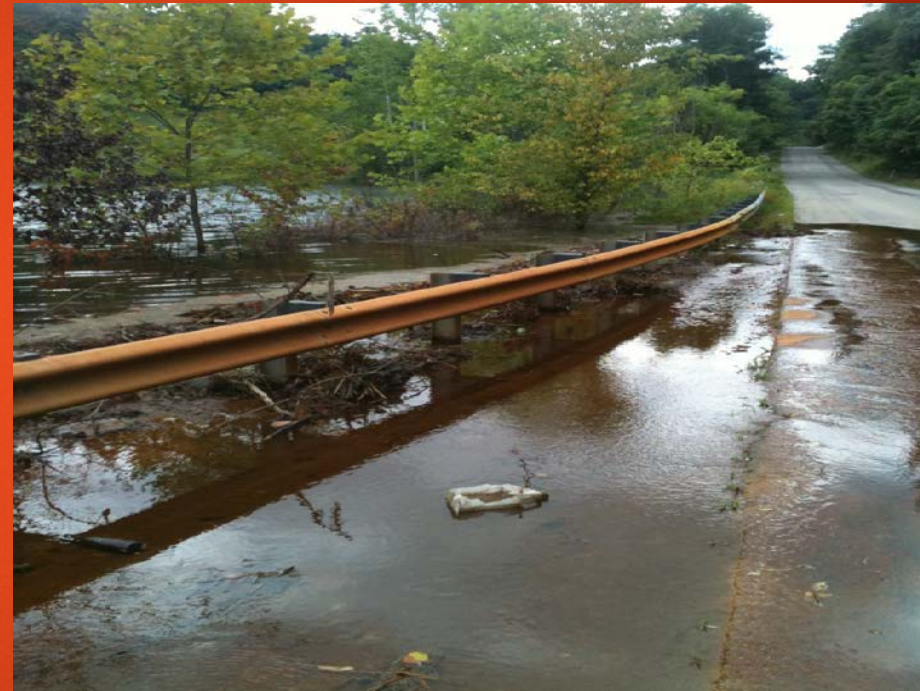
- ▶ Flooding of state route due to beaver activity at outlet of system
- ▶ HFLB clogged and overgrown with vegetation
- ▶ VFP1, VFP2B, & VFP3 siphons not functional
- ▶ VFP1, VFP2B, VFP3 stone clogged with Fe precipitates
- ▶ SP1/ Oxidation precipitation channel overflowing
- ▶ No flow to VFP2A (clogged inlet pipe)
- ▶ Underdrain pipes clogged in multiple components

- ▶ Left: Beaver dam at outlet of oxbow lake located at the system outlet
- ▶ Right: Flooding due to beaver dam on state road (August 2015)

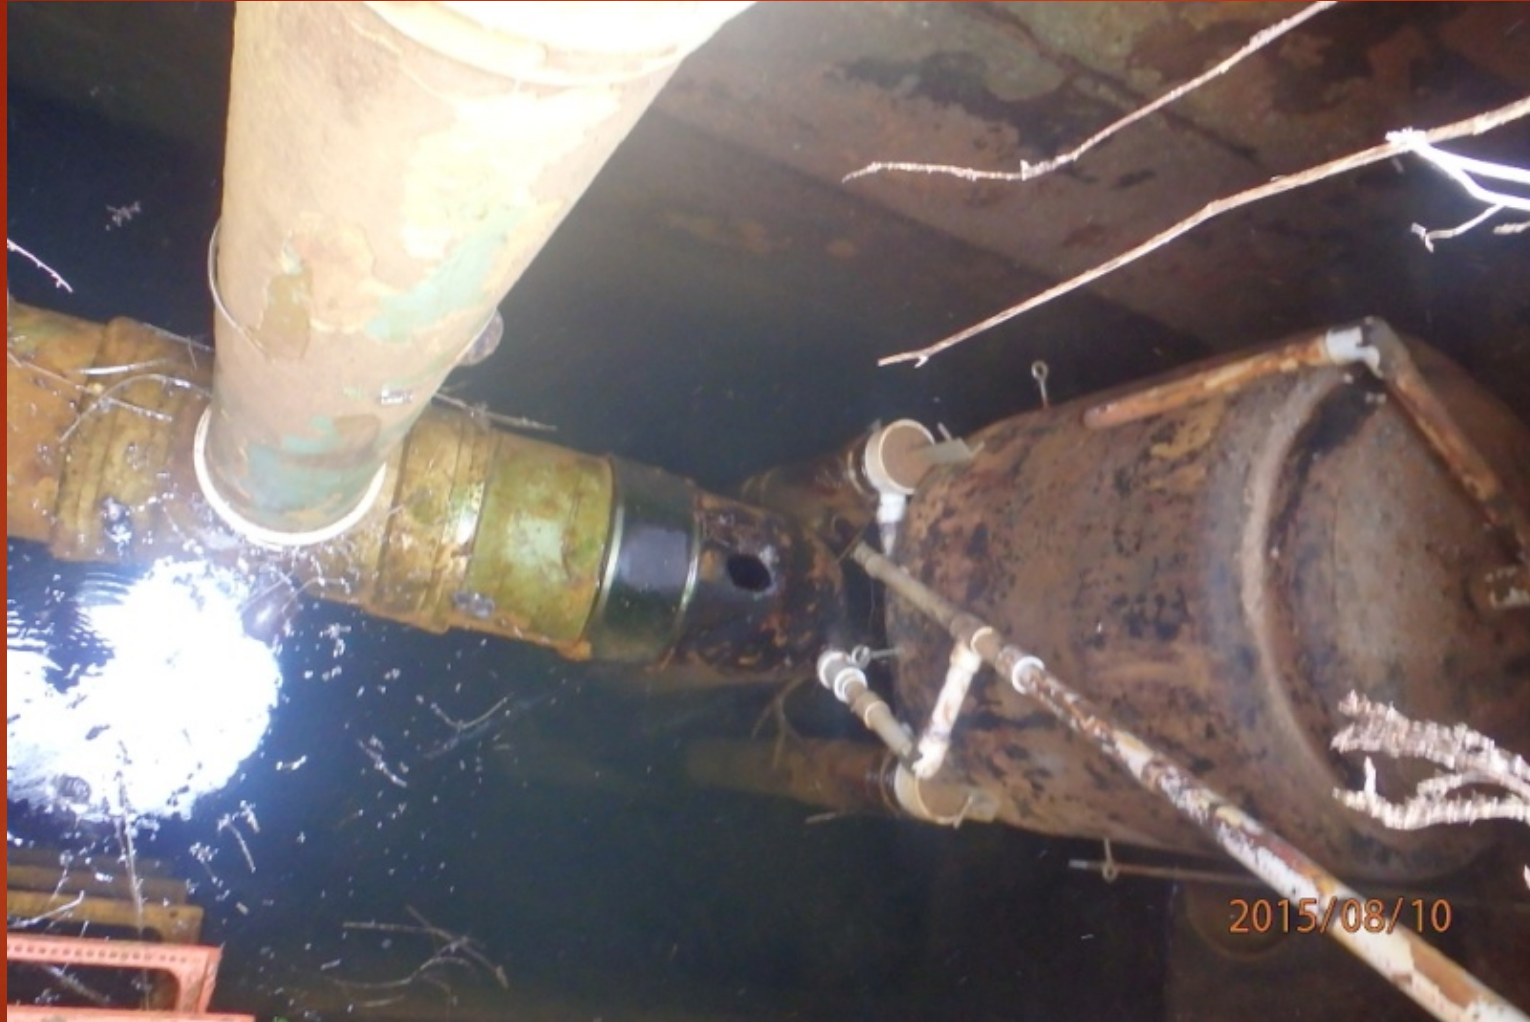
VFP2B Siphon Repair

- ▶ Siphon trigger damaged by wildlife

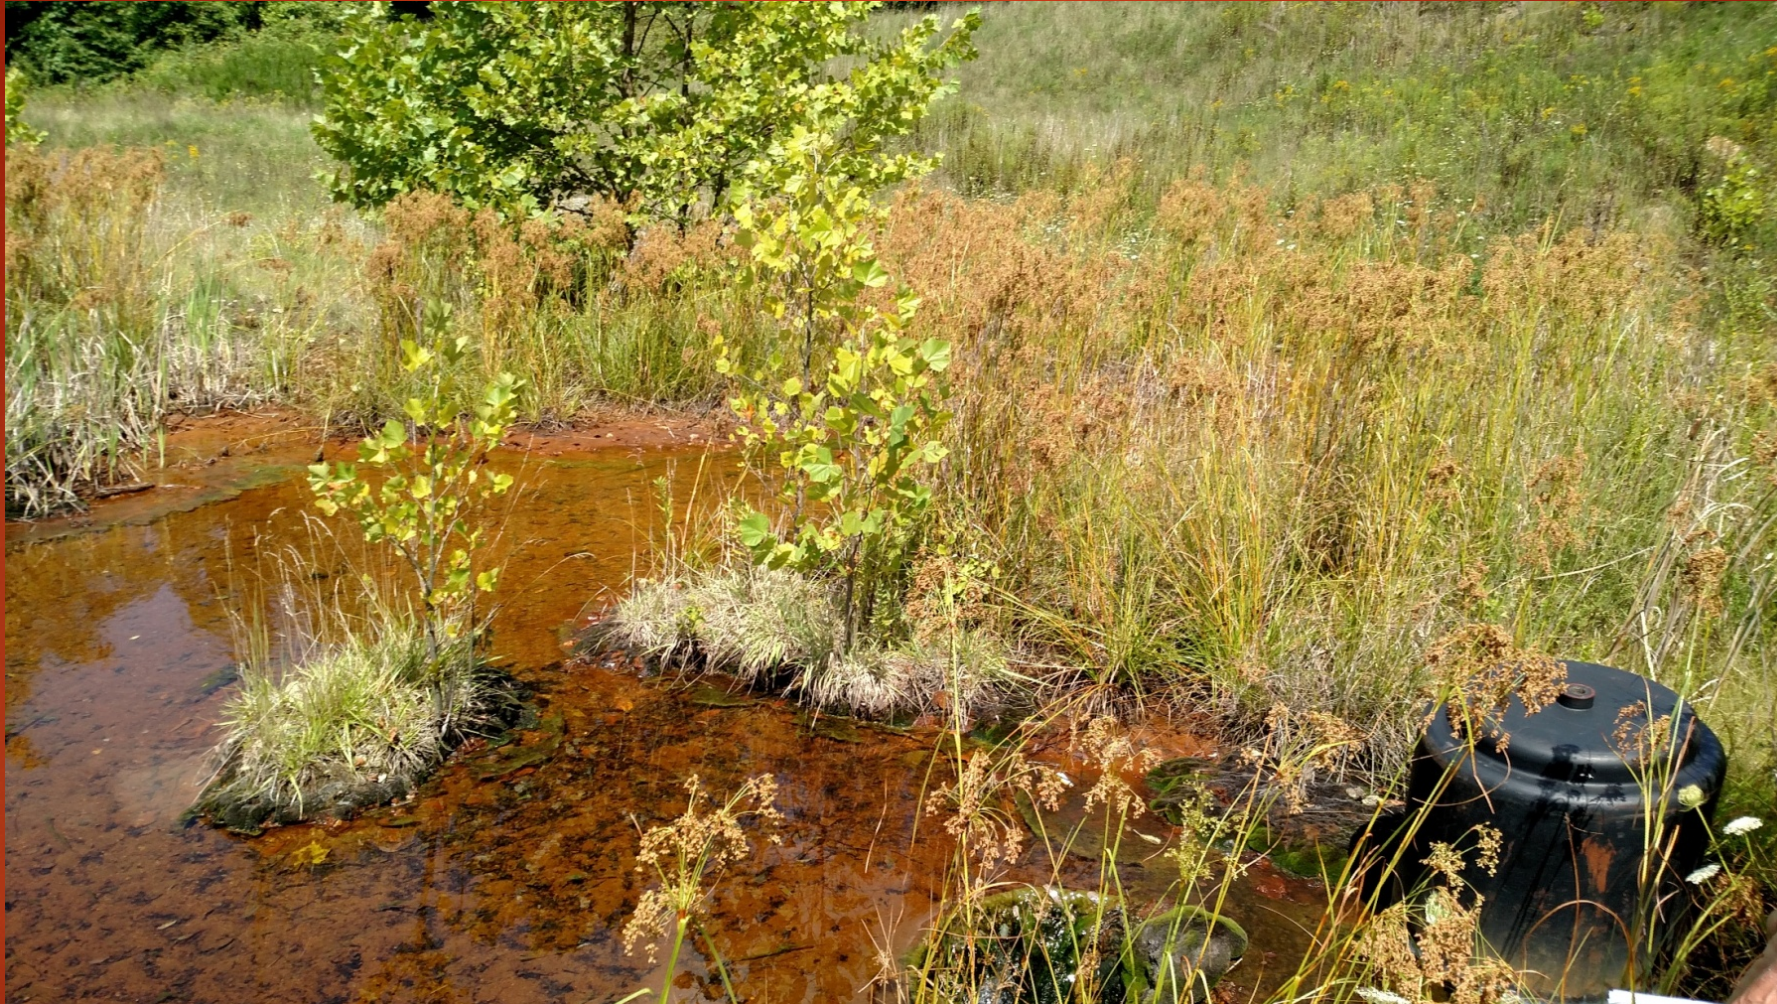
VFP1 Media Clogged

- ▶ Media was clogged in VFP1 causing all raw water to short circuit pond

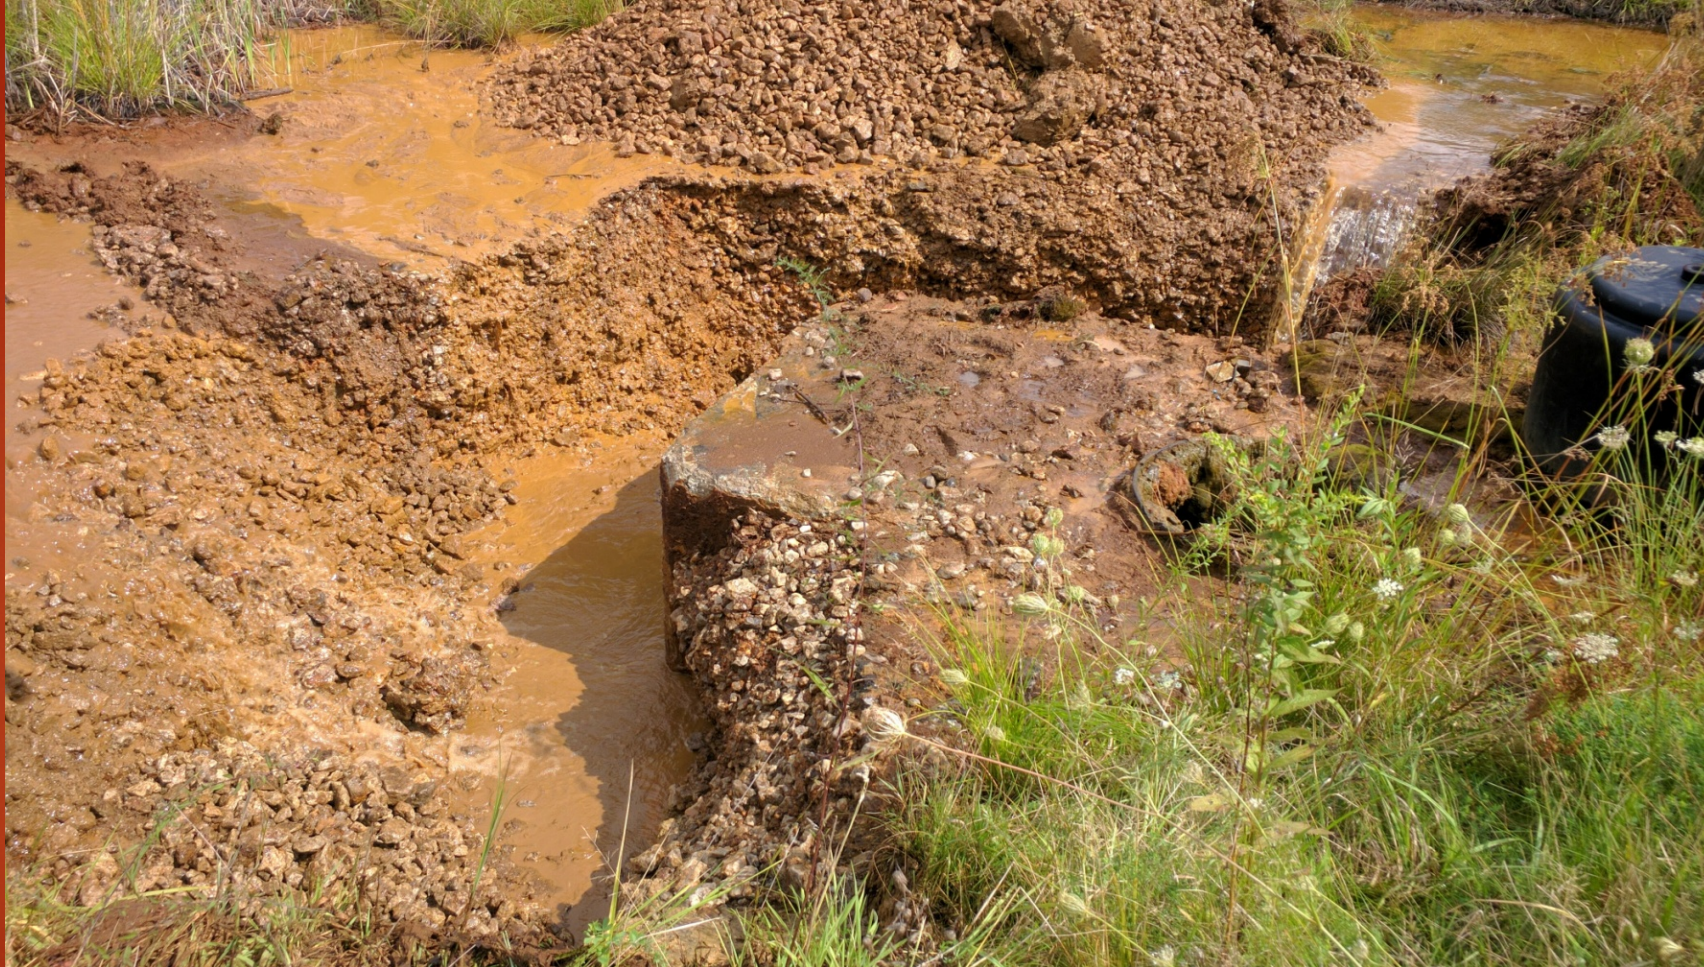
VFP1 Media Cleaning

- ▶ Iron precipitates had completely filled void space within the pond

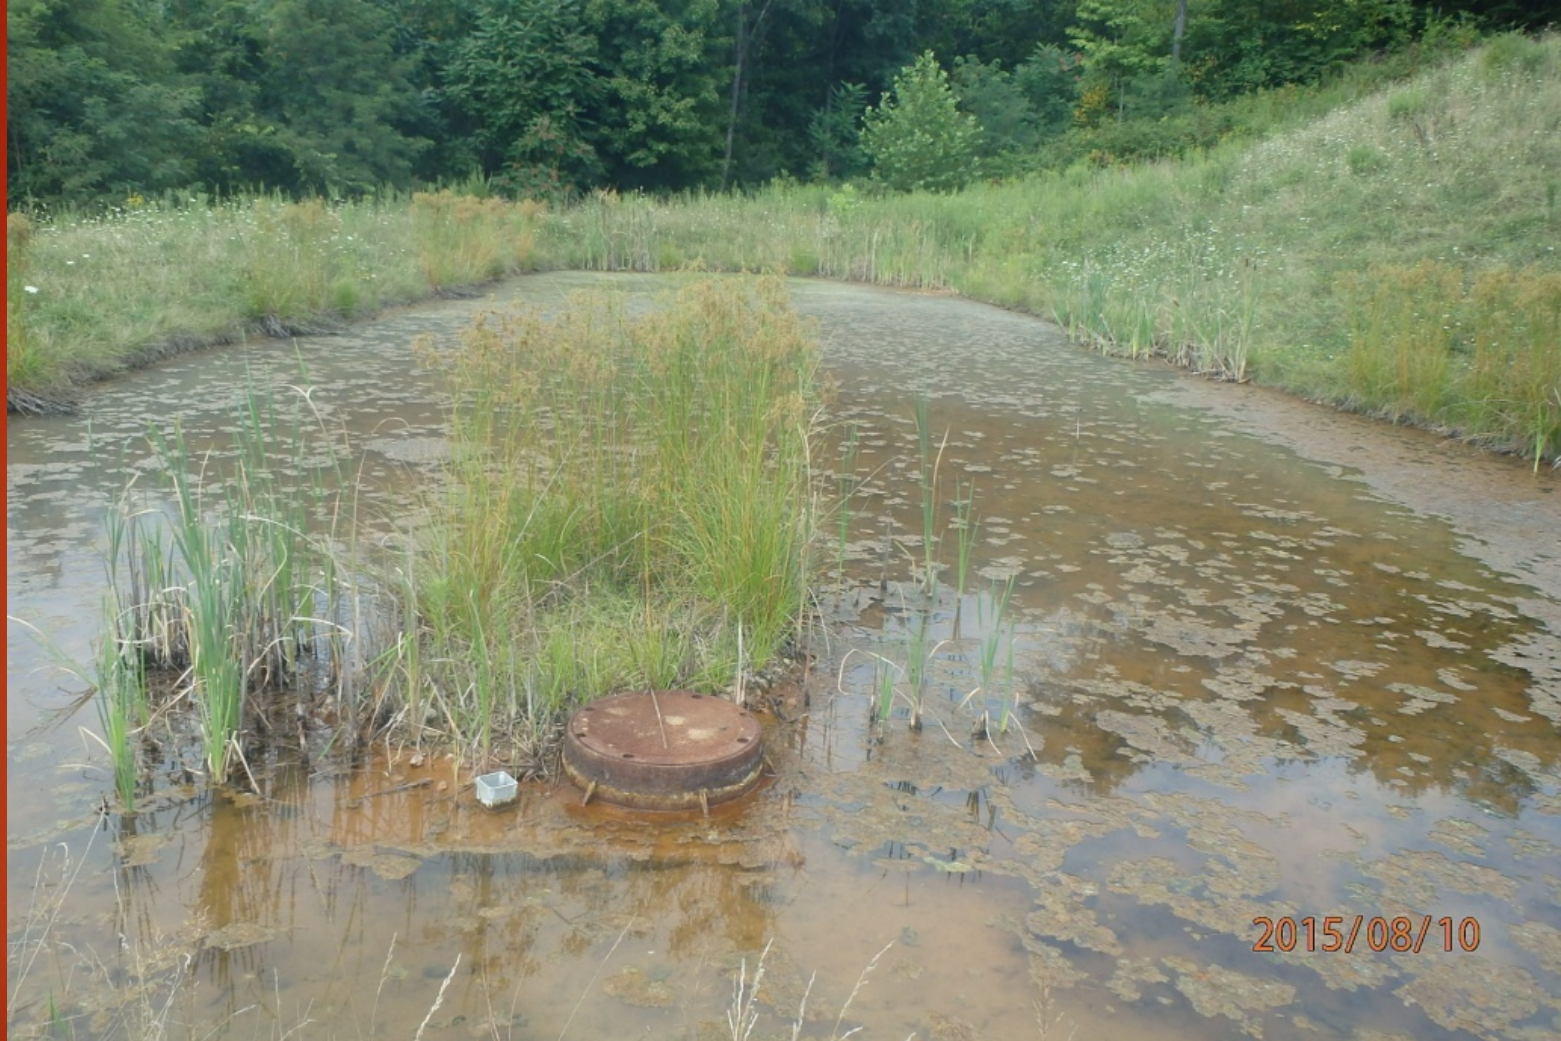
VFP3 Media Clogged

- ▶ All flow bypassed treatment through emergency spillway

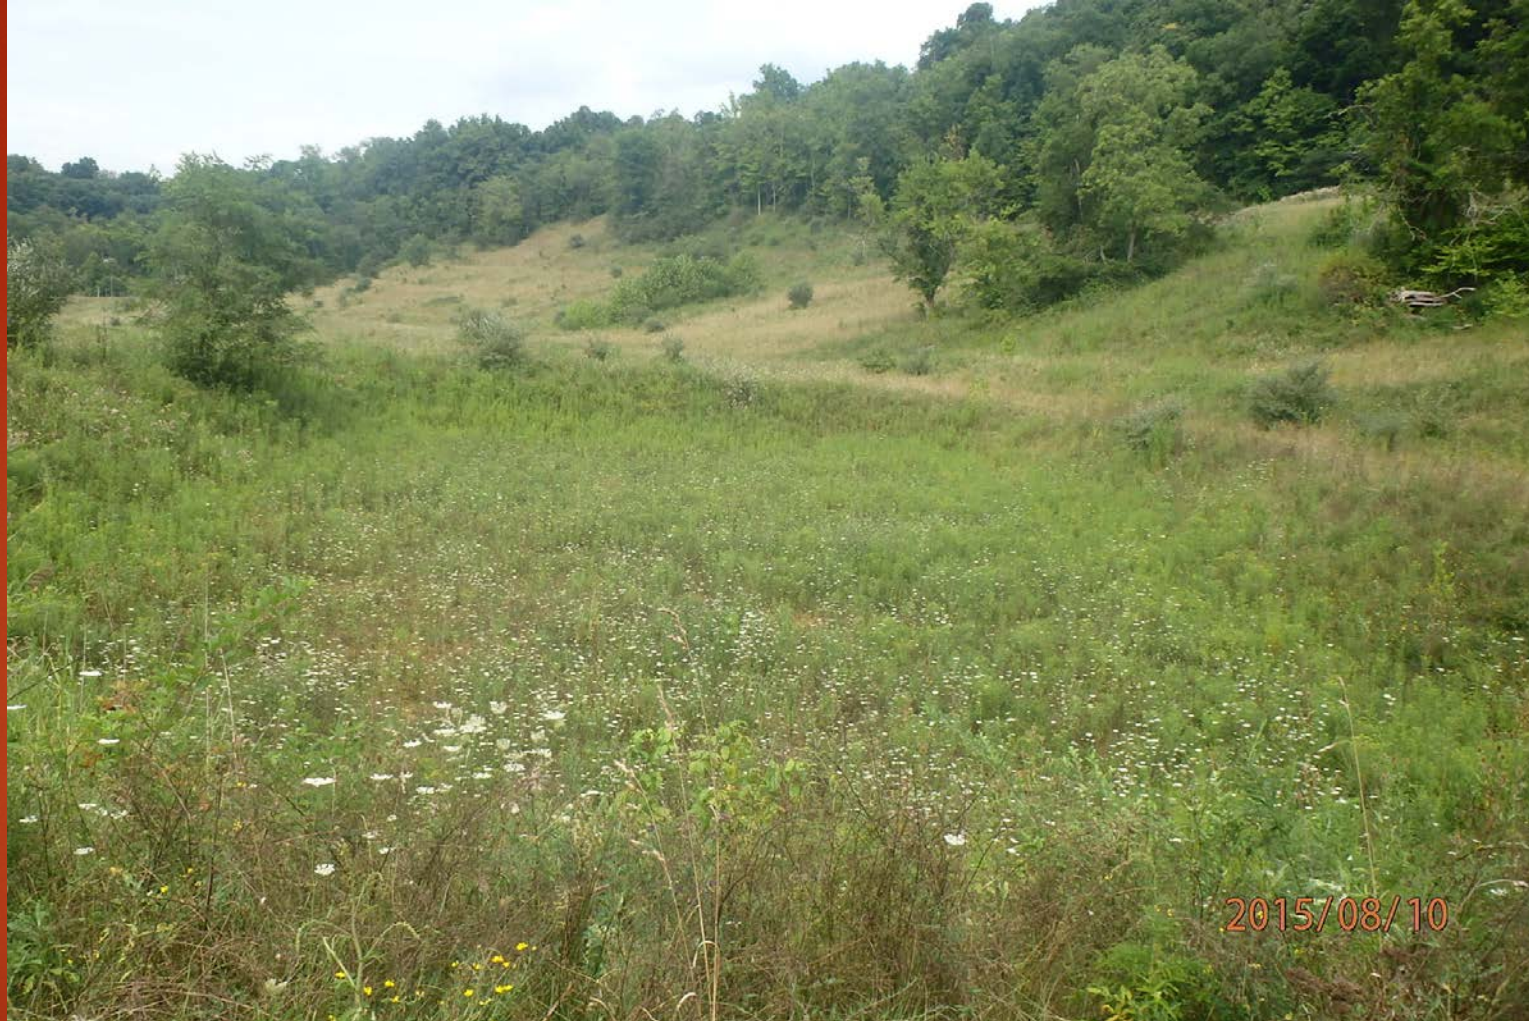
VFP2A Offline

- ▶ System component offline for almost 10 years with no treatment

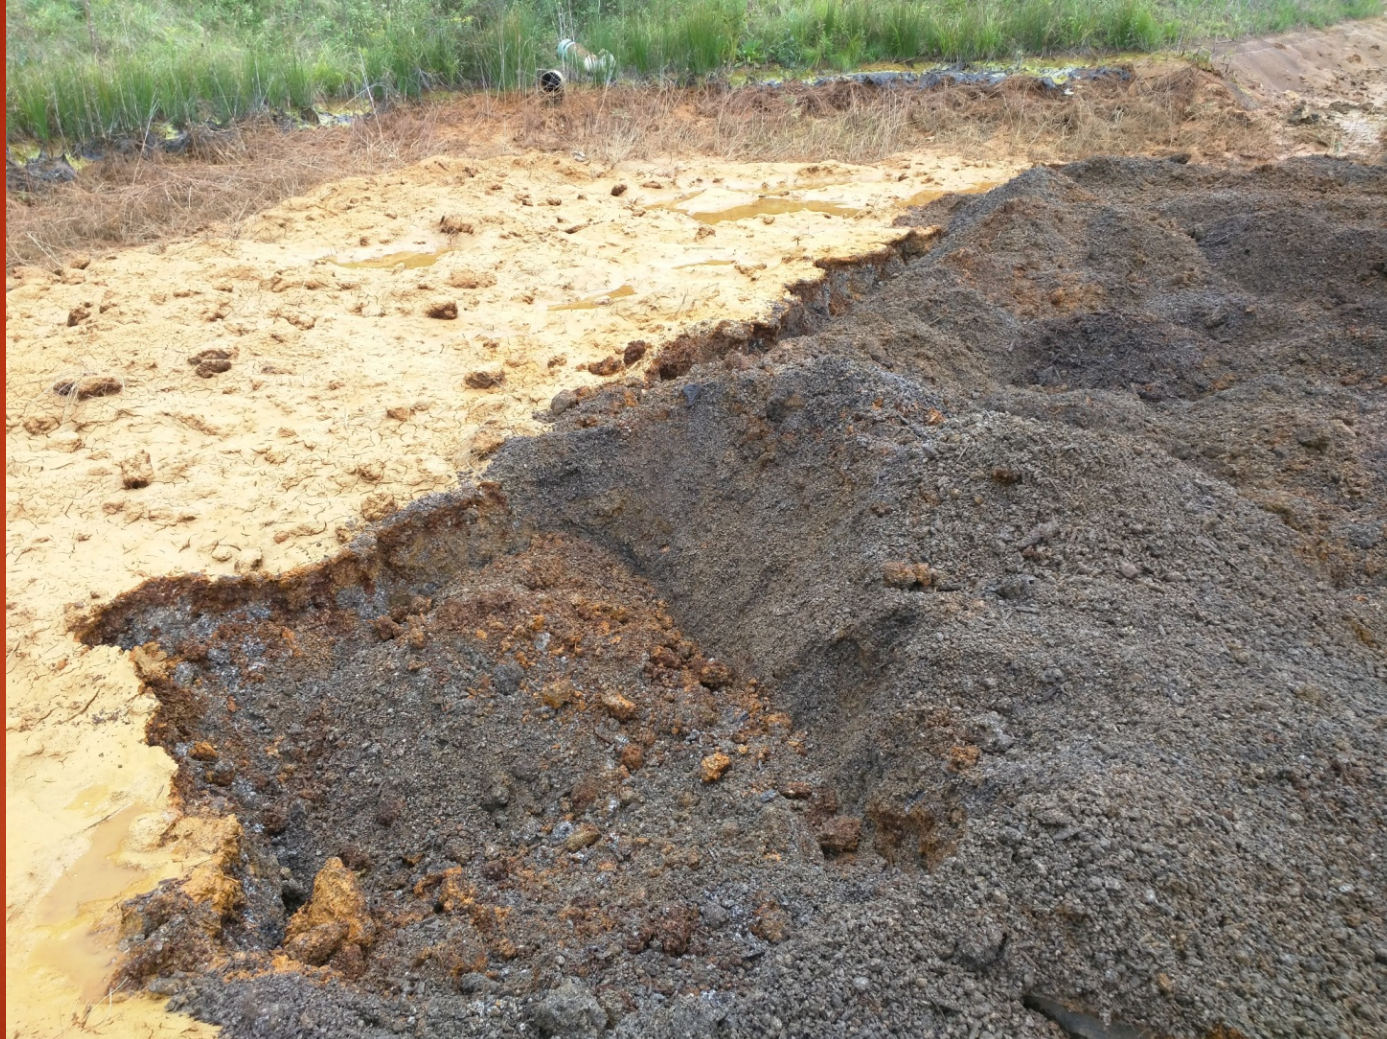
VFP2A Stirred (Again)

- ▶ High quality treatment from media but less than expected flow prompted a second media stir
