Targeted Maintenance Efforts to Ensure a Decade of Successful Passive Treatment

Robert W. Nairn

School of Civil Engineering and Environmental Science

Mayer Ranch Passive Treatment System, Tar Creek Superfund Site, Commerce, OK

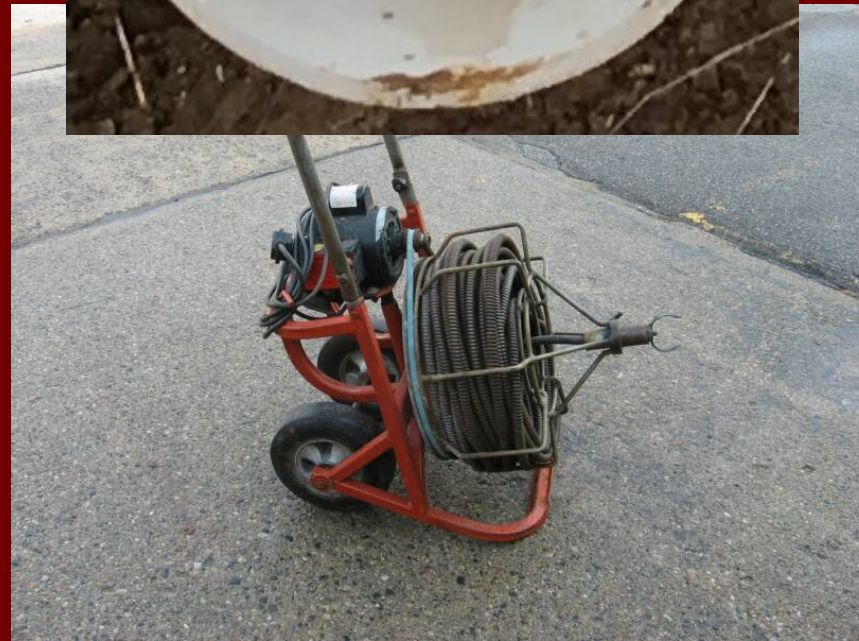
Pipe is clogged? Snake it!

- Rented sewer snake
- Tried every head attachment known to man
- Cloudy water, but no evidence of clog
- Reestablished flow for a few days/weeks

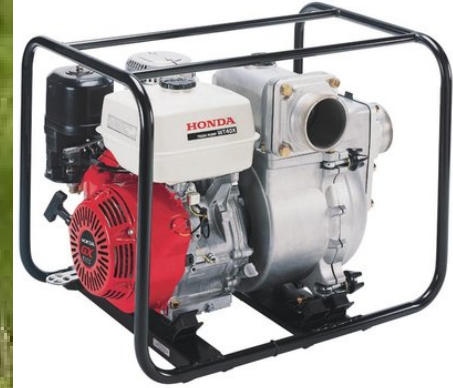
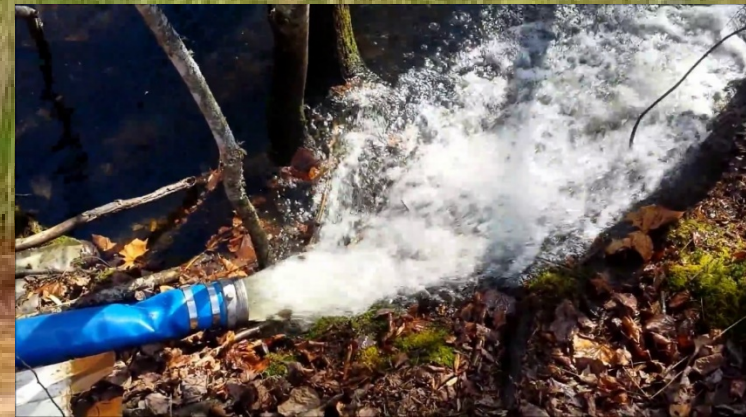
Pipe is clogged? Jet it!

- Down-sized 3" trash pump outflow to 1" with PVC fittings
- Cloudy water (and lots of it!), but no evidence of clog
- Reestablished flow for a few days/weeks

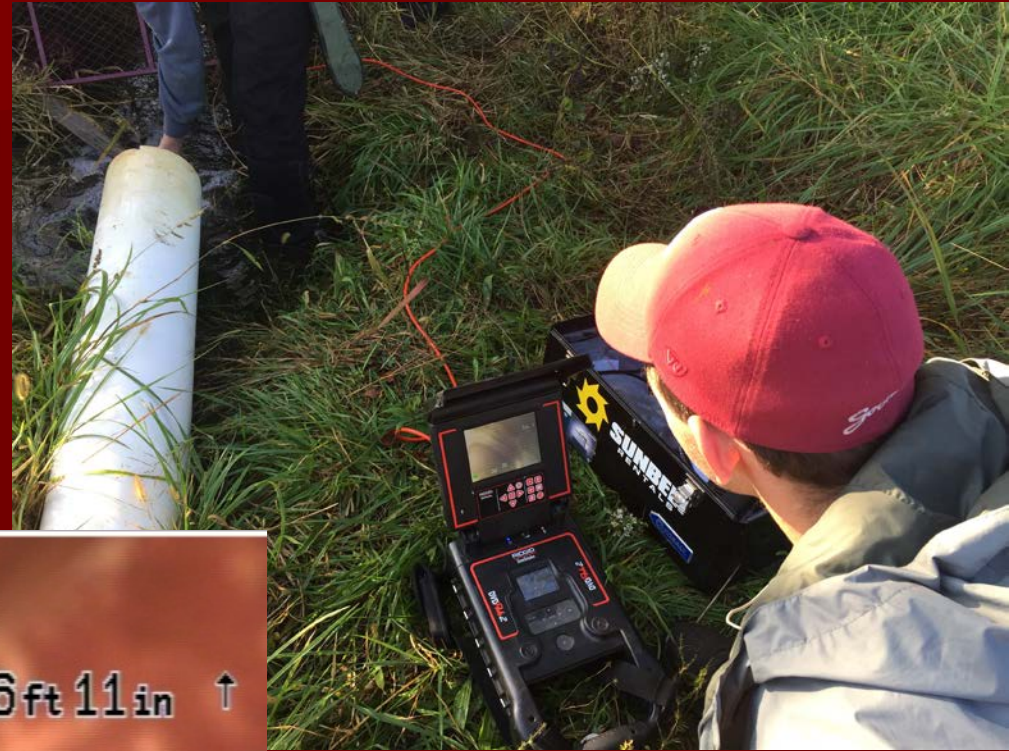
Pipe is clogged? Let's see...

- Rented sewer camera
- Pipe stained, but no obstruction

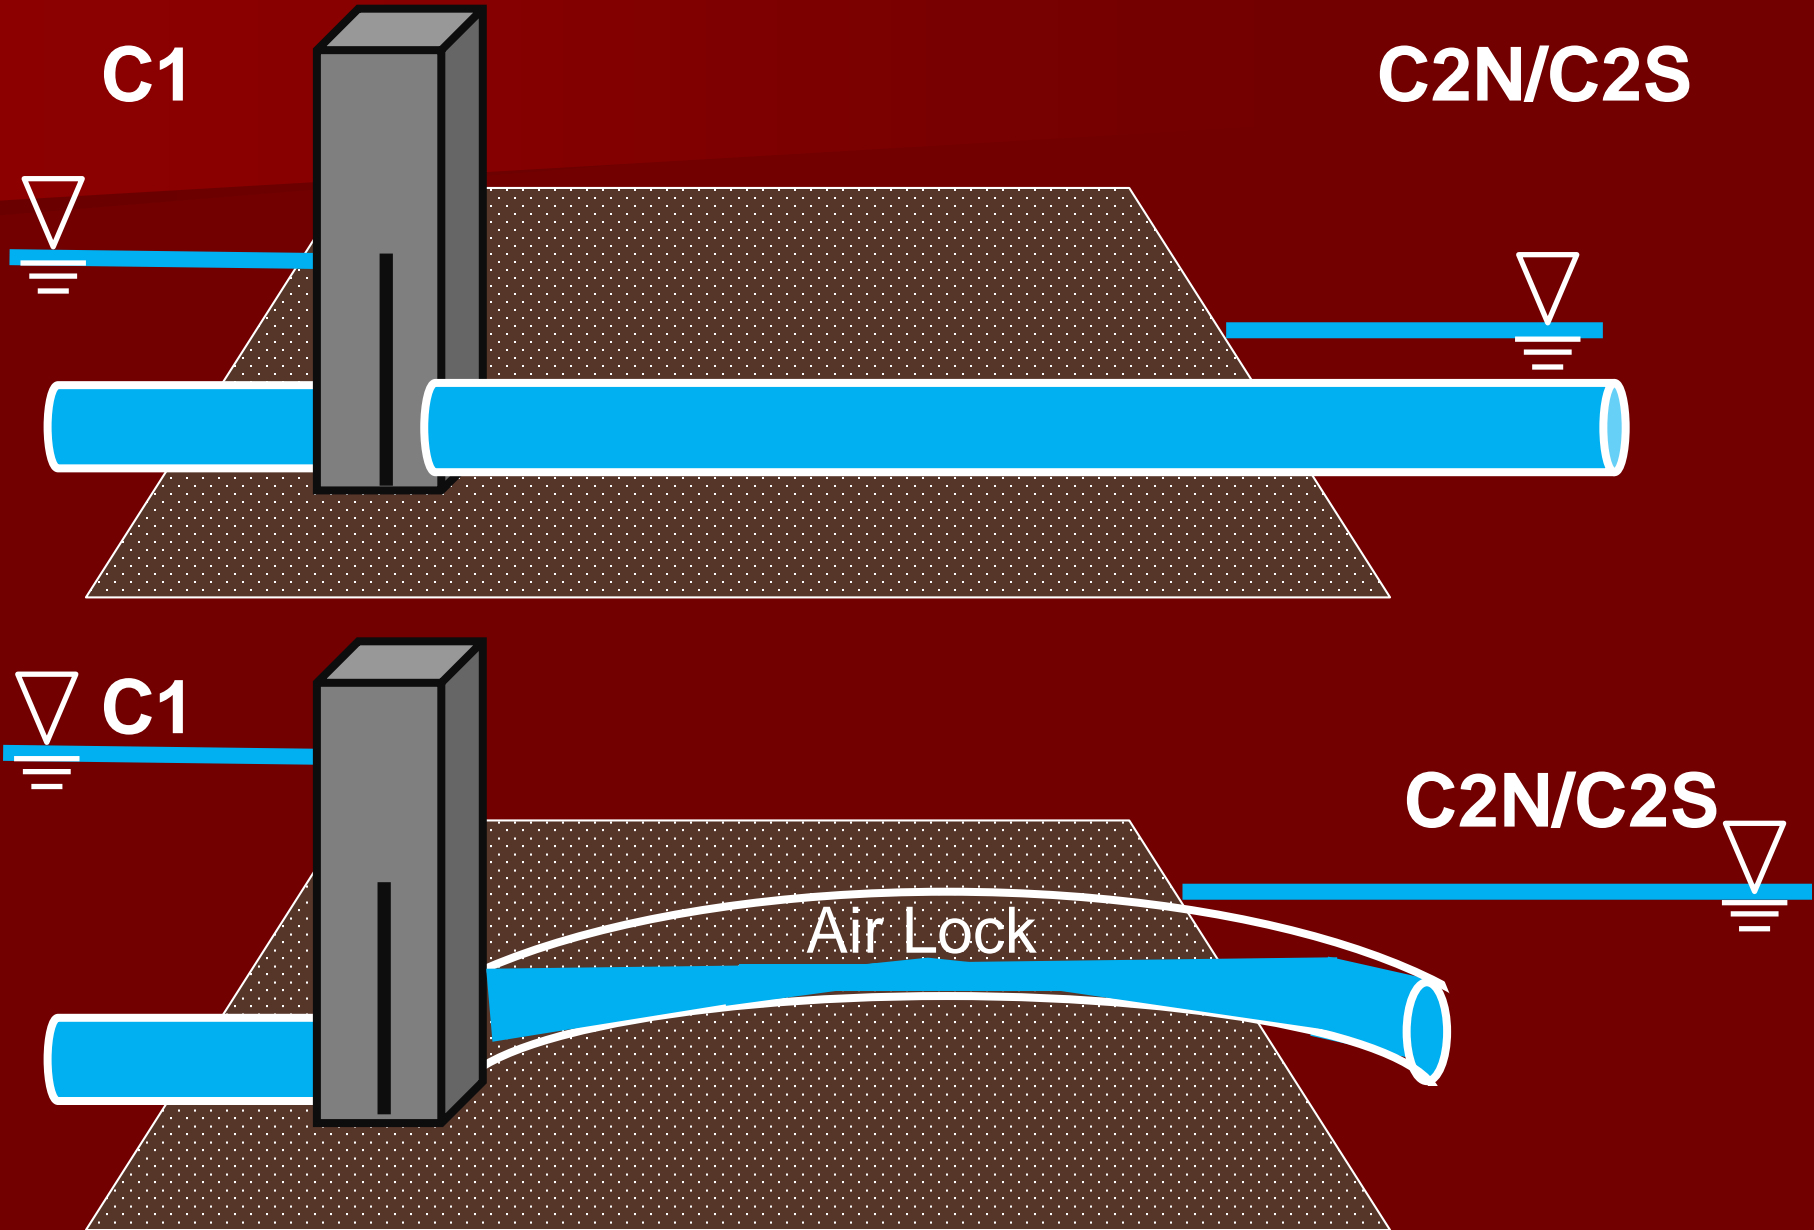
What is buried out there?

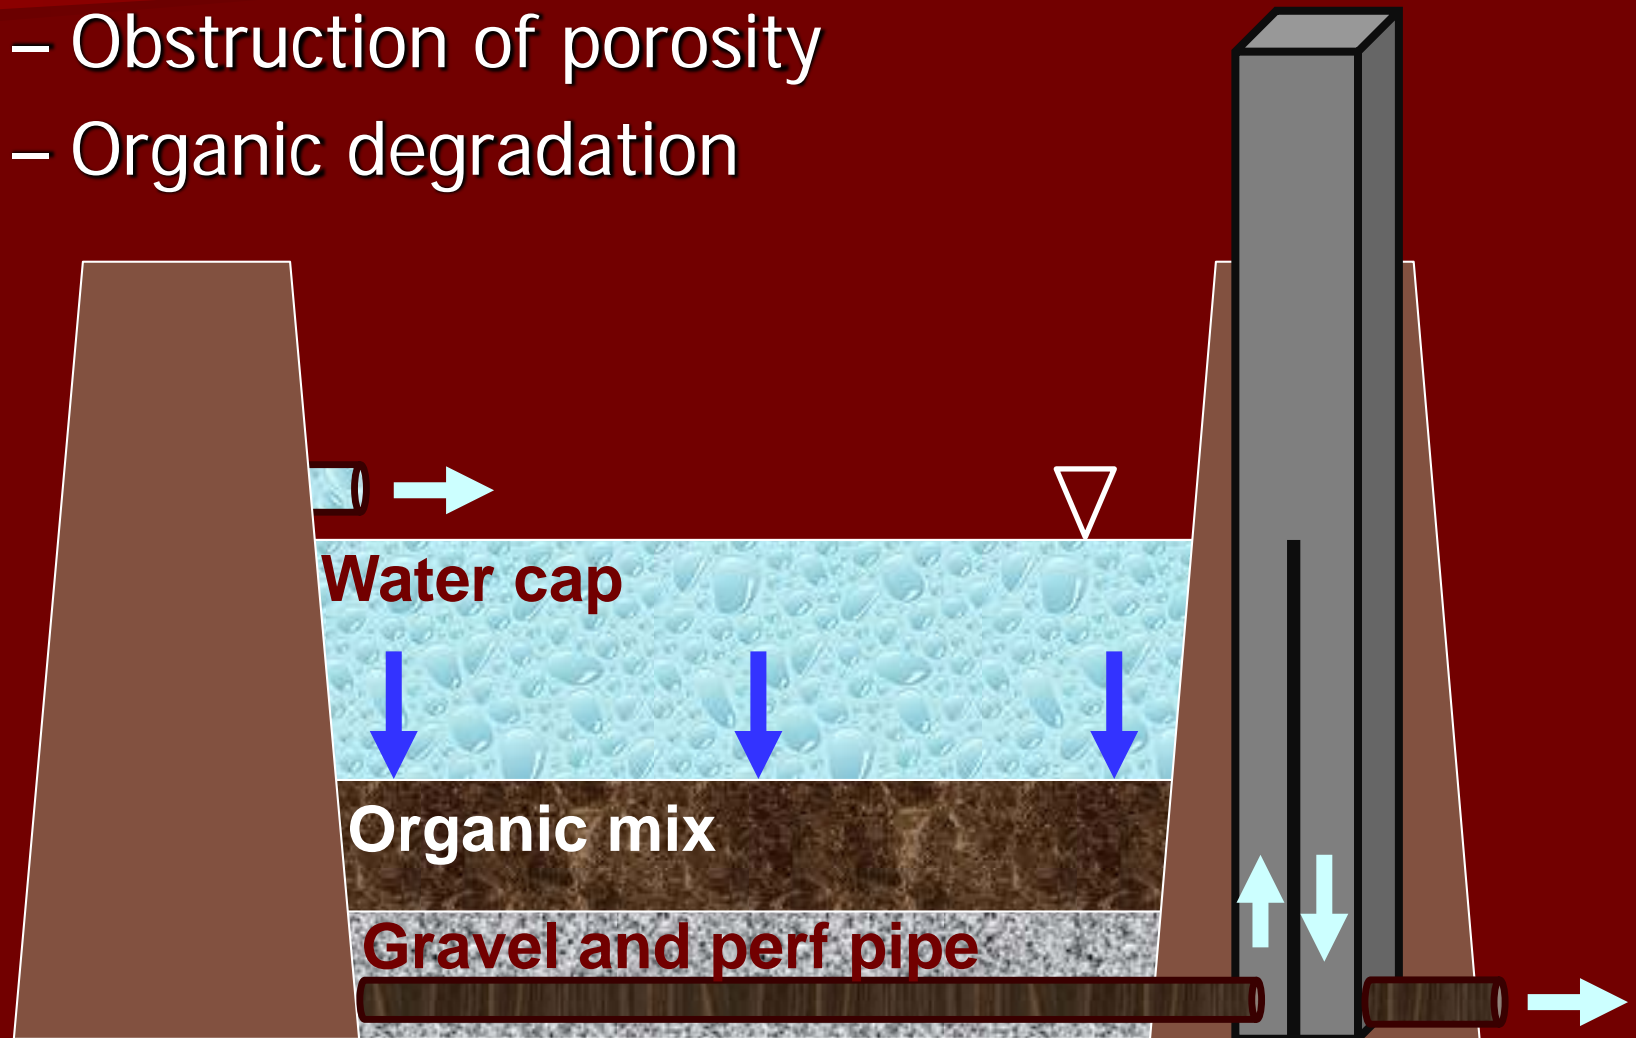
What else is buried out there?

- Decrease in K over time
 - Obstruction of porosity
 - Organic degradation

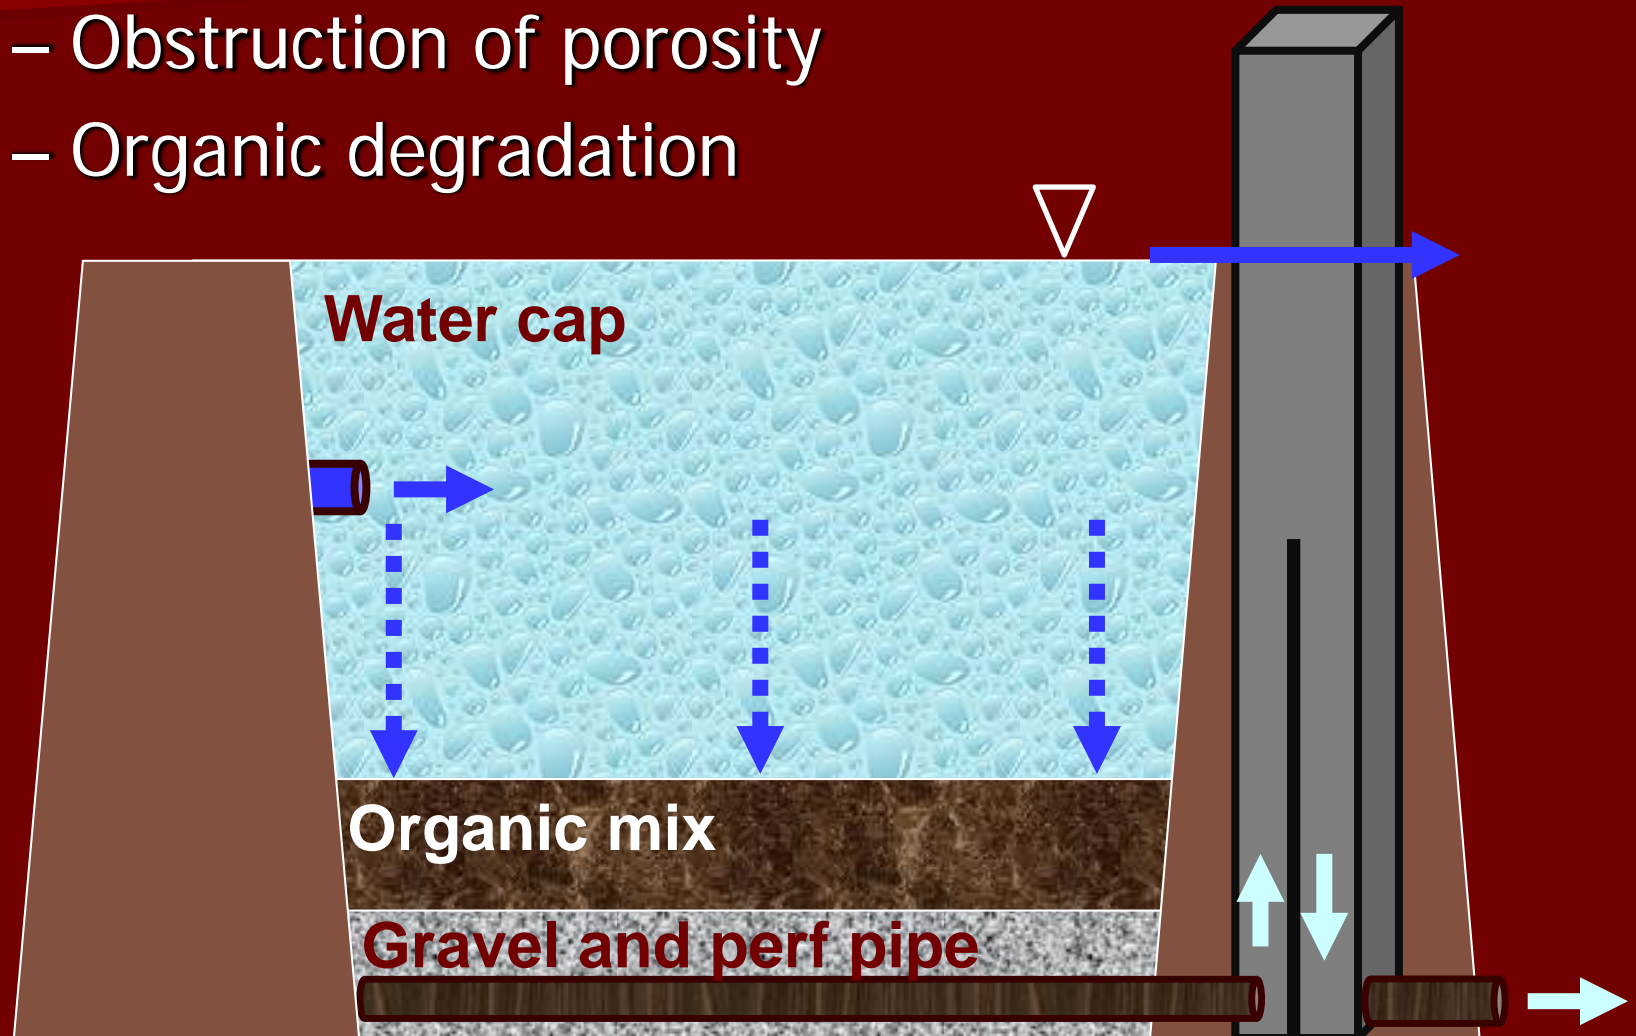
What else is buried out there?

- Decrease in K over time
 - Obstruction of porosity
 - Organic degradation

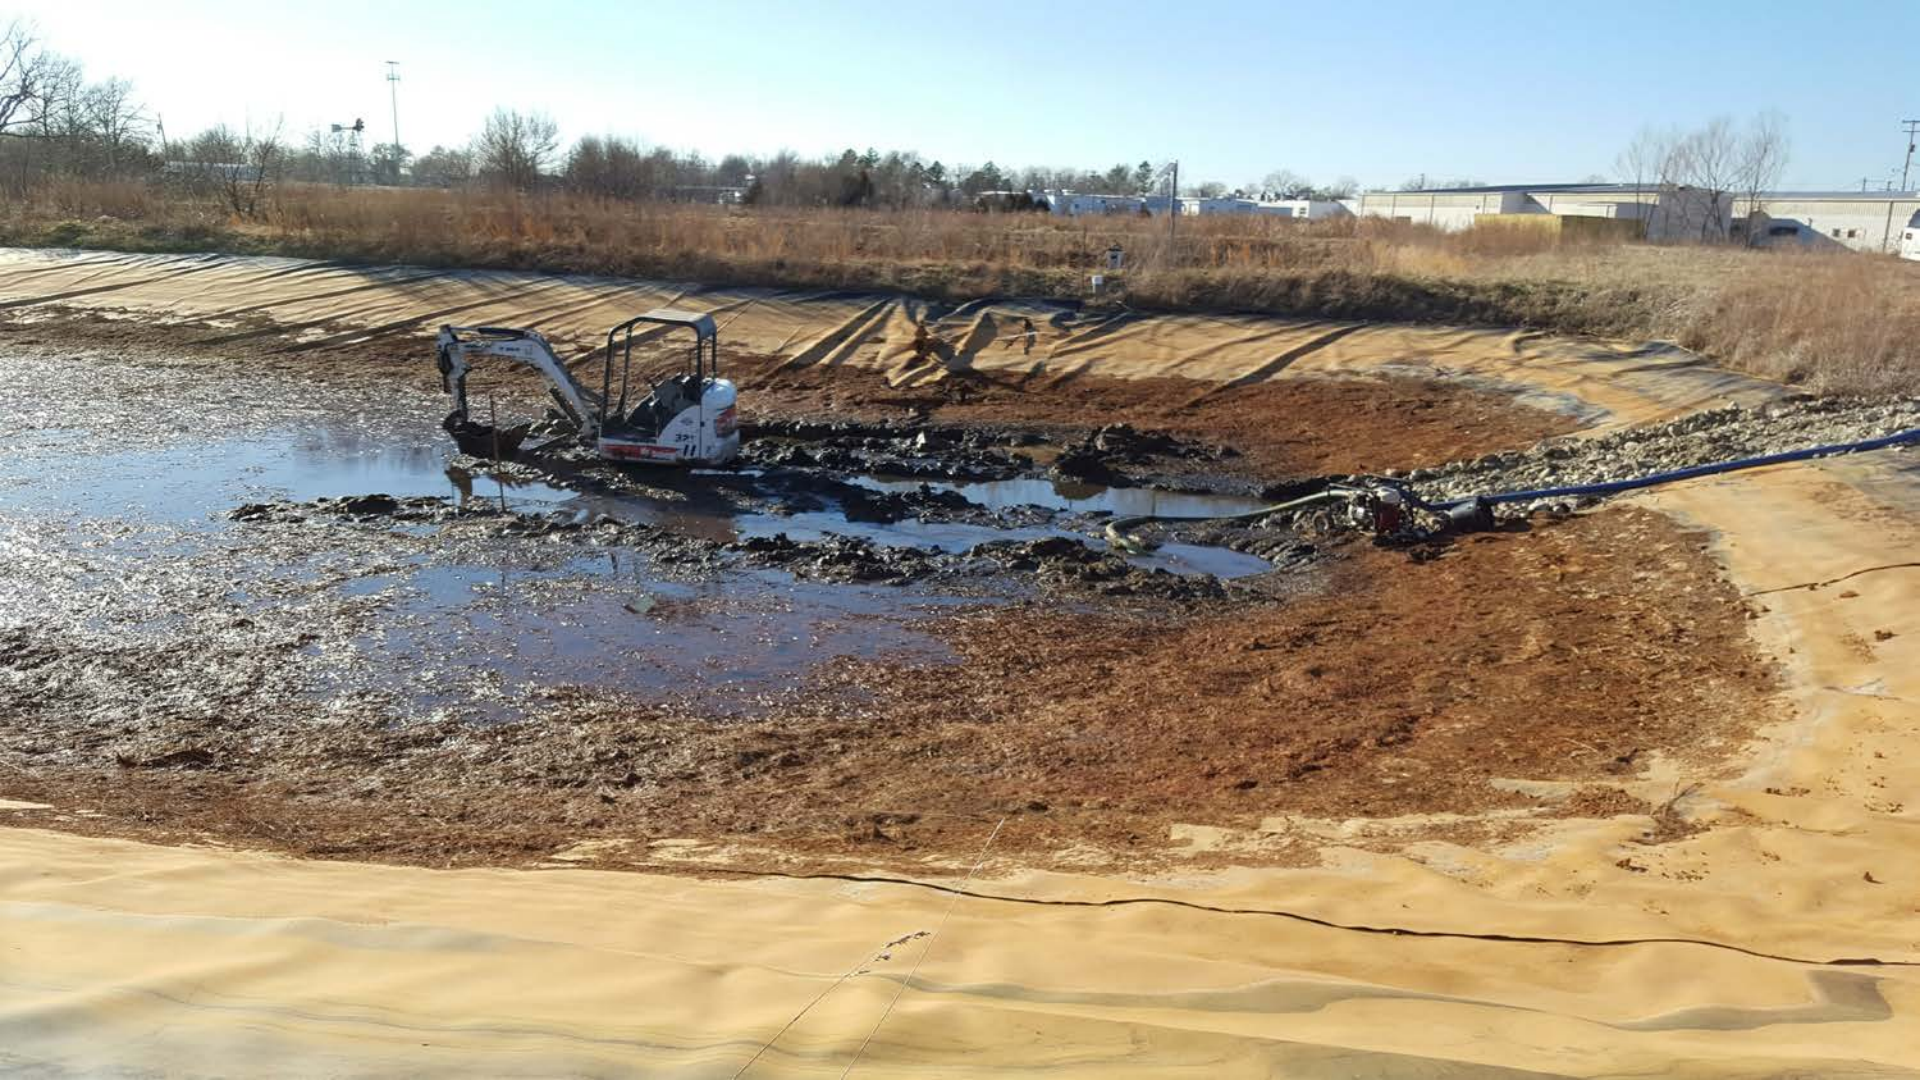
Decreases in Hydraulic Conductivity

K (m/day)	
	C3N VFBR	C3S VFBR
2008 (pre-construction)		
Laboratory-Falling Head	4.77	4.77
2016 (8-years operation)		
Laboratory-Falling Head	0.51	---
Field-Falling Head	0.13	0.31
Modified Infiltrometer	0.19	0.17
Slug Test	1.25	0.43

Restore Hydraulic Conductivity!

Flip the Substrate

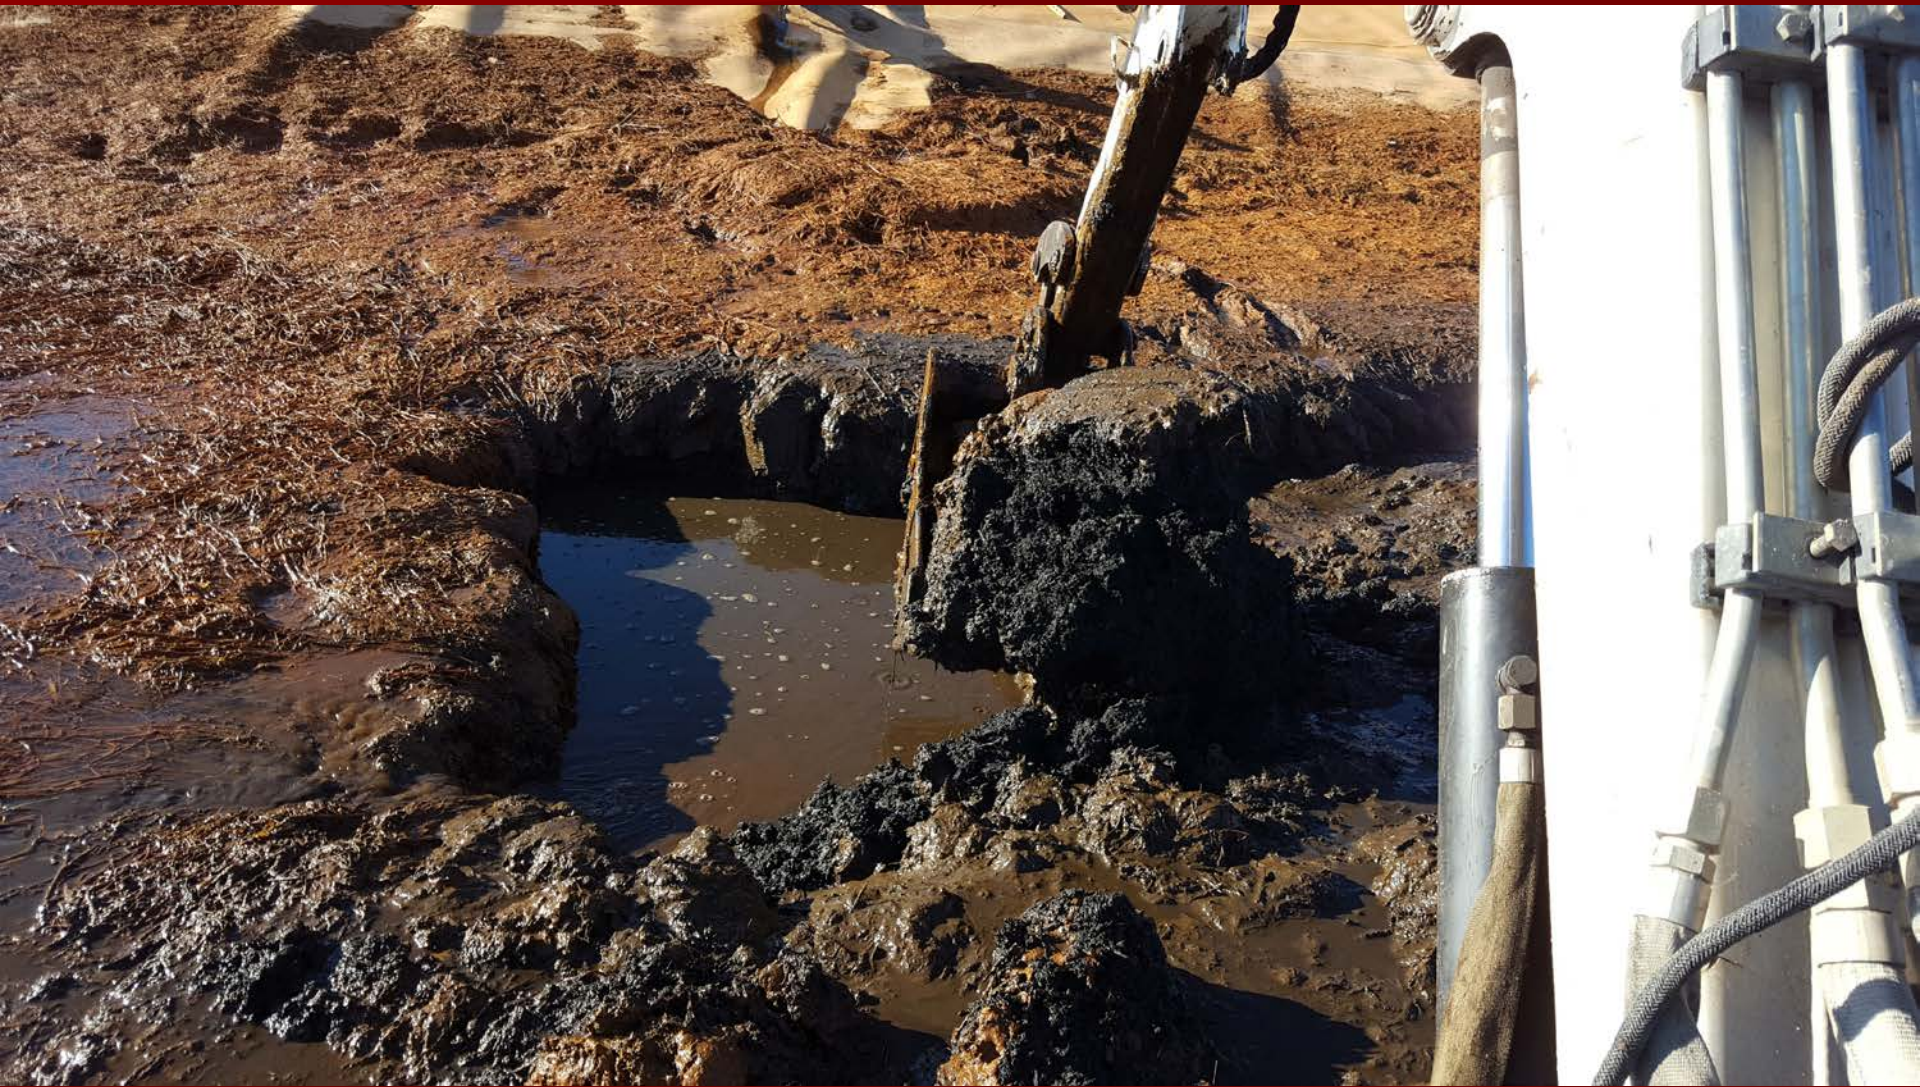
Intact 9-yr Old Substrate

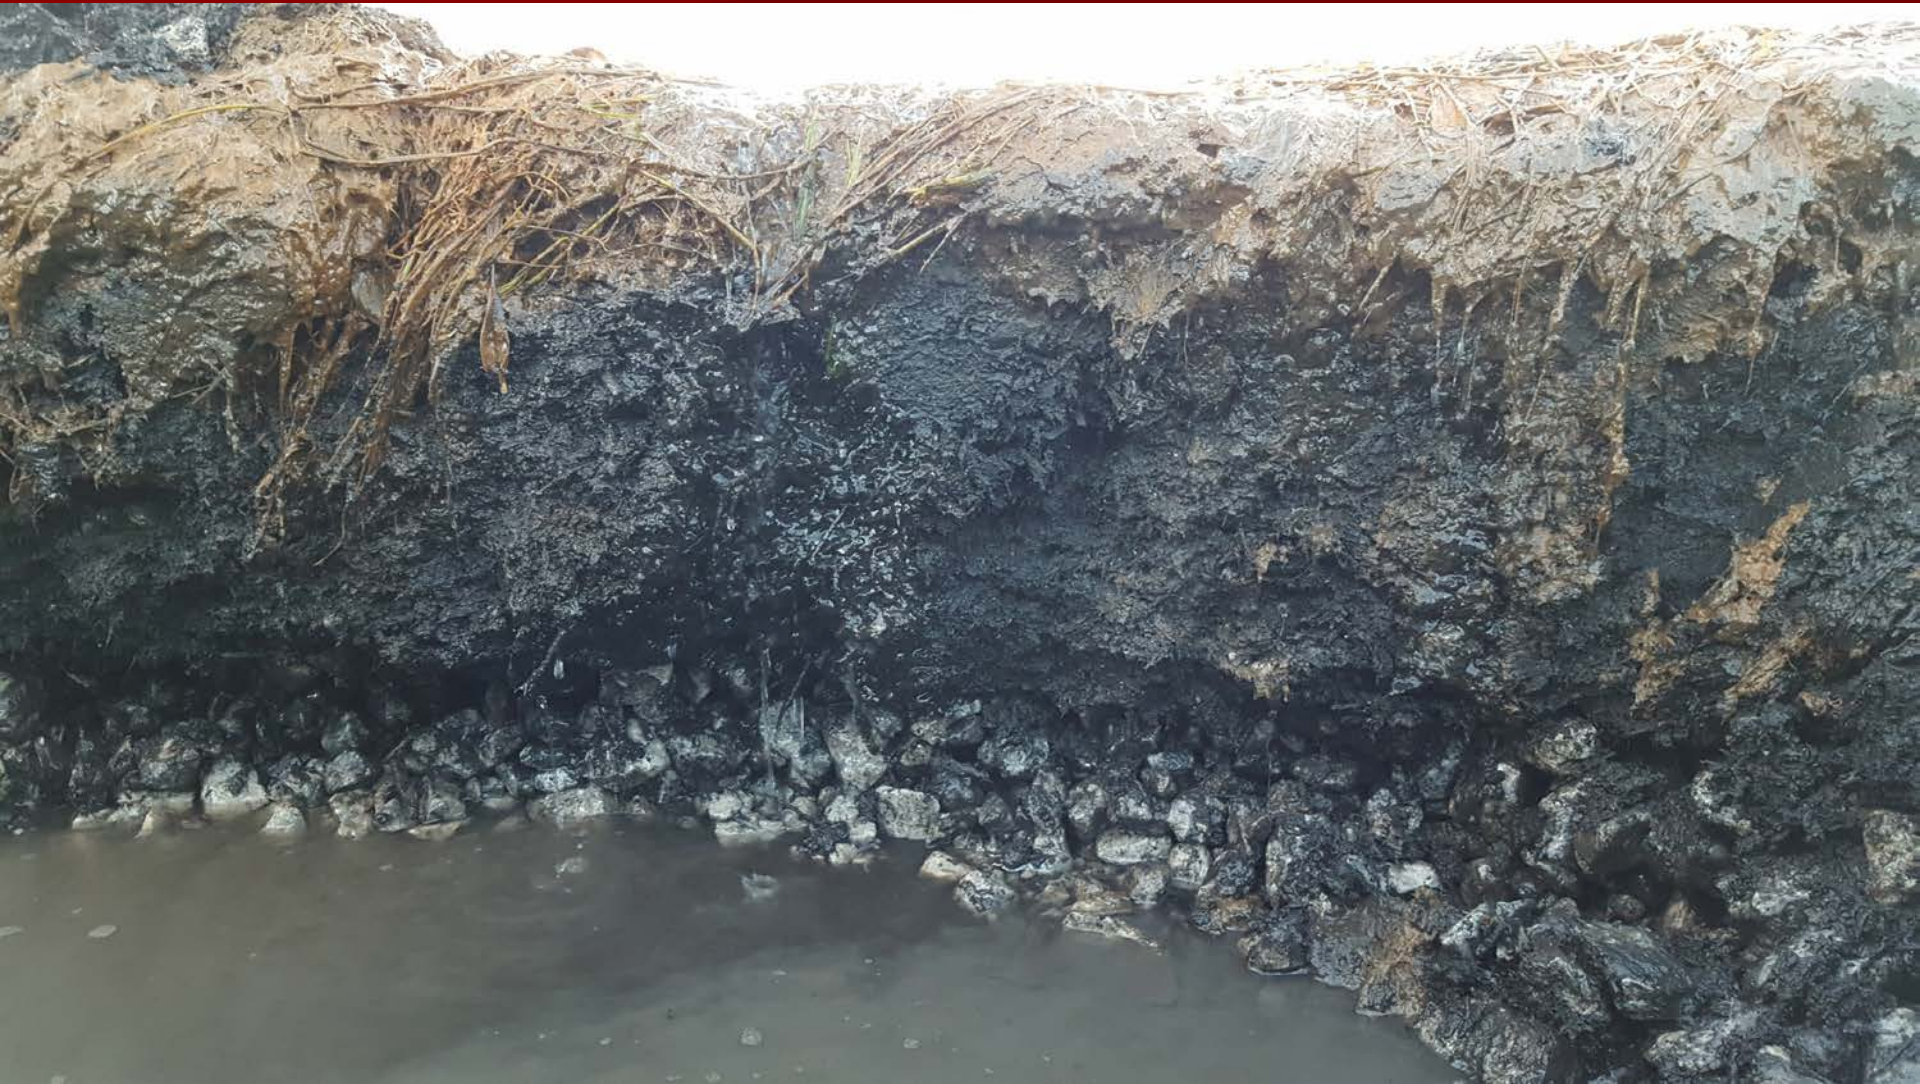
Little Loss of Depth

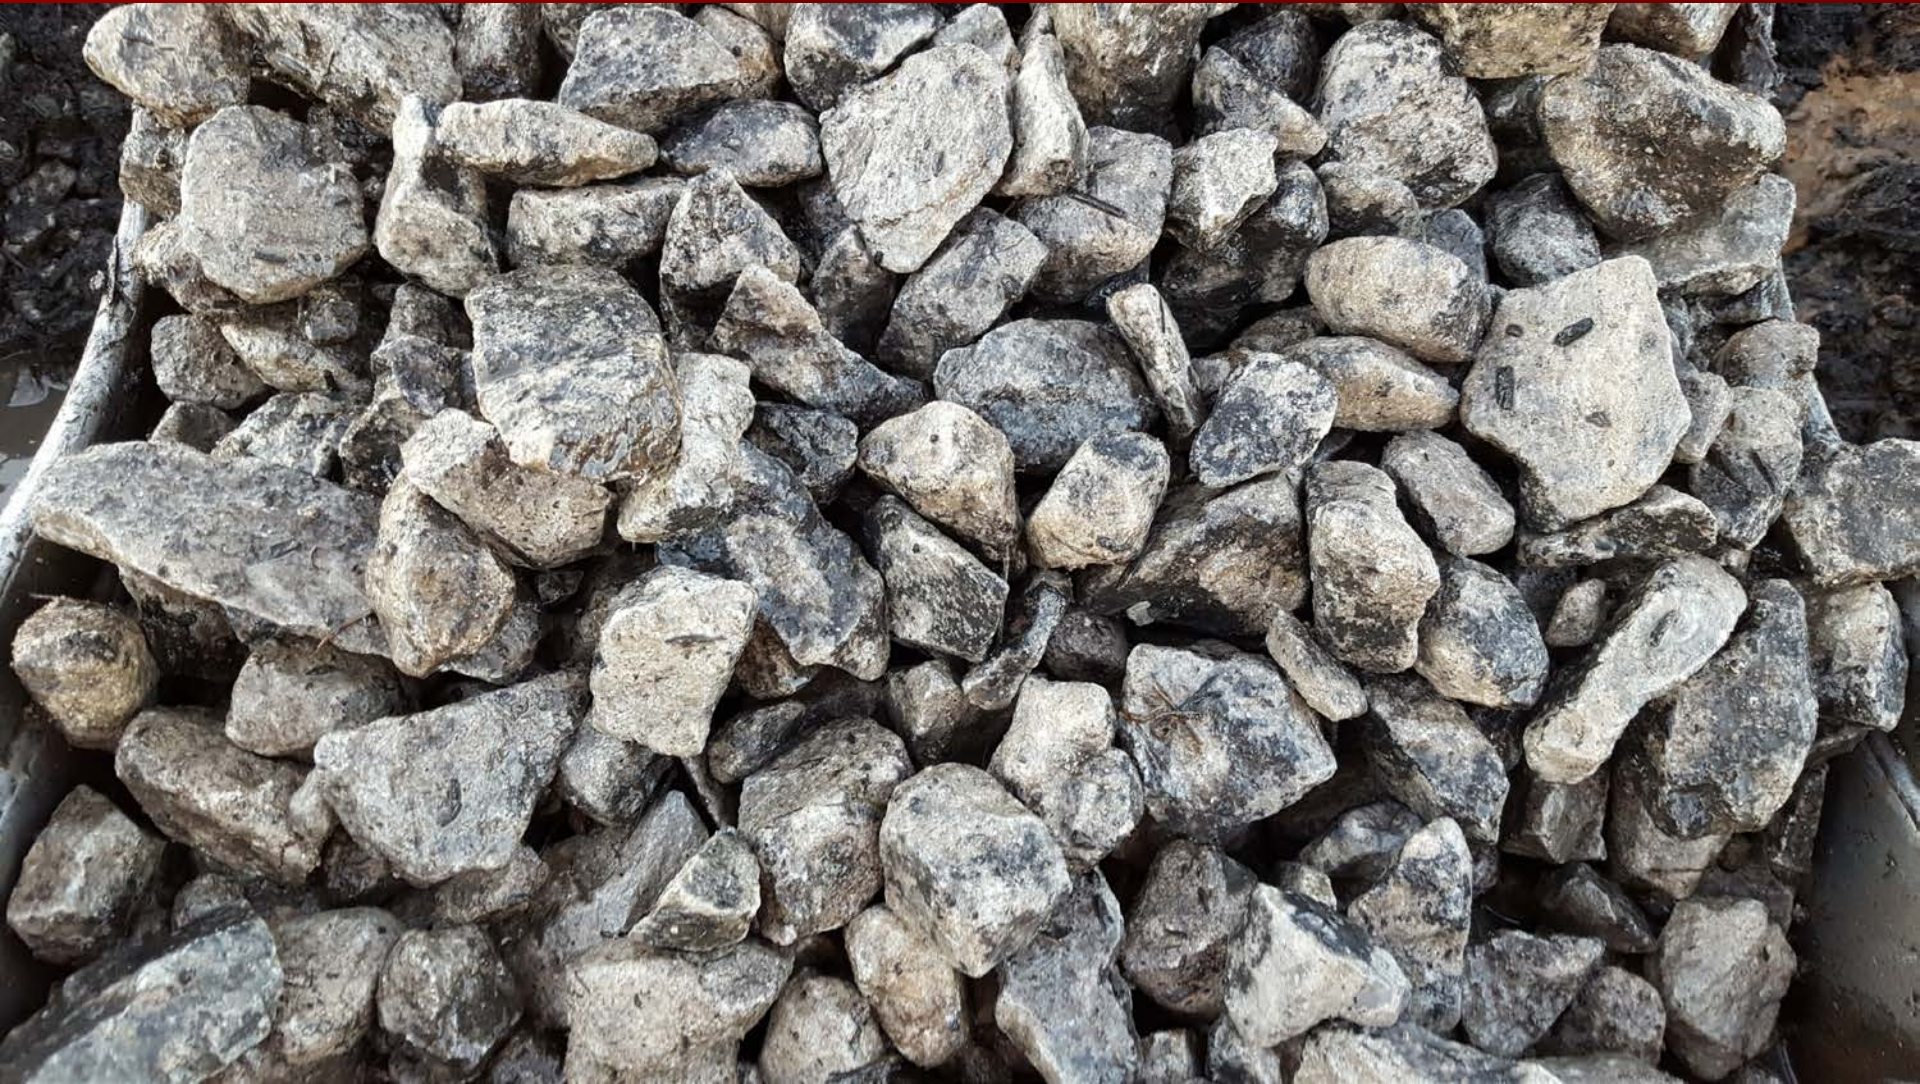
Clean Underdrain Stone

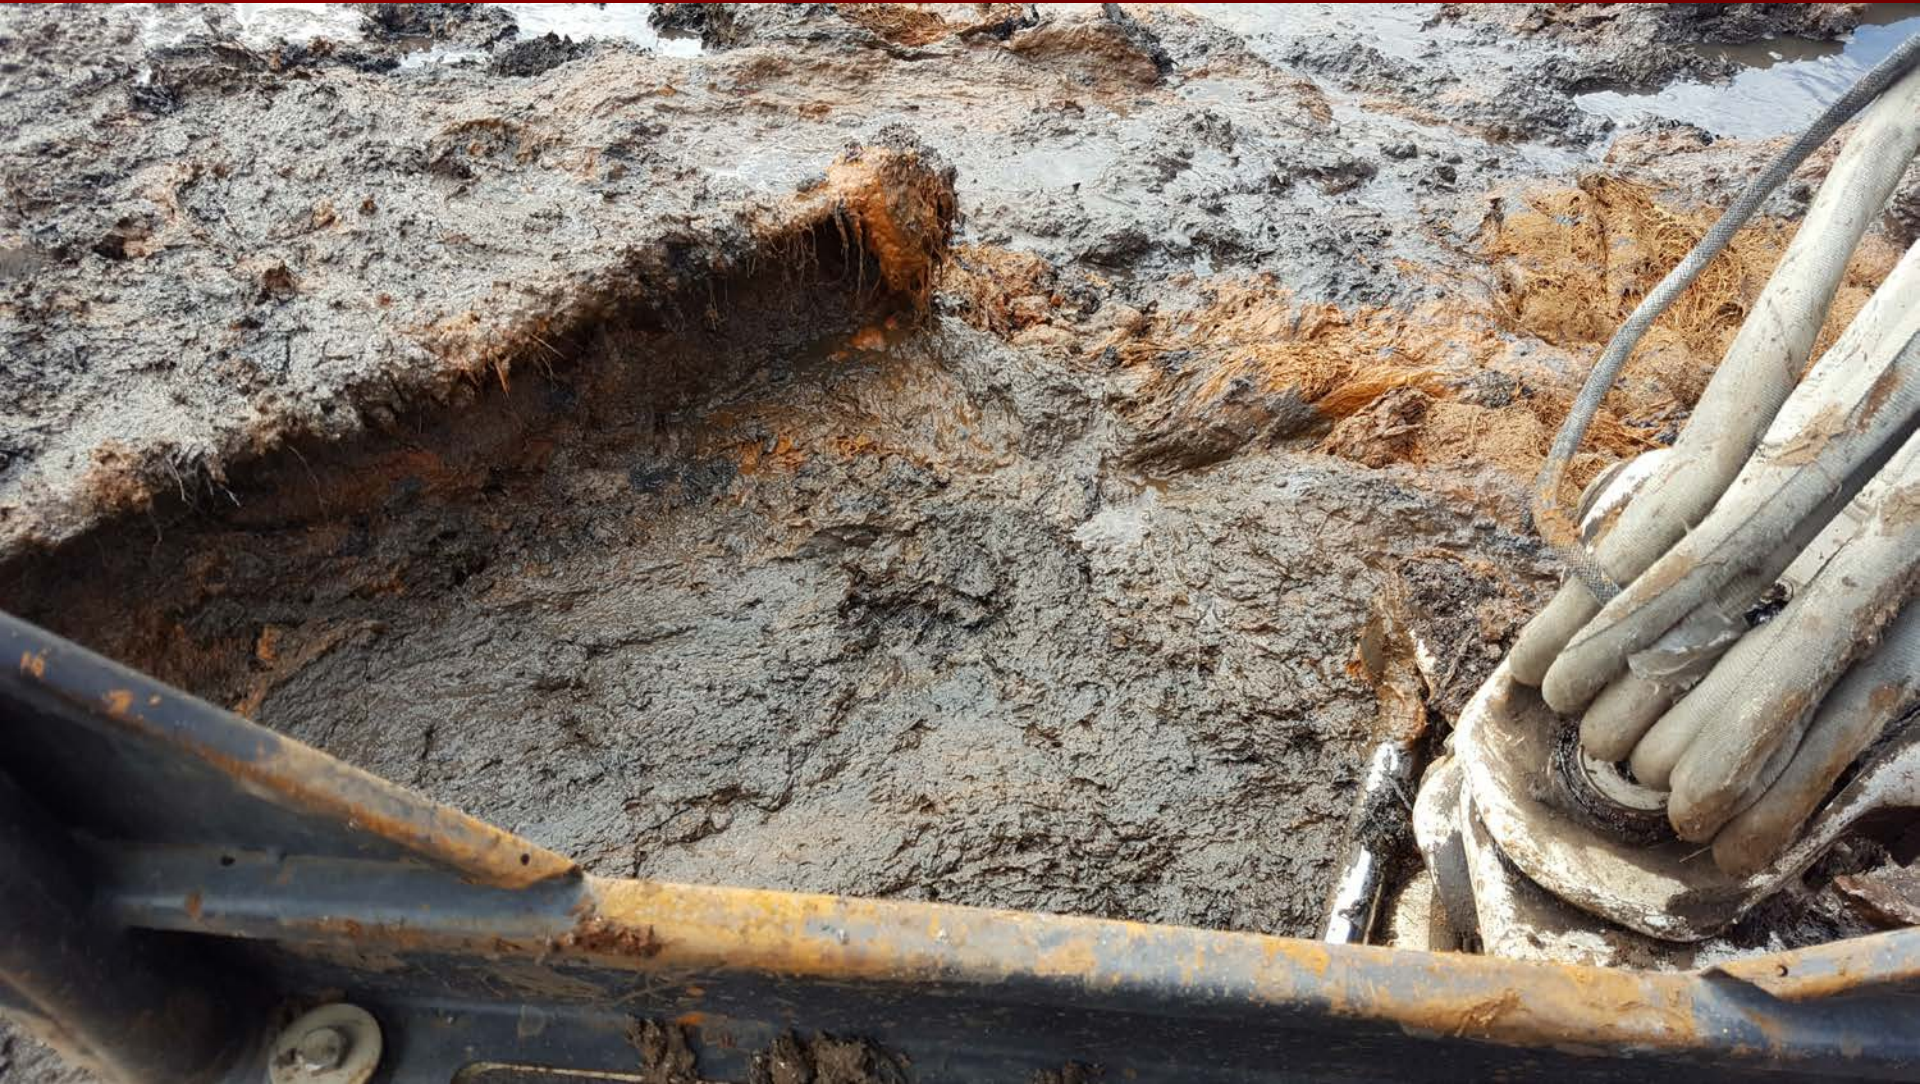
Degraded Material Near C3S-In
