# McDonald, PA Carbon Dioxide Gas Investigation and Remediation

September 2021 – May 2022

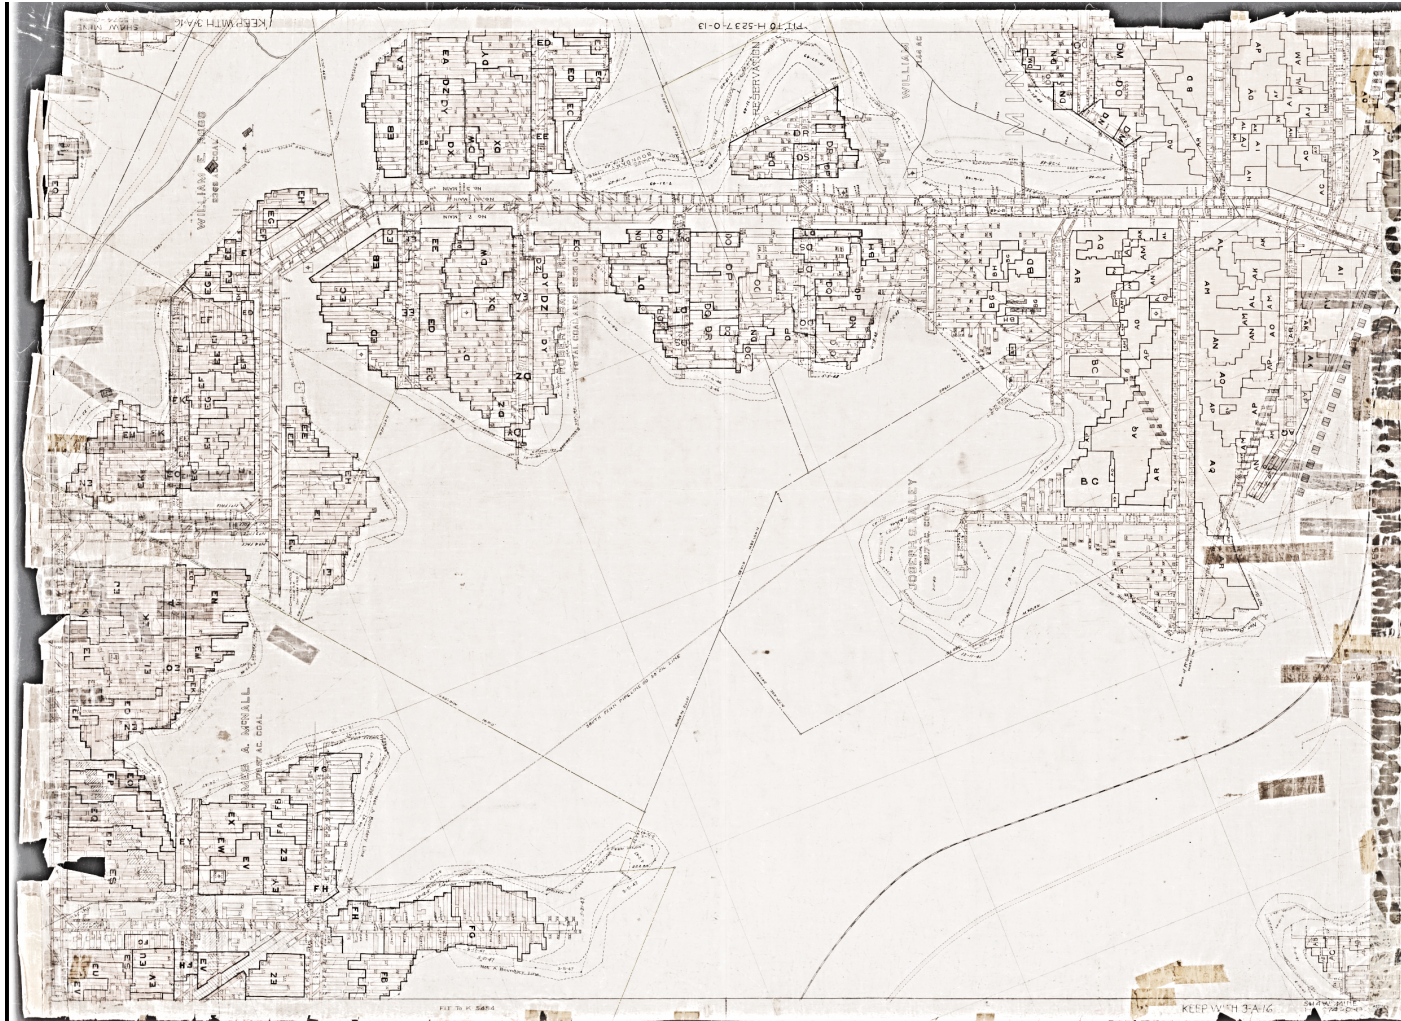
# Coal Mine Map

- Pittsburgh coal seam.
- The last mining in 1937.
- Approximately 30 feet of cover.
- PHUMMIS
  - PA Historic Underground Mine Map Inventory System

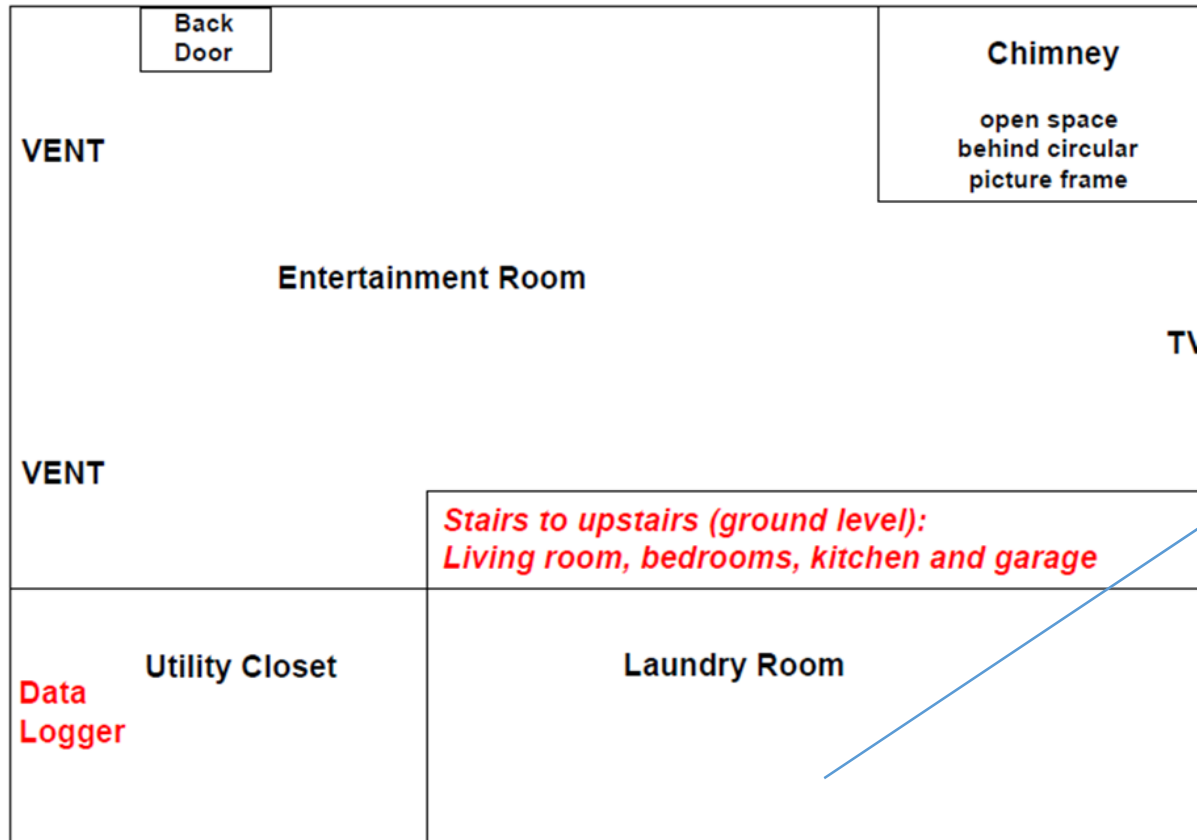
# Indoor (Basement) Samples

| Date | Time | CO <sub>2</sub> | O <sub>2</sub> |
|---|---|---|---|
| <b>10/29/2021</b> | <b>9:06 AM</b> | <b>1.52</b> | <b>19.6</b> |

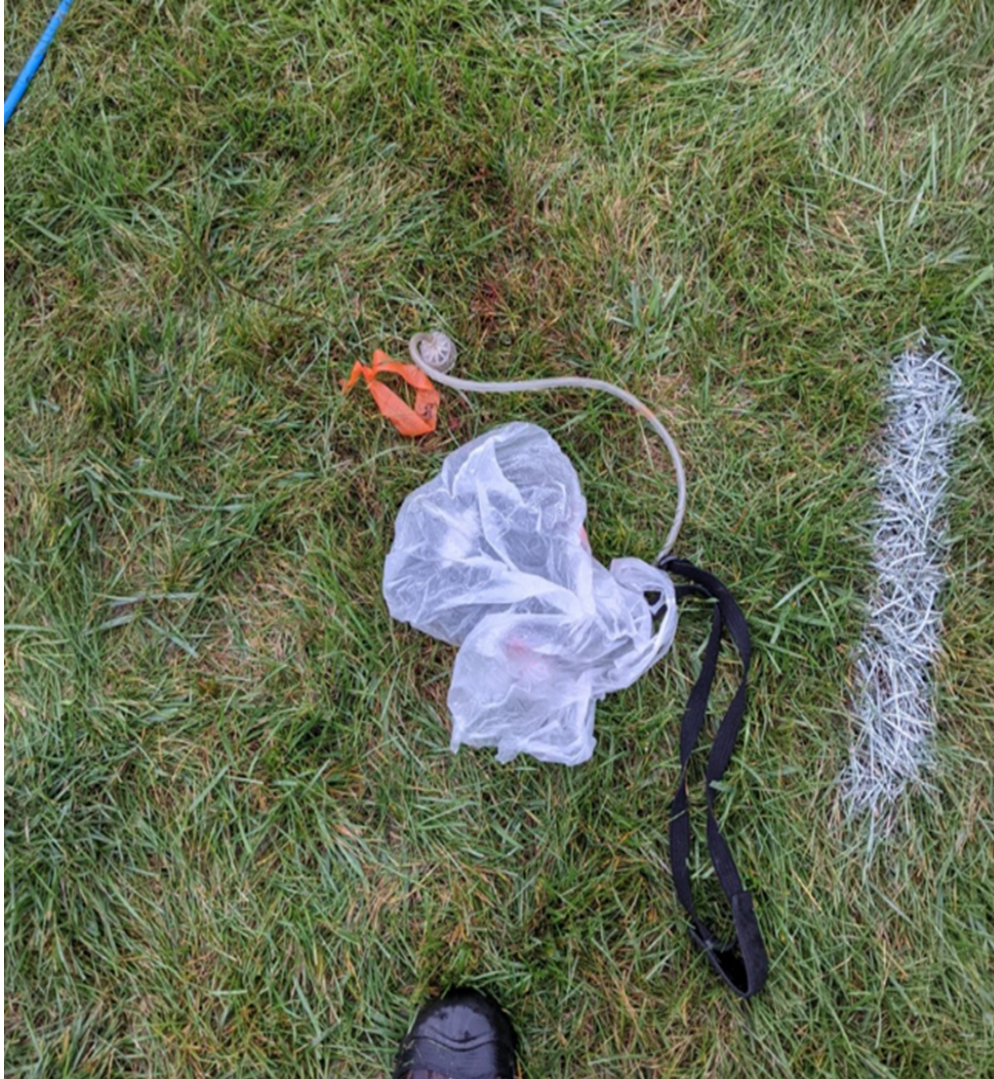
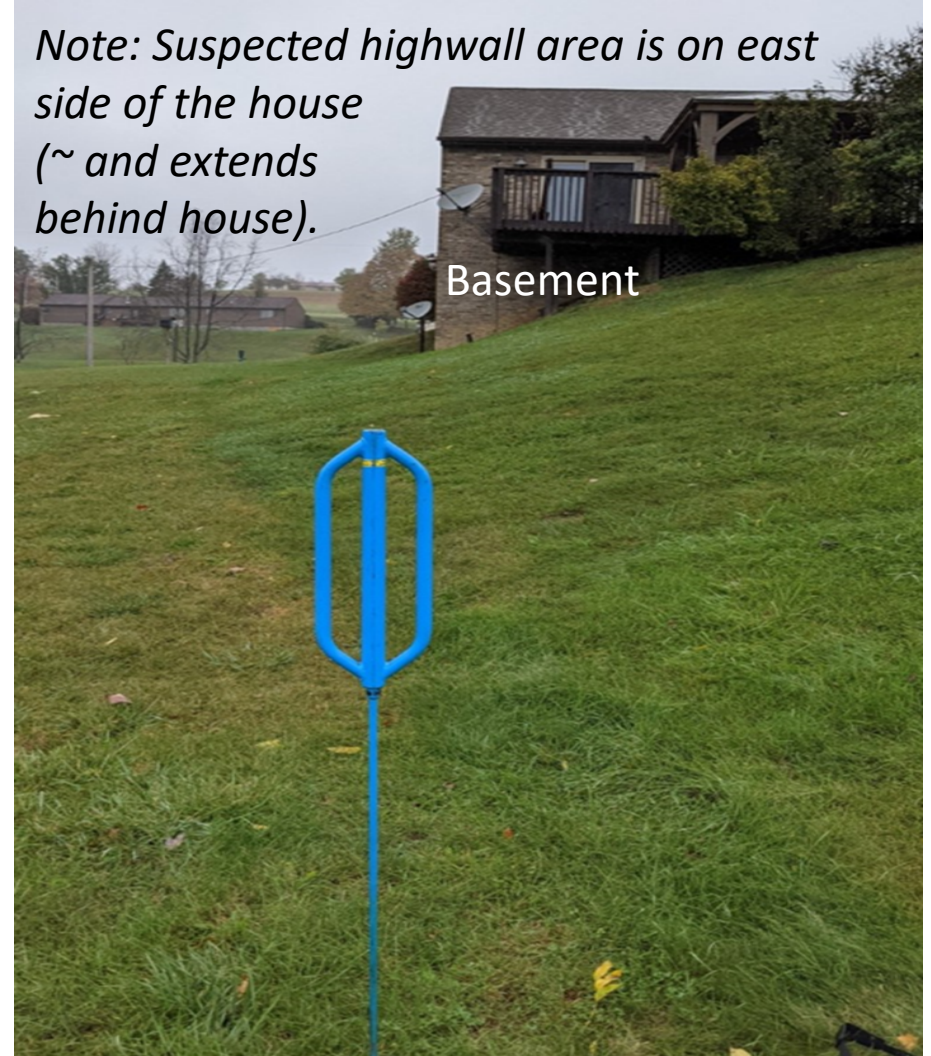
# Drive Bar Gas Samples

*Note: Suspected highwall area is on east side of the house (~ and extends behind house).*
