ASBESTOS TAILINGS RECLAMATION

IN SOUTHERN AFRICA¹

by
JJP van Wyk²

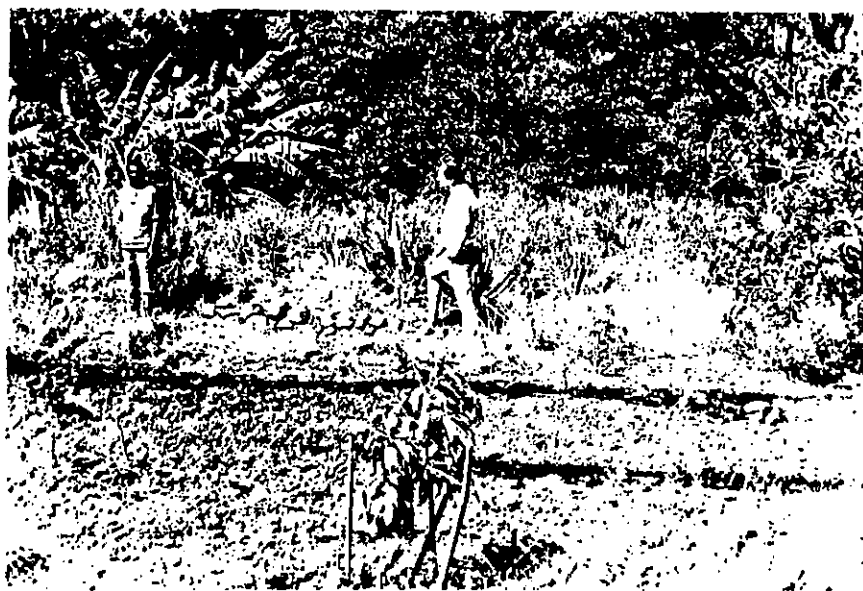
Figure 6.

According to the local farmers the plain, or part of it, floods bi-annually (figure 6).

The depth of the tailings on top of the surface varies from 0,5 - 4 metres on dwelling sites, and from 300 mm to ploughing depth below the surface in the agricultural lands. Most of the tailings have been dumped

Fruit and vegetable farming on the Gemeni
floodplain.

As soon as the inhabitants can be convinced by their local Government and Chief to temporarily evacuate the area, the rehabilitation will begin by means of removal of slimes where it has been dumped on the surface and not ploughed into the soil.

The rest (80 %) of the area will be cleaned up by means of a mini open cast mining operation where the contaminated soil and surface tailings will be buried and clean soil from the sub surface will be brought to the surface and spread over the contaminated buried material.

The area will be contoured to prevent erosion in case of future flooding.
