## **CASE STUDY: KERBER CREEK RESTORATION PROJECT: EMPLOYING STATISTICAL TECHNIQUES TO ANALYZE EFFECTS OF RESTORATION ACTIVITIES, SAGUACHE, CO<sup>1</sup>**

T. I. Klein<sup>2</sup>, L. Archuleta, J. Willis, N. Tedela, and B. Sanchez

Journal American Society of Mining and Reclamation, 2013 Volume 2, Issue 2 pp 56-79

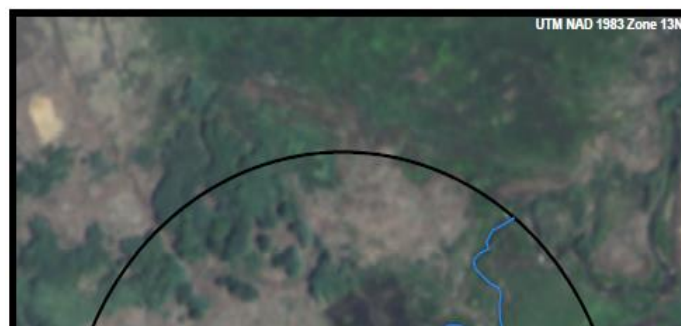
While site KC18 exerts a positive directional influence on the regression model since the measured sinuosity value is greater than the predicted value (Fig. 6, plot of sinuosity vs. predicted value), site KC17 exerts a negative influence because the measured sinuosity value is less than the predicted value. Beaver activity, which has been observed since the restoration effort was completed at site KC17 in 2010, may partially explain this negative directional influence. Although beaver dams often have a positive effect on certain hydrologic functions of degraded stream channels (Pollock et al., 2007) and may increase sinuosity over time as a result of dam breaches (Demmer and Beschta, 2008), sediment deposition and flow impedance behind dams could have delayed the effects of restoration or led to short-term decreases in sinuosity. The presence of one beaver dam is evident from the 2011 NAIP imagery used for the measurement of sinuosity (Fig. 9). This dam was also confirmed in the field by the landowner and project staff.
