CONTROLLING ACID SEEPAGE FROM BURIED COAL WASTES
THROUGH GROUNDWATER INUNDATION AND WETLANDS¹

Dennis A. Haag and Chester J. Covert²

Abstract. -- A system consisting of an underground dike, subsurface drain and wetland was designed and installed to control expected acid mine drainage originating from reclaimed coal mine tipples located in Vernon County, Missouri. Design parameters were based upon field and laboratory investigations of the characteristics of coal refuse (slurry and gob), mine spoil and clay cover materials.

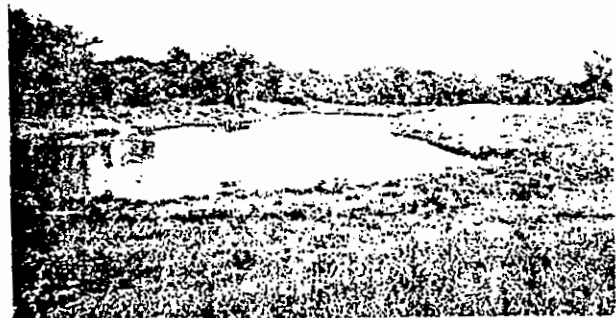
Figure 7. -- Panama wetland with emerging vegetation one year after completion (Fall 1986). Note dike to right of water.

Direct planting of wetland plant species was not required due to an abundance of naturally established wetlands in AML sites located upstream. By the Fall of 1986, the Panama site had been colonized by water primrose (*Jussiaea* spp.), cattails (*Typha angustifolia*), smartweeds (*Polygonum* spp.), and rice cutgrass (*Leersia oryzoides*) along with thriving stands of switchgrass (*Panicum virgatum*) and reed canary grass (*Phalaris arundinacea*) which were seeded along the impoundment shoreline (fig. 7).
