TEN YEAR RESULTS FROM BACTERICIDE-TREATED AND RECLAIMED MINE LAND¹

Don Splittorf and Vijay Rastogi²

Abstract: In 1984 a reclamation project was undertaken by the Ohio Department of Natural Resources on abandoned coal refuse near East Springfield, Ohio. The site was divided into two areas and each was reclaimed using standard, accepted reclamation practices. However, one area also received a controlled release bactericide treatment of ProMac Products to prevent acidification. Perforated PVC pipe drains were installed in each area at a depth of about 8m from the surface to create artificial seeps which could be monitored. Over a period of five years water quality, soil microbiology and vegetative biomass were measured and compared between the bactericide treated and untreated sides. Results from the first five years were previously reported when monitoring was terminated. Five years later, in 1994, ten years after reclamation, the site was revisited. Water quality, soil microbiology, and vegetation were analyzed to determine the long term effects of controlled release bactericide treatment for reclamation. The site continues to show distinct differences between the bactericide trea

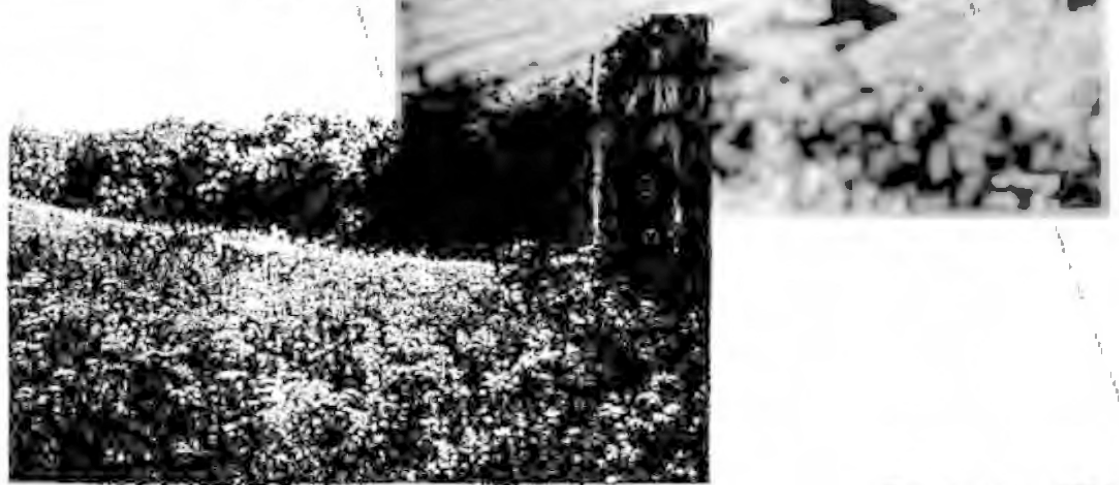
Figure 3(b). 1994 photo of the bactericide treated side.

Figure 3. Photographs of the Rt. 43 site showing loss of vegetation followed by soil erosion on the with vegetation quality on the bactericide treated side.

Figure 3(c). 1994 photo of the control side.

Figure 3(a) shows an aerial photo of the site taken in 1987. The vegetation quality difference again is very apparent. Figure 3(b) shows vegetative cover on the treated side in 1994 and compares it with the mostly barren and eroded untreated-control side in Figure 3(c).

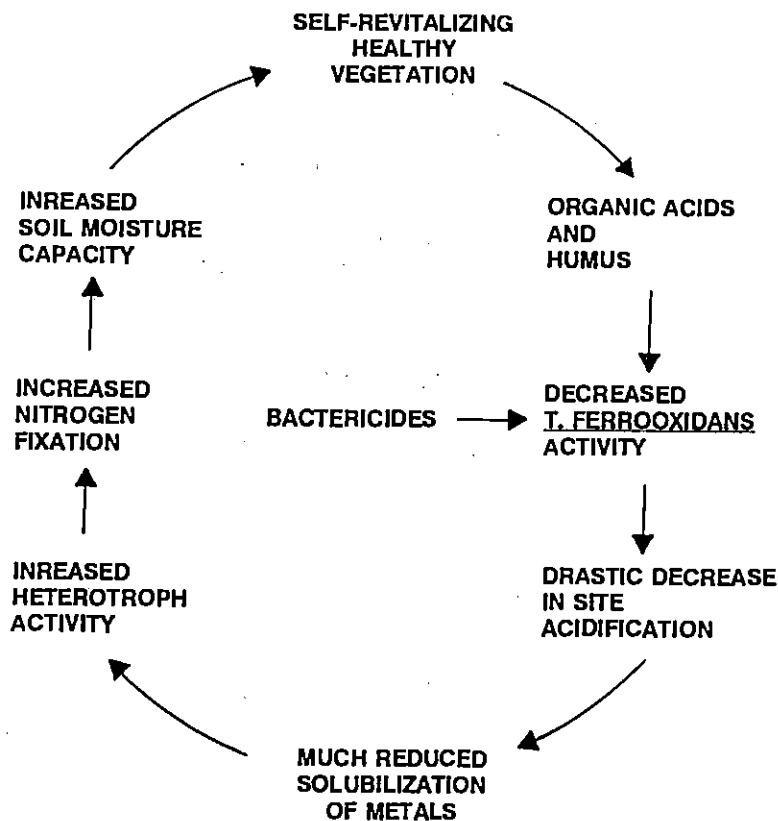
Figure 4. A model of the site recovery cycle initiated by the use of bactericides in mine land reclamation. The cycle illustrates why a single application of bactericide can produce successful long lasting results.

As the above information collected over ten years indicates, the life of bactericide treatment in reclamation is long lasting. The change in microbiology is the result of the cycle shown in Figure 4 which is started by bactericide application but outlasts the controlled release systems.
