REPAIR OF THE CZAR SHAFT SINKHOLE

Abstract. After a portion of the Queen Mine parking lot collapsed into a sinkhole, an engineering study was conducted to confirm that the cause of the damage was settlement into the Czar Shaft in Bisbee, Arizona. Historical records were researched to describe and locate the original shaft, and a seismic refraction survey was performed to define the foundation conditions within and around the shaft. Recommended mitigation measures were developed to repair the parking lot. Mitigation included design and construction of a flexible geosynthetic cap and telltale settlement monitoring system.

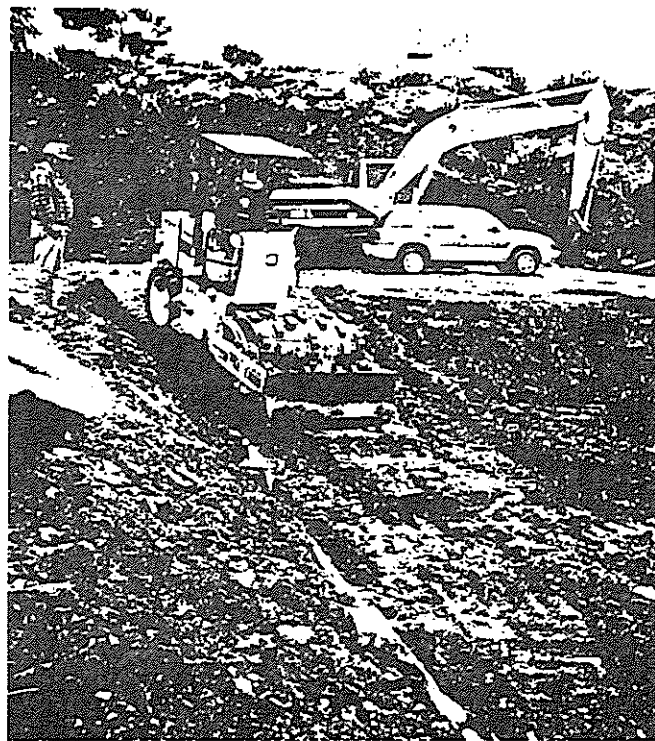
Figure 15: Compaction of Fill Over Geotextile

The settlement monitoring pipe was extended upward through each layer of the filling operations. On the fourth day the fill was placed over the fourth layer of geotextile, and a self propelled tamping foot compactor (Ingersoll Rand SD40D) was used to compact the fill layers. By the fifth day of construction the final geotextile layer was installed and the fill over the geotextile was compacted. Figures 10 and 11 present details of the settlement plate and telltale.
