RECLAMATION OF DISTURBED SULFIDIC COASTAL PLAIN SEDIMENTS USING BIOSOLIDS AT STAFFORD REGIONAL AIRPORT IN VIRGINIA¹

Zenah W. Orndorff and W. Lee Daniels²

Proceedings America Society of Mining and Reclamation, 2004 pp 1389-1407

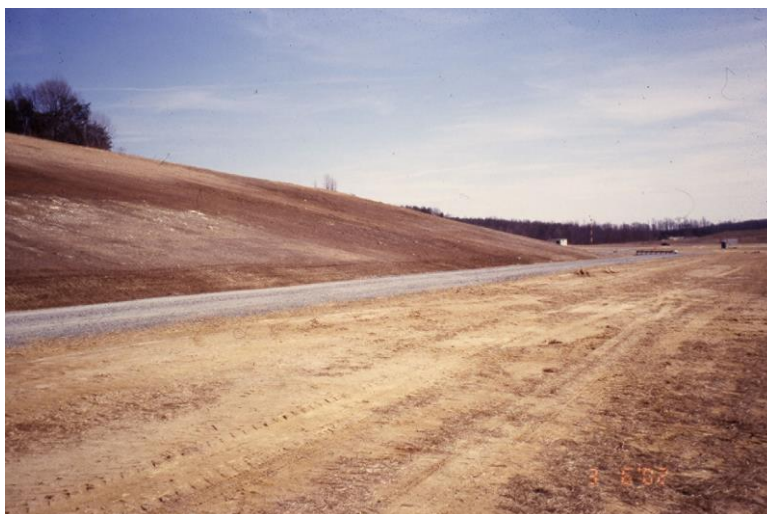
Figure 2. Barren fields resulting from the development of acid sulfate soils over disturbed sulfide-bearing Tertiary marine sediments at Stafford Regional Airport.

This site was first visited in the late fall of 2001 at which time acid-sulfate weathering problems were readily apparent. Over 150 ha of cut and fill slopes were barren of vegetation, acid drainage was prominent, concrete lined drainage ditches and culverts were coated in iron, and significant etching and degradation of the cement components were noted (Fig. 2 – Fig.4). Galvanized steel standpipes in water control structures in storm-water basins below the site had also been completely degraded by the drainage over time, releasing large volumes of sulfidic sediments into the receiving floodplain (Fig. 5). As discussed below, acidic drainage from this site had seriously degraded surface water both on- and off-site (Fig. 6 and Fig. 7).

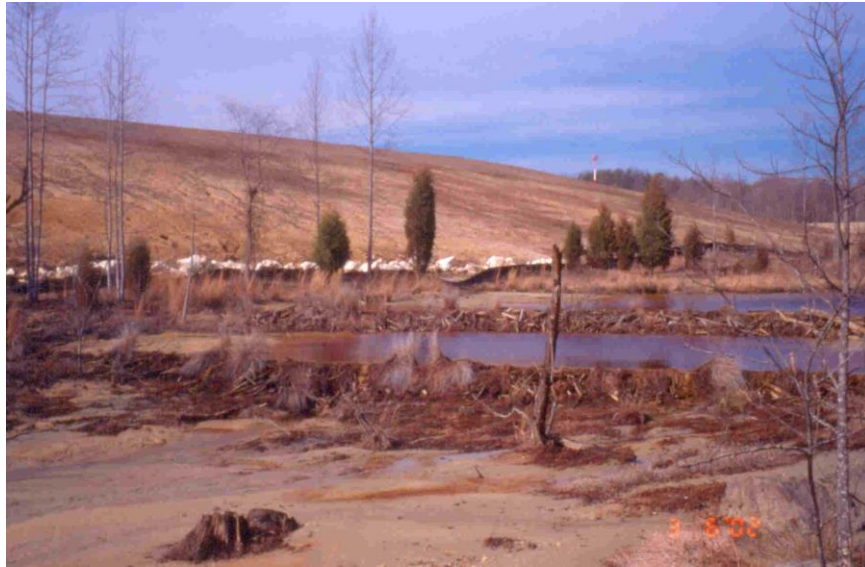
Figure 3. Erosion of acid sulfate sediments and acidic runoff and seepage from steeply sloping spoil fills (not shown in picture) have severely impacted this wetland area.

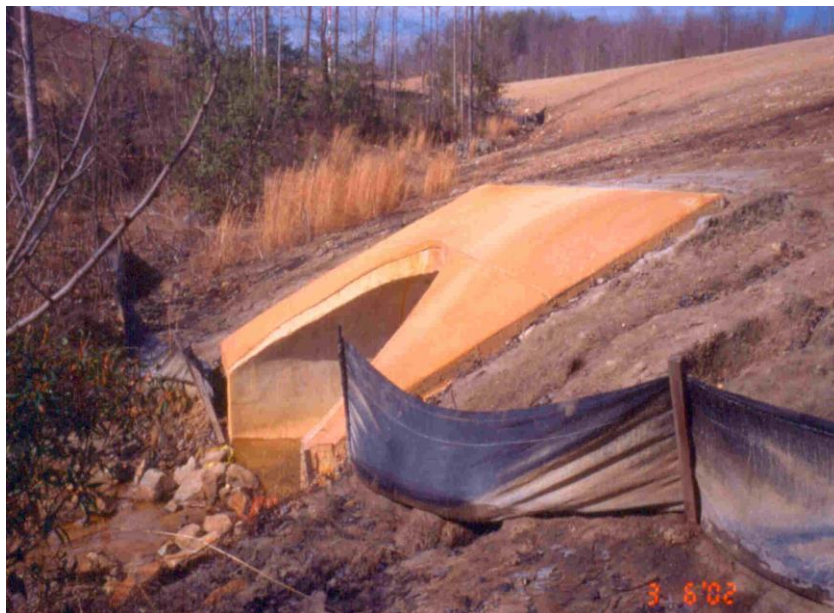
Figure 4. Throughout Stafford Regional Airport, concrete structures such as this culvert exhibit iron-staining as well as etching and degradation of cement components.

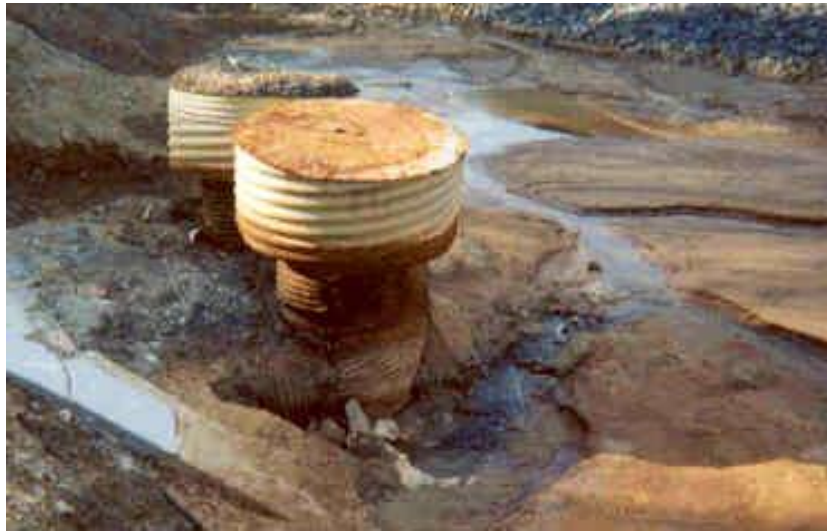
Figure 5. Galvanized steel standpipes in water control structures in storm-water basins below the site have been completely degraded by acidic drainage.

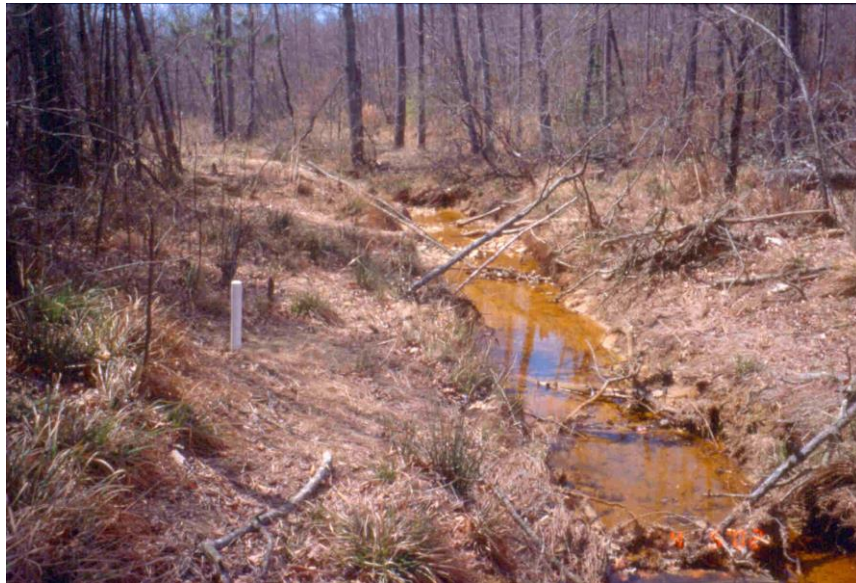
Figure 6. Acidic drainage from Stafford Regional Airport enters the Potomac River watershed.

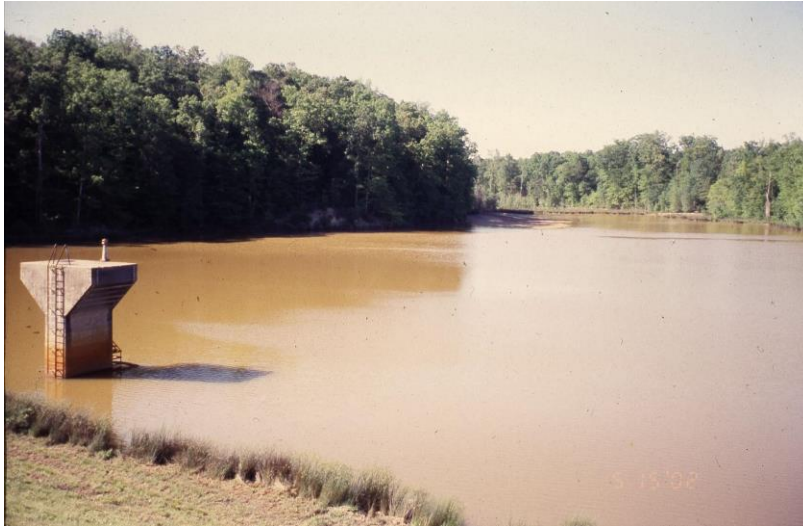
Figure 7. Drainage from Stafford Regional Airport flows off-site to this storm-water basin.

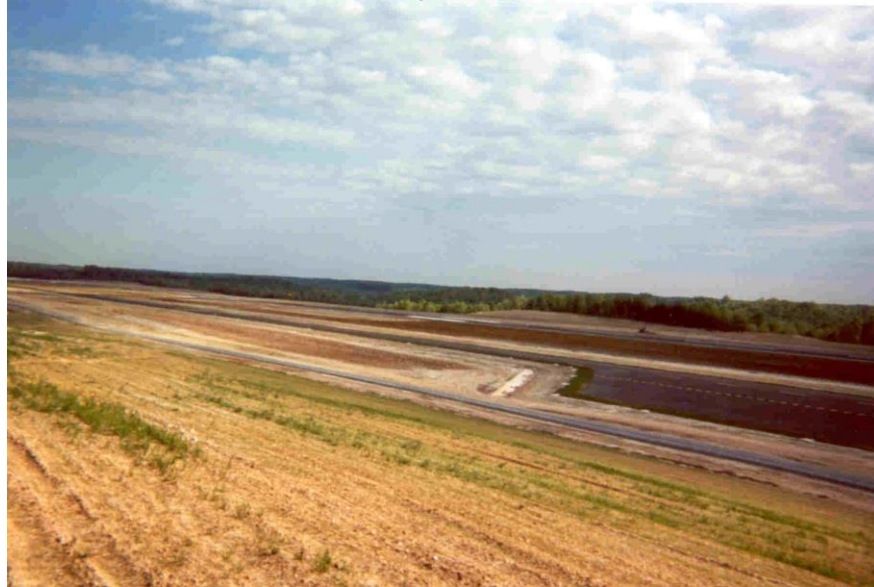
Figure 11. Overview of Stafford Regional Airport in June, 2002. The vegetated area in the foreground was incorporated and seeded by mid-April. The barren area in the background was not completed until late May.

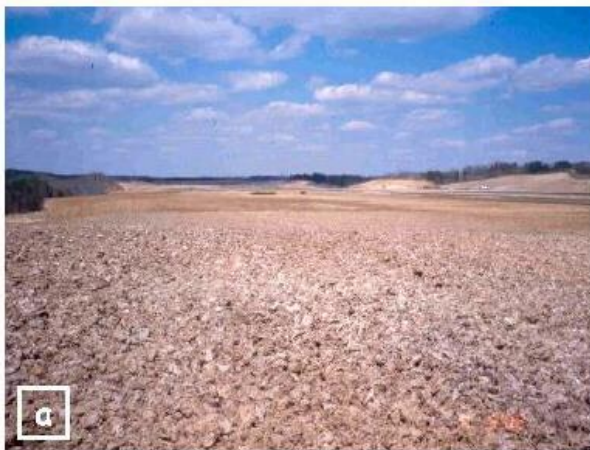
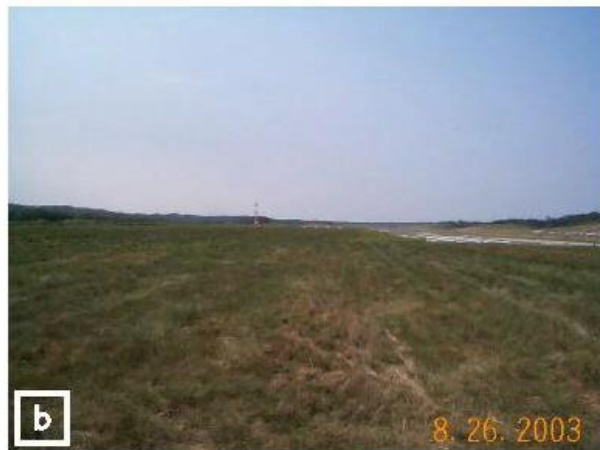
Figure 12. (a) Field near runway in July, 2002. Late-May 2002 remediation efforts were largely unsuccessful due to an unusually hot and dry growing season. (b) The same field in August 2003 after reseeding in September 2002 and a reasonable growing season.
