NATIVE PLANT REESTABLISHMENT ON HIGHWAY CUT SLOPES USING COMPOST APPLICATION¹

Pamela S. Blicker², Stuart R. Jennings and John D. Goering

Proceedings America Society of Mining and Reclamation, 2006 pp 68-103

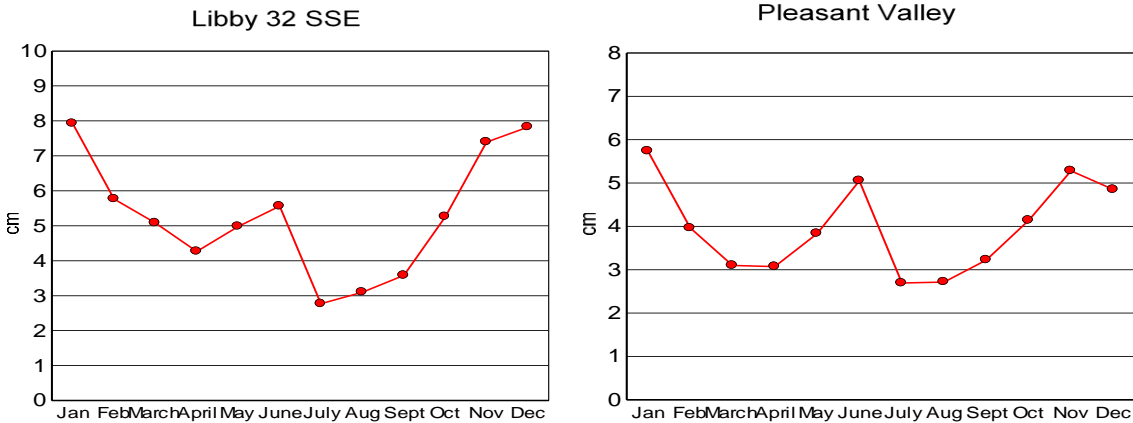
Figure 2. Monthly precipitation for NOAA stations 245020 (Libby 32 SSE) and 246576 (Pleasant Valley).

Climatic conditions. Climatic data are available from two stations near the research sites: 1) Libby 32 SSE (station 245020), and 2) Pleasant Valley (station 246576). These stations are approximately 13 km southwest and 16 to 18 km northeast of the research sites respectively (Figure 1). Elevation at both of these climatic stations is 1097 m versus approximately 1036 m at the research sites. The distribution of annual precipitation is very similar at the two climatic stations. Approximately 60 percent of the precipitation occurs during the October through March period with January receiving the greatest monthly precipitation for the year. June receives the greatest precipitation during the growing season, while July, August, and September are the driest months of the year (Fig. 2). Most precipitation in the November through April period occurs as snowfall with some accumulated snow depth occurring during these months. Mean annual precipitation for the Libby 32 SSE climate station is 63.4 cm (24.96 inches) while the Pleasant Valley station reports 47.7 cm (18.78 inches) of annual precipitation.

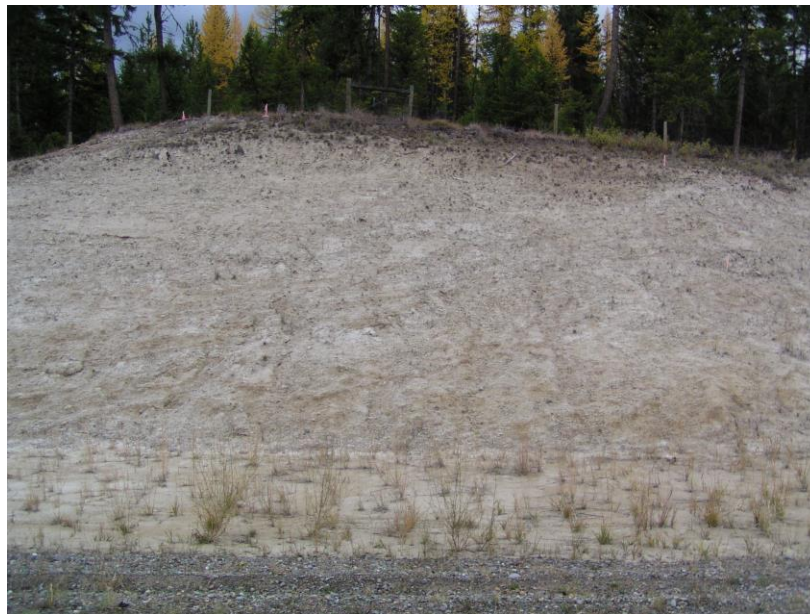
Figure 3. Research Plot 1 at the Middle Thompson Lake site prior to plot implementation. Note accumulated sediment in ditch, rills, and the general lack of vegetation cover.

Middle Thompson Lake Research Site. The Middle Thompson Lake site is located along the north side of U.S. Highway 2 adjacent to Middle Thompson Lake (Figure 1). Geologic materials consist of fine textural class sediments that are assumed to be glacial lake sediments (Fig. 3). One of the primary erosion mechanisms occurring in local lakebed silt parent materials appears to be the slumping of saturated surface layers that overlie frozen substrate during spring thaw cycles.

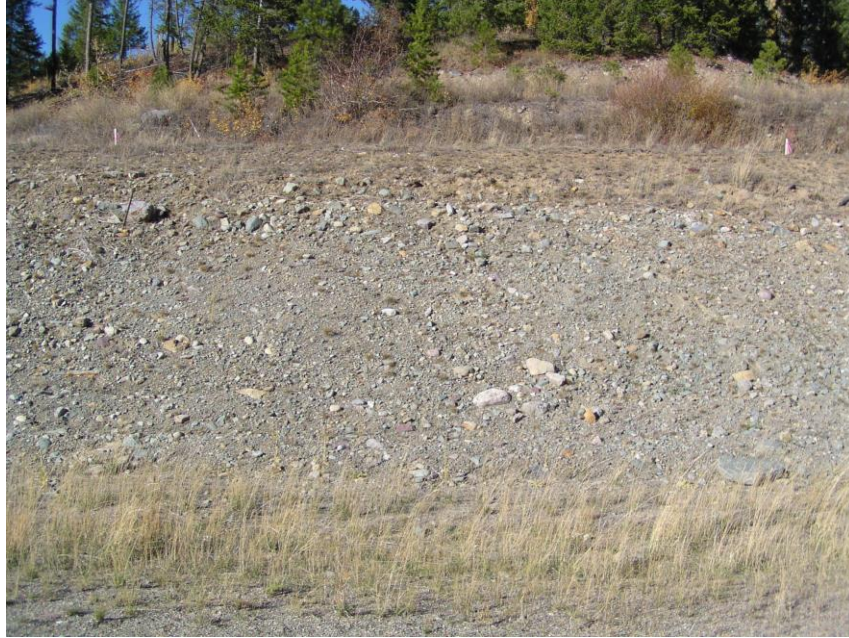
Figure 5. Loon Lake research area preconstruction conditions, Plot 8.

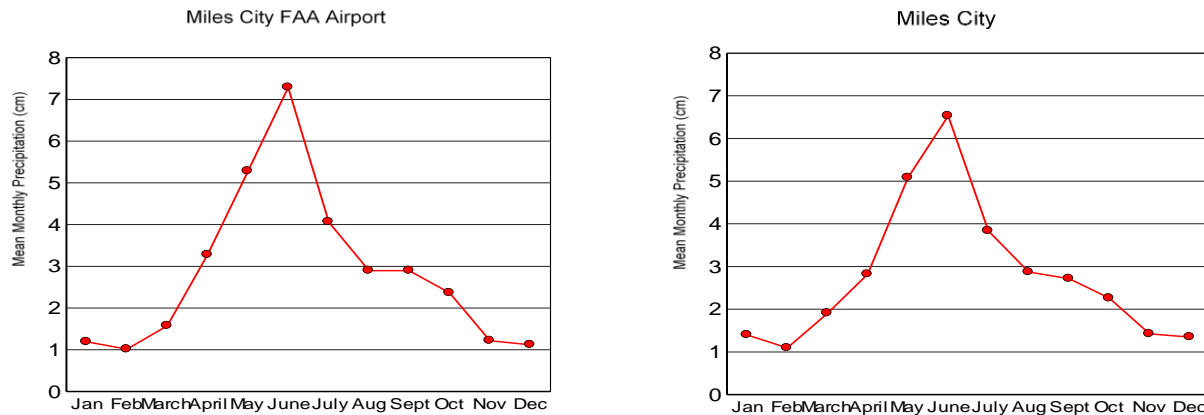
Figure 8. Monthly precipitation for NOAA stations 245690 (Miles City FAA Airport) and 245685 (Miles City).

Climatic Conditions. Climatic data is available from two stations near the research sites: 1) Miles City (Station 245685), and 2) Miles City FAA Airport (Station 245690). These stations are approximately 5.4 and 6.3 km southwest of the research sites respectively (Figure 7). Elevations at these stations (719.3 and 799.8 m, respectively) bracket the elevation of the research plots. The period of record for Station 245685 is January 1, 1893 through July 31, 1982. The record for Station 245690 extends from January 16, 1937 through the present. The overall amount and distribution of average monthly precipitation at the two stations is very similar, with the airport receiving slightly more total annual precipitation (34.2 versus 33.3 cm) likely due to the 80.5 m elevation difference between the stations (Fig. 8). The annual distribution of precipitation is typical of Eastern Montana. Approximately 75 percent of the precipitation occurs during the growing season from April through September with the month of June receiving the greatest amount. The October through March period is typically dry and in stark contrast to the Happys Inn sites which receive most of the annual precipitation during this period. Most precipitation in the November through April period occurs as snowfall with the 15 cm (6 inch) maximum accumulated snow depth occurring in February.

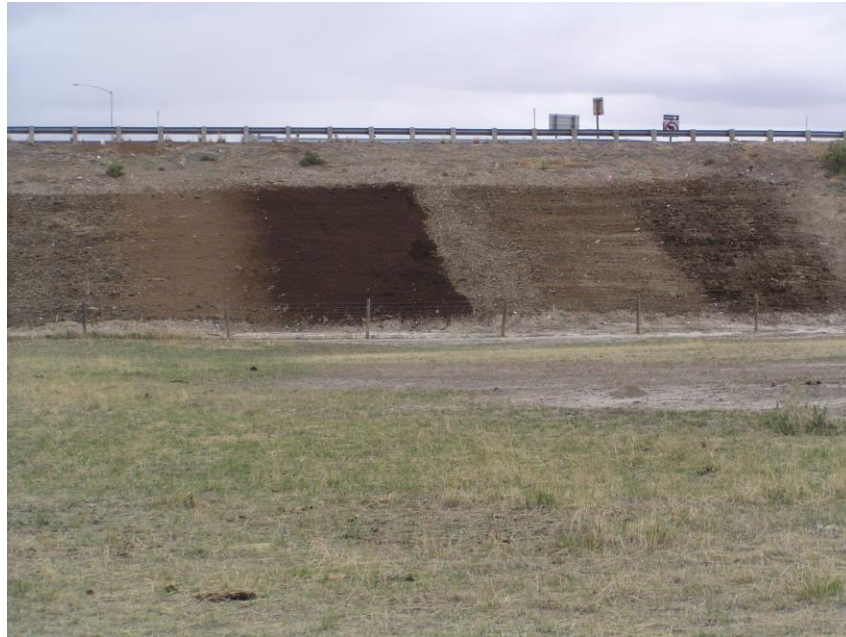
Figure 9. Plots 19 (compost blanket) and 20 (incorporated compost), I-94 off-ramp area, showing Rocky Mountain compost on the left (light-colored) and Earth Systems compost on the right (dark-colored)

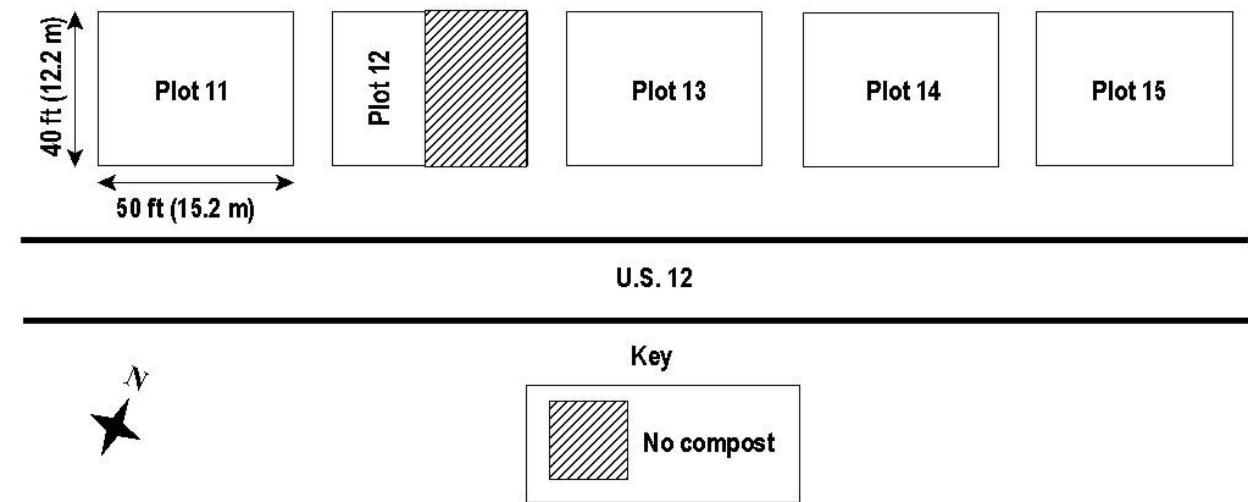
Figure 10. Research plot layouts at the U.S. Highway 12 cut slope site.

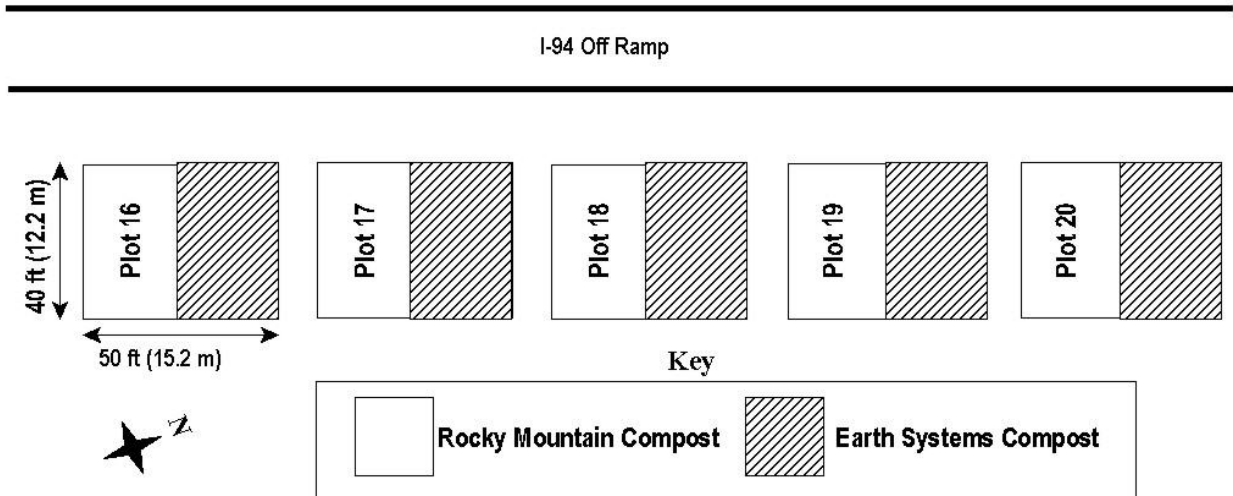
Figure 11. Research plot layouts at the I-94 fill slope site.

Research plots 16 through 20 were 12.2 m (40 ft) wide with a slope length of 15.2 m (50 ft) (Figure 11). Plots were separated with 3.0 m (10 ft) buffer strips. All plot areas are 185.8 m² (2000 ft²). This site was characterized by fine textural class soils and high coarse fragment content (Table 3). Nearly all of the coarse fragment content consisted of un-weathered shale bedrock fragments. Each of plots 16 through 20 were split into 2 subplots, with Rocky Mountain compost applied to the south west subplot portion and Earth Systems compost applied to the northeast subplot portion.

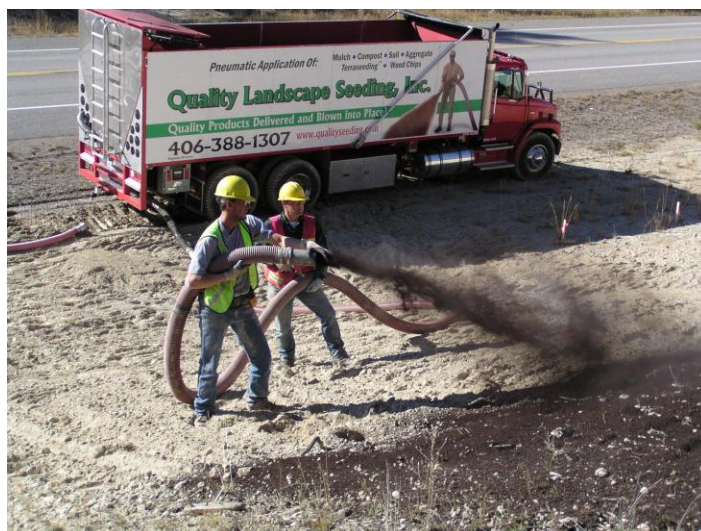
Figure 12. Express Blower Model EB-30 applying compost at the Middle Thompson Lake site.

Blower Truck. The blower truck experienced no difficulties applying compost to the research plots (Fig. 12). The maximum length of the research plots was only 10 to 20 percent of the capability of the truck (standard hose length is 111.6 m or 366 feet) and no clogging of feeders or blower hose occurred. Minor hand shoveling inside the truck box was required to feed compost to the walking floor when the unit was near empty. This was apparently caused by the tilt of the unit produced by stationing it on uneven ground to maintain a clear traffic lane. Compost application was timed for several plots. Approximately 10 minutes was required to apply a controlled 1.3 cm compost layer on each plot and an additional 15 to 20 minutes to apply the remaining 3.8 cm of compost on the 5.1 cm treatments for an approximate rate of 0.05 ha/hr (Table 7). These rates should not be construed as the expected rate on a full scale project. Due to the size of the research plots, more time was required to ensure the applied compost was within plot boundaries. The application of two specific compost layers increased application time by about 10 percent. Manufacturer literature suggests normal application rates of 0.76 to 1.53 m³ (1 to 2 cubic yards) per hour. At the higher rate, a 5.1 cm compost blanket would be applied at 0.18 ha/hr.

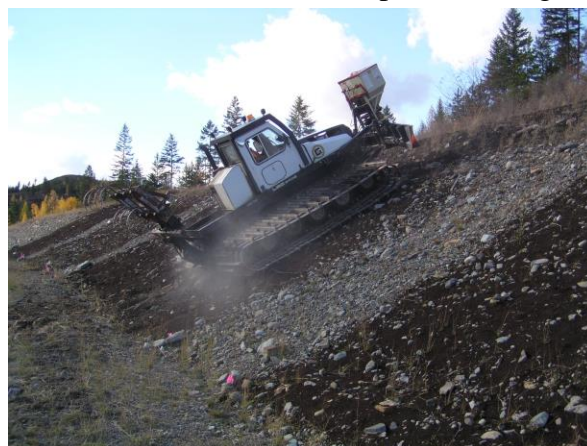
Figure 13. Modified LMC 3700C initiating tillage on plot 8, Loon Lake site.

Snowcat. The snowcat utilized for this project was a modified LMC 3700C (Fig. 13). This unit is powered by a Caterpillar 3208 diesel engine rated at 165 kw (225 hp) and weighs approximately 8160 kg (18,000 lbs).

Modifications to this unit were:
 Reinforced undercarriage; Upgraded cooling system; Solid rubber boggy wheels; Pisten Bully drive sprockets and 2.5 m wide steel tracks; Rear 3-point quick hitch; Front 3-point brackets to mount broadcast seeder; and MSHA certified ROPS canopy.

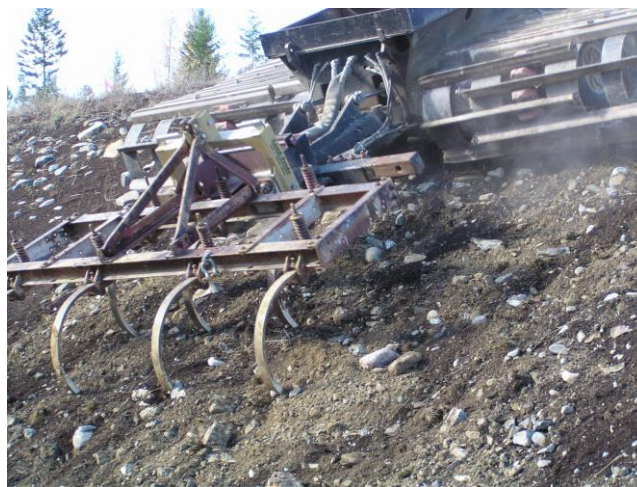
Figure 14. Graham Hoeme 2.4 m (8 ft) spring shanked chisel plow at Loon Lake.

Chisel Plow. The Graham Hoeme chisel plow utilized for this study worked equally well in both coarse and fine textural classes of material (Fig. 14). Shank spacing was set at 0.35 m (1.1 ft) for the 2.4 m (8 ft) wide implement. Potential tilling depth was well in excess of the specified 10.2 cm (4 in) compost incorporation depth for this project. No breakage or other problems were encountered with this unit. It is likely that a wider implement of similar design could have been utilized, especially at the Middle Thompson Lake site.

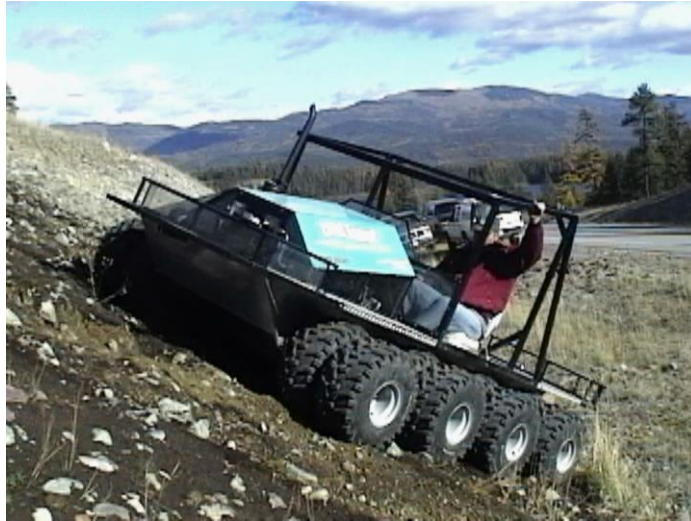
Figure 15. Land Tamer industrial model LT adjacent to Loon Lake research site.

Land Tamer. PFM Manufacturing provided a standard industrial LT model for demonstration purposes at the Loon Lake site (Fig. 15). This unit is a diesel powered eight-wheeled vehicle utilizing a hydrostatic drive. While this machine had no trouble traversing the 50 percent slopes at Loon Lake, either on the contour or at an angle, it suffered from problems similar to the snowcat. Its rigid suspension limited wheel contact when riding over large cobble and boulders. The resulting loss of traction was sufficient to prevent direct traverse up slope at this site even without any tillage implements. The Land Tamer was not demonstrated at the Middle Thompson Lake site. It is the authors' opinion that this unit would have performed acceptably well on the silt-dominated materials using a small tillage implement.

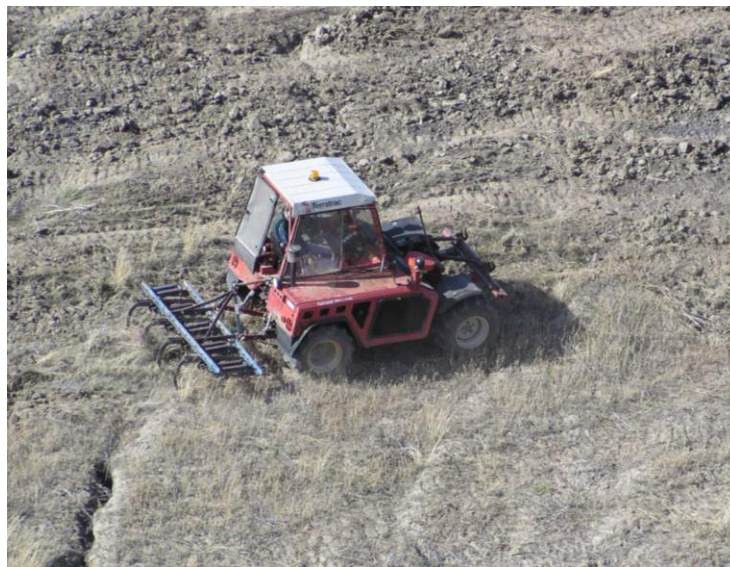
Figure 16. AEBI Terratrak TT88 .

AEBI Terratrak TT88 Steep Terrain Tractor. The tractor employed for this work was an older (1990) AEBI Terratrak model TT88 equipped with a hydrostatic drive (Fig. 16). The Phase I report for this research project identified the AEBI tractors as good candidates for compost incorporation on steep cut slopes. The TT88 used shares the dual 3-point system and dual PTOs (front and back) common to most Terratrak models, had an EROPs type enclosed cab, and a 44 kW (60 hp) diesel engine. While the slope steepness of the Miles City research plots fell somewhat short of the desired 50 percent, the abilities of the TT88 were not seriously challenged working on these plots (30 to 40 percent range). Tillage both across and up-down slopes was completed easily.

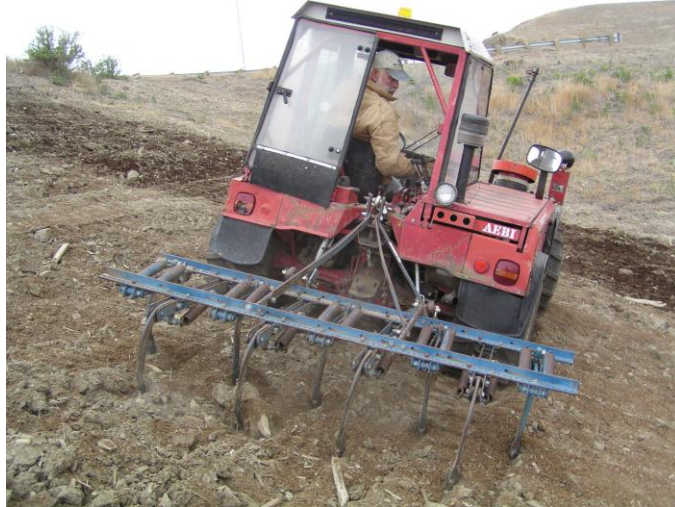
Figure 17. Ford spring-shanked tiller on Plot 20 (Rocky Mountain compost in foreground, Earth Systems material in background).

Ford Spring Shanked Tiller. The Ford tiller used for this work had 9 shanks mounted at 0.30 m (1 foot) centers (Fig. 17). All shanks were spring-loaded which allowed passage over several large boulders encountered when tilling plots 11 through 15. All shanks were equipped with chisel points. All initial plot tillage was across the slope. Compost mixing was initially up-down the slope followed by a second pass across the slope. The AEBI TT88 had little difficulty obtaining the desired 10 cm (4 inch) tillage depth and was capable sinking the shanks 0.3 m (1 foot), especially when tilling down slope.

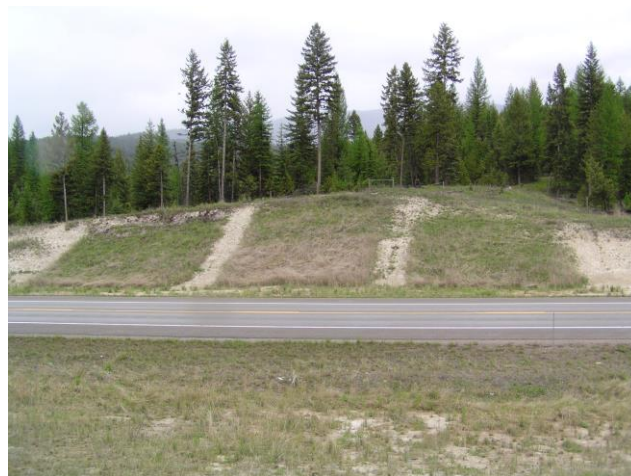
Figure 18. Happys Inn Plots, Spring 2005

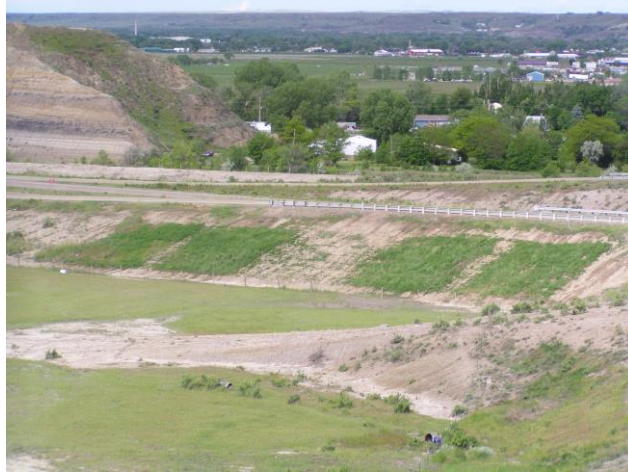
Figure 19. Mile's City I-94 Off Ramp Plots, Spring 2005
