# DEVELOPMENT AND APPLICATION OF PRE-REMEDIAL DESIGN TOOL FOR THE CLARK FORK RIVER SUPERFUND SITE<sup>1</sup>

D. Neuman<sup>2</sup>, P. Hansen, D. Smith, K. Knutson, and S. Brown

Proceedings America Society of Mining and Reclamation, 2008 pp 721-737

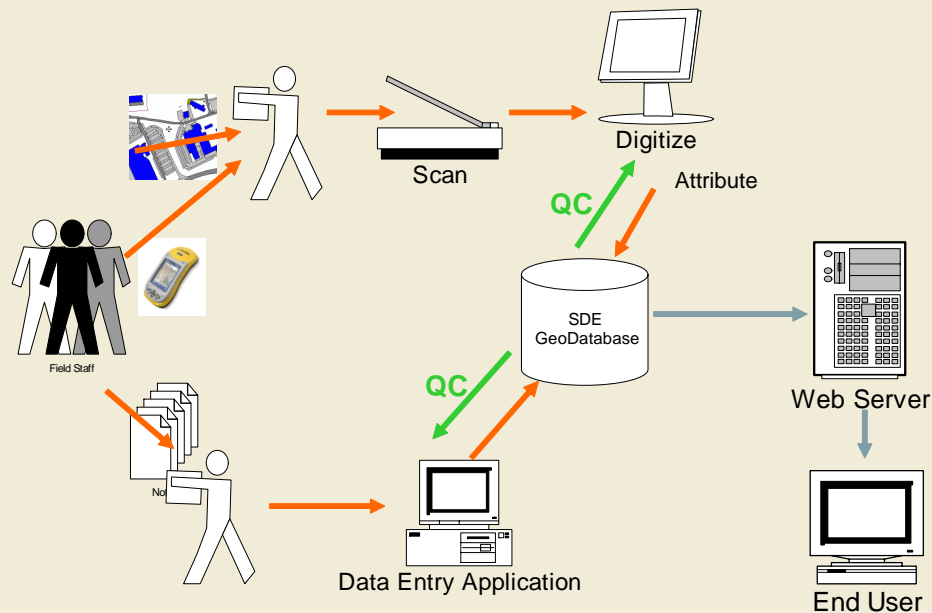
Figure 2. Schematic of CFR-RipES data and information and access via web server.

All information and data from the field observations and measurements were collected and sent to a central facility for processing. The types of information included the high resolutions maps on which polygons were drawn, and digital information pertaining to polygon attributes (e.g. percent cover, soil pH, depth of visible tailings, amount of lateral cutting, GPS coordinates, land owner parcel, copper concentration in soils, land use, date, time, field crew identification, etc.). Information contained on maps was scanned and digitized; other data required entry into databases. Seventeen different data streams were then collated in a SDE geodatabase as shown schematically in Fig. 2.

Data and information were subjected to several layers of quality control from raw data generated in the field to ensuring accurate data output, to many data queries. Data can be accessed by end users via a dedicated web server. Several layers of security are designed so that some users can only view data, while others have full access to the information. It is EPA's intent that the information will be used for remedial design, construction oversight, and success monitoring after remediation is completed.

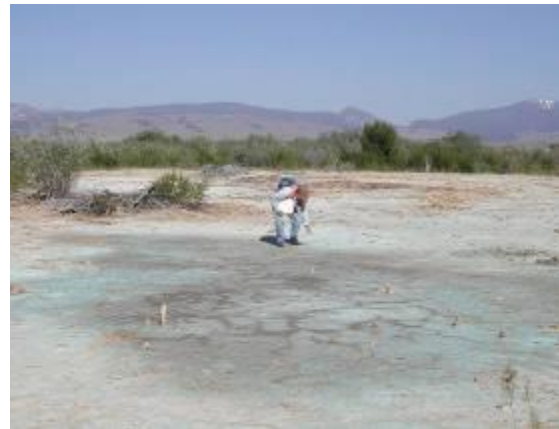
Figure 5. Example of exposed tailings.

Because of phytotoxic condition, these areas are generally devoid of vegetation, supporting less than 25 % live plant canopy cover. Tufted hairgrass (*Deschampsia cespitosa*) is present, if there is any live vegetation. Efflorescent metal salts are visible on the soil surface during dry periods. For mapping purposes these exposed tailings must meet the above criteria and be at least 37 m<sup>2</sup> (400 sq ft) in area.

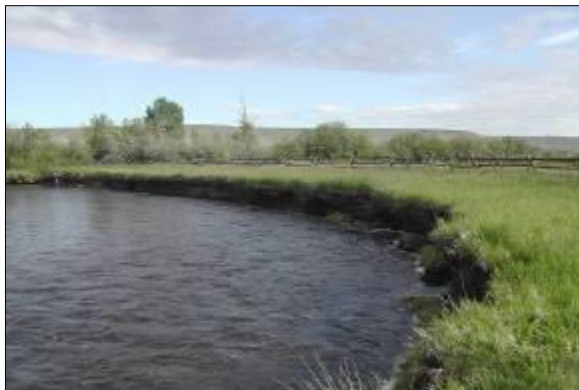
Figure 12. Class 2 streambank.

Examples of Streambank Class 2 (CFR-RipES score of 53%) and Class 3 (100%) are exhibited in Figs. 12 and 13.

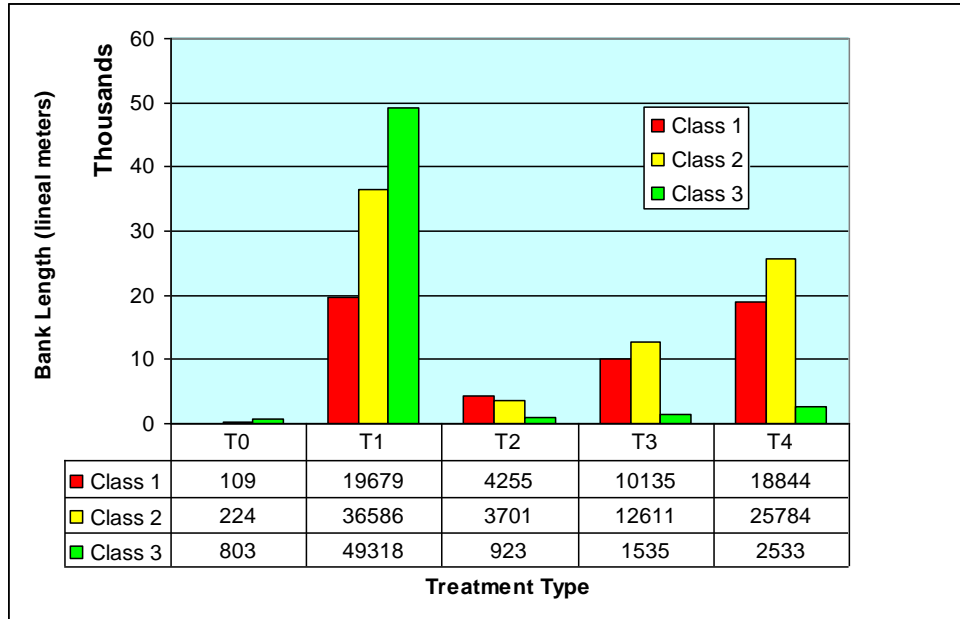
Figure 15. Streambank length (meters), treatment and class.

**Streambank Treatments.** A query of the CFR-RipES for streambank treatments for any selected portion of the Clark Fork River would generate a map (Fig. 14) displaying the meandering river, and streambanks treatments: Treatment 1 (green color); Treatment 2 (yellow color); Treatment 3 (orange color); and Treatment 4 (red color) as mapped RipES field team. Bank treatment lengths are calculated for each treatment (Fig. 15).

A total of 187,041 m (116.2 miles) of streambank were categorized into Classes (1, 2, and 3), and remedial treatment intensity was assigned as no treatment (T0), minimal treatment (T1) through maximum treatment intensity (T4). Some 105,583 m (65.6 miles) of streambanks will require minimal treatment (T1), while 47,161 m (29.3 miles) of streambanks will require maximum treatment (T4). Remedial designs for these treatments were provided in the Record of Decision document (EPA 2004).
