# MINE INSPECTION ASSISTANCE USING REMOTE SENSING IMAGERY<sup>1</sup>

**Abstract.** With advances in mining technology, surface mines are becoming larger and more complex. The use of satellite imagery and remote sensing technology may provide a way to reduce the cost associated with field inspection of larger mine sites.

<sup>1</sup> Paper was presented at the 2009 National Meeting of the American Society of Mining and Reclamation, Billings, MT, *Revitalizing the Environment: Proven Solutions and Innovative Approaches* May 30 – June 5, 2009. R.I. Barnhisel (Ed.) Published by ASMR, 3134 Montavesta Rd., Lexington, KY 40502.

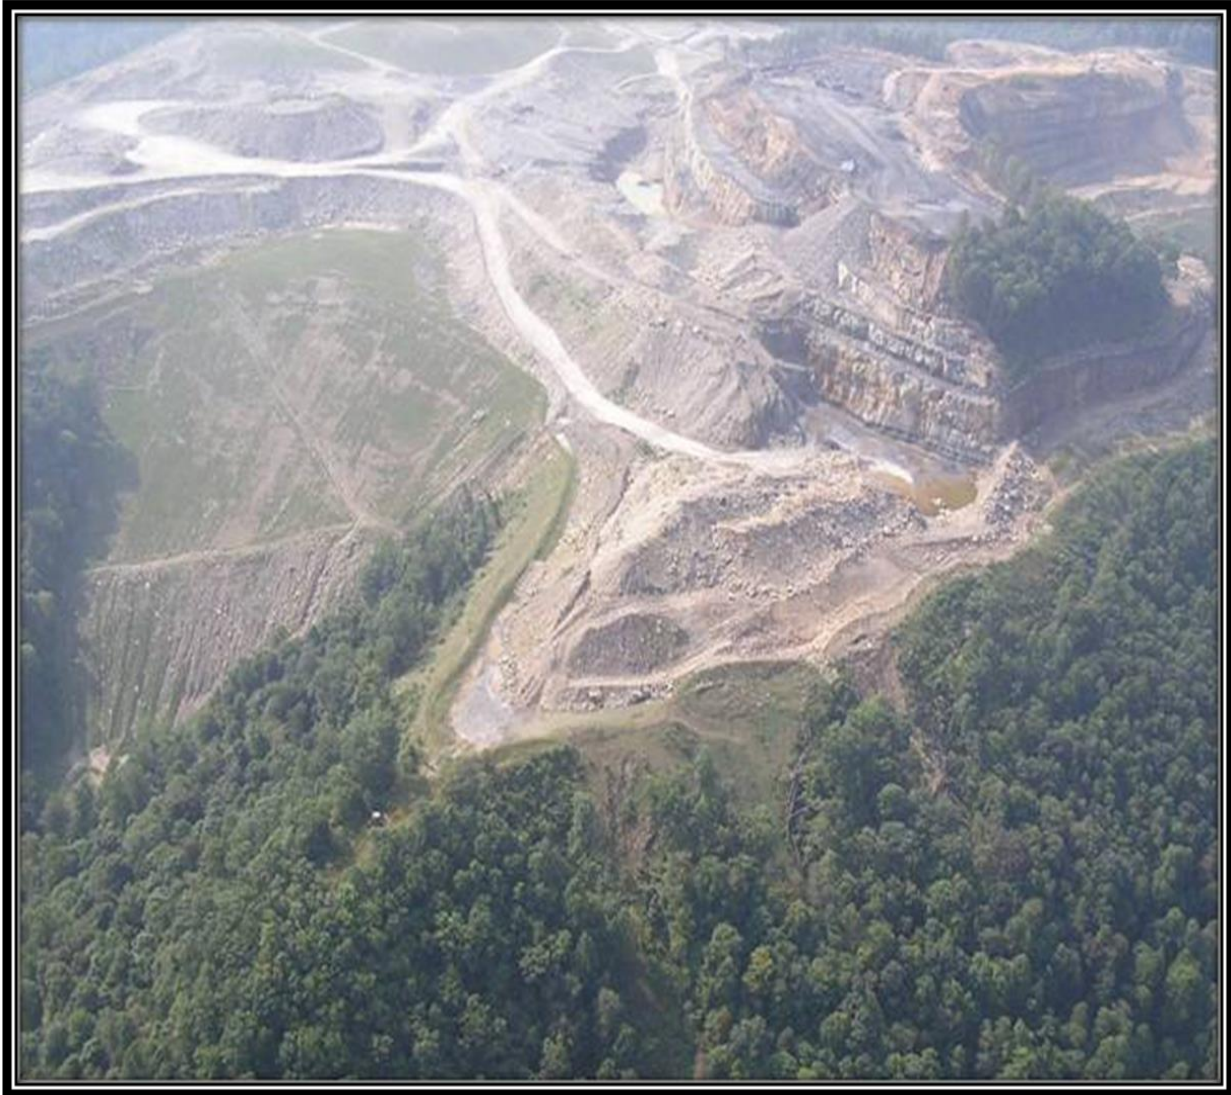
Figure 1. An aerial view for a State of WV, Office of Surface Mining oversight inspection of an active mine site.

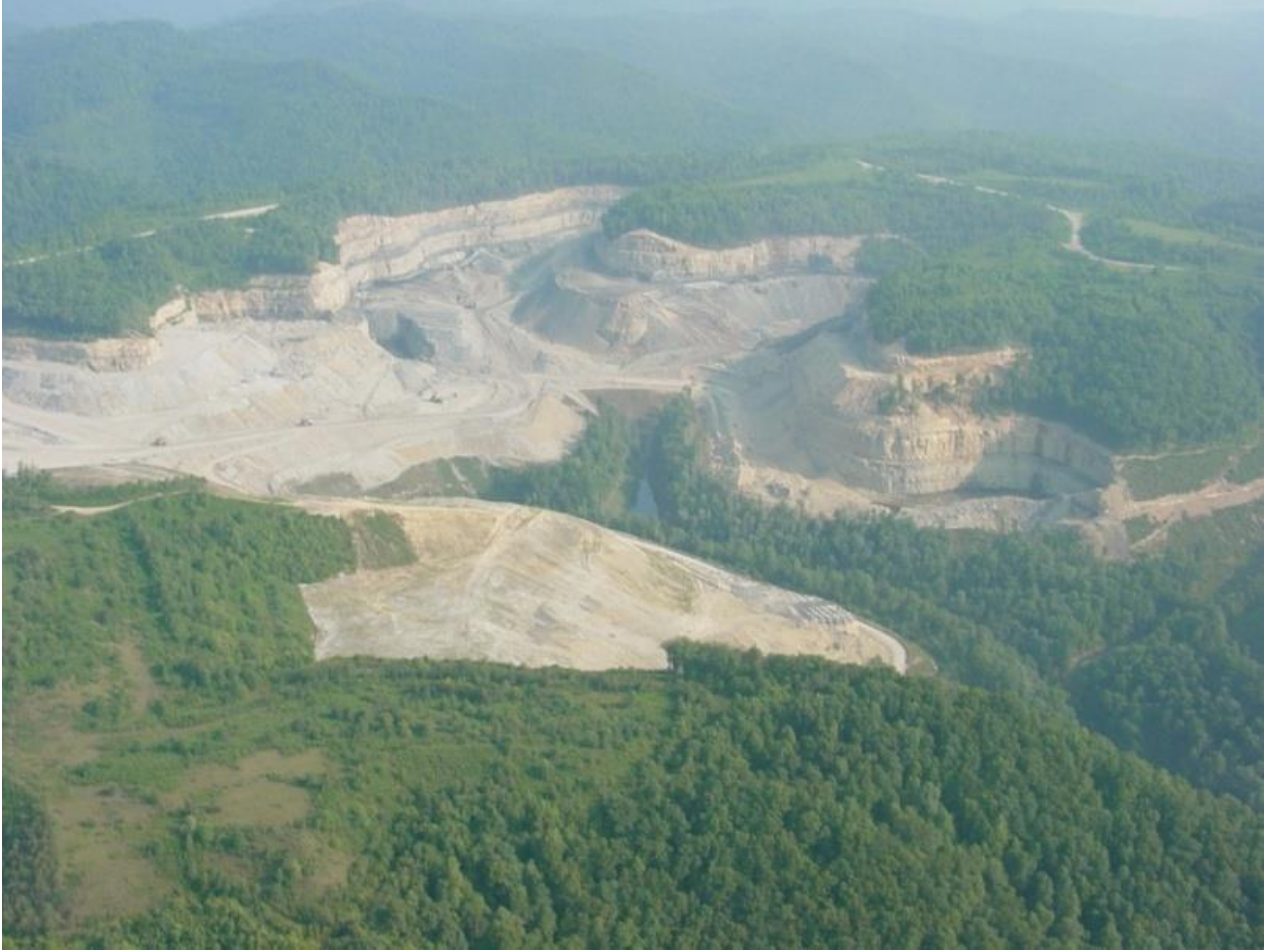
Figure 5. Regular photo taken at the time of aerial inspection of the mine site.

The accuracy of the remote sensing approach makes this process a viable alternative to manual regular photo interpretation (Fig. 5). In the evaluation conducted, large scale mining areas identified with the remote sensing technique were compared with regular photos using the same images. Figure 6 is the panchromatic (pan-sharpened) image of the same mine site with detailed discernible mining features such as, valley fills, parking areas, and highwalls that are viewable without an initial field visit.

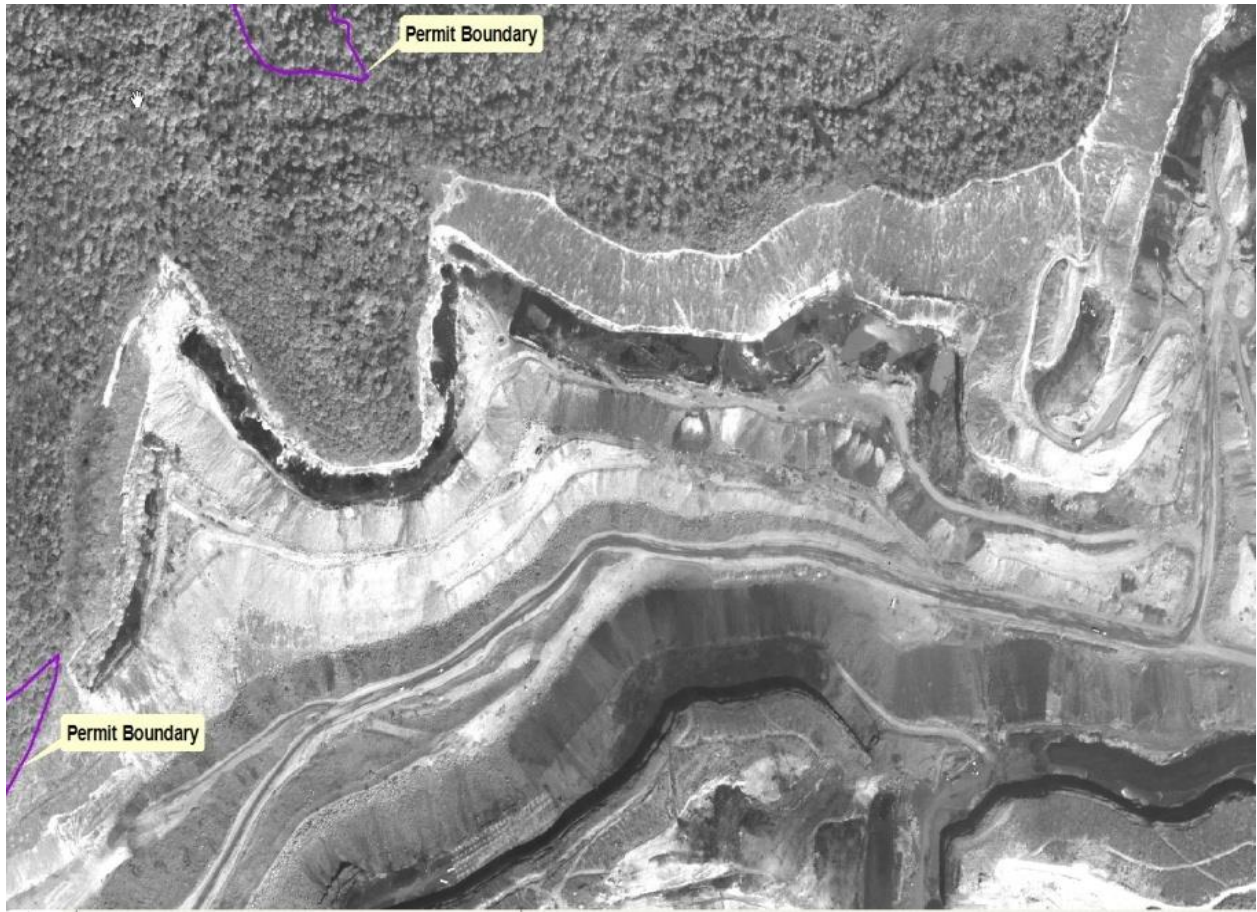
Figure 6. Panchromatic view of same image as Figure 5 from a different angle.

Commercial satellite imagery from Digital Globe is composed of two parts: a high-resolution, black-and-white scene panchromatic (pan-sharpened) as scene in Fig. 6, and a multispectral color (plus near-infrared) scene (Fig. 7).

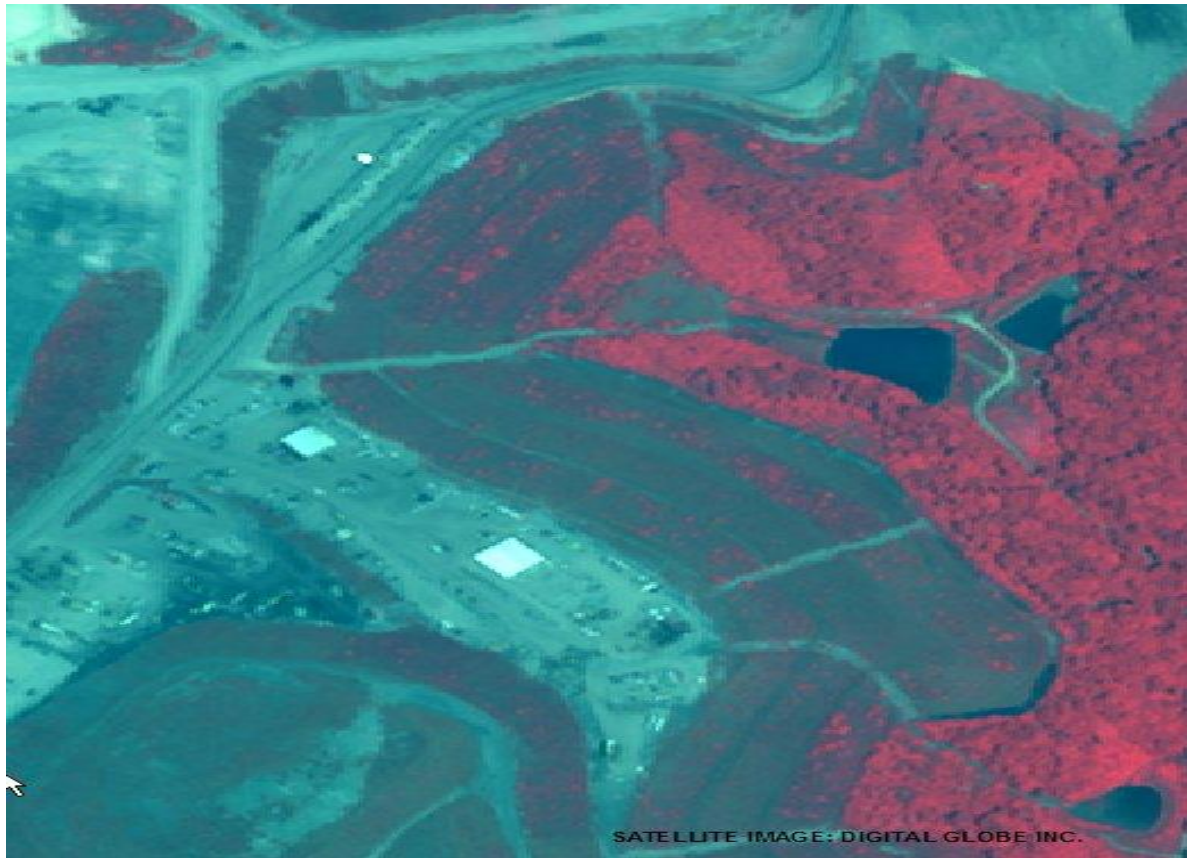
Figure 7. High-resolution multispectral scene.

The primary use of color infrared photography is vegetation studies. This is because green vegetation is a very strong reflector of infrared radiation and appears bright red on color infrared images as seen in Fig. 7. Not only was the remote sensing method determined to be sufficiently accurate, but it also required only a small fraction of the labor effort needed for analyzing the data.

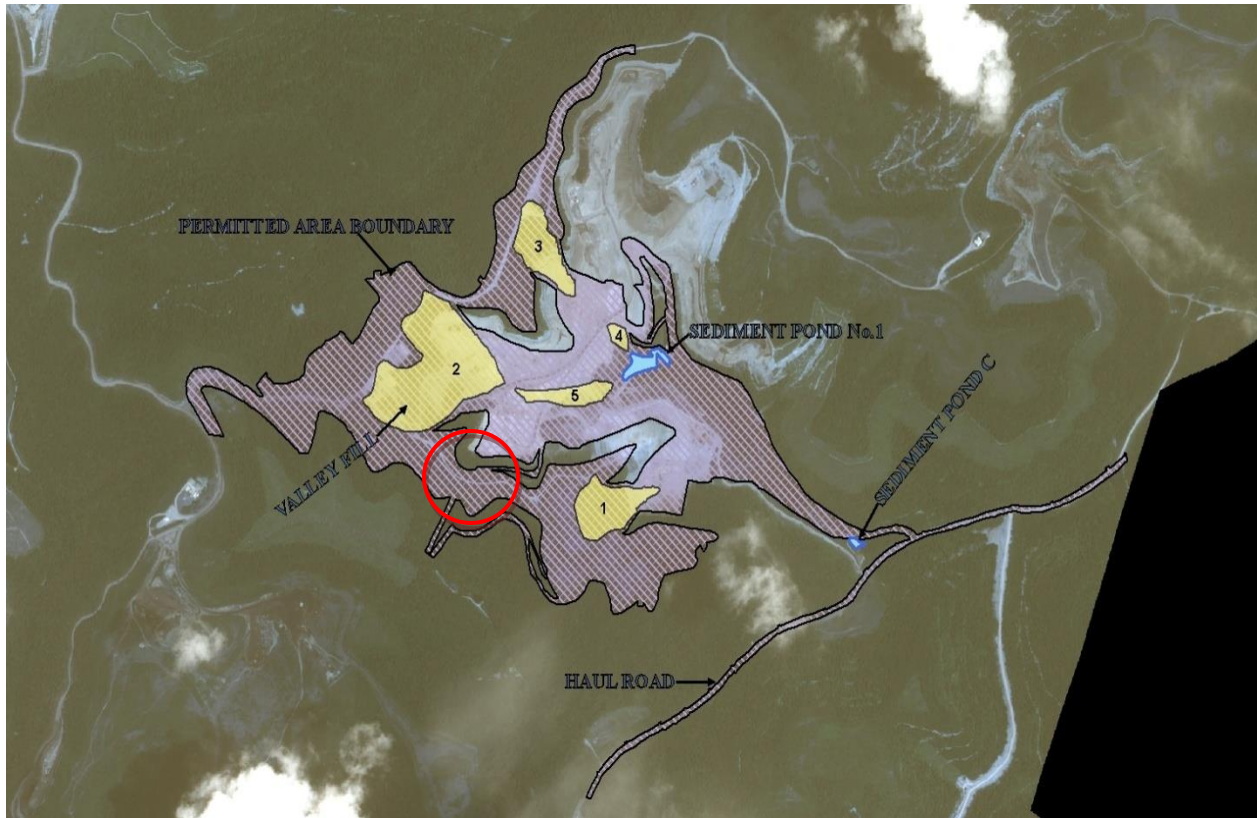
Figure 10. The overlaid boundaries from the permit data (Fig. 8) onto the satellite imagery (Fig. 9) appear to exhibit an inconsistency in the allowed permit boundary as shown by the red circle. This indicates mining appears beyond the allowed permitted boundaries.

In Fig. 10, permit boundaries were overlaid on the satellite imagery. Based on the results of the remote sensing imagery a determination can be made that delineations of the permitted boundaries appear to be outside the approved permitted area. By viewing only the regular photo, this would be difficult to detect. With real time data acquisition this kind of detailed assessment can aide in making oversight determinations.

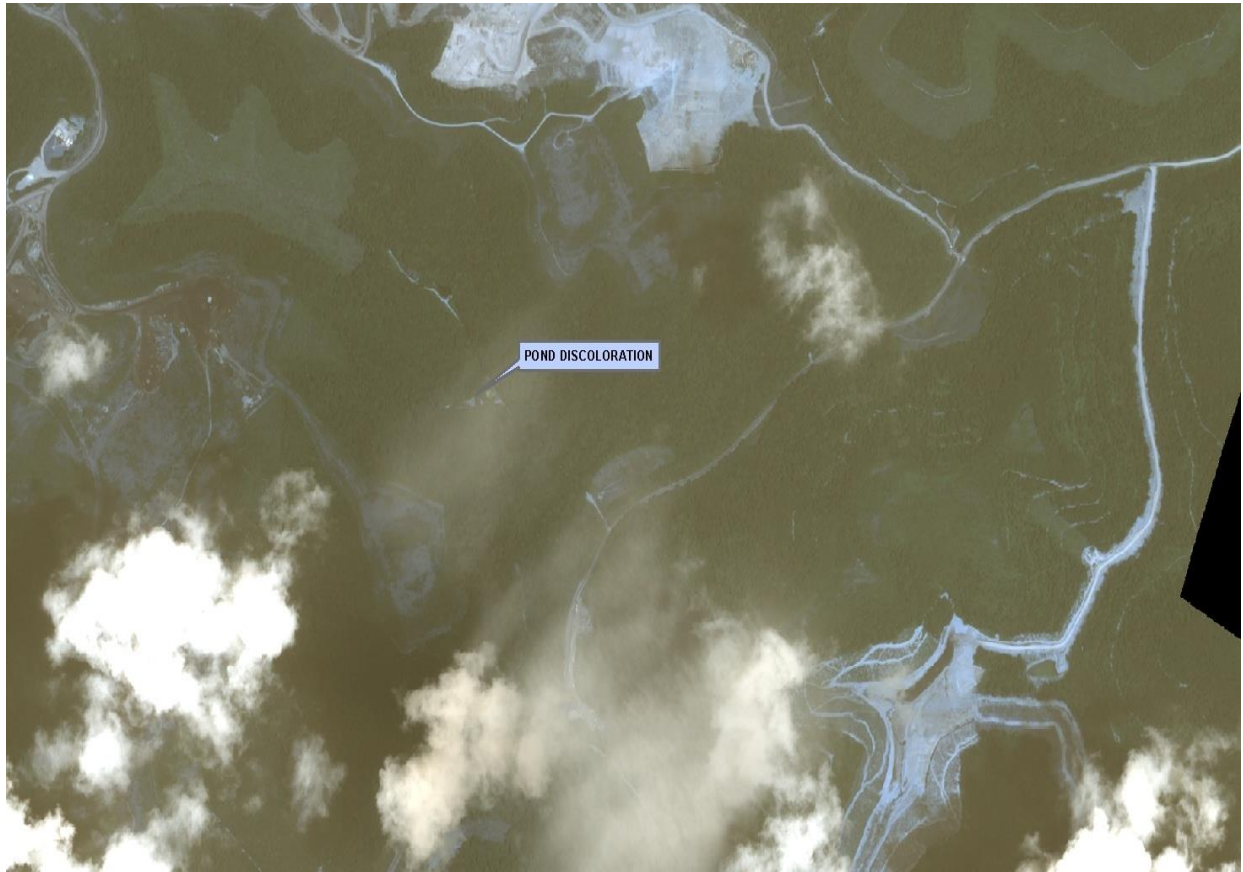
Figure 11. A pond identified from the permit application appeared to be discolored in the zoomed satellite imagery. Clouds covered several mining sites making them non-viewable.

In Fig. 11, a known pond from the permit application appeared to be discolored in the zoomed satellite imagery. After review of the satellite imagery a ground inspection was conducted to determine if the discoloration of the pond was sediment in transport or depositional. The inspection team determined that, in fact the pond had been discolored due to alkaline treatment at the time of imagery acquisition and had since been flushed with fresh water inflow.

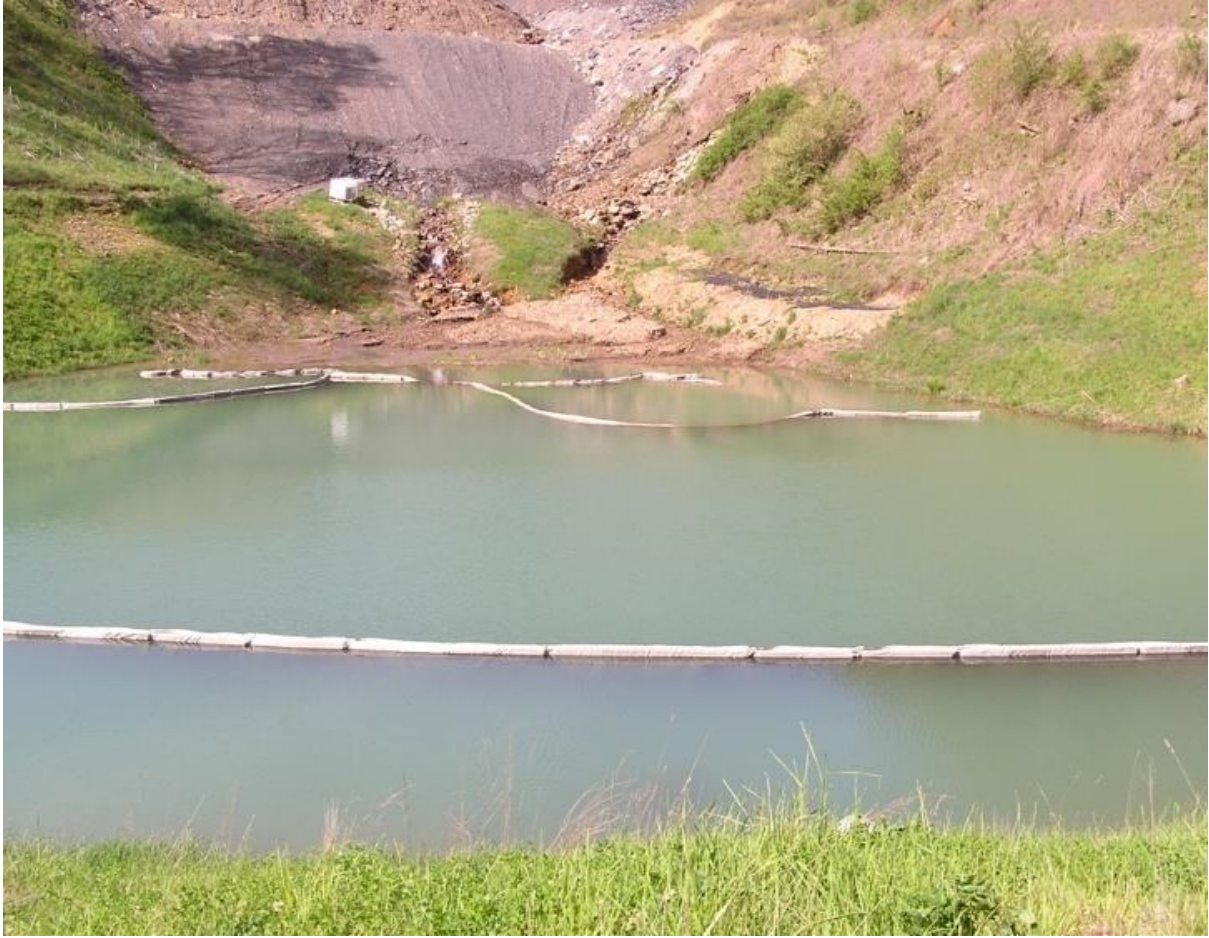
Figure 12. Photo from inspection of discolored treatment pond shown in satellite imagery.

Figures 12 and 13 shows the pond from the aerial view and the ground verification view. In fact, the sediment in the pond was depositional and transported sediment.

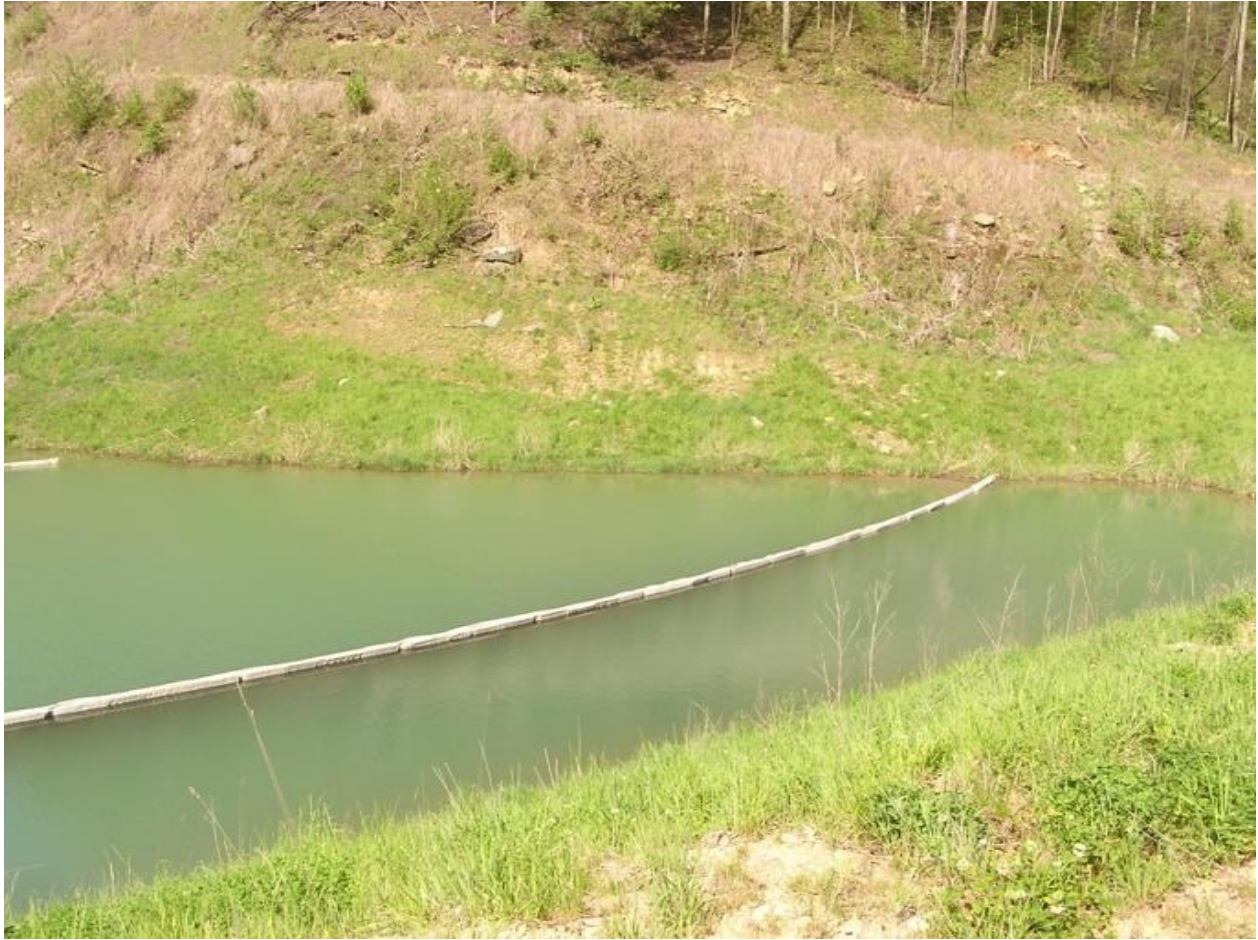
Figure 13. Photo from field inspection verification of pond after treatment.
