ASSESSING THE USE OF HIGH RESOLUTION SATELLITE IMAGERY TO INVENTORY ABANDONED MINE LAND FEATURES IN VIRGINIA¹

Proceedings American Society of Mining and Reclamation, 2009 pp 950-962

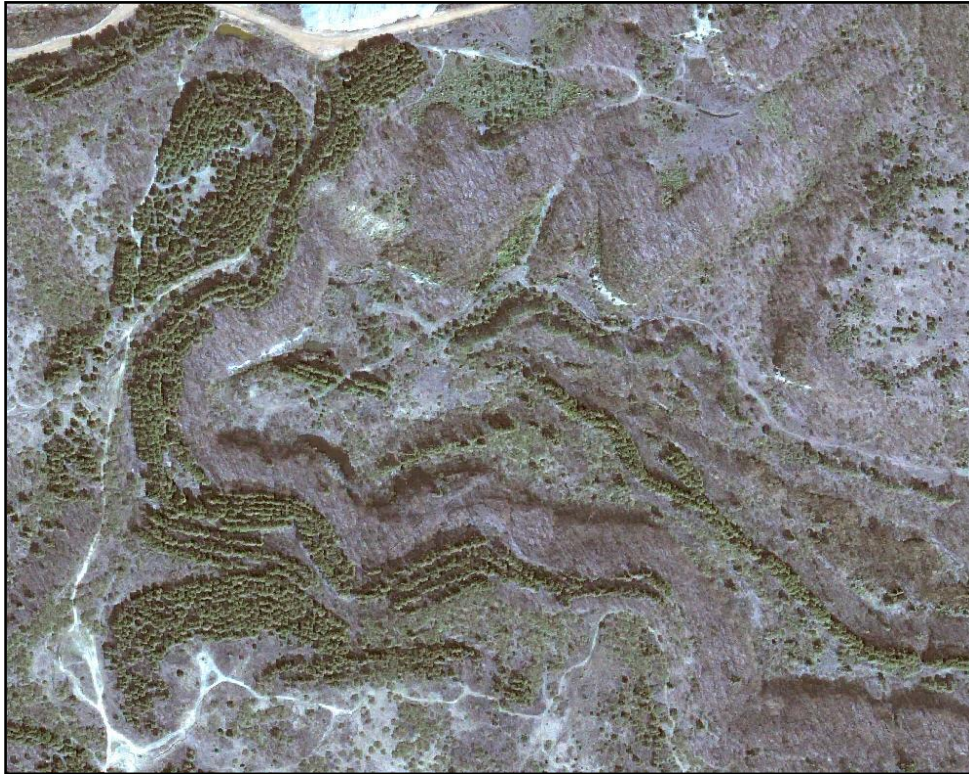
Figure 3. Example of QuickBird Image and Areas for Potential Remining Consideration

The feature “Areas for Potential Remining Consideration” are generally represented on the landscape as highwalls adjacent to between two to four linear rows of conifers, usually spaced approximately 6 feet apart. A forty-meter buffer was placed around the dangerous highwalls (DH) to defining a region of interest. Rows of trees were then extracted using linear training samples of the conifer rows. Larger forested areas that remained in this category were stratified out using clutter removal (misclassified data) processing. All buffered DH’s that have adjacent rows of trees remaining in the buffered area were classified as “Areas for Potential Remining Consideration”.

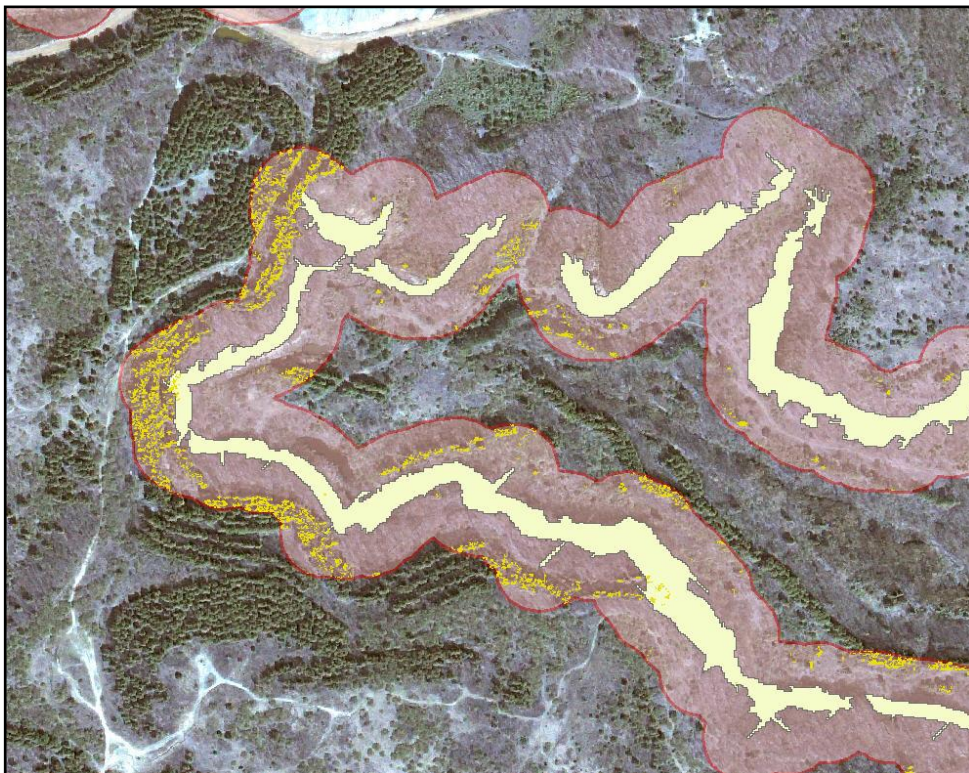
Figure 4. Example of DH, 40 meter DH Buffer and Rows of Trees Highlighted in Yellow.

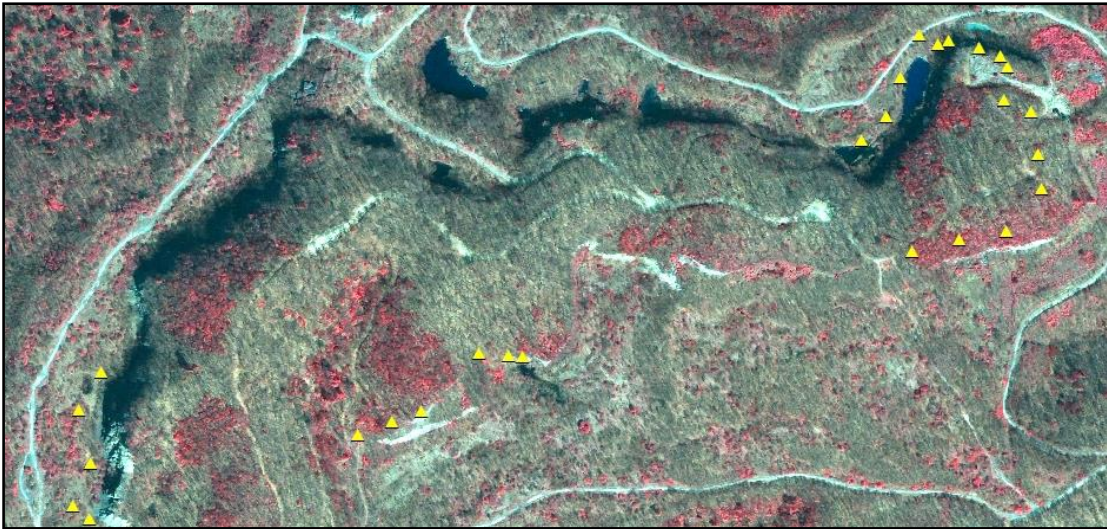
Figure 5. Example of Dangerous Highwall Feature and Field Points

The following is an example of the methodology used for feature extraction of Dangerous Highwalls (DH). Figure 5 shows a portion of the QuickBird image along with field sampling points of a highwall feature. Highwall features appear on the image as dark shadow. In addition to Feature Analyst, ArcGIS Spatial Analyst and ERDAS IMAGINE software was used for DH feature extraction.

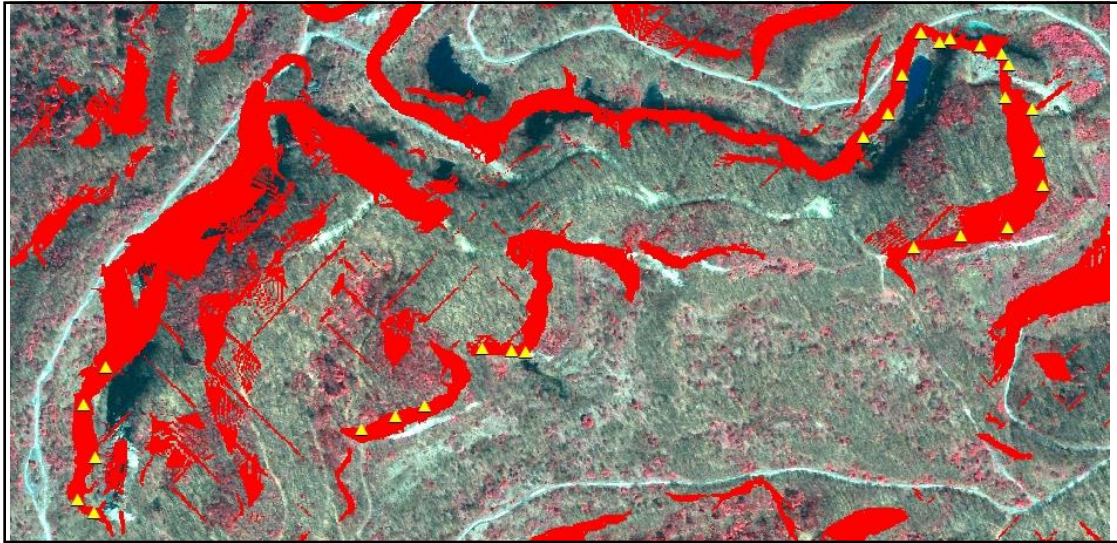
Figure 6. Dangerous Highwall Features with Field Points

Topographic contour data was required for this process and was provided by VA DMLR from the State of VA 2007 aerial photography program. A Digital Elevation Model (DEM) was derived from the contour data in ERDAS IMAGINE. The DEM cell size was 5 ft., the same as the contour interval. A slope analysis was performed using ArcGIS Spatial Analyst. DH field points were incorporated into the slope analysis, generating a slope category of greater than 60 degrees and a DH designation for this feature.

The red areas in Fig. 6 represent slope angles of greater than 60 degrees. The field sample points were left on the image for comparison purposes.

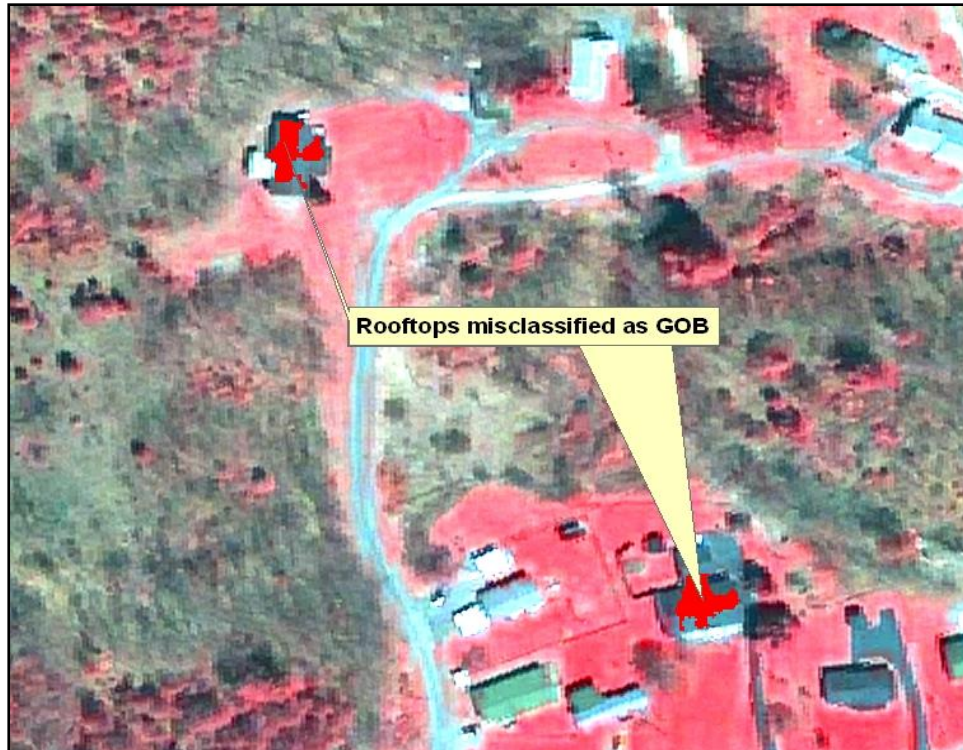
Figure 7. Asphalt roofing spectral signatures mimic gob and spoil piles.

The ability to map Gob and Spoil piles correctly is based on numerous, accurate field sample points and with the understanding that only new piles without overburden are the target. A mask to limit the amount of clutter was used in this model. Given the spectral similarity of this feature to non target features such as urban areas and asphalt roadways, a fair amount of clutter is to be expected (Maloof et al. 1998) (See Fig. 7). Also, a Normalized Difference Vegetation Index (NDVI) band ratio enhancement was performed in ERDAS IMAGINE to create a mask of vegetated and non-vegetated areas. These two masks were applied to the feature extraction model. A training set was created from the imagery using known ground truth points over known gob piles. Figure 8 shows the modeling steps required to extract this feature. Figure 9 shows a Gob pile with the ground truth field sample points. The results of the feature extraction model are shown in Fig. 10. In this feature extraction gob piles and spoil piles are grouped into the same feature class. Both features are so similar in shape and spectral response that it is not possible to separate out the two with QuickBird-2 imagery.

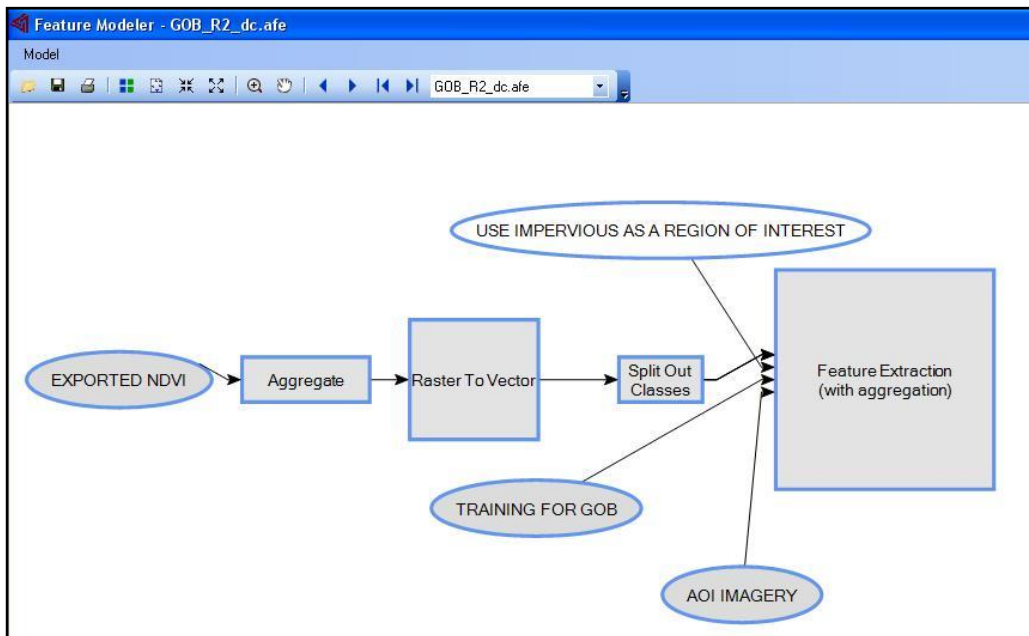
Figure 8. Feature Analyst modeling steps used in creating gob and spoil piles feature class.

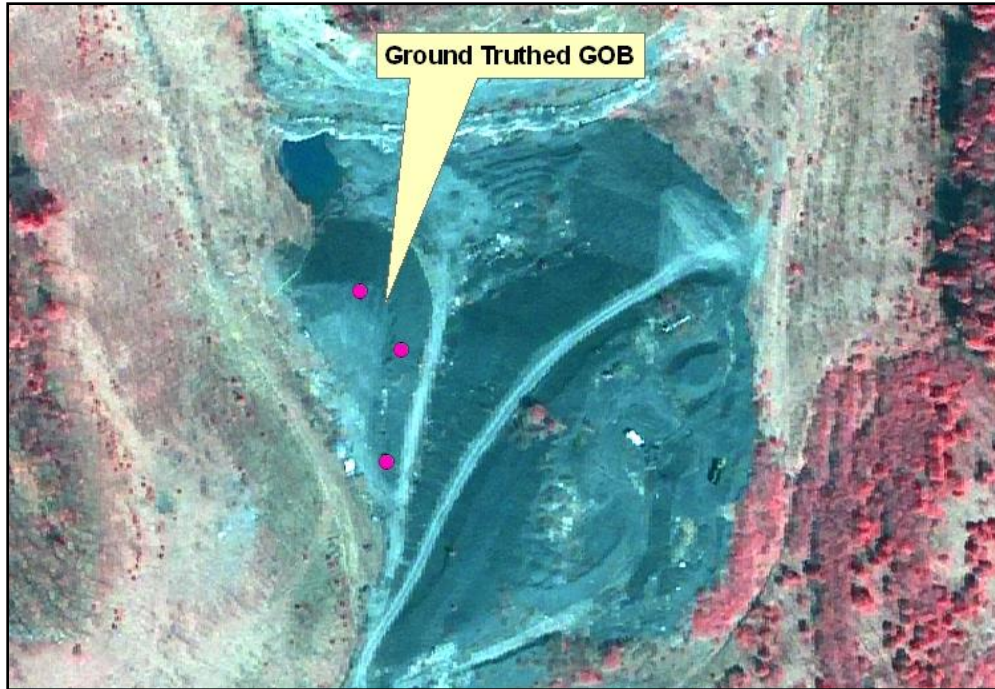
Figure 9. A Gob pile feature with field sample points to develop a training set.

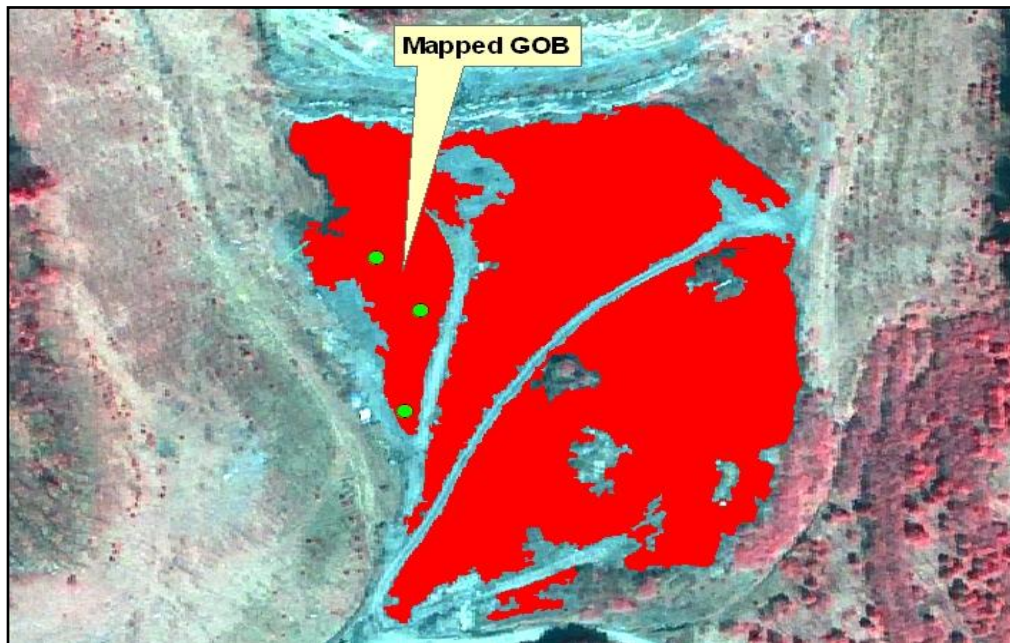
Figure 10. Results from Gob pile feature extraction process.
