ACHIEVING RECLAMATION SUCCESS GLOBALLY – PEABODY ENERGY'S EXPERIENCE IN MONGOLIA¹

V. R. Pfannenstiel² and Davganamdal Tumenjargal

Abstract: The Ereen Coal Mine operated as a Peabody joint venture project in Mongolia, suspended operations in early 2009. Peabody developed a reclamation and environmental stewardship plan for the site which was initiated in spring 2009. The project would also fulfill the spirit and intent of the 2006 Mongolian Minerals Law. Project development included analysis of environmental baseline conditions and application of best reclamation practices necessary to create a non-erosive and sustainable landform, establish perennial vegetation and restore traditional land use. Mongolian scientists and engineers from Ulaanbaatar teamed with U.S. Peabody engineering and environmental staff to develop and implement a plan to meet Mongolian regulatory requirements and restore pre-mine land capability. The mine area, out of pit dumps and adjacent undisturbed lands were surveyed to develop a post-mining landscape design to establish through drainage and return a stable landform. Backfill material was sampled to identify any spoil that could be unsuitable for plant gro

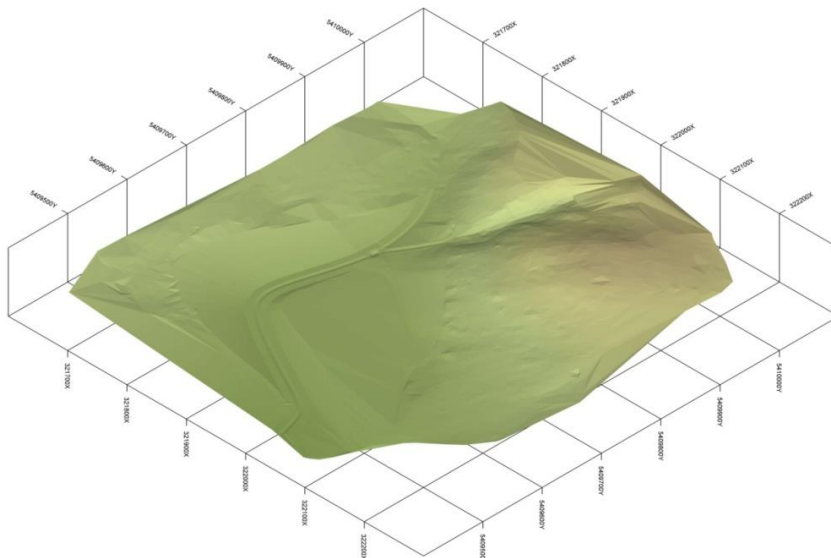
Figure 4. Ereen Mine reclamation final post-mine topography design.

topography was designed by U.S. based Peabody engineering staff using Maptek's Vulcan 3D mine planning software. The mine disturbance topography as of April 2009 is shown in Fig. 3 while the final post-mine topography design is illustrated in Fig. 4.

Post-mine topography was designed to be practical and effective. Strict adherence to the design during construction established a stable regional landform that drains positively. Management during backfilling and grading insured suitable plant growth media was maintained in the upper graded profile. Topsoil replacement procedures insured adequate replacement depths and conservation of the resource. Deep ripping and seedbed preparation completed effective minesoil reconstruction and proper seedbed conditions. Use of native species and proper seeding techniques established an effective vegetative cover. The John Deere seeder was

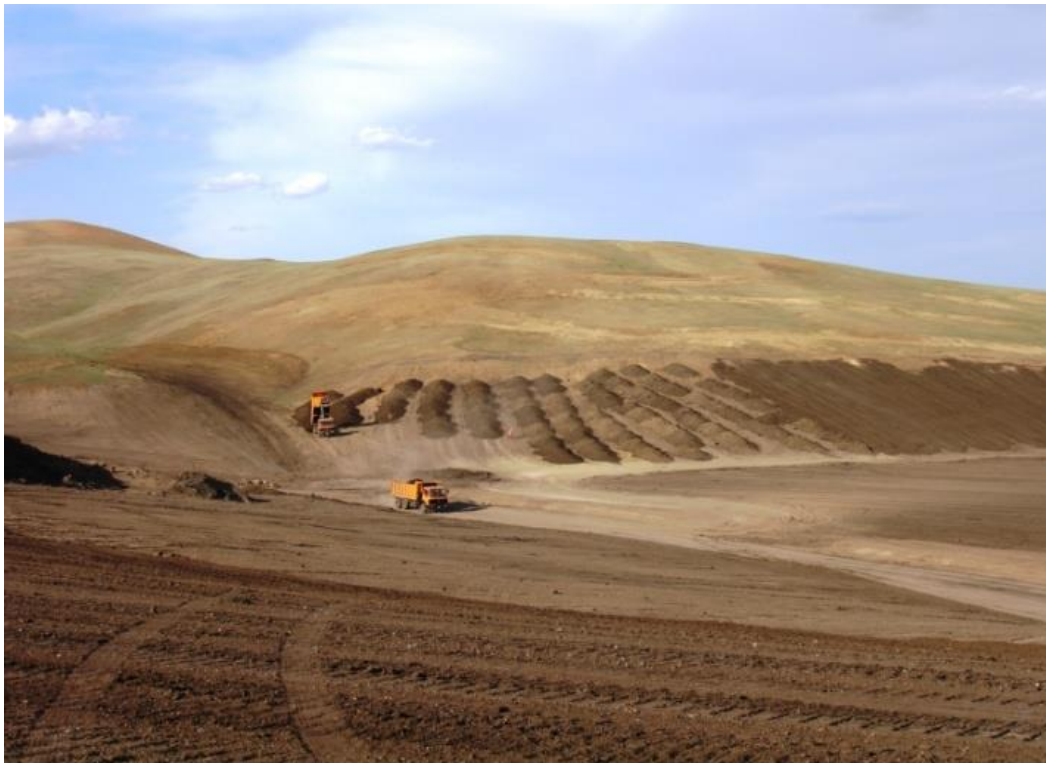
Figure 5. Application of scarce topsoil was completed through an innovative approach.

Topsoiling is a critical best practice to insure revegetation success and sustainability of land use. Ideally, as a best practice prior to mining operations, topsoil resources are documented and salvaged to insure sufficient quantity is available for replacement depths necessary to establish the intended vegetation communities. Volumetric estimates of the salvaged topsoil at Ereen indicated that an approximate 20 cm topsoil replacement depth might be possible. Observation of native soil profiles indicated that this would approach the minimum desired depths. To insure maximum use and critical application of the limited topsoil resource, the team on site developed an innovative approach (Fig. 5). After determining how much area at a 20 cm depth would be covered by an average truck load, a dumping grid was located on the final graded surface. The backhoe operators loaded each truck as consistently as possible. After sufficient dumping was completed on the grid, a dozer was used to spread the topsoil to the 20 cm depth. Importantly, the most skilled dozer operators were chosen for this aspect of the project and trained to maintain

close tolerances in topsoil spreading. To verify results of these efforts, 33 depth measurements were taken in a systematic grid on 6 hectares of replaced topsoil. Replaced topsoil depths averaged 22.6 cm ($s=5.51$) which reflected conscientious team and operator efforts. In spite of these efforts as the project neared completion, it was apparent that topsoil would be short. Sufficient additional topsoil to complete the project was found a short distance from the project site in topsoil stockpiled during construction of the mine access road which was to be retained as a permanent road for local community use. Topsoil replacement was completed in spring 2010.

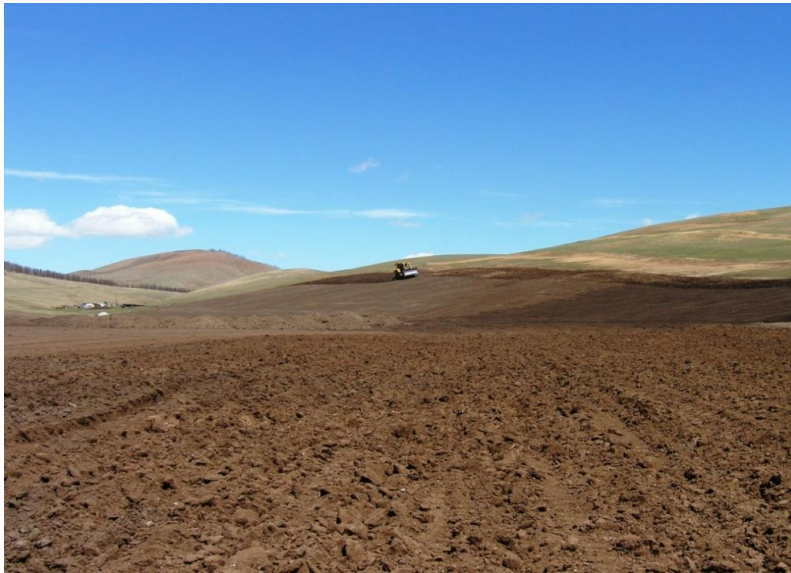
Figure 6. All areas were deep ripped on the contour. Note smooth blend of topography.

Following topsoil application, final minesoil reconstruction and seedbed preparation were completed. Heavy equipment traffic can cause severe compaction on reclaimed sites. To mitigate these conditions at the Ereen site, contour ripping best practices were applied using a D6 dozer with a triple shank ripper attachment. Ripping depth was approximately 0.4 m with shank spacing at 0.9 m. All operations were conducted on the contour (Fig. 6). This best practice aided in erosion protection, improved infiltration and soil moisture and enhanced root zone physical conditions. Following ripping, the soil was contour disked to reduce clods and establish seedbed conditions that promote good soil to seed contact when seeding.

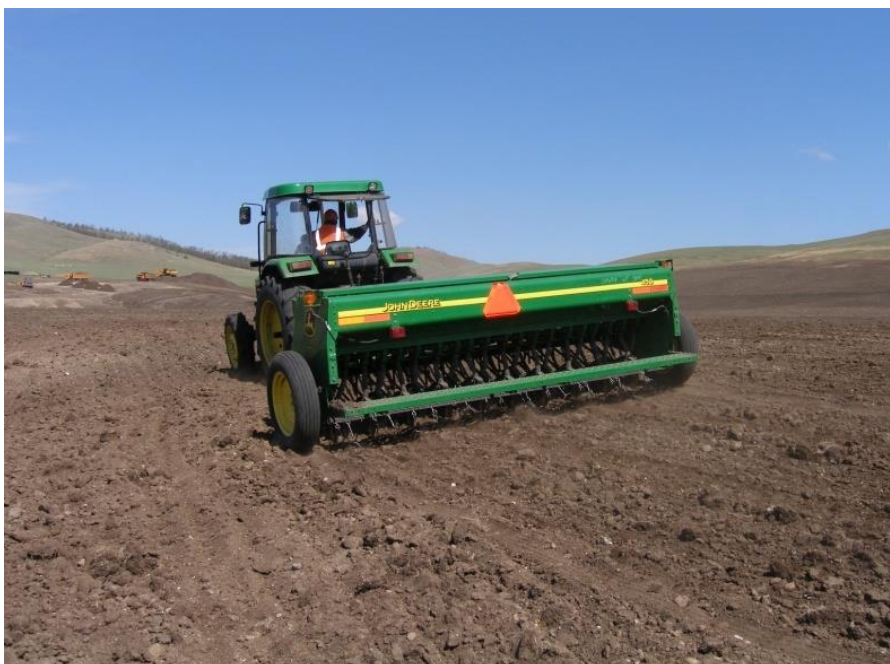
Figure 7. Proper seeding equipment was critical to achieving revegetation best practice goals.

Seeding was conducted in late May 2010 following proper seeding season best practices (seed prior to anticipated optimum moisture conditions). The 4 m wide John Deere 450 drill seeder, equipped with small and large seed boxes, accurate seed metering and double disk furrow openers, aided best practice seeding (Fig. 7). The John Deere tractor used to pull the seeder had

been modified with Russian standard hydraulic hose couplings making it incompatible with the drill seeder. Quick and innovative action by the mechanics on site modified the drill seeder to take a Russian standard hydraulic cylinder and avert a significant problem in timely completion of the reclamation project. The seeder was then calibrated to accurately apply the desired seeding rate and was periodically checked to insure continued calibration. Proper seeding rate was not only important in achieving the desired stand characteristics, but also to avoid waste of the scarce seed available for this project. The alfalfa seed was placed in the small seed box for broadcast application (shallow seeding depth) while the three larger grass species were placed in the large seed box for seeding into the disk furrow (moderate seeding depth). All seeding was conducted on the contour. Small areas of the site not accessible to the seeding equipment were hand broadcast seeded on roughened surfaces.

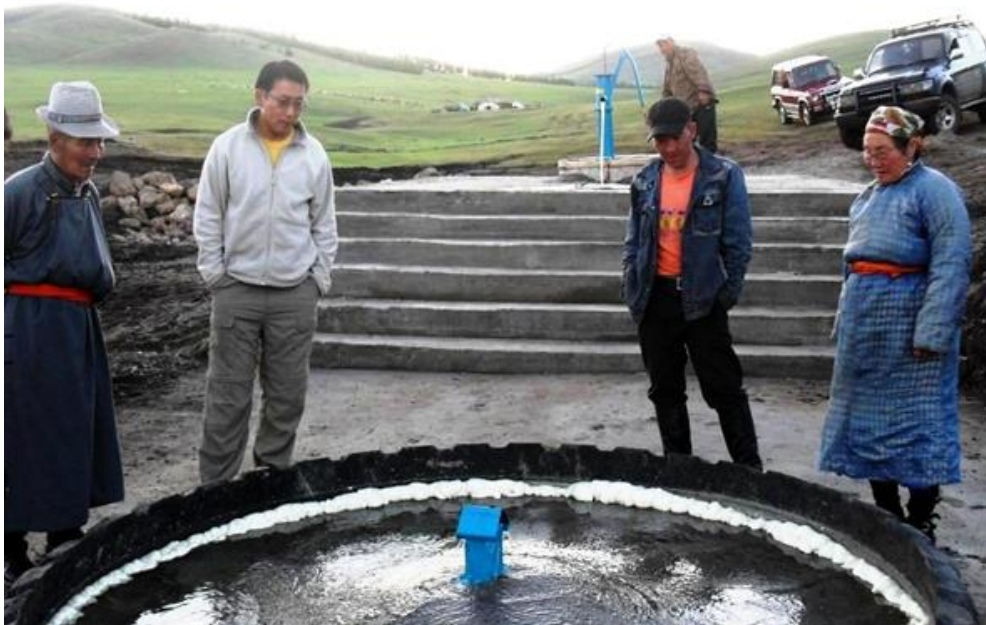
Figure 8. The Ereen project provided domestic and livestock water not previously available in the area.

In spring 2010, the well and pond downstream of the well were constructed and a simple but sturdy Mongolian pump was installed on the well. A pipe providing a continuous flow of well water to the pond was also installed at this time. Domestic and livestock water sources were separated for sanitation. An additional livestock water source was constructed adjacent to the well by using a used large equipment tire with the sidewall removed, placed in a concrete base and filled from the well pump through grating and a pipe (Fig. 8). Common in the western U.S.,

this inexpensive and very sturdy tank had not been used previously and was of high interest to Mongolian land managers for use at other locations. The simple and effective design is easily replicated and addresses infrastructure utility and longevity. To insure sustainability of the new water sources, community outreach meetings were held to explain sanitation, management, and maintenance as well as to select a local caretaker family for the well and associated facilities. The well water meets domestic drinking water standards and water samples continue to be taken to verify water quality. In the fall of 2011, an insulated well house was constructed over the well pump to better insure an available domestic and livestock water supply during the critical winter months on the steppes.

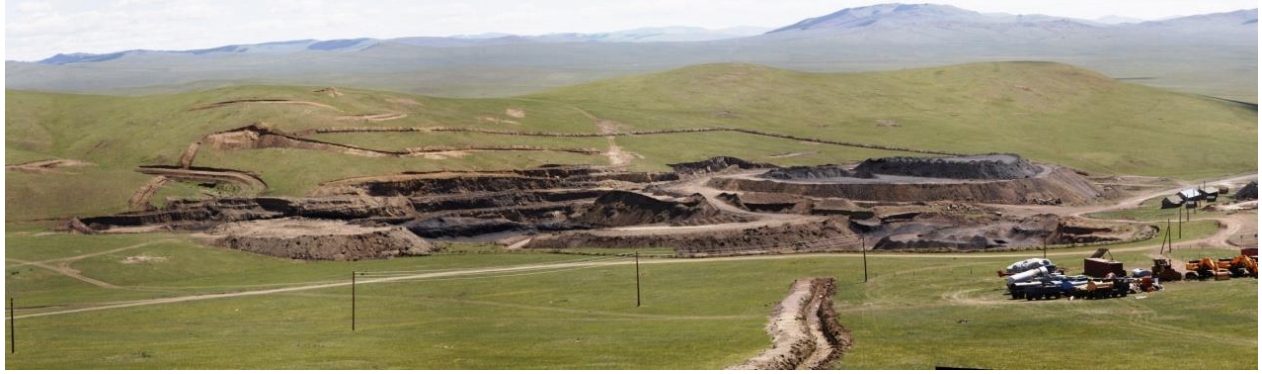
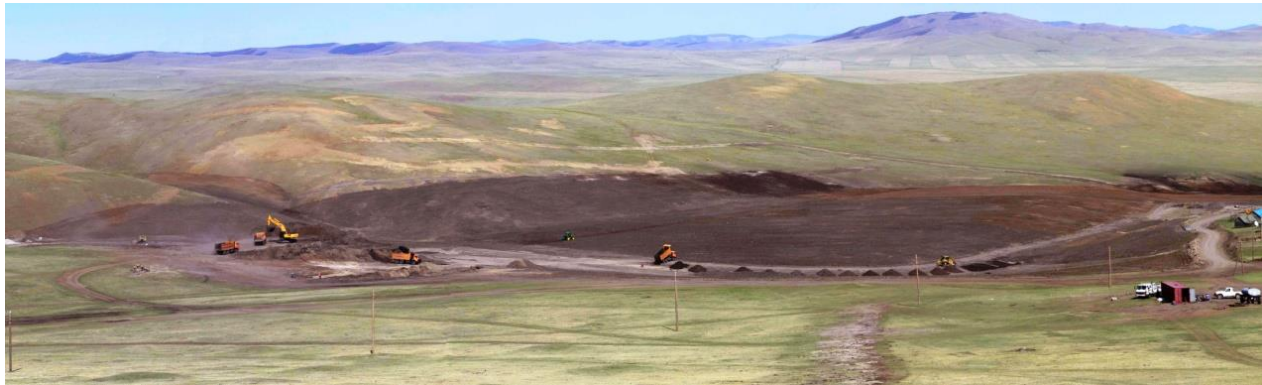
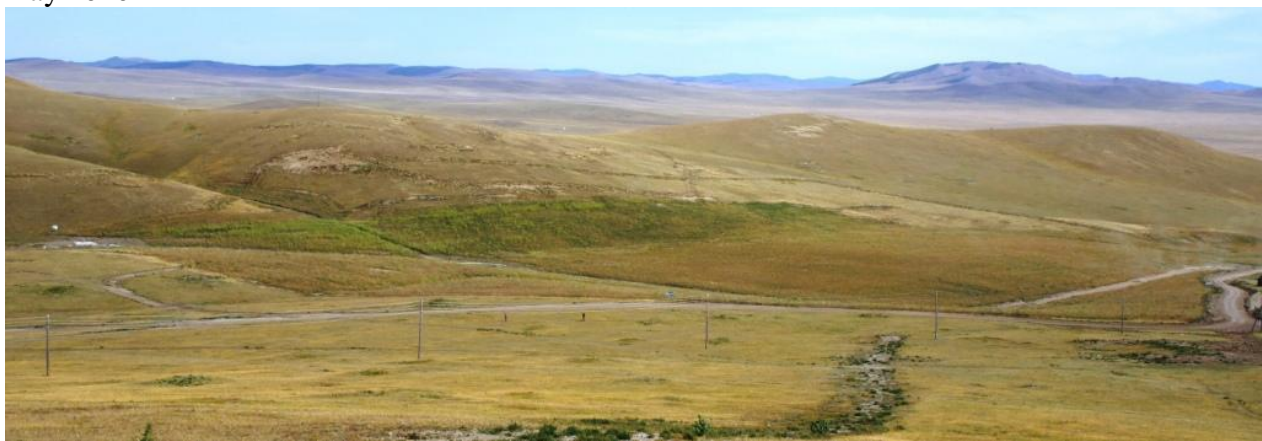
Figure 10. Progression of the Ereen Mine site from end of active operations in 2009, final reclamation activity in 2010 and in 2011 one year after completion of reclamation showing stable landforms, establishing vegetation and successful reclamation.

The best practices necessary for each unique operation are sequential, mutually supporting and reflect comprehensive and technically based approaches necessary to achieve reclamation success. In an ongoing and active mining operation, the same best practices approach applies, but with an additional critical best practice – an integrated mine and reclamation plan to achieve cost effective and successful mining and reclamation. The best practices reclamation approach has proven successful at Peabody’s U.S. operations and was the key to successful reclamation at the Ereen mine site on the steppes of northern Mongolia, a historical first for this country (Fig. 10).
