## A Preliminary Stream Assessment for Watershed Restoration<sup>1</sup>

**Abstract.** An assessment of Laurel Run, Indiana County, was conducted in the summer of 2001 through a partnership effort between the Pennsylvania Department of Environmental Protection and Stream Restoration Inc. The purpose of the assessment was to evaluate the potential recoverability of a stream affected by abandoned mine drainage (AMD) before construction of a passive treatment system in the headwaters of Laurel Run. Several major discharges have severely degraded the stream to the confluence with Blacklick Creek (Ohio River Basin). At the mouth of Laurel Run, the stream has a flow rate exceeding 4,200 L/min (1,100 gpm) with pH 5.5, 42 mg/L acidity, 2.5 mg/L iron, and 2.9 mg/L manganese. In addition, baseline data were collected to examine the overall health of the watershed for future planning and preliminary Total Maximum Daily Load (TMDL) studies. Twenty-one sites were assessed using standard EPA Rapid Bioassessment Protocol sampling methods, examining physical, chemical, and biological characteristics. The number and variety of benthic macroinvertebrate taxa were much lower when compared to a physi

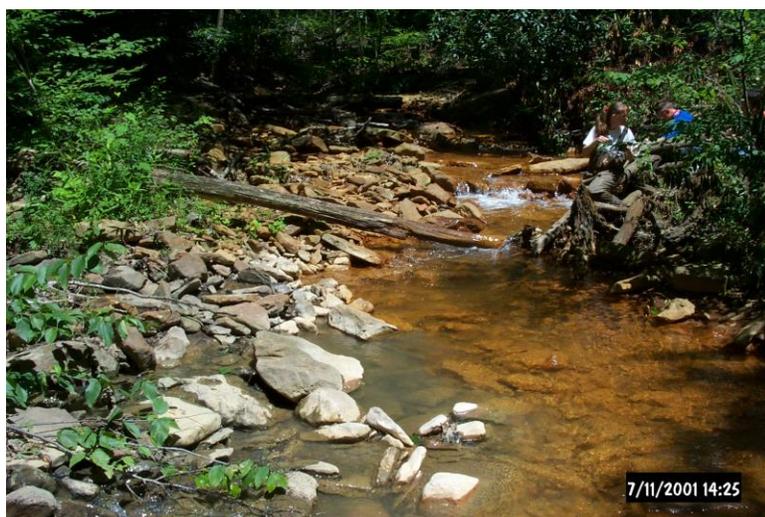
**Figure 3:** UN1A entering degraded Laurel Run.

and metals. At site LA2 there are decreases in pH, alkalinity, acidity, total suspended solids, aluminum, iron, and sulfates while manganese slightly increases. Again, this is due to the precipitation of the metals on the streambed. UN1A is the mouth of another impacted stream to Laurel Run (Figure 3). UN1BA, UN1BB, UN1BC, and UN1E are mine discharges that represent the majority of flow to this tributary. UN1C contains the lowest pH and highest concentrations of metals affecting this tributary to Laurel Run. Finally, LA1 is at the mouth of Laurel Run. In comparison with the upstream sample station of LA2, LA1 increases in pH and alkalinity and decreases in metal and sulfate concentrations.

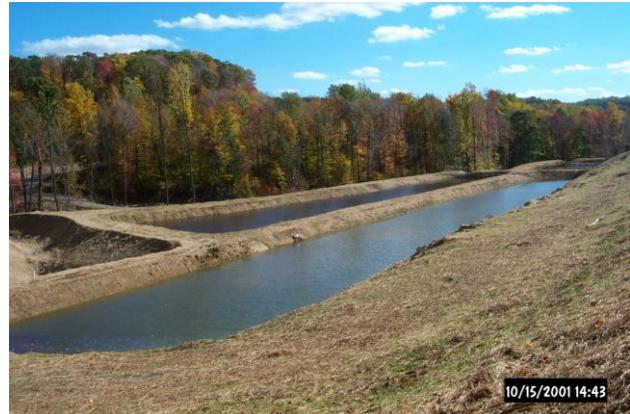
**Figure 4:** View of flush pond and Vertical Flow Ponds looking south.

In September 2001, a passive treatment system was placed online through a public-private partnership effort involving Stream Restoration Inc., Amerikohl Mining, Inc., PA Game Commission, private landowners, and the Pennsylvania Department of Environmental Protection. This system consists of two Vertical Flow Ponds built in parallel, a flush pond, and a ½-acre wetland. The vertical flow ponds were built entirely of environmentally-friendly materials (limestone and mushroom compost) and utilized an innovative piping system to flush metal particulates from the ponds (Figure 2, 4, 5).

Samples taken October 15, 2001 indicate that the passive treatment system is drastically reducing the amount of iron, aluminum, and manganese into Laurel Run (Table 3, Figure 4 and 5).

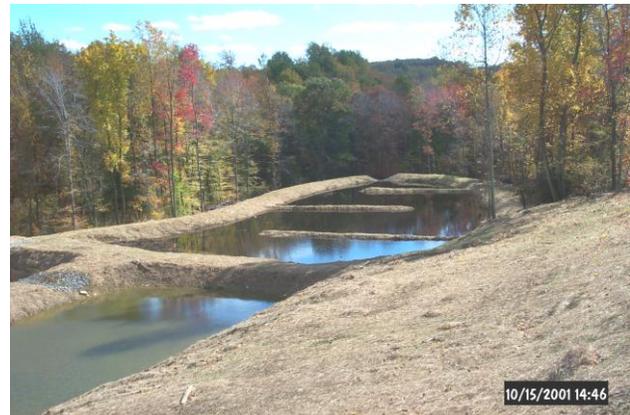
**Figure 5:** Vertical Flow Pond effluent entering unplanted wetland area to the south. Effluent of wetland enters Laurel Run.
