CASE STUDY: “THE JENNINGS SYSTEM” – OVER A DECADE OF SUCCESSFUL PASSIVE TREATMENT¹

Abstract. Treatment of drainage from an underground coal mine, abandoned for over 65 years, has been a focus of the Jennings Environmental Education Center (a Pennsylvania State Park) since failure of a mine seal in 1984. Early prototypes of environmentally-friendly technologies or passive treatment components have been installed and monitored since 1989. As Jennings is dedicated to environmental education at various interest levels for the general public and for students of all ages, water monitoring to demonstrate the performance of the system has been imperative. In 1997, a Vertical Flow Pond (VFP) with treatment media consisting of 272 metric tons (300 short tons) of spent mushroom compost mixed with 345 metric tons (380 short tons) [9.52 mm x 1.180 mm (3/8”x16 mesh); >90% CaCO₃] of limestone aggregate, a step-down (Bioswale) wetland, and an aerobic wetland/settling pond were installed to treat the acidic, metal-laden, raw water which averages 76 Lpm (20 gpm), 3.0 pH, 270 mg/L acidity, 40 mg/L total iron, 15 mg/L total manganese, and 15 mg/L total aluminum. At the time of installation, the predi

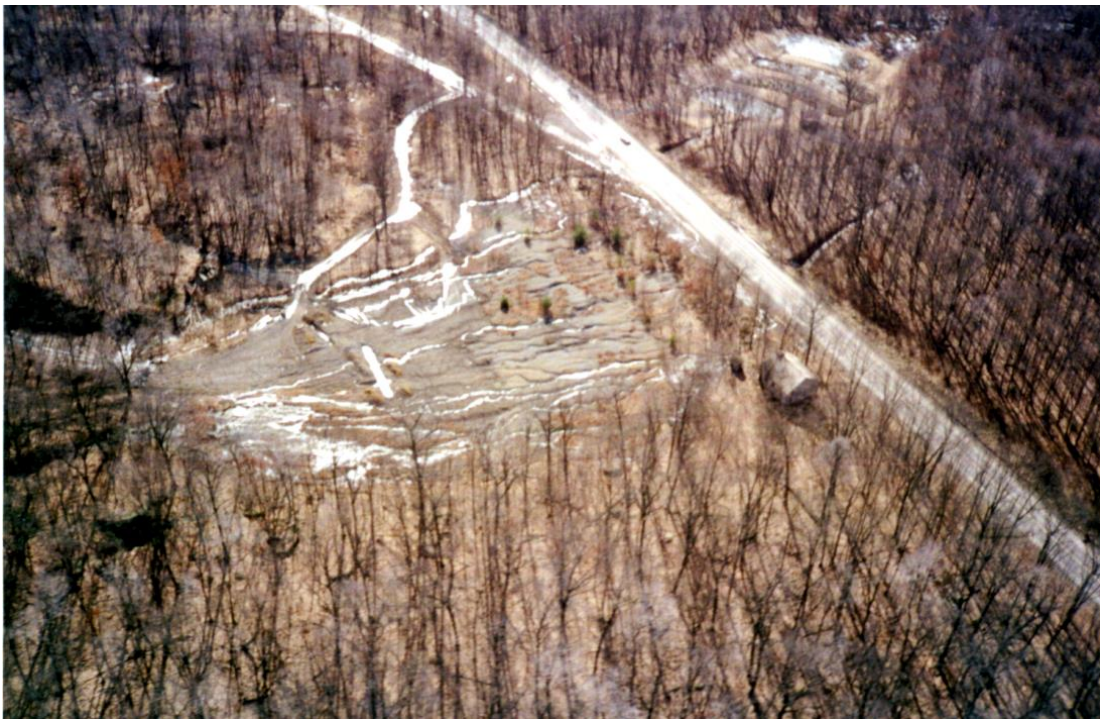
Figure 1. Aerial view (winter 1992); “lower wetland system” (upper right corner); drift entries (center left); area for passive treatment system installation and revegetation (center). (photo by PADEP, Knox District Mining Office)

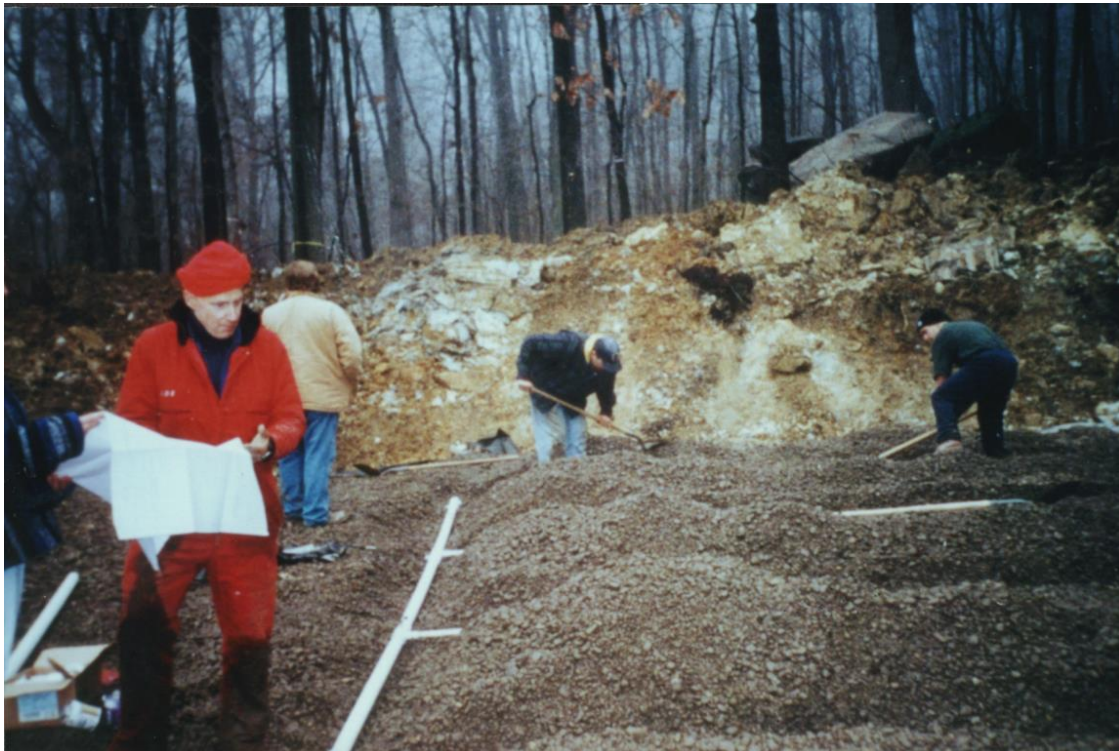
Figure 2. Grove City College and Slippery Rock University students assisting Charles D. Cooper, PE, PLS (CDS Assoc., Inc.) with the installation of the VFP underdrain (1997).

A passive treatment system consisting of a Vertical Flow Pond (VFP) followed by a Bioswale and aerobic wetland/settling pond (WL/SP) was constructed in 1997. The raw water influent piping to the VFP was connected to an existing collection system installed ca. 1992 by the U. S. Bureau of Mines, CDS Associates, Inc., and volunteers. Geotextile was used as a pond liner. The underdrain was constructed using 5.08-cm (2-inch), solid, PVC headers with 1.90-cm (¾-inch) perforated PVC laterals spaced at 1.82-meter (6-foot) intervals. The underdrain piping was then embedded in AASHTO #57 river gravel (non-reactive) 0.3-meter (1-foot) in thickness. The headers are connected to a 10.2-cm (4-inch) corrugated plastic outlet pipe. Woven, permeable, geotextile was installed over the bedding stone of the underdrain to separate the treatment media. The treatment media consists of 272 metric tons (300 short tons) of spent

mushroom compost amended with 345 metric tons (380 short tons) of 9.52 mm x 1.18 mm (3/8" x 16 mesh), >90% CaCO₃, limestone. The limestone and spent mushroom compost were mixed and placed with a hydraulic excavator. Girl Scouts, homeschooled students, and Grove City College and Slippery Rock University students constructed the underdrain and assisted with mixing and placement of the treatment media.

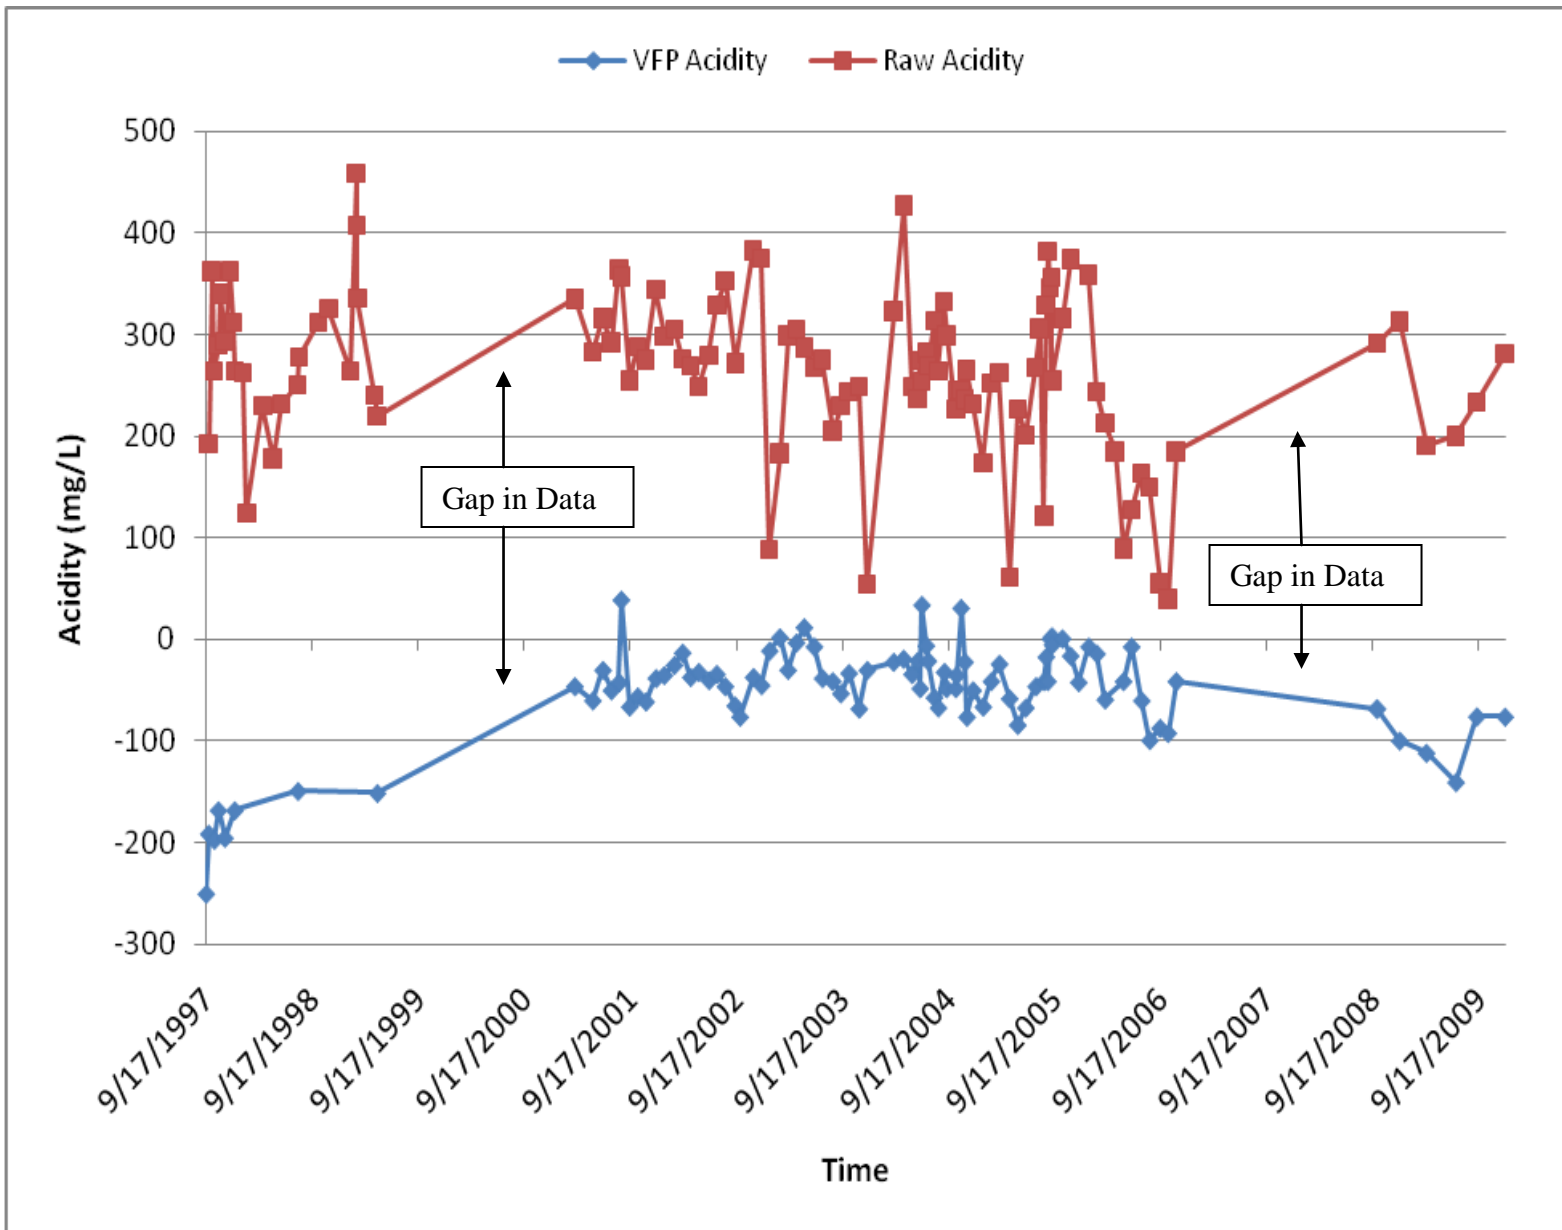
Figure 4. Comparison of Acidity: Raw (VFP Influent) and VFP (Effluent)

A series of graphs have been included to provide a visual overview of the effectiveness of the system. Figure 4 compares hot acidity values in the raw untreated mine water with the effluent of the VFP over time. Note that except for a few occasions, the VFP has almost always produced net-alkaline water. Figure 5 compares total iron values in the raw water with the effluent of the VFP and of the WL/SP over time. Typically, the WL/SP has less than 5 mg/L of total iron, which is assumed to be primarily particulates. Figure 6 compares total Al values in the raw water with the effluent of the VFP and of the WL/SP over time. Even when the total Al value for the VFP effluent is greater than 1 mg/L, the majority of the Al is assumed to be in the form of particulates, as the pH is generally greater than 6. (Note “gaps” in monitoring data especially for the WL/SP effluent as shown in Fig. 5 & 6.)
