INSTALLATION AND STABILITY OF INVERTED PYRAMID-SHAPED PLUGS  
FOR CLOSING ABANDONED MINE SHAFTS GALENA, KS DEMONSTRATION PROJECT<sup>1</sup>

John S. Volosin<sup>2</sup>

Abstract.-- The Bureau of Mines designed and installed 11 inverted- pyramidal- shaped plugs in a mine closure demonstration project completed in Galena, KS in December 1983. The demonstration project resulted from a study done by the Geological Surveys of Missouri, Kansas, and Oklahoma for the U.S. Bureau of Mines in January 1983. This study identified over 1400 open mine shafts and nearly 500 subsidence collapse features that remained from the original 14,000 shafts sunk in the Tri-State Zinc-Lead Mining District. In Galena, KS, alone over 377 open mine shafts were readily accessible and 150 abandoned mine shafts were within the city limits. Of these, the Bureau of Mines selected 14 abandoned sites for the mine shaft closure demonstration project. During the demonstration project, 11 mine shafts were closed with the inverted pyramid shaped reinforced- concrete plugs, 2 were closed with reinforced concrete caps after backfilling, and one shaft was closed by backfilling only. The stability of the closure devices ha

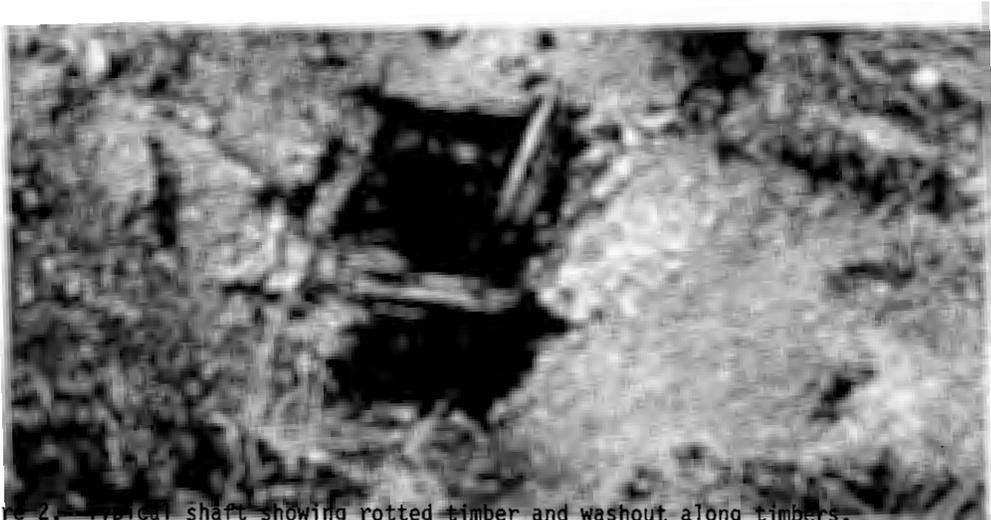
Figure 2.--Typical shaft showing rotted timber and washout along timbers.

Two of the open shafts selected for plugging are shown in figures 2 and 3. A contract was let in 1982 to obtain the shaft dimensions, assess the conditions of shaft side walls, obtain the elevation of an estimated contact between overburden and solid rock, and the location of underground workings in the shaft vicinity. These measurements were used in preparing the competitive bid specifications for the plug installations reported herein. Another contract was awarded in August 1983, to perform the actual closure demonstration work in which 11 shafts were plugged, 2 were capped, and 1 was backfilled.

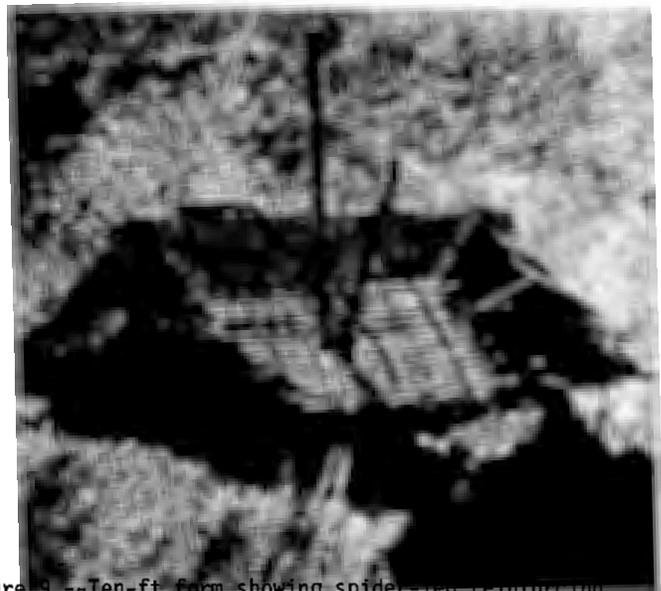
Figure 9.--Ten-ft form showing spider-leg reinforcing over edge of form to support the expanded metal.

Class A concrete was delivered to the site from a local batch plant. Just prior to pouring, a reference monument was attached to the center of each plug (fig. 9). The 8-ft forms each required 3.2 yd<sup>3</sup> of concrete, the 10-ft forms 6.2 yd<sup>3</sup>, and the 12-ft forms 10.7 yd<sup>3</sup>.

After the first three plugs were placed, it was noted that there were gaps between the form and the sidewalls along the edge of the pyramid shaped form. In these areas, reinforcing bars were positioned over the edge of the form and extended to the side of the prepared opening. This was covered with a 2-ft width of expanded metal, and 4 inches of concrete was poured on this expanded metal.

Before pouring concrete in the last eight forms, steel reinforcing rod was bent and fastened to the installed horizontal reinforcing grid and extended in spider-leg fashion several feet over the edge of the form (fig. 9). The 2-ft wide expanded metal was positioned over these reinforcing rods, and concrete was poured over this when the form was filled (fig. 10). An additional 1 to 1-1/2 yd<sup>3</sup> of concrete was required for each shaft because of these modifications.
