DES BEE DOVE MINE COMPLEX A CHALLENGE IN THE RECLAMATION OF A PRE-SMRCA SITE¹

C. A. Semborski and D. C. Oakley²

Abstract: The Des-Bee-Dove Mine complex (owned by PacifiCorp and operated by Energy West Mining Company) had a long and rich mining history beginning in the 1880's. Since development of the mine surface facilities pre-dated SMCRA, initial construction did not include segregation and storage of soils. A total of approximately 13.8 hectares were disturbed prior to the commencement of reclamation in 1999. The goal of the reclamation project was to reclaim the mine site to within approximate original contour (AOC) using existing soil resources excavated on-site and achieve a diverse vegetative stand that would stabilize and protect the reclaimed slopes. Within this disturbed site, there were 14 portal openings necessitating elimination of approximately 762 meters of cut slopes. Also within this site was a 1.0 ha pad constructed into the side of steep canyon walls. This pad alone required approximately 36,000 m³ to fill to AOC.

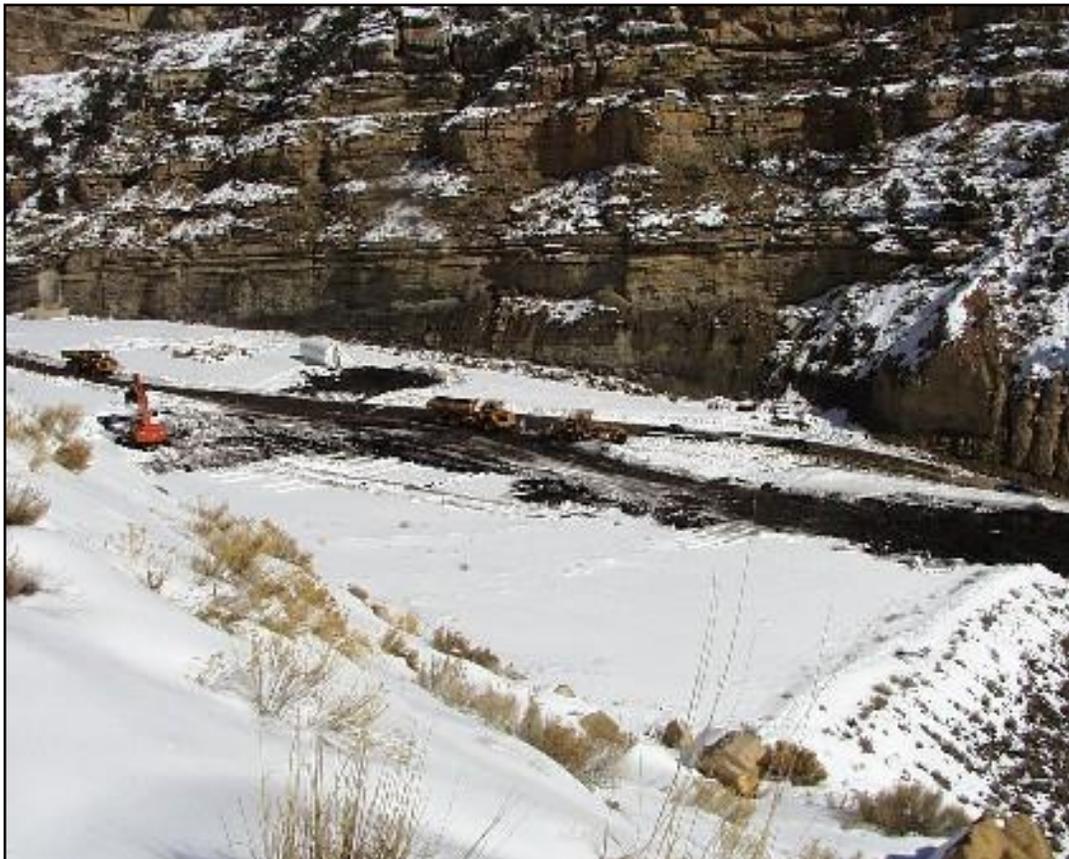
Figure 1: Tipple/Material storage yard pad. Approximately 110,000 tons of coal was buried in this pad.

In 2000, current permit requirements necessitated that soil sampling be conducted on five-year intervals at designated locations. Soil sampling of these locations had begun in 1985 to form a baseline soils analysis of the disturbed and undisturbed areas. Sampling continued every five years thereafter comparing the disturbed and undisturbed areas to determine whether surface mining activities were impacting soil quality. Because of the initiation of final reclamation, a decision was made to take additional samples in areas where the potential for soil contamination was high (e.g. tipple/material storage yard, see Fig. 1).

The first sample site was placed on the south end of the tipple/material storage yard. After drilling approximately 1.0 m (3 ft), coal fines begin surfacing from the auger. At 1.5 m (5 ft), full extent of one auger length, coal was still evident. Curiosity dictated that the total depth of the coal be known since this was the area in which a designed channel was planned for construction. A total of 20 m (65 ft) of auger steel (total on truck) was used without finding the bottom extent of the coal. A second sample site was selected approximately 15 m (50 ft) west of the first site. Similar results were realized.

A decision was made to delineate the volume of coal that apparently had accumulated in this canyon in prior years. Drill holes were placed on approximately 15 m (50 ft) centers throughout the extent of the tipple/material storage yard. Cross-sections were established and a volume of approximately 99.8×10^6 kg (110,000 tons) of usable coal fines was estimated to be stored in the canyon. In the original reclamation plan, it was proposed to construct a channel through the tipple/material storage yard. However, without the newly obtained drill-hole information, the channel would have been constructed on top of this buried coal pile. A new plan would need to be developed to remove the coal from the canyon and construct the channel on a more suitable base. Figure 1 shows the extent of the buried coal within the storage yard.

In 2001, PacifiCorp obtained permission from UDOGM to remove the coal from the canyon and completely revise the reclamation plan. Coal removal took approximately four months to complete and removed approximately 98×10^6 kg (108,000 tons) of high Btu, low ash coal from the canyon. All spoil from this project (approximately $12,700 \text{ m}^3$ or 17,000 cy) was stored on the bathhouse pad and used as fill in that area. As the coal removal project was taking place, PacifiCorp simultaneously began revising the entire Des Bee Dove Mine reclamation plan. The reclamation plan was designed in two separate phases. Phase 1, the upper mine facilities, was designed in-house. The Phase 2 portion was developed with the assistance of a private consulting firm.

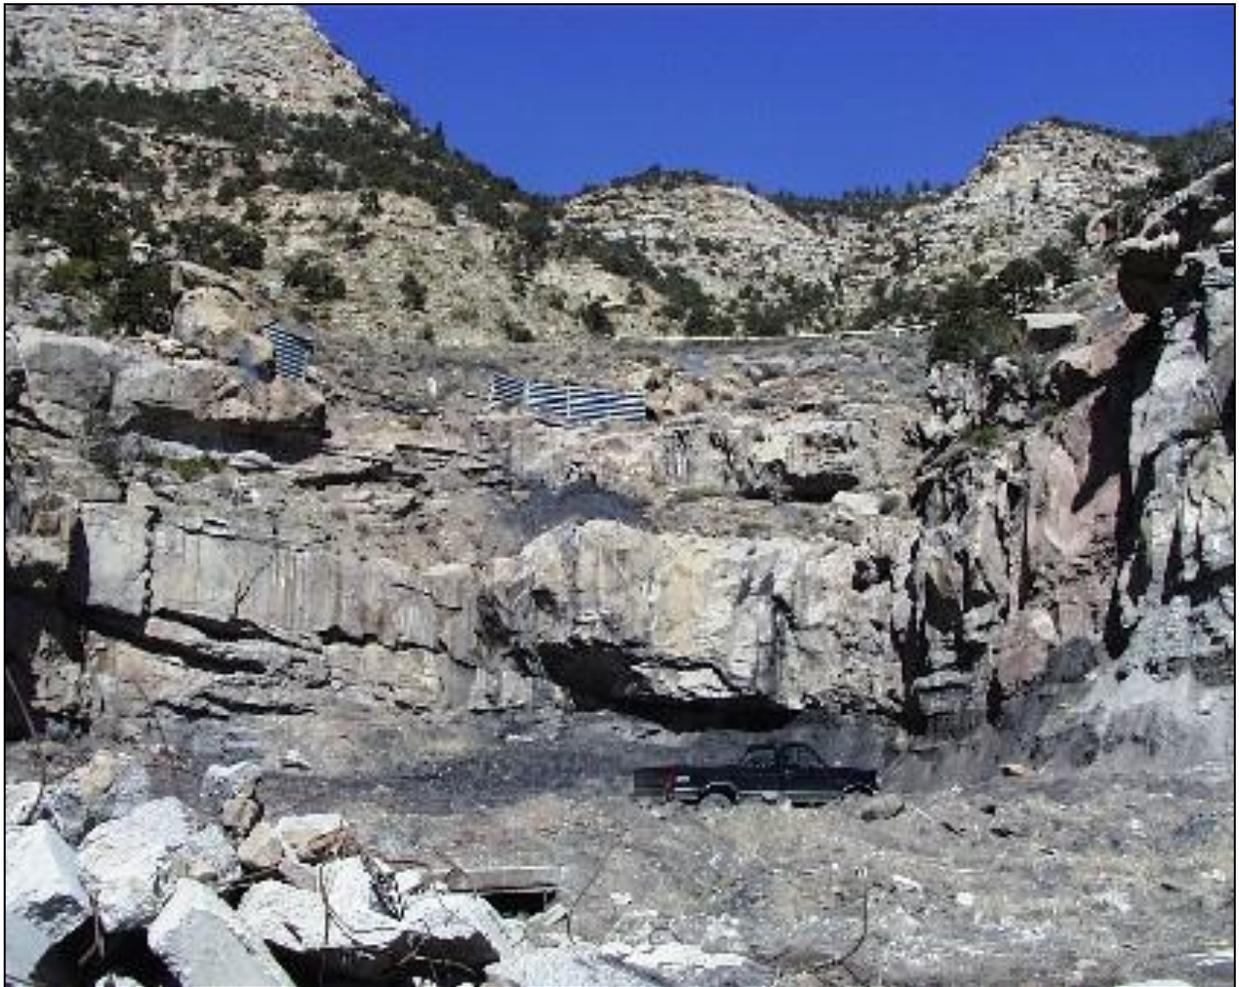
Figure 2: Outcropping of the interburden between the upper and lower mines. The black truck in this figure is parked on the lower mine pad.

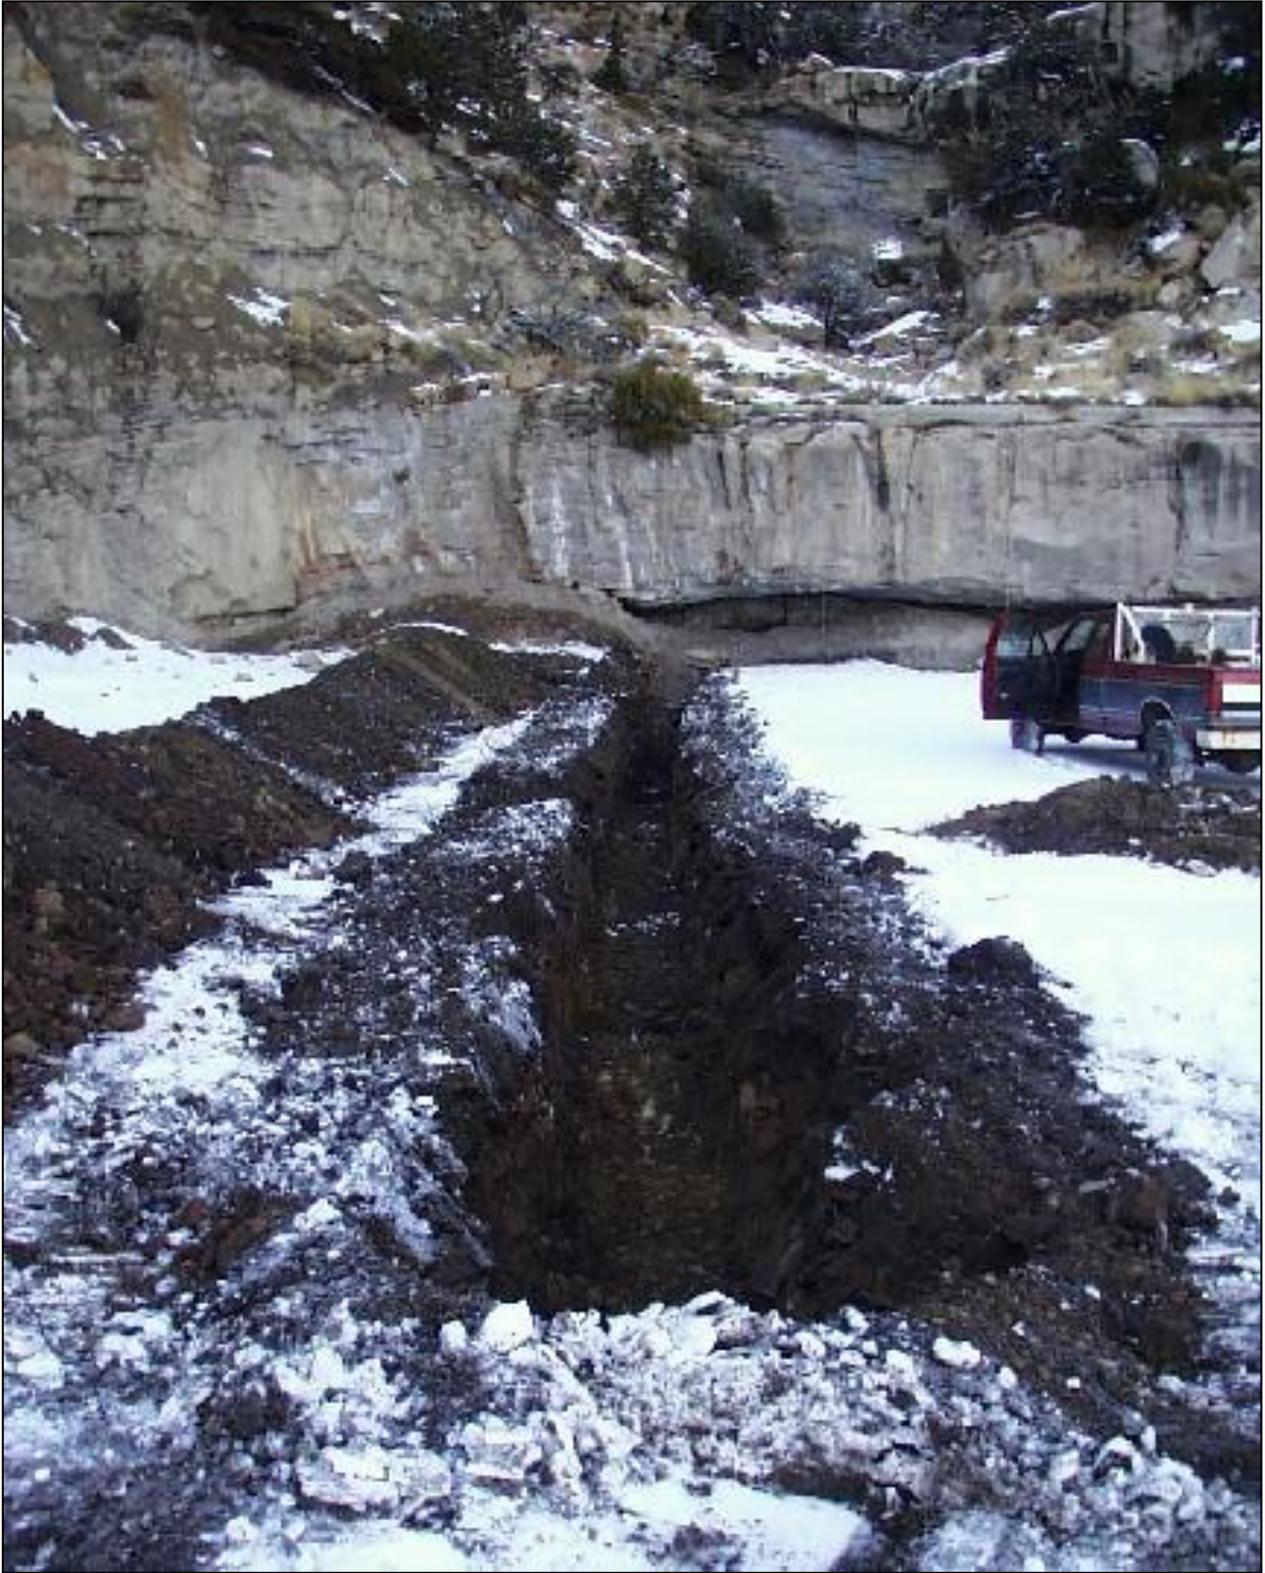
Figure 3: Trench #2 developed on the upper mine pad.

- #T2** -This trench was located on the pad site near the portal of the Beehive Mine. It consisted mostly of waste coal and rock over sandstone bedrock at a depth of 0.9 m to 1.2 m (3 ft to 4 ft). A 6 m (20 ft) section along the end of the trench near the portal had very dark grayish-brown loam soil material of better quality than elsewhere in the trench. It was of limited extent but visually was suitable substitute topsoil material.

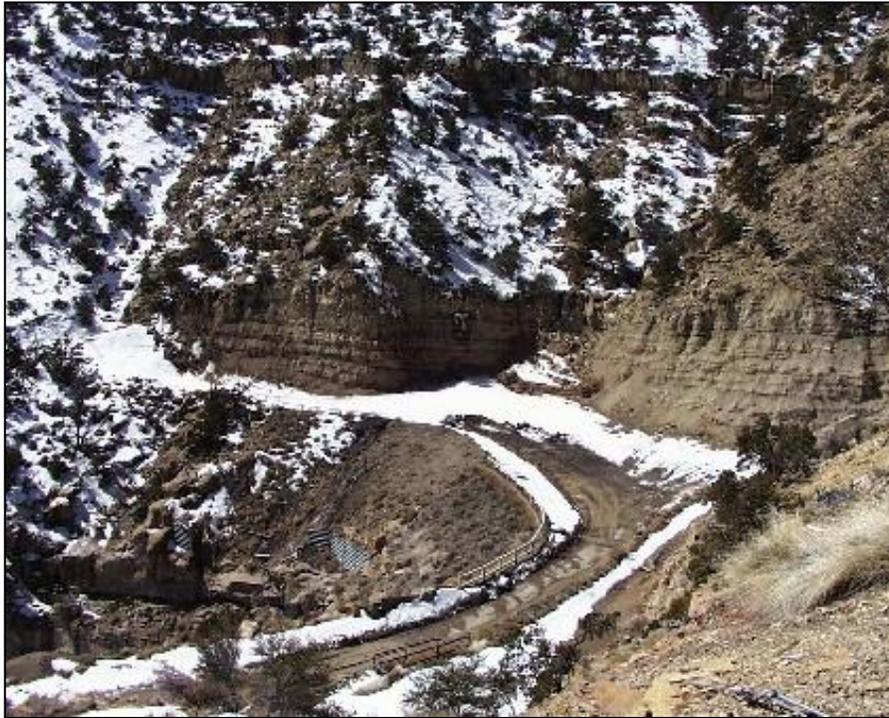
Figure 4: Upper mine portal of the Phase 1 area prior to backfilling and grading activities.

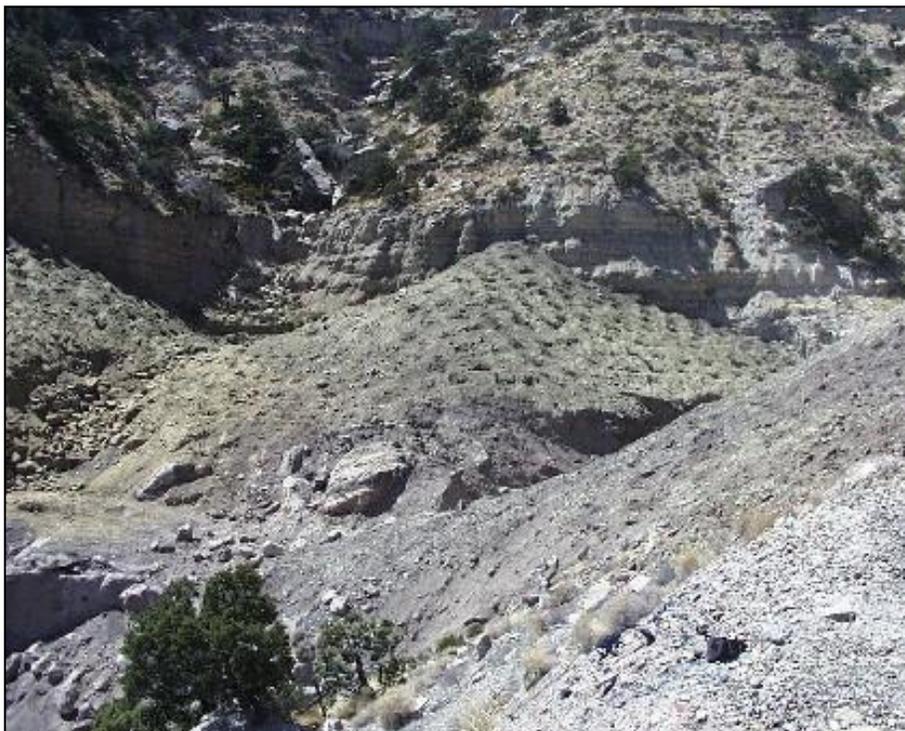
Figure 5: Upper mine portal pad of the Phase 1 area after final reclamation.

Reclamation of the remaining Phase 1 area (i.e. substation pad, water tank pad, access road, etc.) was completed utilizing the existing soil material. A total depth of approximately 0.6 m (2 ft) of substitute topsoil was used to cover the portal pad area. The remaining areas of the Phase 1 reclamation site was covered with approximately 0.3 m (1 ft) of substitute topsoil to complete the backfilling and grading processes. A certified weed-free hay was spread at a rate of 2,250 kg/ha (2000 lbs/ac) over the entire area and incorporated by deep gouging (pocking) in a random and discontinuous fashion. Pockmarks were developed to a size of approximately 0.9 m (3 ft) in diameter and 0.46 m (1.5 ft) deep. The pockmarks capture or trap precipitation, influencing infiltration, and serves to control erosion through water retention and thus, enhancing vegetation growth. The area was seeded by hand and hydromulched with a wood fiber mulch. A tackifier was mixed with the mulch at a rate of 560 kg/ha (500 lbs/ac) to provide additional soil stabilization. Fig. 4 and 5 show how the Phase 1 area looked before final reclamation and after. Phase 1 reclamation was completed in May 2001.

As of the writing of this report, a rich and diverse vegetative stand has developed in the Phase 1 area beyond original expectations. Erosion is controlled and channels remain stable.

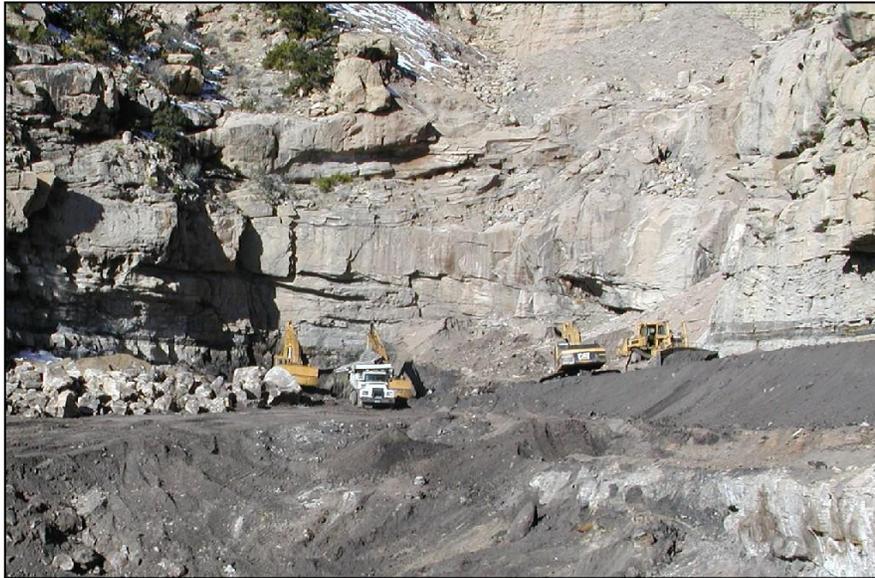
Figure 6: Backfilling highwall with spoil material at the lower mine portal pad.

Once the spoil was excavated and contoured, a final soil covering was placed. Since the spoil material analyzed as an acceptable or non-toxic material, a 1.2 m (4 ft) cover was not necessary. The soil salvaged from the Phase 1 area was used to cover the area. However, the volume of soil was only enough to cover a portion of the highwall located along the access road to the upper mine. Additional soil was necessary.

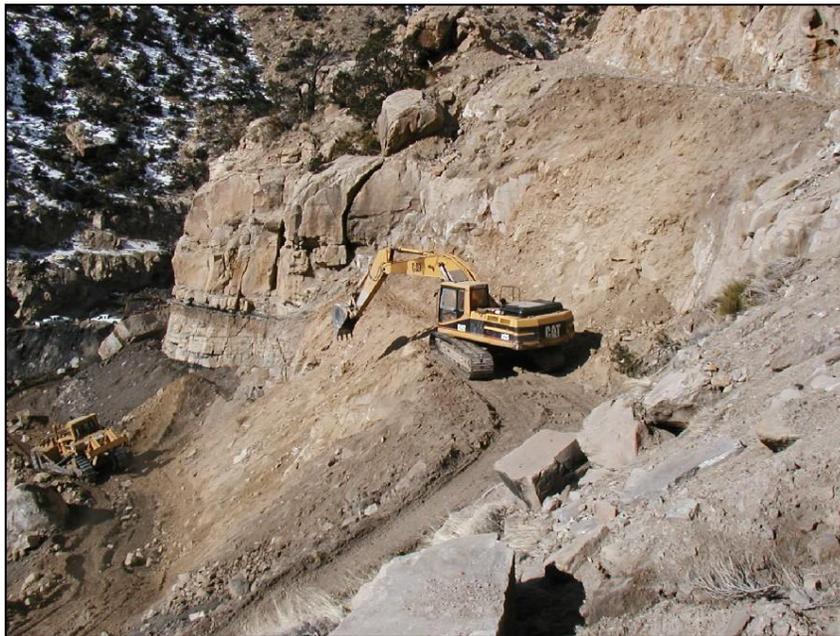
Figure 7: Substitute soil excavation between the switchback area of the upper mine

An area existed between the switchbacks along the road to the upper mine that contained a potential borrow area. The soil in this location had been cast off the side during construction of the access road to the upper mine. This soil was sampled and found to be suitable as a substitute topsoil material. As illustrated in Fig. 7, this soil was stripped to the bedrock and used to cover the remaining highwall area with a substitute soil approximately 0.3 m (1 ft) thick. When completed, the highwall area was poked, seeded and hydromulched.

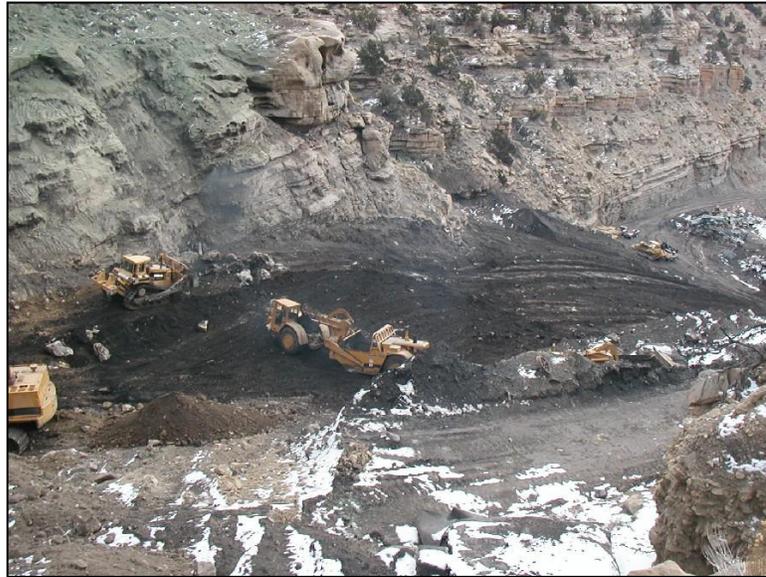
Figure 8: Removing spoil material by dozer and transporting with scraper down canyon.

At the completion of the portal pad and upper access road area, reclamation work continued down canyon. Spoil material not backfilled on the portal pad was pushed by dozer down canyon (Fig. 8) to a point where a scraper could access, retrieve and transport the material away.

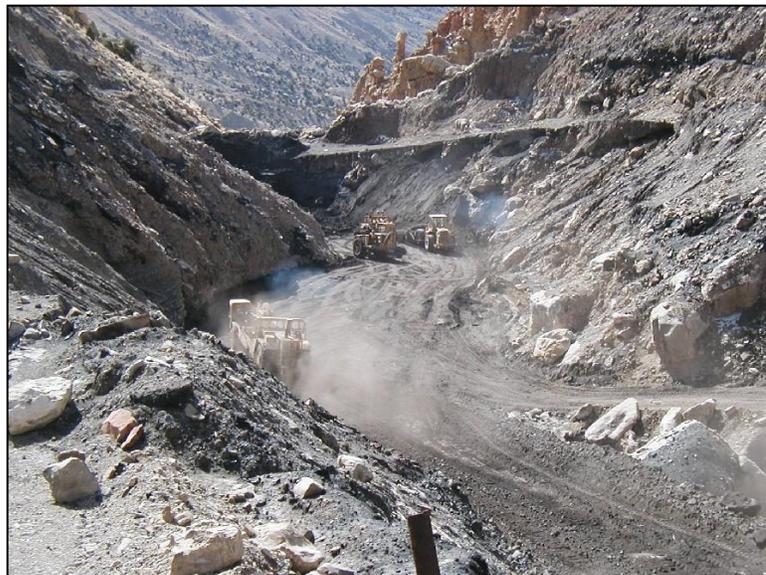
Figure 9: Placement and compaction of spoil material in canyon bottom.

As shown in Fig. 9, this material was used to backfill the canyon bottom. When this area was backfilled to an elevation of approximately 9 m (30 ft), the excess material was transported to the bathhouse pad to backfill the cut. The tipple area was excavated to the native material. Spoil material was excavated and used as fill along the west side of the lower mine portal pad and the lower mine yard area. Excess spoil from this area was transported to the bathhouse pad.

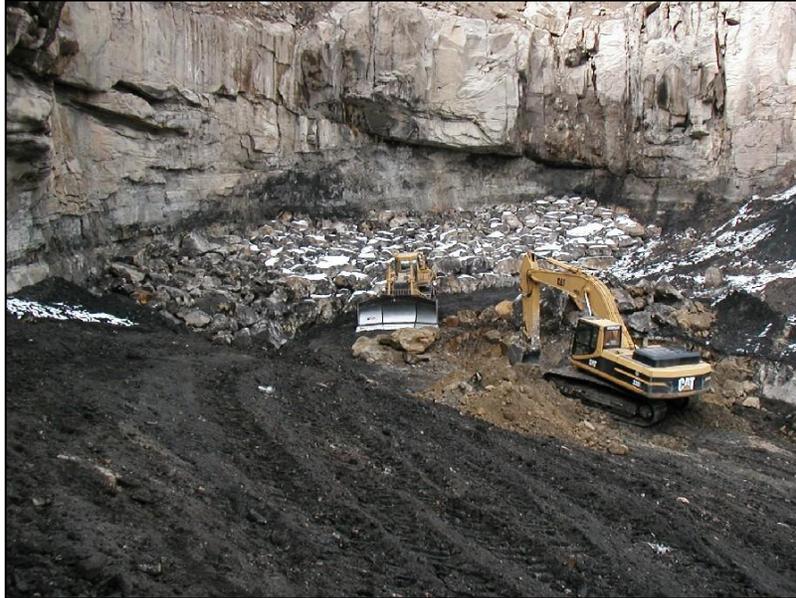
Figure 10: Commencing excavation of the upper channel to uncover the bedrock contacts.

During excavation of the main channel, the reclamation plan dictated construction would utilize the bedrock formations and natural drops that were characteristic of the area. This enabled a large amount of good quality soil material to be excavated from the upper part of the channel (Fig. 10). The excavated soil material was field tested and used to cover the spoil material backfilled on the west side of the canyon. A depth of cover up to about 1.2 m (4 ft) was achieved.

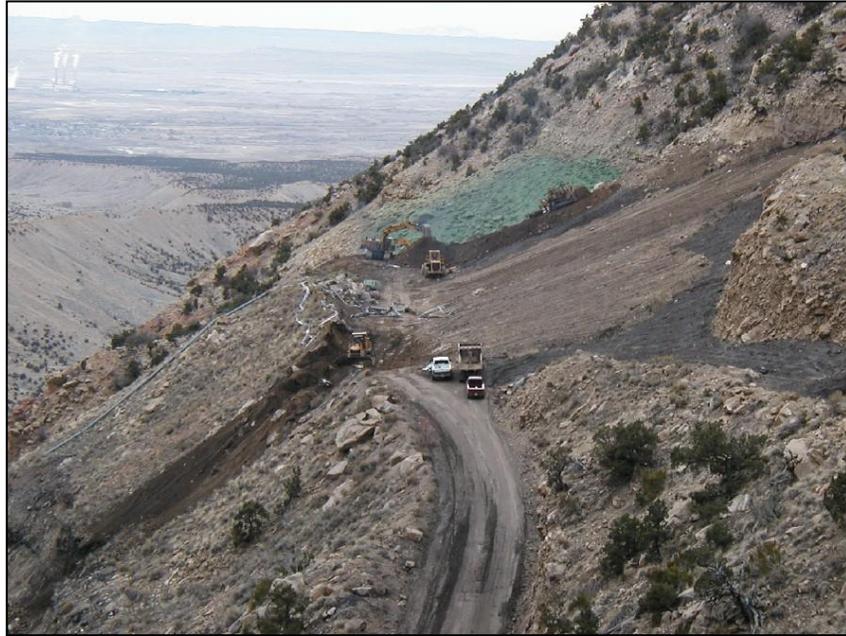
Figure 11: Covering bathhouse fill slope with topsoil.

In an effort to improve the overall final configuration of the bathhouse slope, a decision was made to re-work this area. The advantages of this decision were better slope stabilization, slope grade was reduced from 1.3:1 to 1.9:1 (as-built measurement), increased quantities of substitute topsoil (approximately $7,650 \text{ m}^3$ (10,000 cy)), and increased quantity of rock material to construct the main channel. The additional disturbance increased just 0.24 ha (0.6 ac). This work was completed using a dozer and two track-hoes. Figure 12 shows the process which was used to re-work the slope. The equipment traversed back and forth across the slope, over-casting the soil and rock material, while working its way to the canyon bottom.

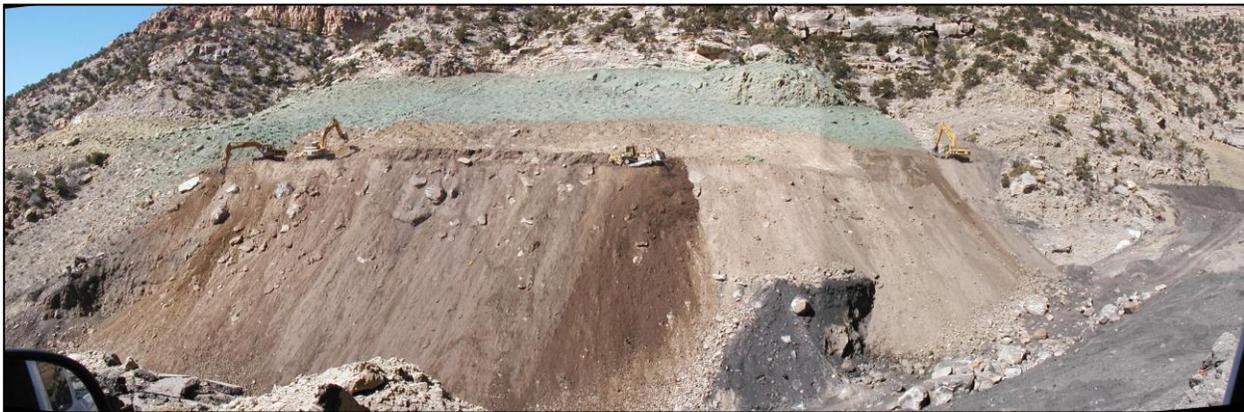
Figure 12: Re-working the bathhouse slope. Equipment traverses back and forth casting material to bottom of canyon.

As loose soil and rock cascaded to the bottom of the canyon, a dozer was stationed at the bottom to segregate the rock material from the soil material. Boulders were pushed to the side and sized according to the channel design requirements. Soil material was pushed by dozer up the east slope to cover the exposed side slopes that remained following the coal removal project. All soil from the bathhouse slope was utilized on the slopes on the opposite of the canyon as well as within the channel itself. As work progressed down the slope off the bathhouse pad, the areas were roughened, seeded and hydromulched.

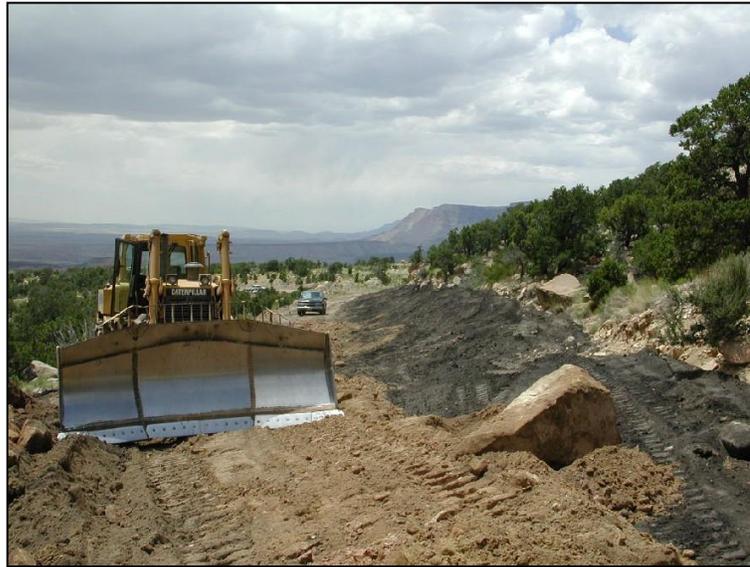
Figure 13: Reclamation of the main mine access road utilizing existing soil material.

The remaining reclamation consisted of the removal of approximately 1220 m (4,000 ft) of the main access road. The existing side cast material was utilized to backfill road cuts. The area was pocked, seeded and hydromulched as shown in Fig. 13.

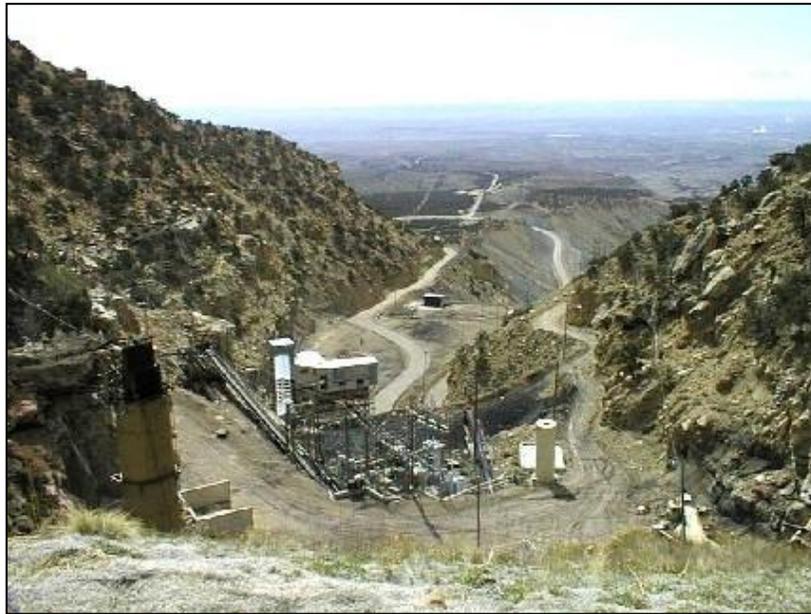
Figure 14: Des Bee Dove mine complex prior to reclamation in 1999.

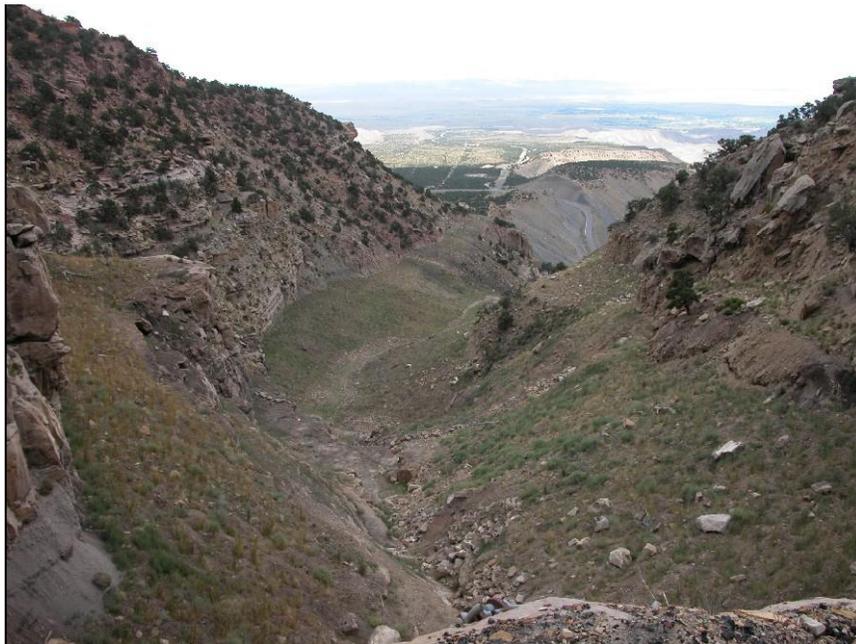
Figure 15: Des Bee Dove mine complex after the completion of reclamation. Photo taken in 2005

Today, three years after the completion of final reclamation, the Des-Bee-Dove Mine complex supports a broad vegetative cover that has protected and stabilized the reclaimed surface. Perennial grasses and woody plant species have begun to outnumber the exotic annuals. As desirable plant species progressively dominate the site, vegetative diversity increases significantly.

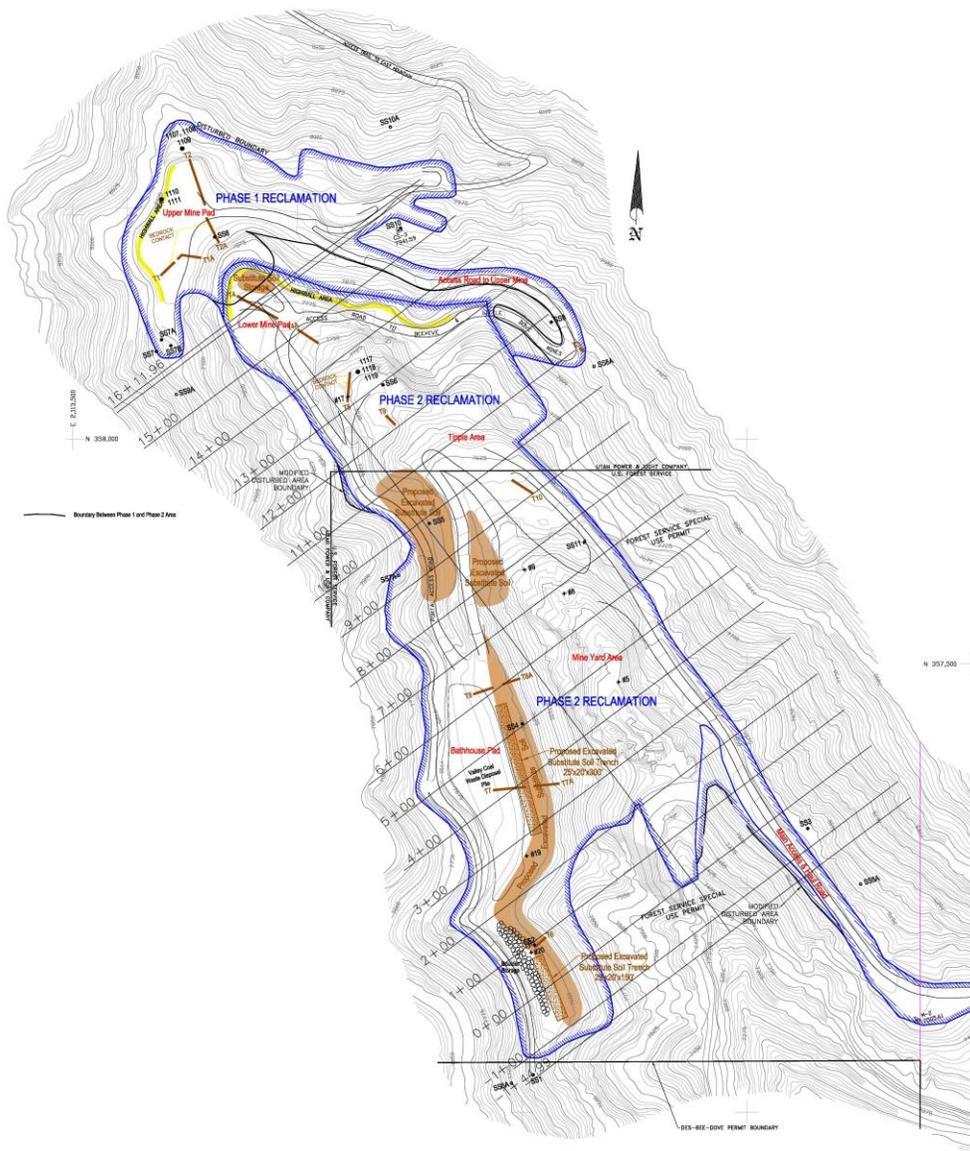
Appendix A: Map of mine site soil trench locations, soil salvage locations and soil storage locations. Note: Contours are post coal removal project.

Phase 1 Reclamation was initiated in May 2002. Recontouring of the pad area began on the west side and worked east (refer to map Appendix A). The majority of the soil material used in the project was obtained from the outslope of the mine portal pad. Approximately 15,600 m³ (20,400 cy) were excavated from this area (mostly from the pad outslope) and transported to fill the highwall developed during mining activities. Coal and substandard soils were found buried throughout the Phase 1 area. During the backfilling and grading activities, all unacceptable soil materials were buried at least 1.2 m (4 ft) below the surface and covered with an acceptable soil material.

The bathhouse pad, as shown in Appendix A, illustrates two borrow areas for proposed substitute topsoil: 1) the outslope of the pad and 2) excavated trenches. The trenches were excavated first. Approximately $6,350 \text{ m}^3$ (8,300 cy) of substitute material was excavated and stored in the mine yard area. This soil was to be used as a topsoil cover for the tippel area. The outslope area of the bathhouse pad was utilized for covering the imported spoil material which nearly filled the 762 m (2500 ft) long cut in that area. An estimated $6,650 \text{ m}^3$ (8,700 cy) was borrowed from this area. Additional soils from the bathhouse pad (e.g. drainage areas, etc.) combined to cover the entire area. The thickness of the topsoil in this area varied between 0.3 m and 0.6 m (1 ft and 2 ft). Fig. 11 shows the excavation and covering techniques used to place topsoil on this slope. The two other borrow areas shown north of the bathhouse area were not utilized since sufficient substitute topsoil was found at a more efficient location, the bathhouse slope.
