WATER QUALITY IMPACTS FROM IN-STREAM MINE TAILINGS IN RIO TARAPAYA, POTOSÍ, BOLIVIA¹

W.H. Strosnider², R.W. Nairn, H. Ríos Montero, F. Llanos Pinto

Proceedings America Society of Mining and Reclamation, 2011 pp 635-654

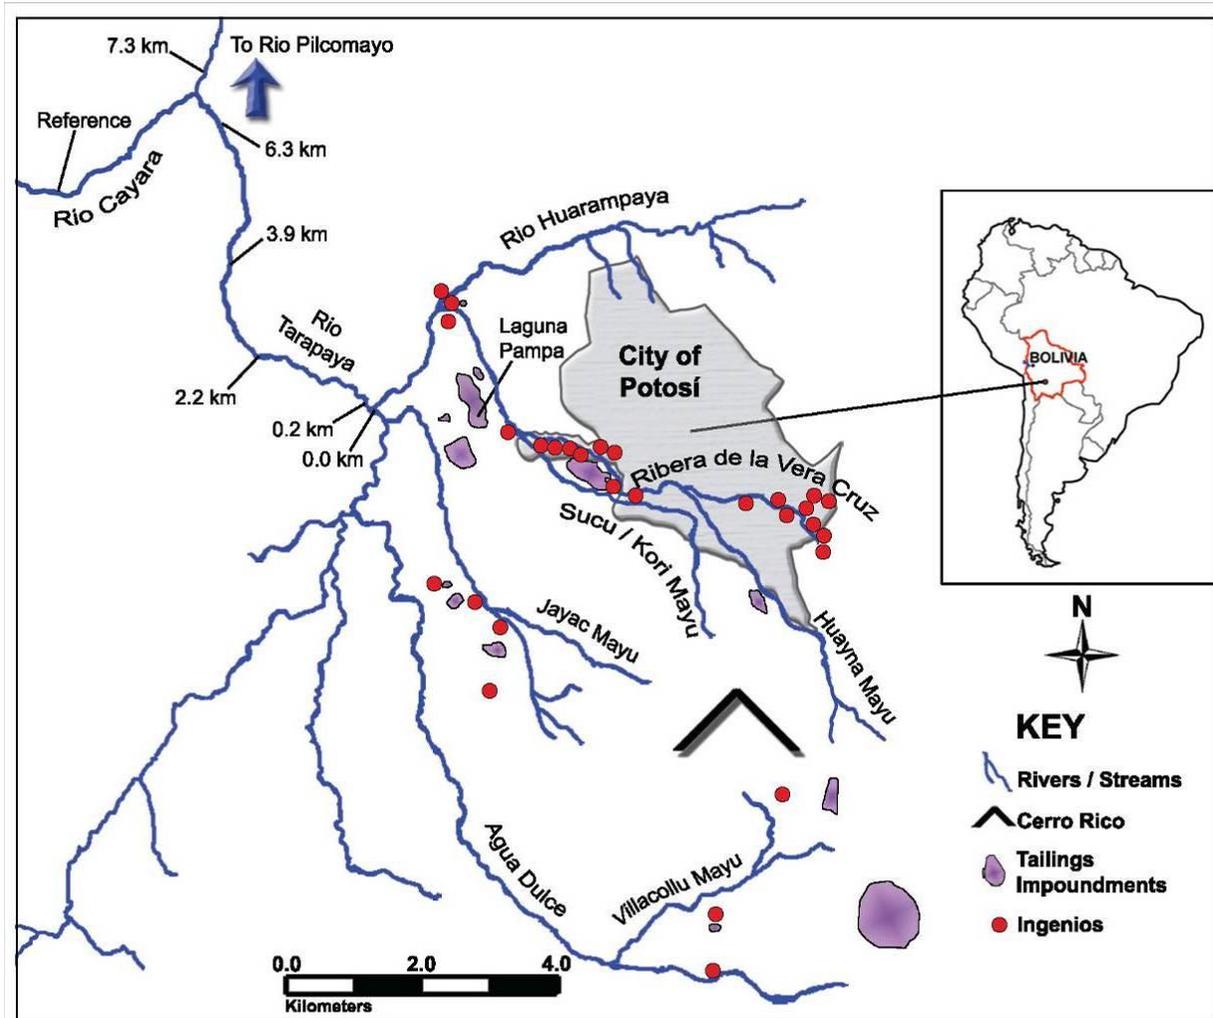
Figure 1: Location of each sampling location with respect to Potosí, mineral processing plants, and tailings impoundments.

Until the construction of tailings dams in 2004, Potosí's *ingenios* (ore processing facilities) continuously discharged tailings to the Ribera de la Vera Cruz, which empties into Rio Tarapaya at the outskirts of Potosí (Fig. 1). Rio Tarapaya is a chief tributary of the upper Rio Pilcomayo. Mining activities prior to 2004 were estimated to release approximately 370,000 tonnes/yr of mining-related sludge to the Ribera de la Vera Cruz (Smolders et al., 2003). As tailings discharge rates necessarily tracked mining activity, and mining proceeded at considerably higher rates at sustained intervals over previous centuries (Strosnider et al., *in press-a*), it can be induced that at least a few hundred million tonnes of tailings have been discharged to Rio Tarapaya via the Ribera de la Vera Cruz over the past five centuries. Despite the new tailings canal and tailings impoundments, some processing effluent still regularly enters the Ribera de la Vera Cruz, often washed in during rain events from an overflowing tailings canal and/or poorly designed floatation ponds or purposely released to avoid costs associated with pumping tailings to the dams (Strosnider et al., *in press-b*). The substrate of Rio Tarapaya is dominated by tailings due to the near-continuous discharges of tailings from Potosí and from events such as the hydropower dam failure in 1626, which caused extreme destruction over two hours as an increasingly polluted torrent of ore, tailings, amalgam and Hg rushed down the Ribera de la Vera

Sampling locations framed a reach of Rio Tarapaya starting at Rio Agua Dulce (sample point 0.0 km on Fig. 1) before its confluence with the Ribera de la Vera Cruz and ending after Rio Tarapaya confluences with Rio Cayara. Rio Agua Dulce is impacted by the AMD and tailings - influenced Jayac Mayu, which drains AMD from the Western slope of Cerro Rico and runs by a few *ingenios* which are likely discharging to it (Strosnider et al. *in press-b*). The second sample point (0.2 km) was approximately 0.05 km downstream of the confluence of Rio Agua Dulce and the Ribera de la Vera Cruz. The Ribera de la Vera Cruz, whose bed is dominated by tailings, receives the untreated municipal wastewater, stormwater, and *ingenio* discharges of Potosí proper along with the AMD discharged on the Northern and Eastern slopes of Cerro Rico (Strosnider et al. *in press-b*). Sample point "2.2 km" was located within a steep canyon in Rio Tarapaya near the "Puerta del Diablo" landmark cave. Sample point "3.9 km" was located just

LS and HS samples were collected at each location noted in Fig. 1 from the top 0.1 m of sediment. LS samples were spaced linearly $\frac{1}{4}$, $\frac{1}{2}$, and $\frac{3}{4}$ across the active channel perpendicular to the direction of flow. Each LS sample was a three-part linear composite centered upon the sampling location with equal parts sediment gathered at the sampling location and 0.2 m to each side perpendicular to the direction of river flow (Fig 4). HS samples were collected below bankfull discharge stage and above the active channel, 25 m up- and down-stream of the central LS sampling location (and the in-stream sediment sampling location). HS up- and down-stream samples were taken on opposite sides of the river than the central sampling location. The side of the river sampled twice was randomized. Each HS sample was a three-part linear composite centered upon the sampling location with equal parts sediment gathered at the sampling location and 0.5 m to each side parallel to the direction of river flow. Three three-part linear composite

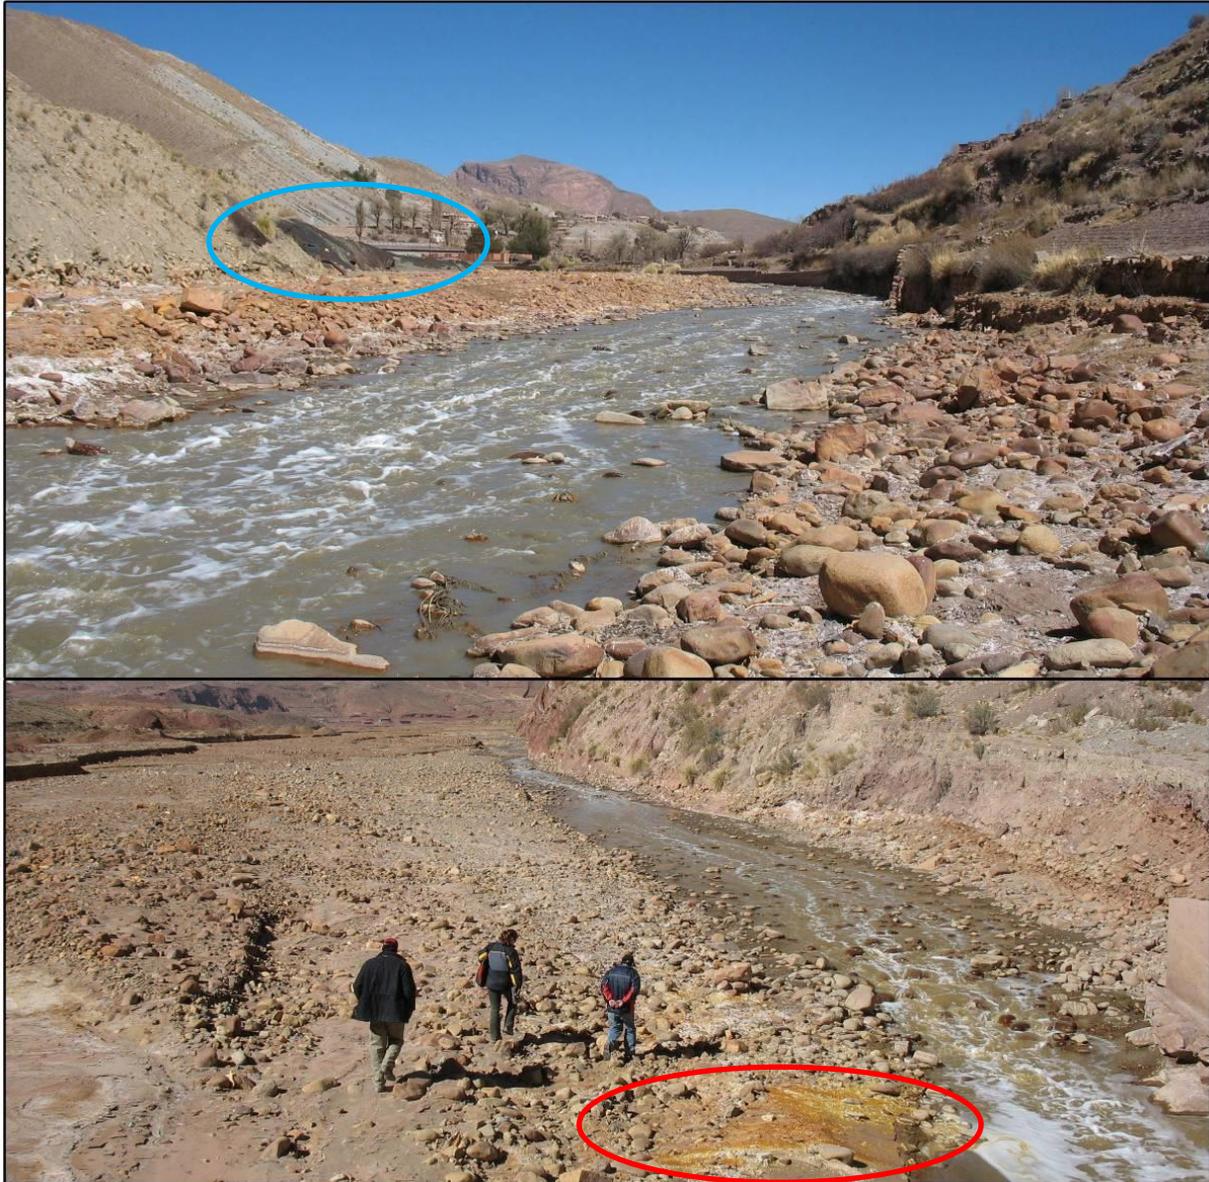
Figure 2: Sampling point “7.3 km” after the confluence of Rio Tarapaya and Rio Cayara (top). The black slag from the Sn-smelter can be seen at the center left of the image circled in blue. Sampling point “6.3 km” as seen from a nearby bridge (bottom). The telltale red tint of pyrite weathering can be seen along the banks of each reach, with a vivid example circled in red.

after Rio Tarapaya exits the canyon of “Puerta del Diablo” and consists of a lower gradient braided channel. Sample point “6.3 km” is in a similar setting that borders a lime (CaO) processing plant (Fig. 2). Sample point “7.3 km” was approximately 0.17 km after Rio Tarapaya’s confluence with the unimpacted Rio Cayara (Fig. 2). A slag heap from a Sn-smelter that operated briefly in the 1980s is centered at this confluence and runs along the East bank of

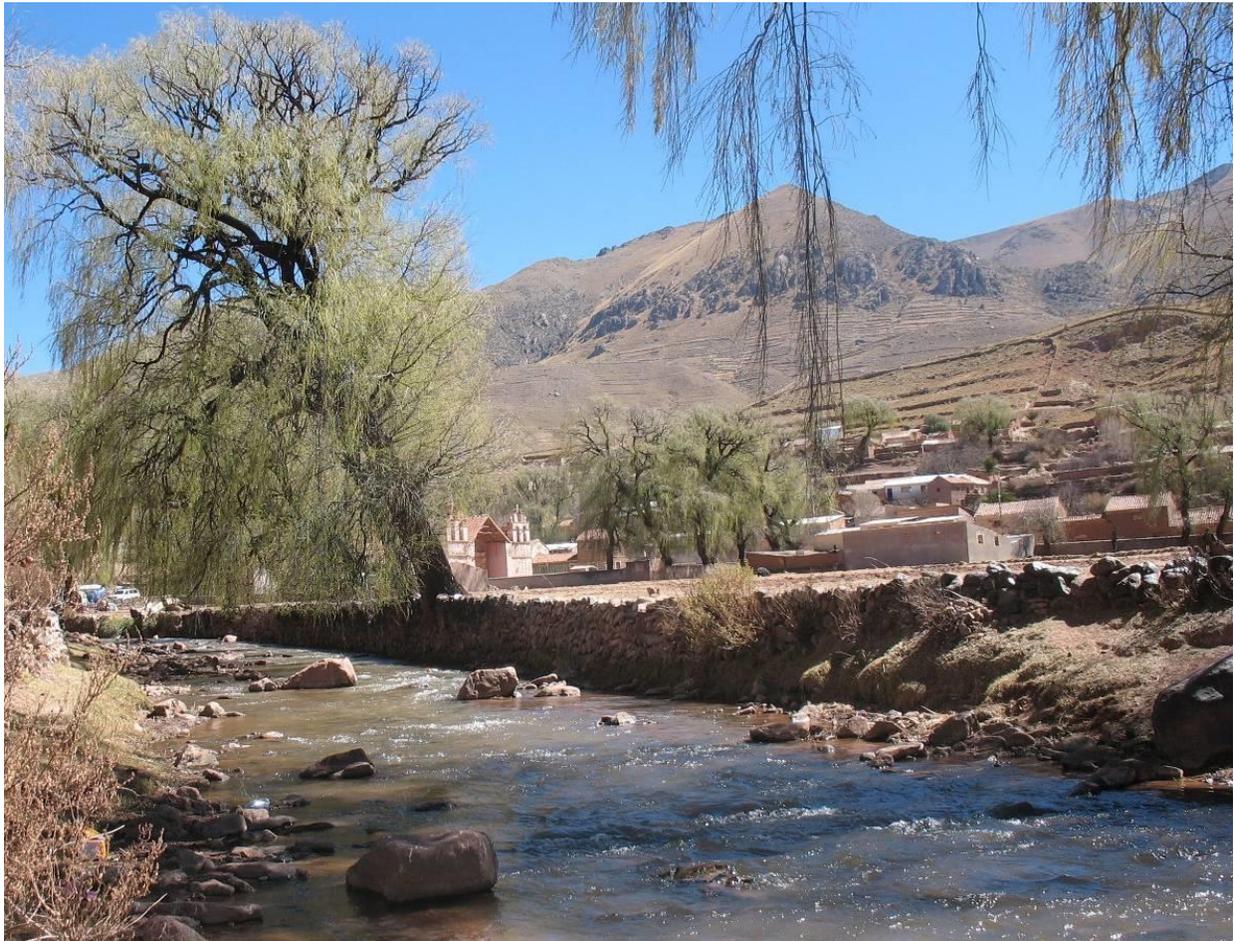
Figure 3: The reference reach in Rio Cayara with respect to the farming community which makes use of it for irrigation, animal watering, and household consumption.

Rio Tarapaya. Tailings dominated the bed material of the entire reach of Rio Tarapaya sampled. The reference reach, Rio Cayara (Fig. 3), is an important water resource in a productive agricultural watershed, which is nearly the same size as that of Rio Tarapaya, in which no evidence of mining was observed although cannot be ruled out because of the ubiquity of mining in the region (Strosnider et al. *in press-b*).

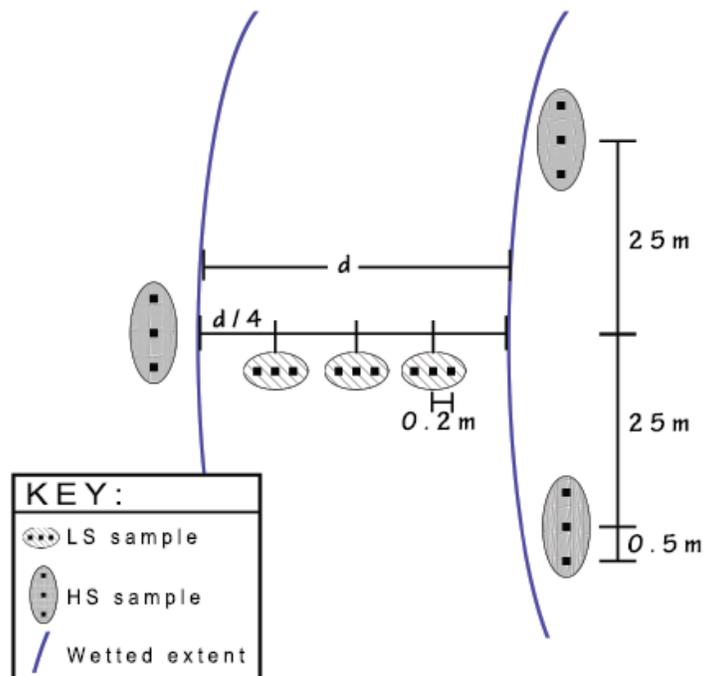
Figure 4: HS and LS sampling plan (not to scale).

samples were taken from an unsaturated zone of the Laguna Pampa tailings dam, Potosí's primary tailings dam. All sediment samples were gathered with a steel shovel that was decontaminated between sites into sealed Whirlpack® bags.
