CO-OPERATIVE PARTNERSHIP AND INNOVATION IN THE PLANNING AND EXECUTION OF THE DECOMMISSIONING OF THE MT MCCLURE GOLD PROJECT¹

Harley Lacy² and Mike Slight²

Proceedings America Society of Mining and Reclamation, 2005 pp 654-666

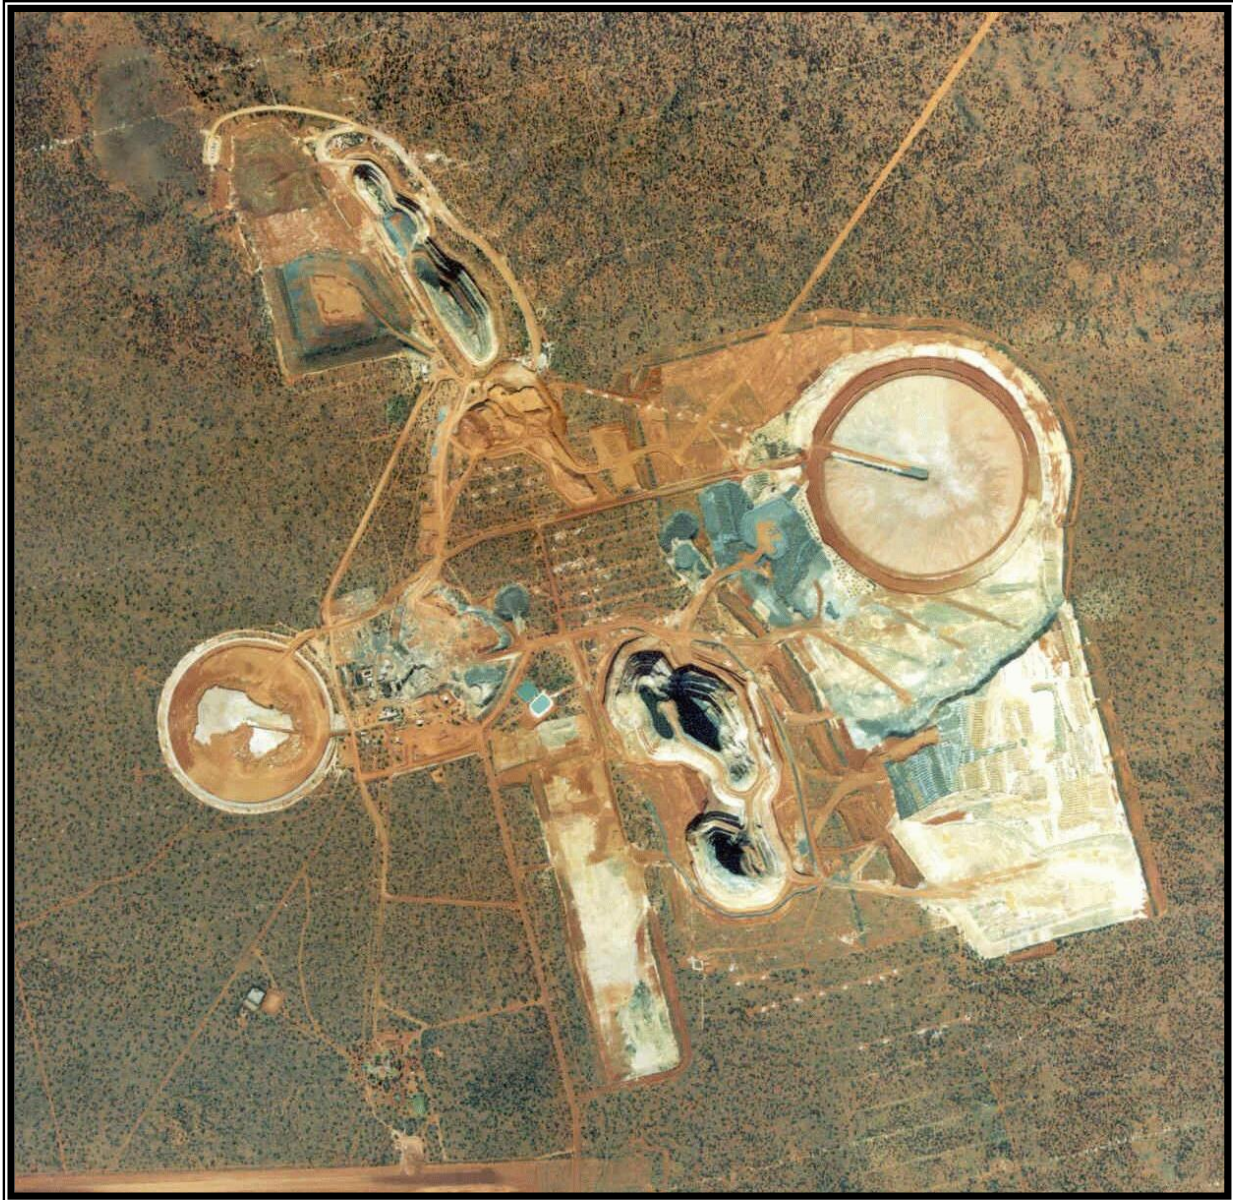
Plate 1 **Mt McClure Mine Site Prior to Closure - 2000**

8. Plant Site Decommissioning: A complete processing plant remained at the project, but had degenerated to the point to which there was no resale value
9. Contractor Management: A general lack of competency in the earthmoving contracting sector with regard to rehabilitation earthworks, and a prevailing contractor attitude that rehabilitation works were not core business
10. Verification: No process of verification of the design and material utilisation principles promoted in the initial closure plan, to assure regulators and other stakeholders of the quality and consistency of the designs. (**Plates 1, 2, 3**).

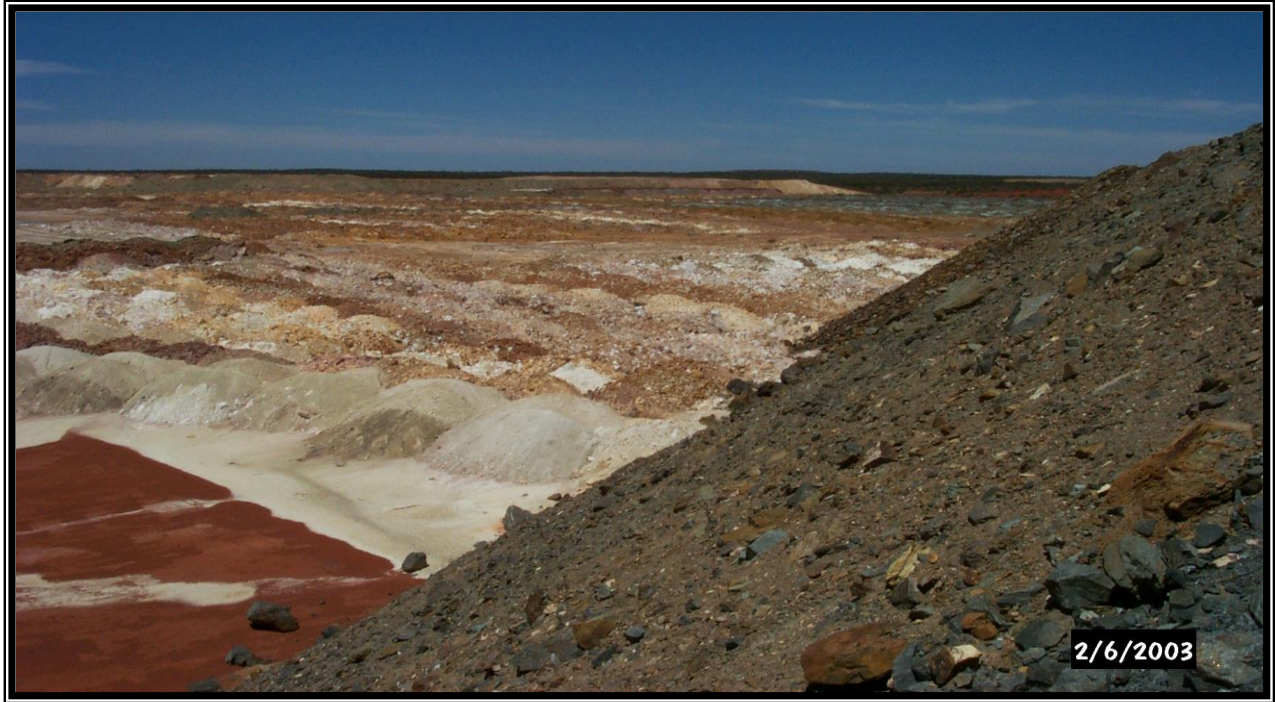
Plate 2 **Waste Rock Material Prior to Rehabilitation**

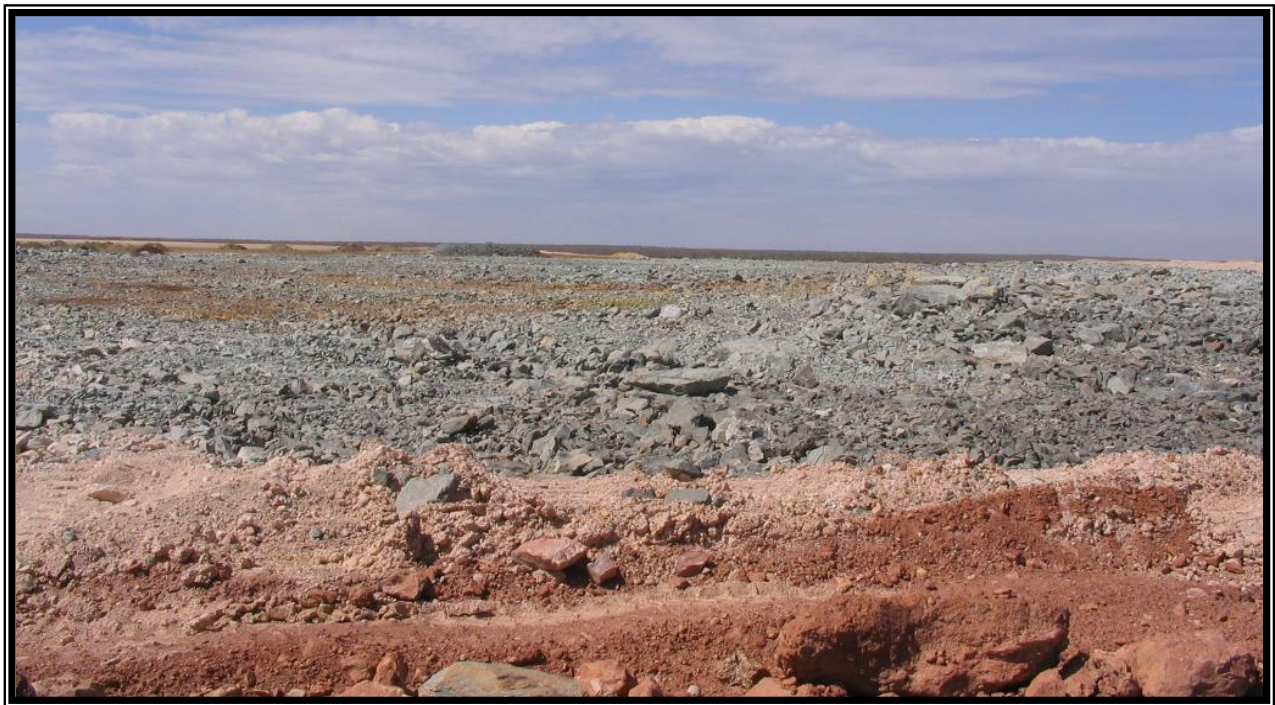
Plate 3 **PAF waste material uncapped over landform surfaces**

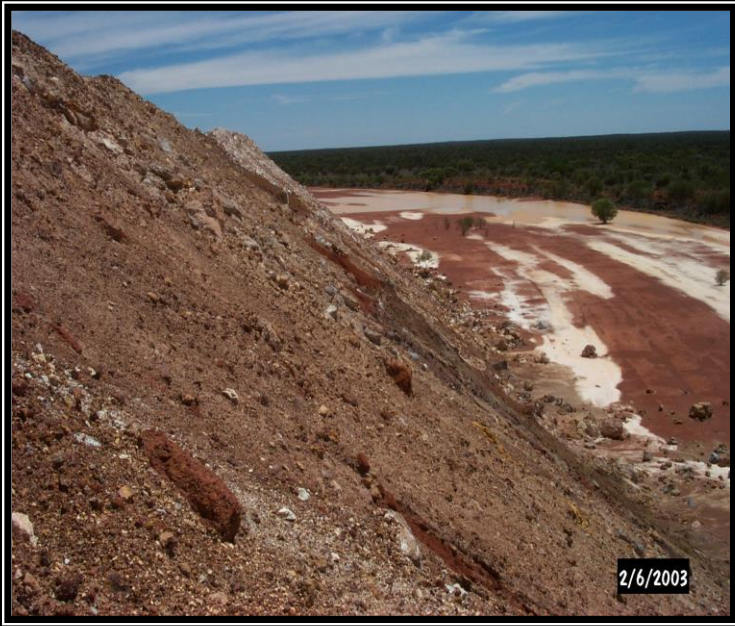
Plate 4 Steep Slopes pre-rehabilitation TFS4

One of the key features of much of the work at the Mt McClure Project is the considerable effort put into good drainage control to manage water appropriately on the tops and berms of the facilities. In many cases, rolled clay bunds were built and then armoured with a coarse caprock. In other places bunding was used to create cells across the upper surface of the tailings facilities and landforms, to ensure that areas of ponded water were minimised, and infiltration maximized.

Large, angle-of-repose landforms were formed into concave slopes and capped with laterite rock mulch. The site has approximately 10 km of slopes in this form, providing a large-scale trial for observation and assessment of the merits of this new form of slope design.

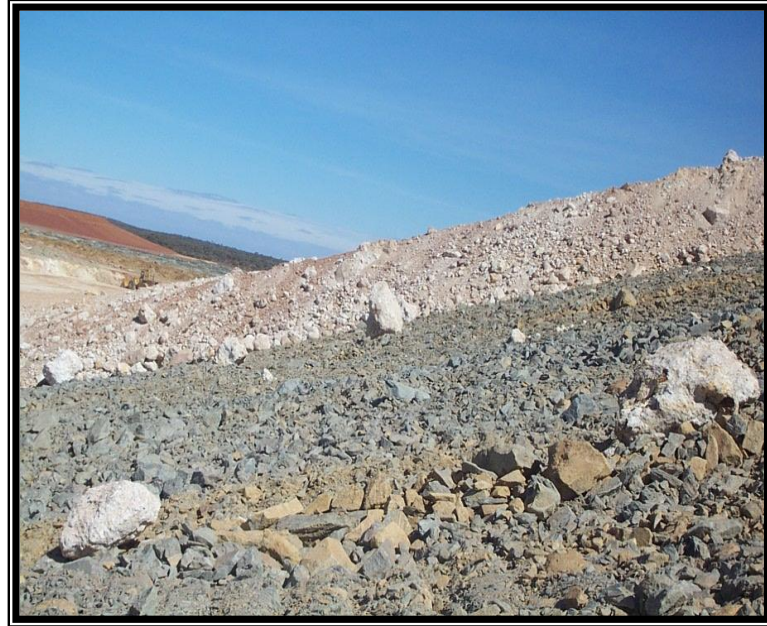
Plate 5 Slopes shaped concave and overlaid with oxide

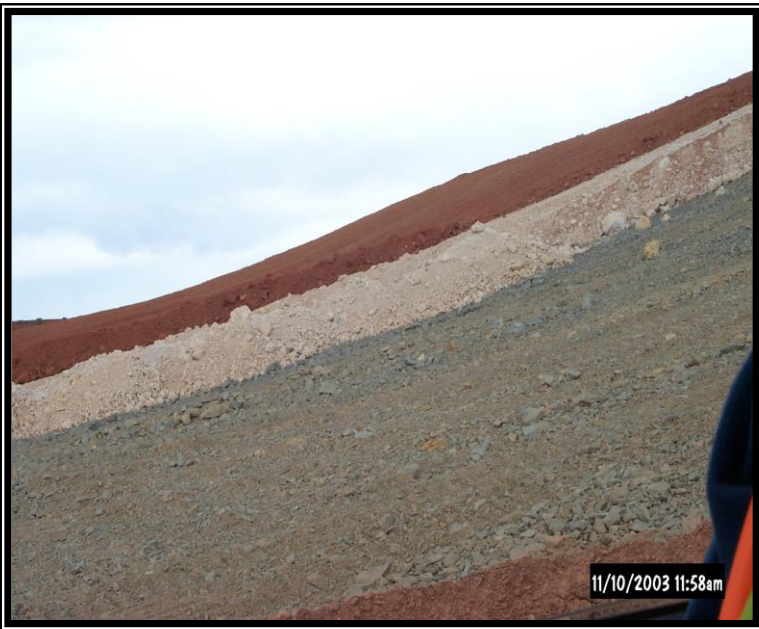
Plate 3 Laterite placed over oxide layer on PAF slopes

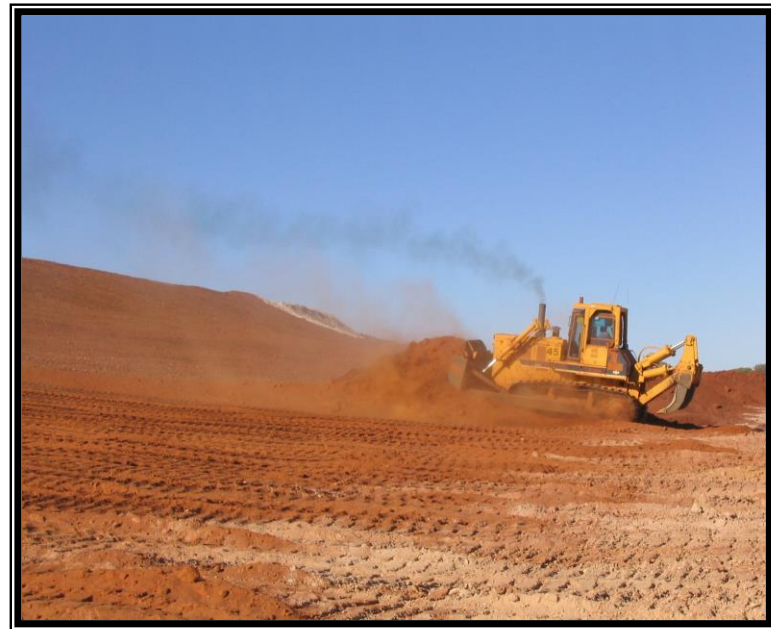
Plate 6 Fine topsoil placed over laterite

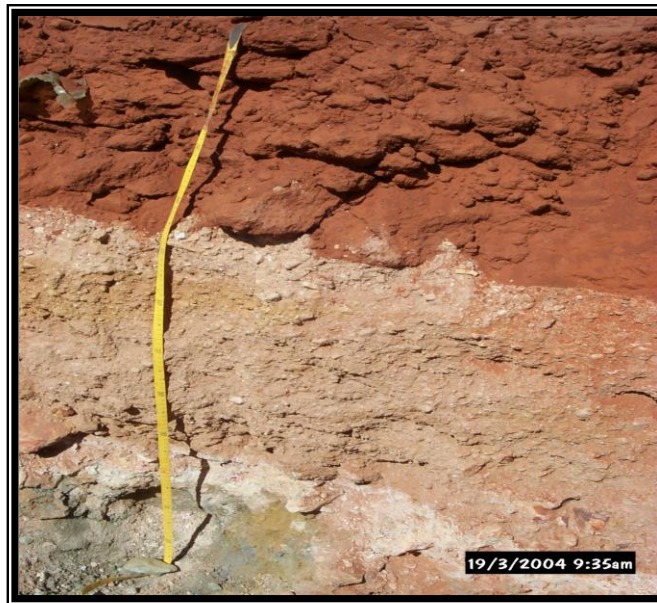
Plate 7 Capping material over acid waste material

The verification process was an innovation that demonstrated that works in their completed state are in alignment with the various principles and technical specifications outlined in the plan. The process included aerial photography, photography of test pits and sample analysis together with monitoring of water and rehabilitation (**Plate 7**).

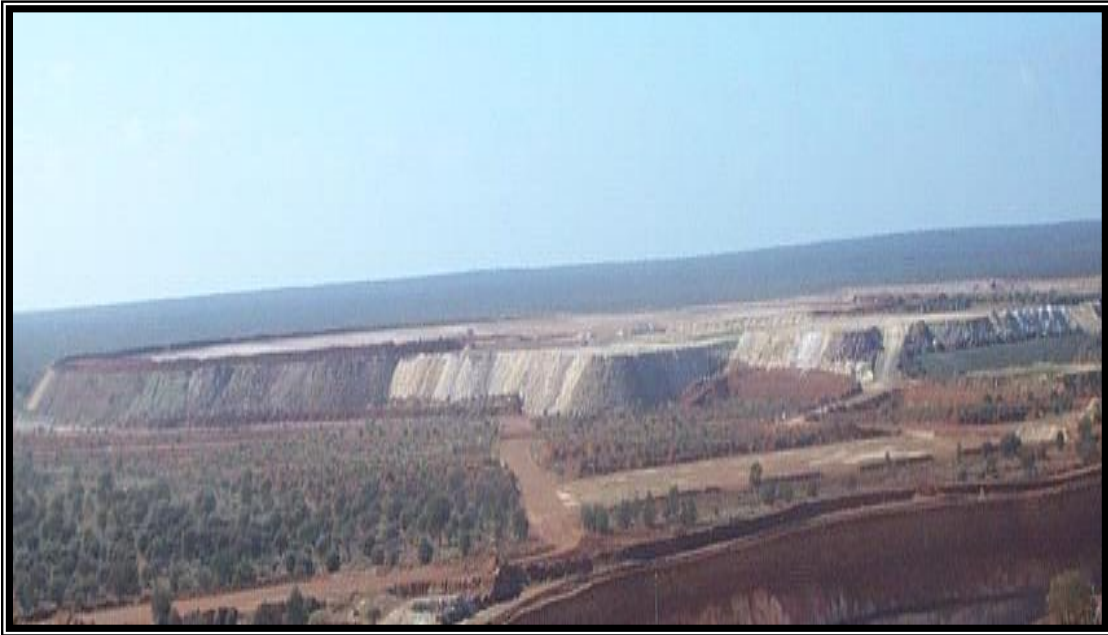
Plate 8 TSF4 Before Rehabilitation Works

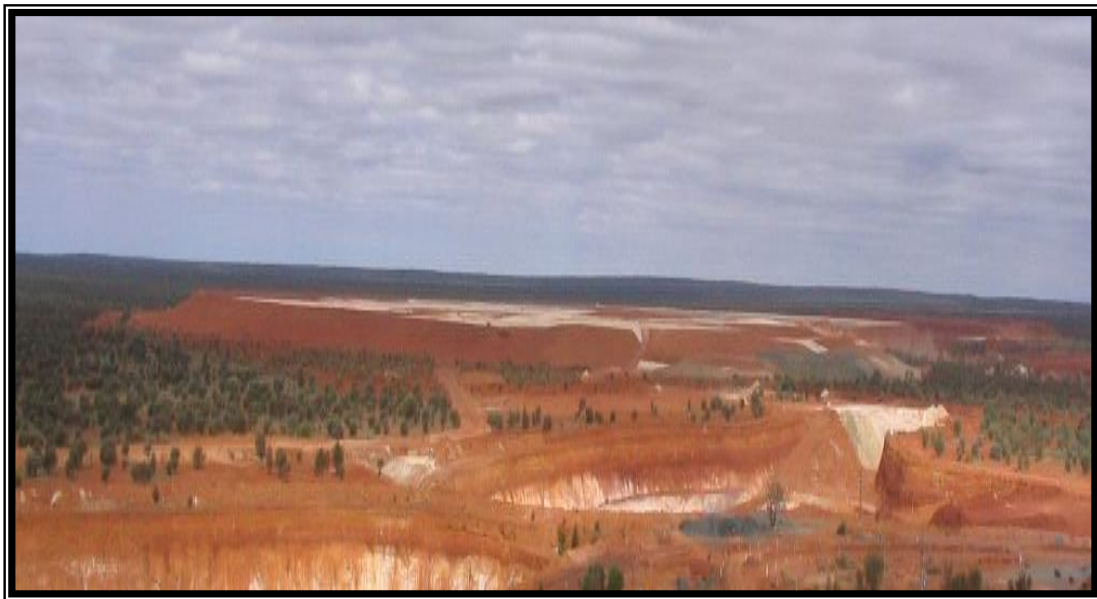
Plate 9 TSF4 During Rehabilitation
