# RESTORATION OF GRIZZLY BEAR AND WETLAND HABITATS AT THE ABANDONED SNAKE RIVER GRAVEL MINE, JOHN D. ROCKEFELLER, JR. MEMORIAL PARKWAY, WYOMING <sup>1</sup>

Chris L. Walla <sup>2</sup> and Daniel B. Adams <sup>2</sup>

Proceedings America Society of Mining and Reclamation, 2006 pp 763-772

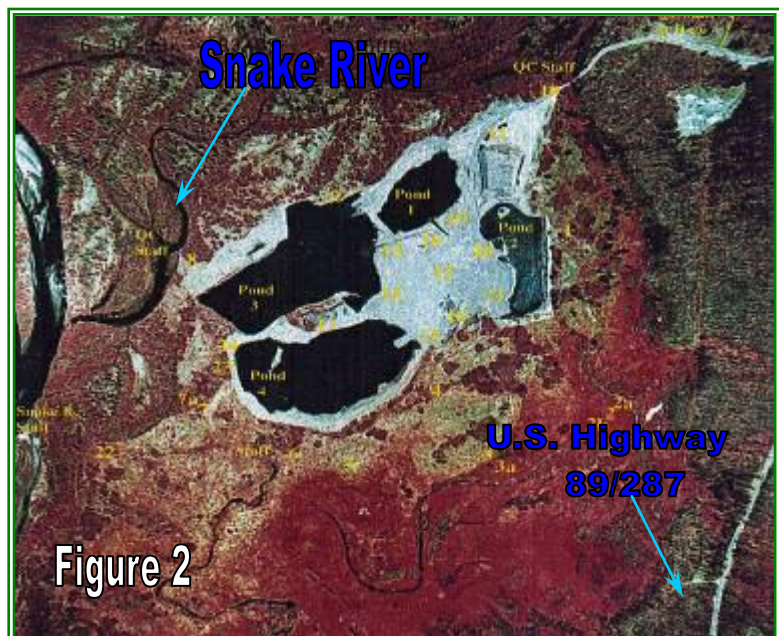
The results of the photo analysis were aided by a 1993 color infrared photograph (See Fig. 2) and annotated overlays prepared by the EPA. The annotated overlays depict alterations of the natural drainage system and vegetation cover of the Snake River Floodplain, and indicate the extent of mine development within the designated “Mine Perimeter” boundary. The annotations facilitated the Engineer’s viewing and understanding regarding the changes that took place before and after August 3, 1977.

The exact dates of mine related disturbances could not be determined. However, the Engineer was able to determine through review of available correspondence, documents, reports and aerial photos that portions of the Snake River Gravel Mine were disturbed prior to August 3, 1977 and are therefore eligible for AML funding. Results of the findings are presented in Tables 1 and Table 2.

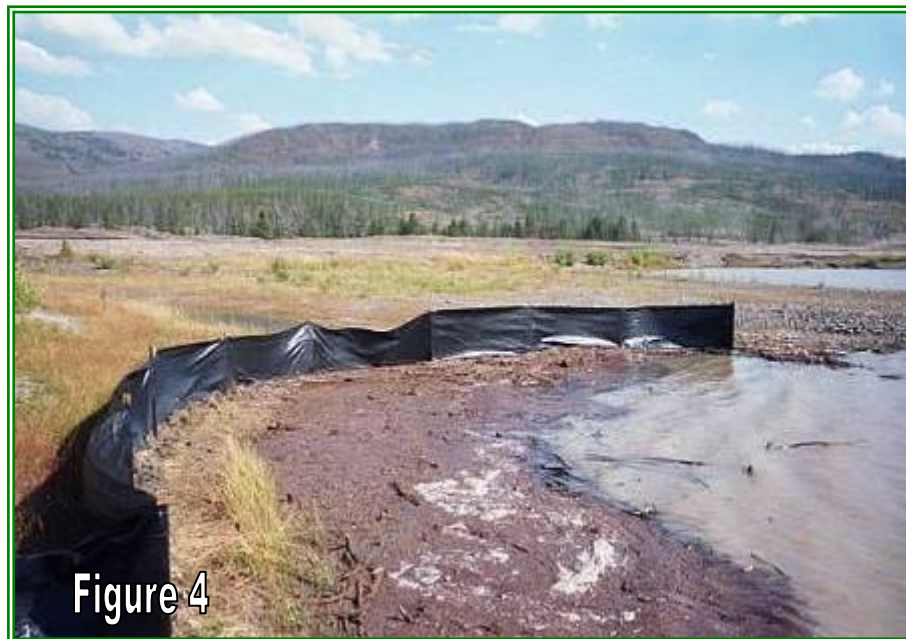
Figure 4

Special efforts were undertaken by the project design team to prepare contract specifications and develop reclamation grading plans that reduced the total impact to the Boreal Toad breeding habitat. Grading work near the eastern portion of Mine Pit 1 was delayed until after the third week of August to ensure the current year's breeding effort was not destroyed. Erosion control sediment fence and sediment traps were constructed along the perimeter of the breeding areas to reduce impacts caused during rain and storm events (See Fig. 4). Field Orders were prepared and implemented that authorized the Construction Manager to adjust grading plans within the project area during construction activities to save existing sparse to moderate stands of short, emergent vegetation within Mine Pit Nos. 1 and 3. In addition, a mandatory training meeting was conducted by the Grand Teton National Park Service prior to initiating grading work to educate the Contractor's construction crew concerning the sensitive nature of the site and its importance to Boreal Toads.

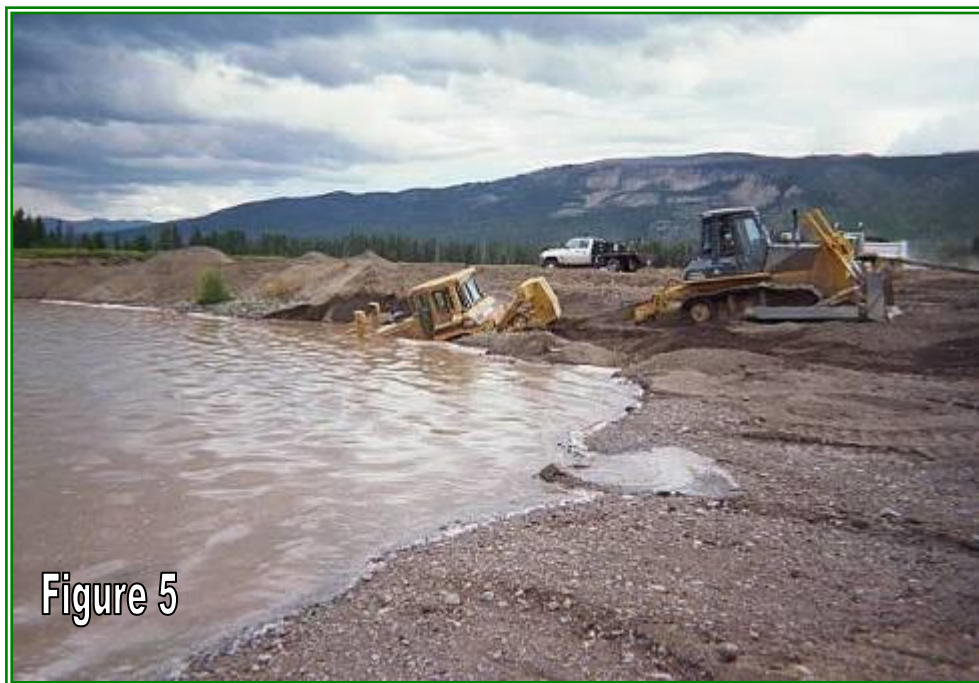
The Department of Environmental Quality (DEQ) considered all waters associated with the Snake River and all of its tributary channels and associated wetlands as Class 1 surface waters. The DEQ concluded that, due to the hydrological connection between the Snake River and the project area by groundwater and potential surface water, any substantial, earth-moving activity within the project area would result in a surface or point source discharge into the Snake River. Therefore, it was necessary for the design team to obtain a DEQ National Pollutant Discharge Elimination System (NPDES) discharge permit and Clean Water Act Section 401 certification prior to performing grading activities. In order to reduce the impact to the Snake River, the reclamation grading plan included the reshaping of existing inundated pits, creation of on-site channels that permit flooding during wet periods, and construction of five (5) on-site ponds. The final alignment and configuration of the ponds were constructed to reduce wave erosion caused by prevailing winds, increase shoreline sinuosity, provide mini-environments for each specific herbaceous plant specie required, and duplicate the pattern of adjacent Snake River oxbows. The project area is located on an alluvial terrace of gravel and cobble within the Snake River floodplain that created stability problems for the contractor's heavy equipment when performing grading activities adjacent to existing pits (See Fig. 5).
