ALKALINE ADDITION PROBLEMS AT THE SKYTOP/INTERSTATE-99 SITE, CENTRAL PENNSYLVANIA¹

Arthur W. Rose and Hubert L. Barnes²

Abstract. In 2002-3, approximately 8×10^5 m³ of pyrite-bearing Bald Eagle sandstone and Reedsville shale were removed from a large road cut through Bald Eagle Ridge near State College, PA. The rock contained an average of about 4.5% pyrite as veins and fine veinlet networks across 200 m of road cut. Smaller amounts of ZnS and other heavy metal sulfides accompany the pyrite. The rock was placed in 9 nearby locations, including large waste piles and several valley fills, two ‘buttresses’ and a lane elevation along about 0.8 km of hillside that was threatening to slide into the road. During excavation of the cut, pyrite was recognized as a potential problem and considerable lime was added as layers to the various piles. Despite the lime addition, highly acidic seeps emerged from the piles and fills, with pH 2.0 to 2.7, Fe 90-1500 mg/L, and acidities as high as 18,000 mg/L (as CaCO₃). These results clearly show that addition of lime and other alkaline materials as layers is not effective.

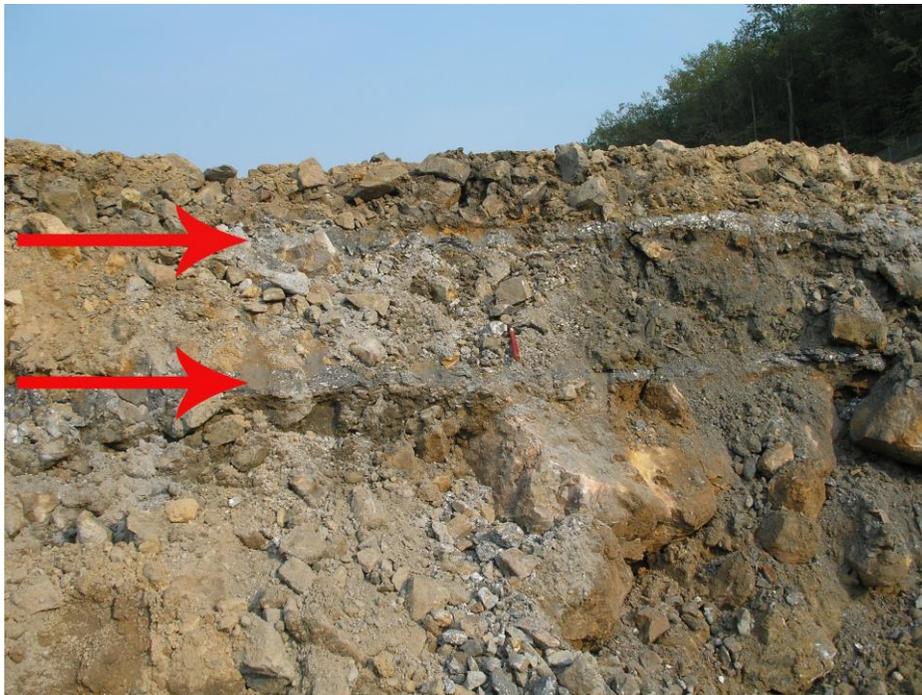
Figure 5. Photo of trench wall cut into the Buttruss after Bauxsol slurry was sprayed onto the surface. Gray layer just above hammer is a lime layer; another is just at the level of the hammer. Red stain is from Bauxsol, but below the lower lime layer it has fallen onto the face from above after the trench was cut. Nearly all Bauxsol is above the lime layers

of acid. At a couple of localities the red Bauxsol had moved down channels until it encountered a layer of lime. Based on red staining, the slurry above the lime layer apparently moved laterally, but beneath the lime layer, there was essentially no indication of any penetration of Bauxsol. The lime layers acted as aquicludes, preventing downward flow of the slurry.
