RESTORATION OF THE FLOODPLAIN OF THE SOUTH FORK OF THE COEUR D'ALENE RIVER: A CASE STUDY OF APPLIED RESTORATION THEORY¹

Timothy A. White², Gary W. Rome, John H. Rogers, Brenda K. Osterhaug, Carmela L. Grandinetti, and Joan Stoupa

Proceedings America Society of Mining and Reclamation, 2003 pp 1427-1450

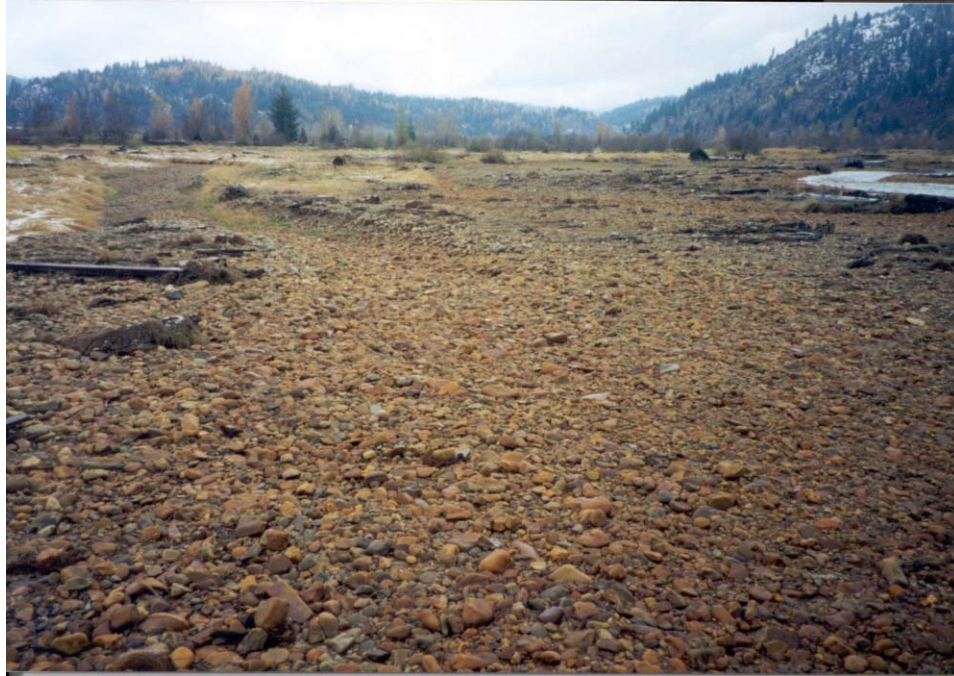
Figure 1. Smelerville Flats looking west. Note branch of the South Fork Coeur d’Alene River on the right. In immediate foreground are metals-contaminated tailings that were subsequently excavated and transported to another location for long-term containment (Photo taken in November 1996).

The Bunker Hill Mining and Metallurgical Complex Superfund Site (the Site; Figures 1 and 2) is located in the northern Idaho county of Shoshone. The Site, part of the Bitterroot Mountains, lies in the Silver Valley of the South Fork of the Coeur d'Alene River (SFCDR). The Silver Valley is a steep mountain valley that trends from east to west and, as the name suggests, is rich in precious metals and other minerals of economic importance. The Site has an elevation of approximately 685 meters above mean sea level (MSL). Interstate 90 (I-90) bisects the Site east to west and more or less parallels the SFCDR through this area.

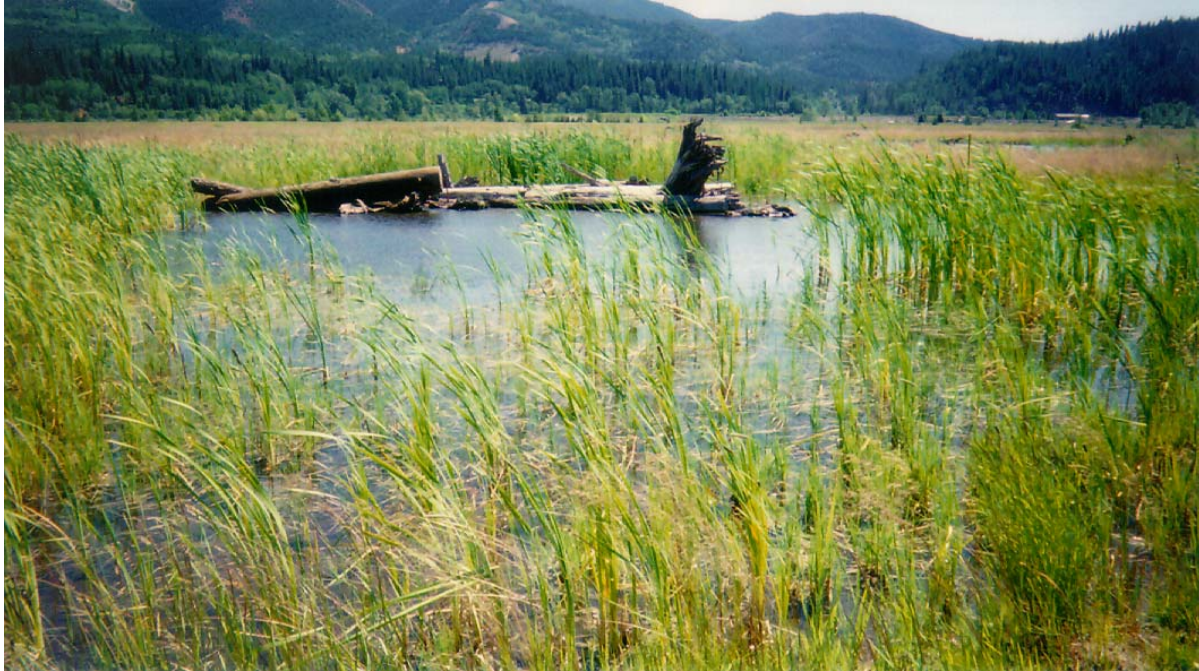
Figure 3. Example of naturally-regenerated palustrine emergent marsh, Smelterville Flats, Smelterville, ID (Photo taken in July 2000).

Emerald Pond, located along the western portion of the Flats area, was one of the first areas from which tailings were removed and has had more time to develop wetland communities. In the summer of 2002, Emerald Pond supported a large PEM community composed of hardstem bulrush (*Scirpus acutus*), spikerush (*Eleocharis* spp.), and young cattail (*Typha latifolia*). Along pond margins and along interior drainages feeding the pond, cottonwood (*Populus trichocarpa*) and willow seedlings were regenerating in profusion (*Salix* spp.; Figure 3).

regeneration (Figure 3). Water foxtail (*Alopecurus aquaticus*), cattail, and daggerleaf rush (*Juncus ensifolius*) have initially covered the downstream wetlands while cottonwoods and willows are regenerating here as well. Overall, herbaceous vegetative cover is rapidly advancing in these areas, although the overall physiognomy is somewhat smaller in stature than near the pond. As with Emerald Pond, noxious weeds are not currently a problem in wetland areas of the Flats.

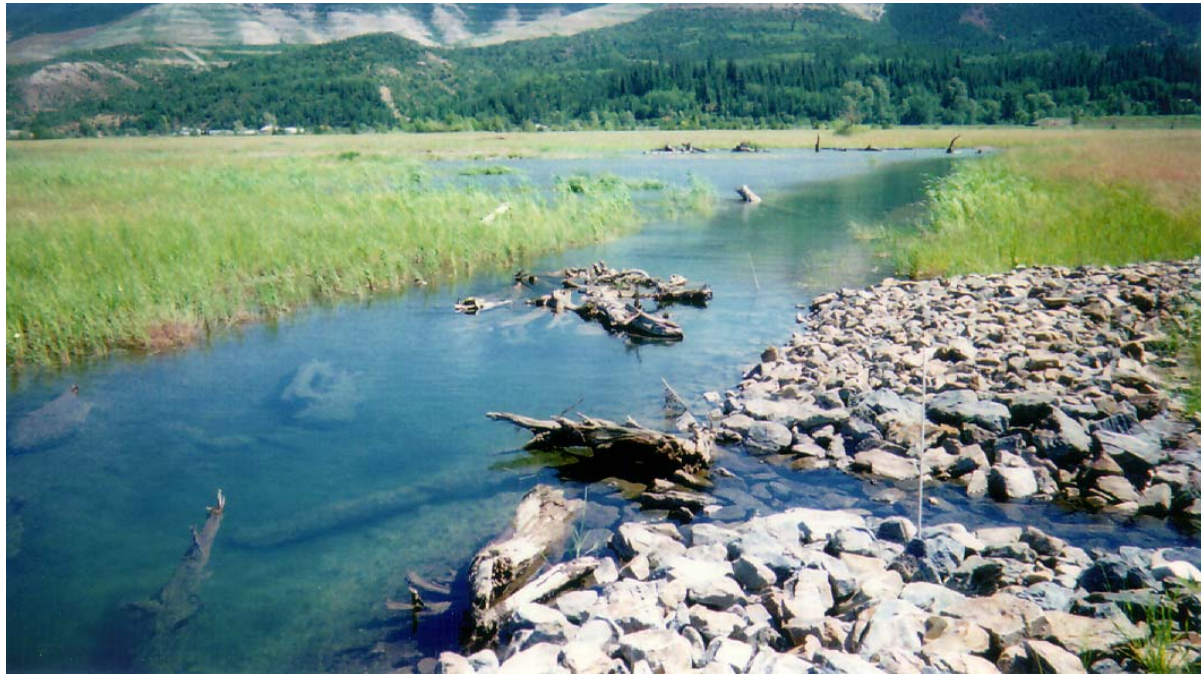
Figure 4. Off-channel habitat has naturally regenerated to sedges, rushes, cattail, and other palustrine emergent marsh species without need for artificial planting. Note the remedial grade control structure in the right foreground that conveys water from the river to the floodplain through the constructed streambank (photo taken in July 2000).

Aquatic areas such as shallow ponds and drainages contained water in September 2002 (Figure 4). Large woody debris, retained during clearing of the site prior to tailings excavation, has been replaced throughout the lower Flats wetlands areas. These structures are meant to provide refuge habitat for fish as well as roosting and resting areas for birds and amphibians. Currently, vegetation in inundated areas includes hardstem bulrush (*Scirpus acutus*), pondweeds (*Potamogeton* spp.), and various species of spikerush (*Eleocharis* spp.).
