ADVANCEMENTS IN GEOMORPHIC RECLAMATION DESIGN APPROACH

Wyoming Abandoned Mine Land Project 17 H-2 Lionkol Mining District Sweetwater County, Wyoming

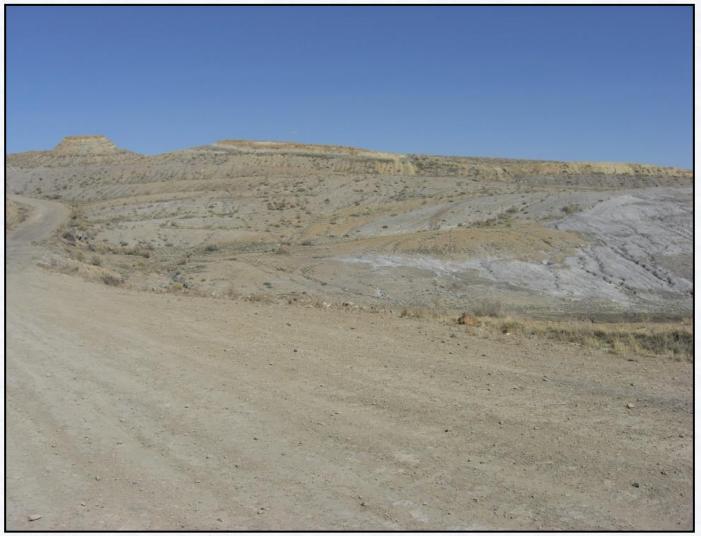
Reliance No. 11 South Eroded Pit Floor and Spoils

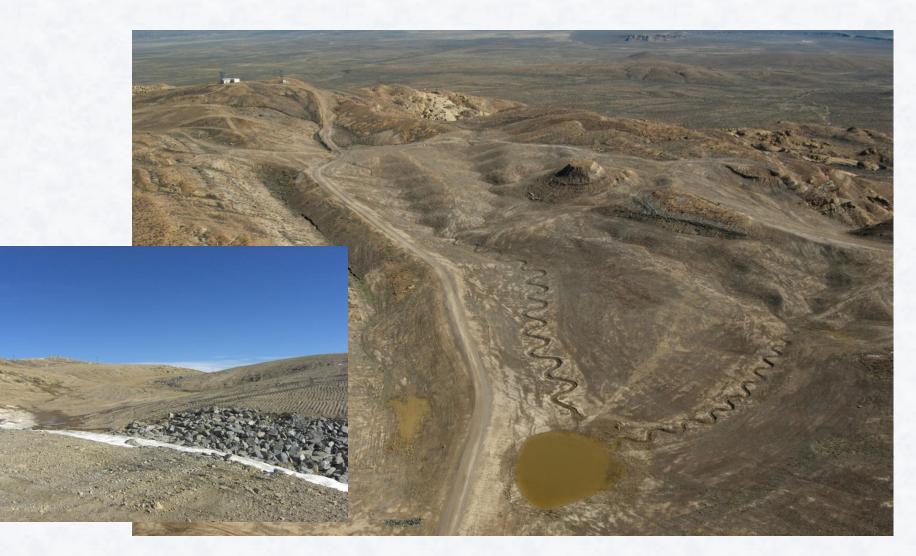
Reliance No. 11 Traditional Reclamation Elements

Reliance No. 11 North and South Design Approach •Combination of NR and traditional reclamation techniques Blend with native and outcrops • Used Carlson's stability criteria < 1.0 psf for bankfull flows</p> < 1.5 psf for flood-prone flows</p> Traditional structures Runoff attenuation impoundments Traditional flat-bottom channels Riprap erosion control structures

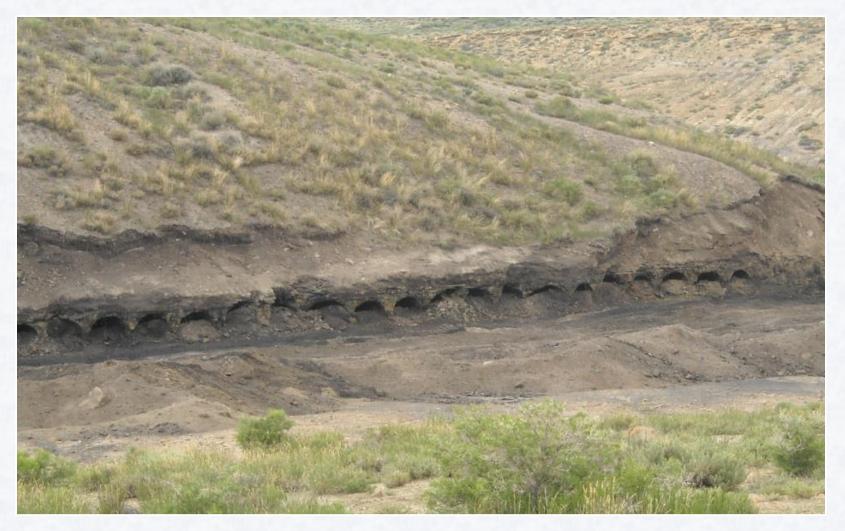
Reliance No.3 Pit with Highwall (center) Prior to Reclamation.

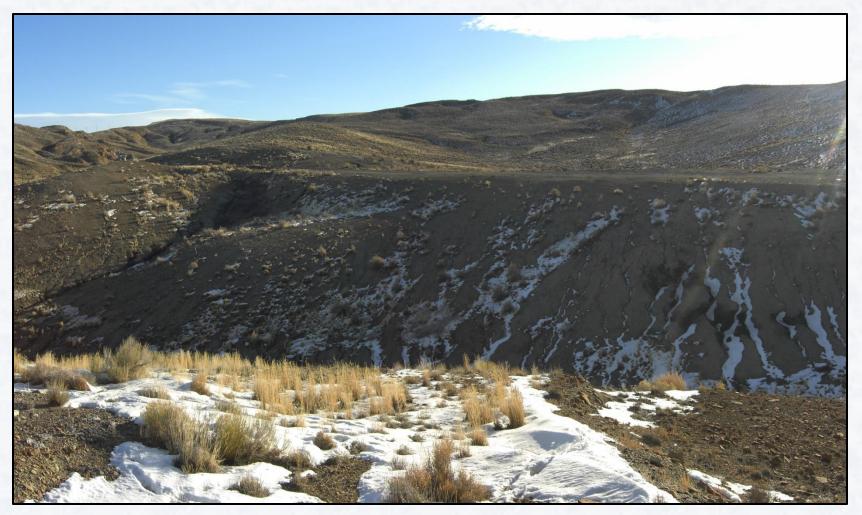
Exposed Auger Holes in Reliance No.3 Highwalls.

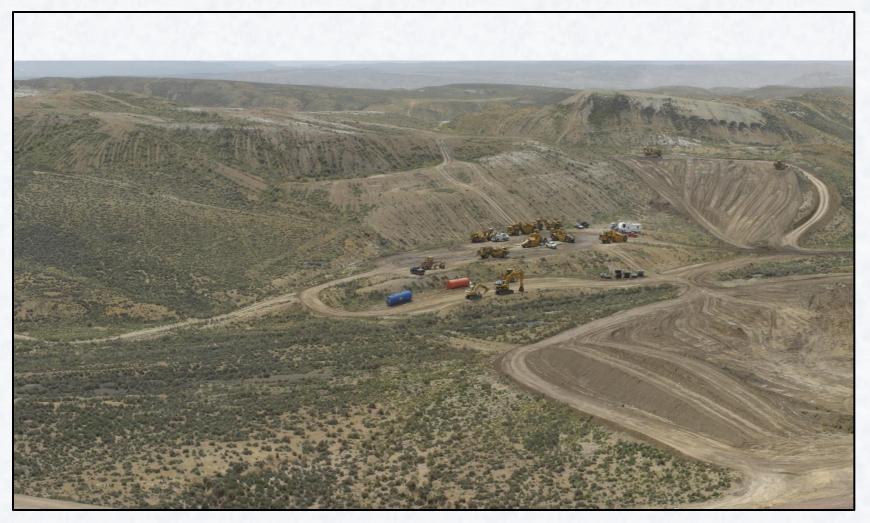
Initiation of Construction at Lionkol Main Pit Showing Oversteepened Slopes with Rilling.

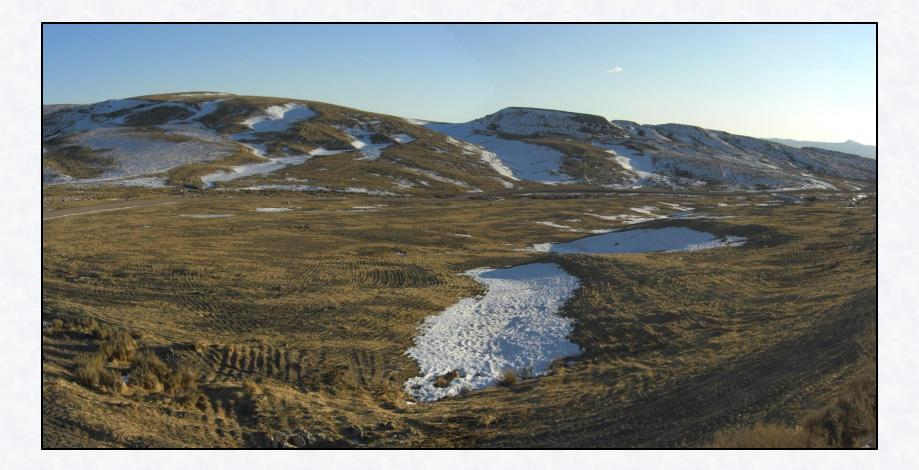
Completed Reclamation at Lionkol, Winter 2009. Note "A" Channels Capturing Snow in Upper Left.

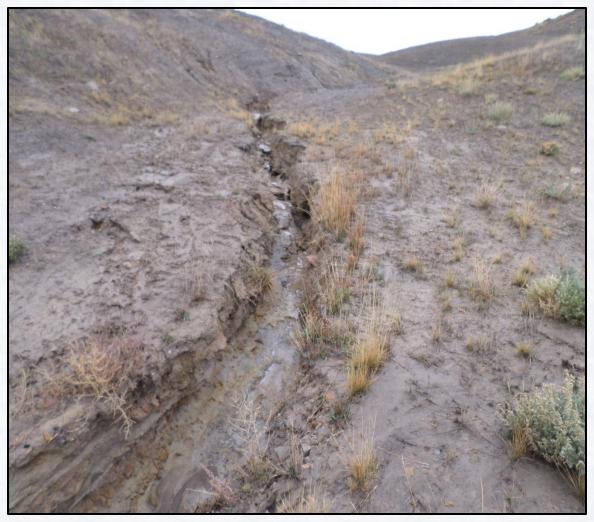
Lionkol Failing "A" Channel

- Completed 2013 after four summers, mixed vegetation success
- Despite high design shears, geomorphic channels performing well
- Four pilot channels formed, all on steep gradient "A" channels with contributing basin area.
- Meandering main channels performing well, validating the design approach

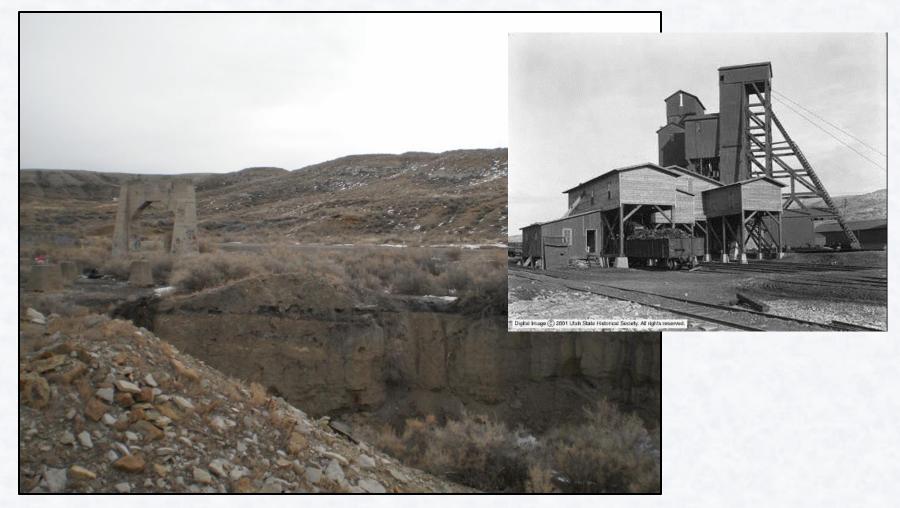
Lionkol Drainage Eroded Channel at Historic Tipple

Failures occurred associated with culverts and rock outlets, not geomorphic reclamation

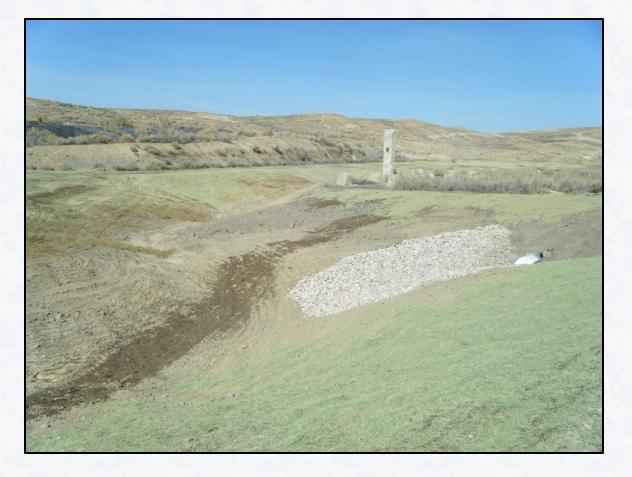
Lionkol Drainage Channel Alignment Around Cultural Site

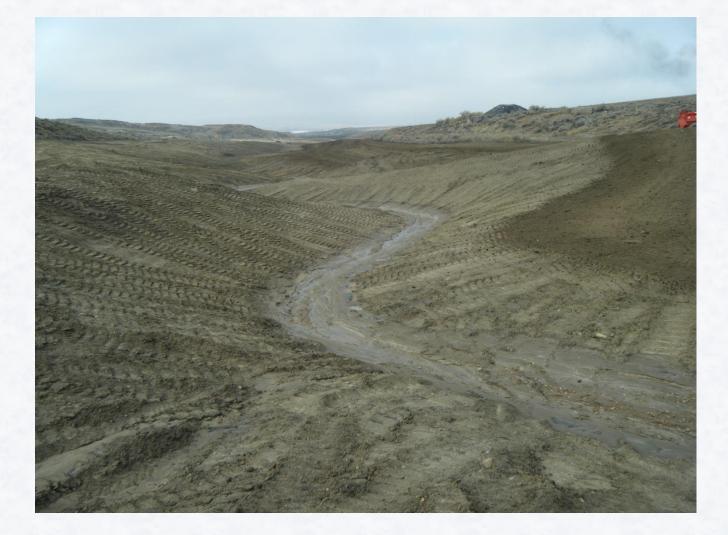
Lionkol Drainage Constructed Channel after Storm

Performance Evaluation
Completed 2013 after one dry summer, limited vegetation
Despite large basin and high flow events, meandering geomorphic channels performing well

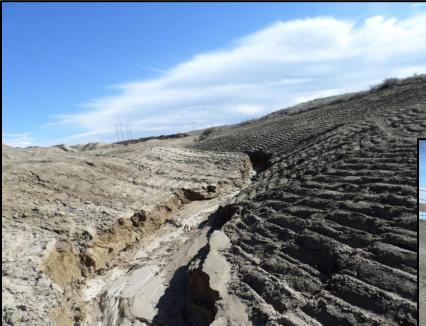
Lionkol West Channels after Storm

Recent channel constructed of fill experienced erosion, others conveyed flow without significant damage

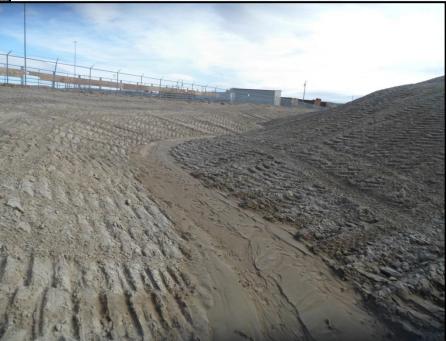
Channel Constructed in Fill
