**MATURE SUBALPINE TREE &
SHRUB TRANSPLANTING AT THE
CLIMAX MINE, CLIMAX, CO**

**Robin Bay & Ken Carlson – Habitat Management, Inc.
Aaron Hilshorst – Climax Molybdenum Company**

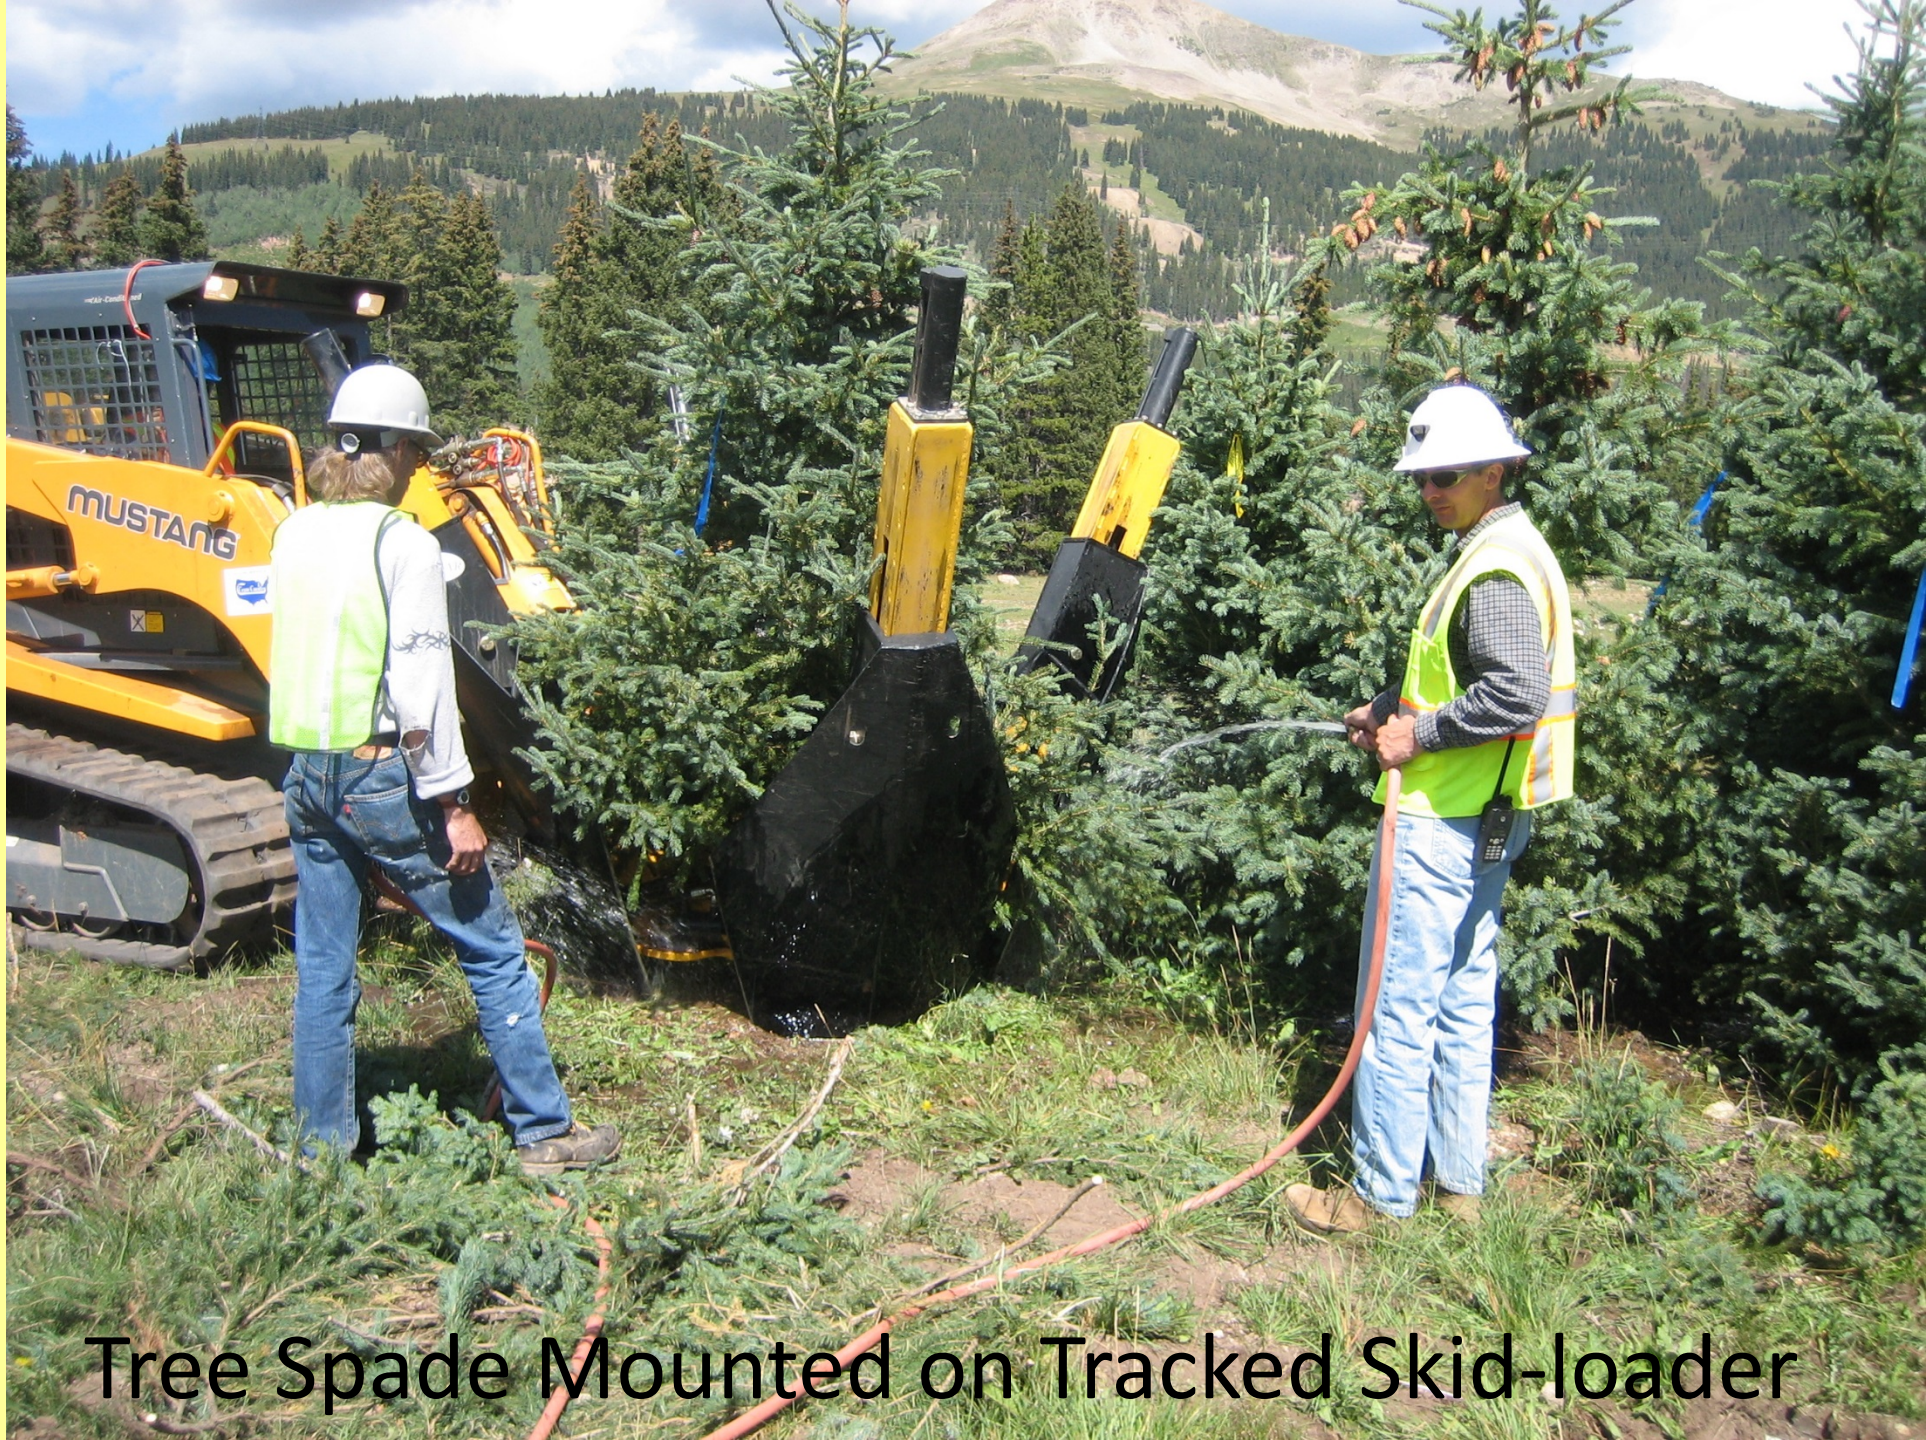
Tree Spade Mounted on Tracked Skid-loader

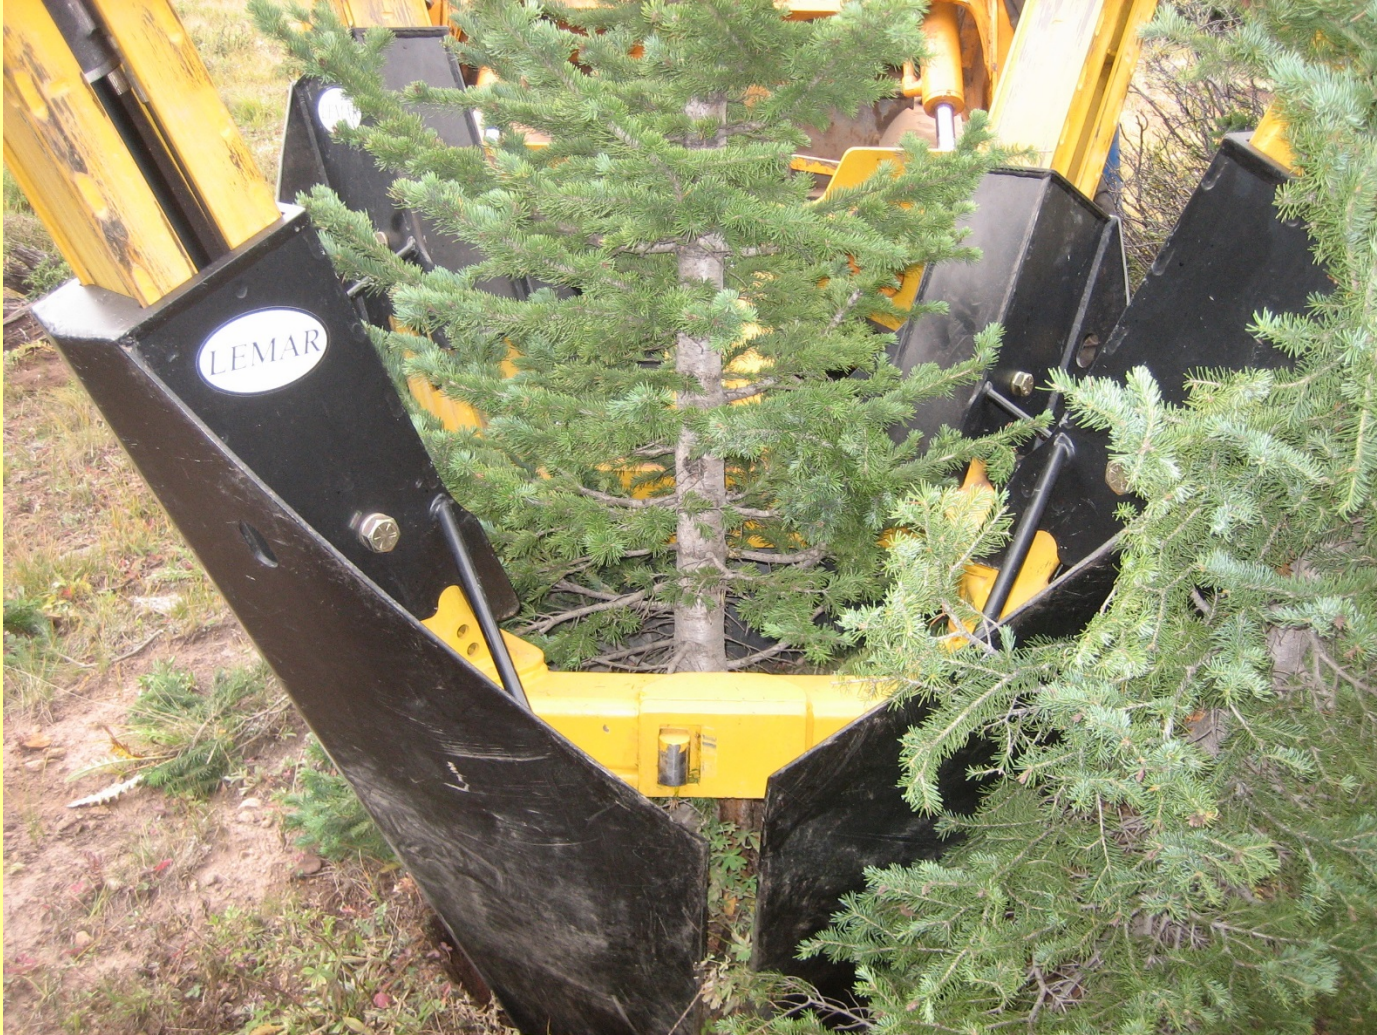
Tree lifted from ground

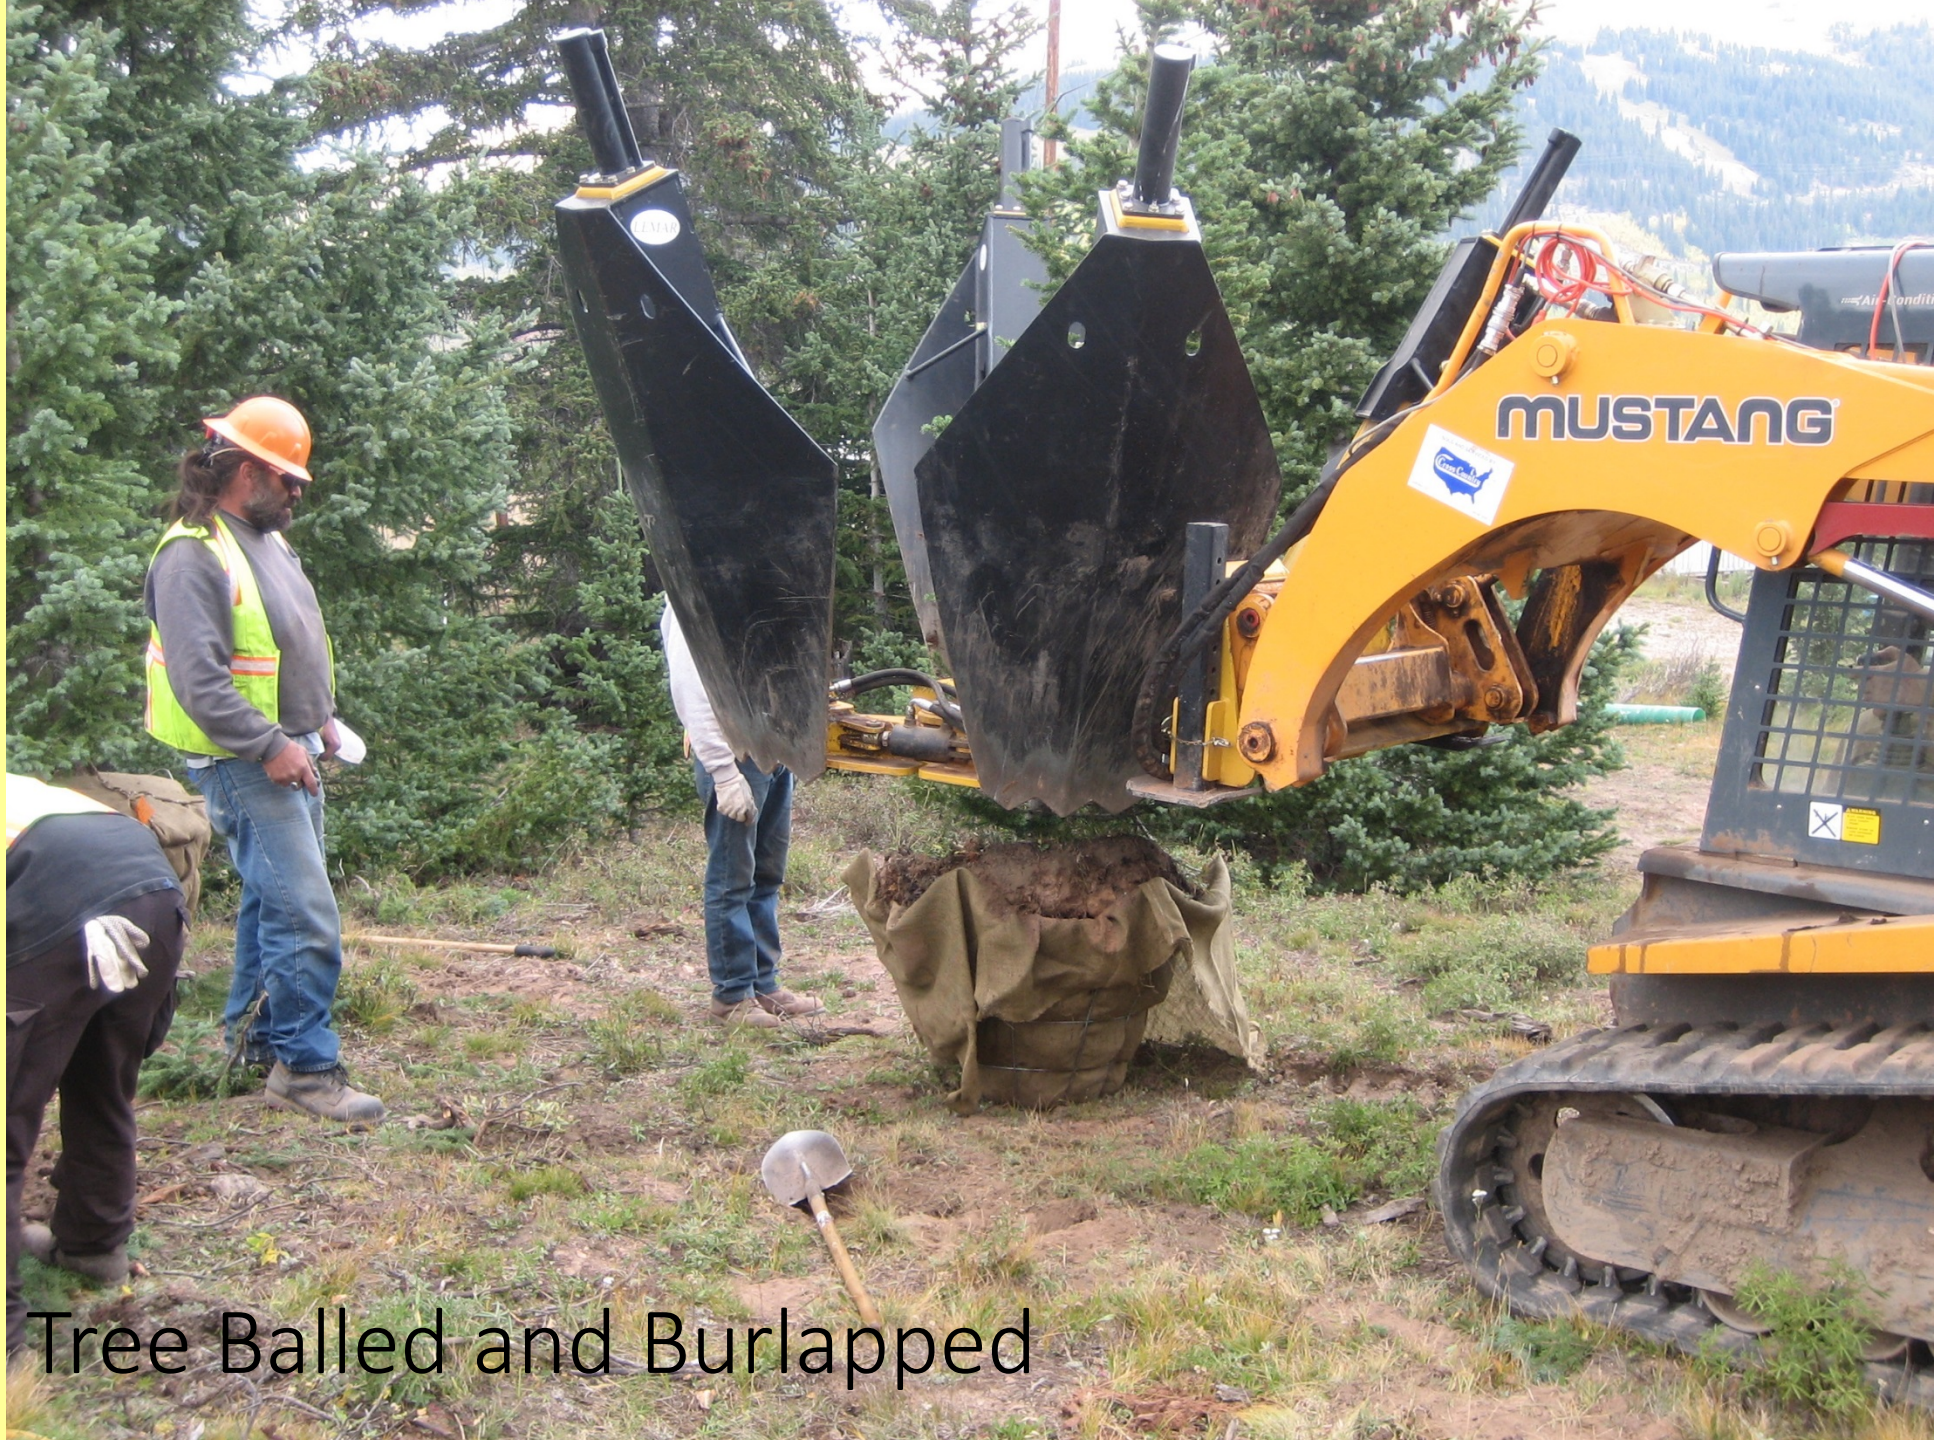
Tree Balled and Burlapped

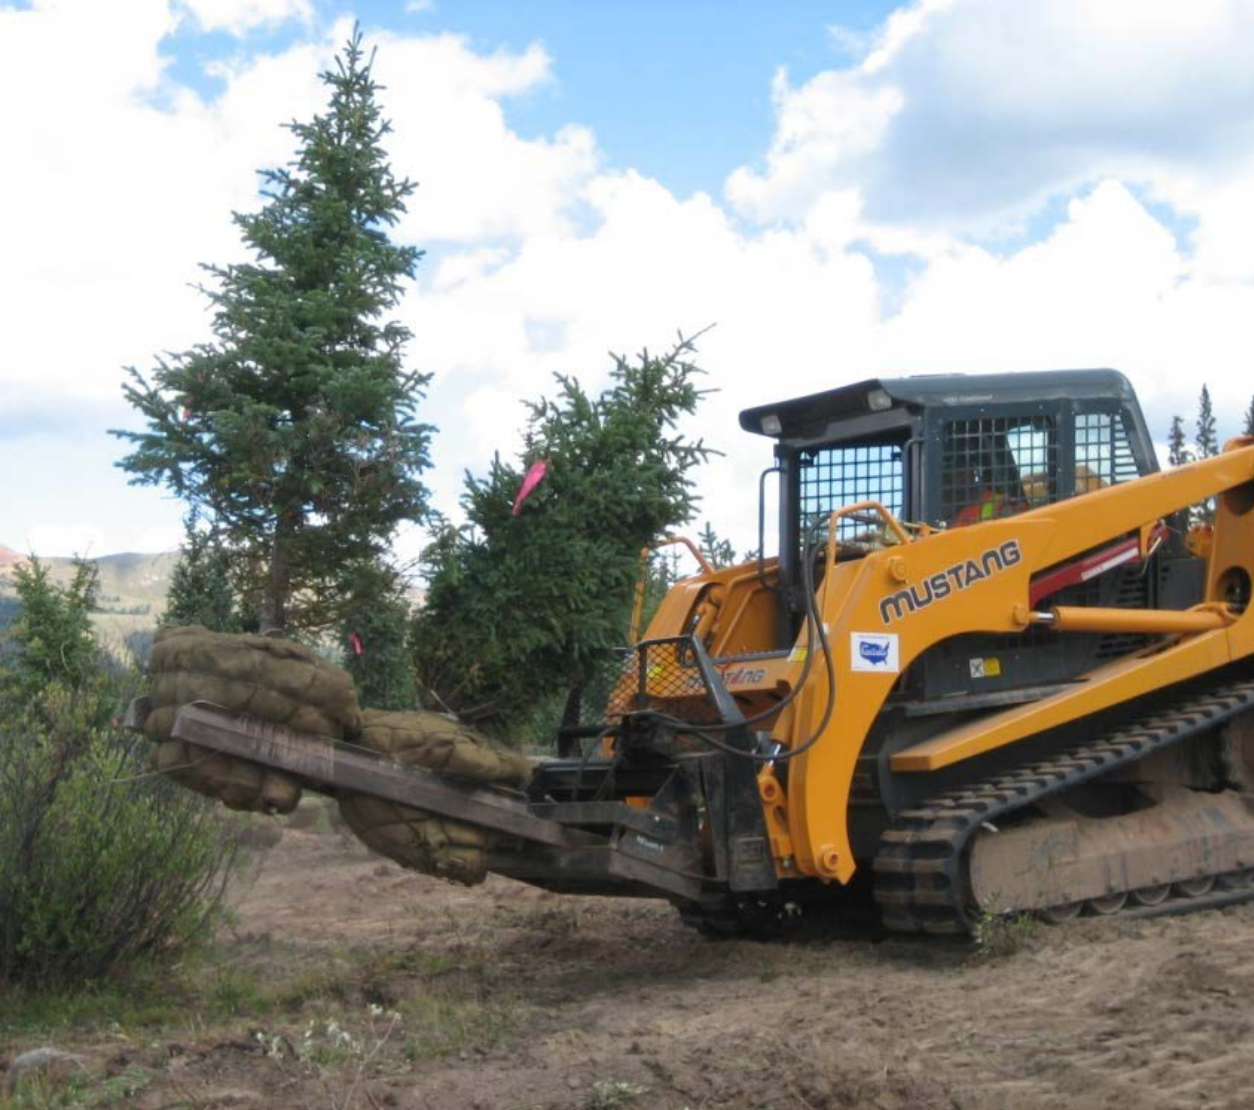
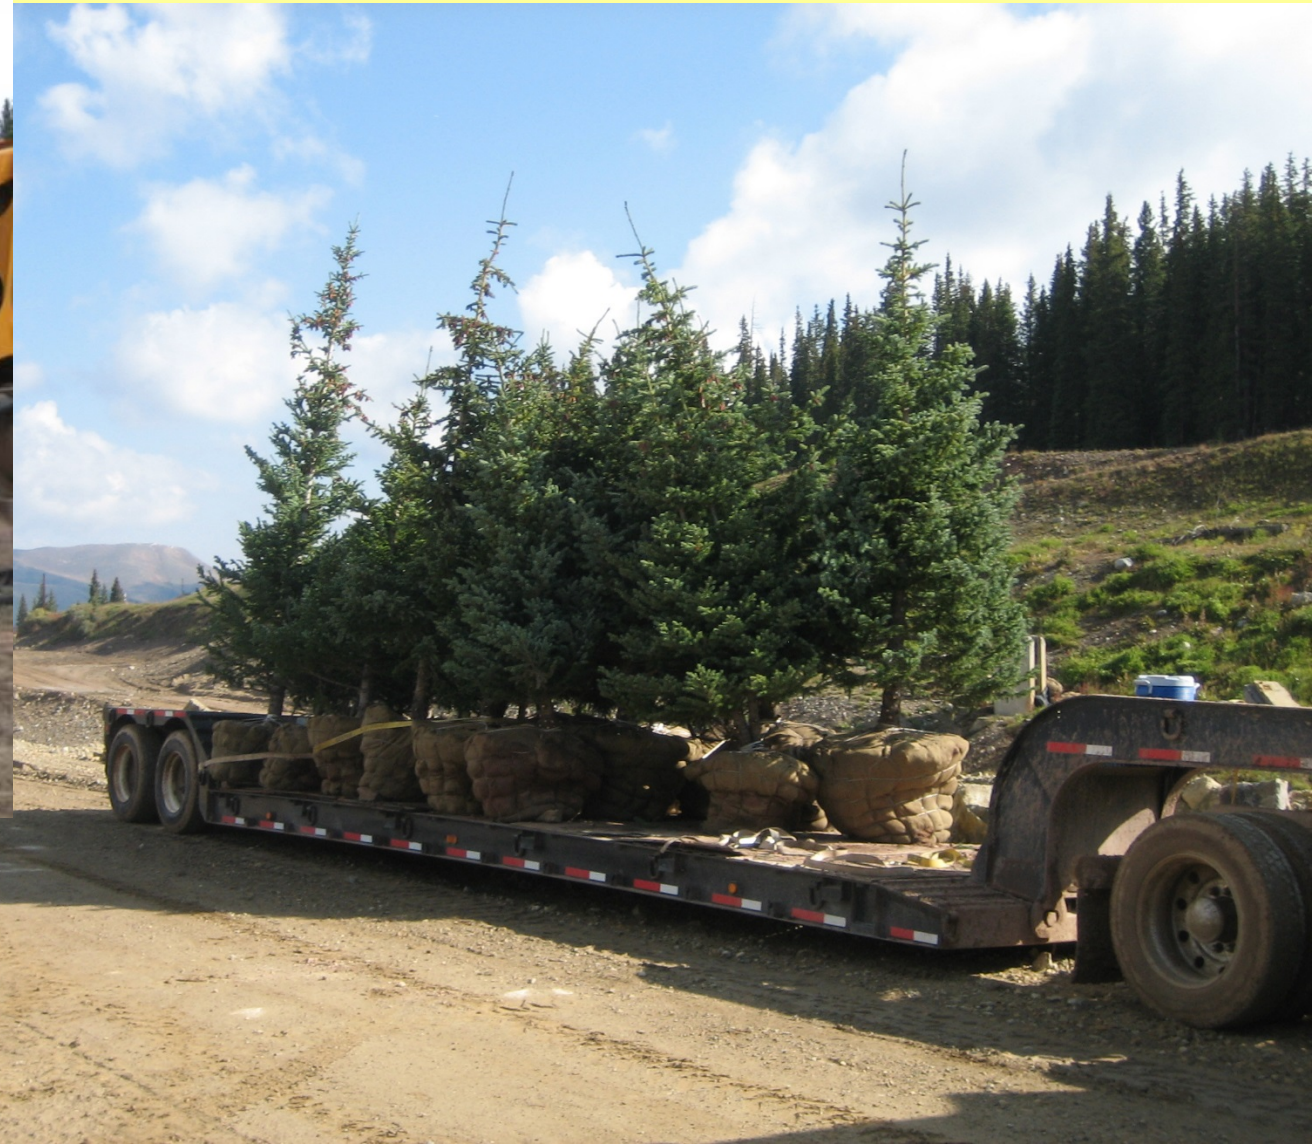
Trees Transported to Planting Sites

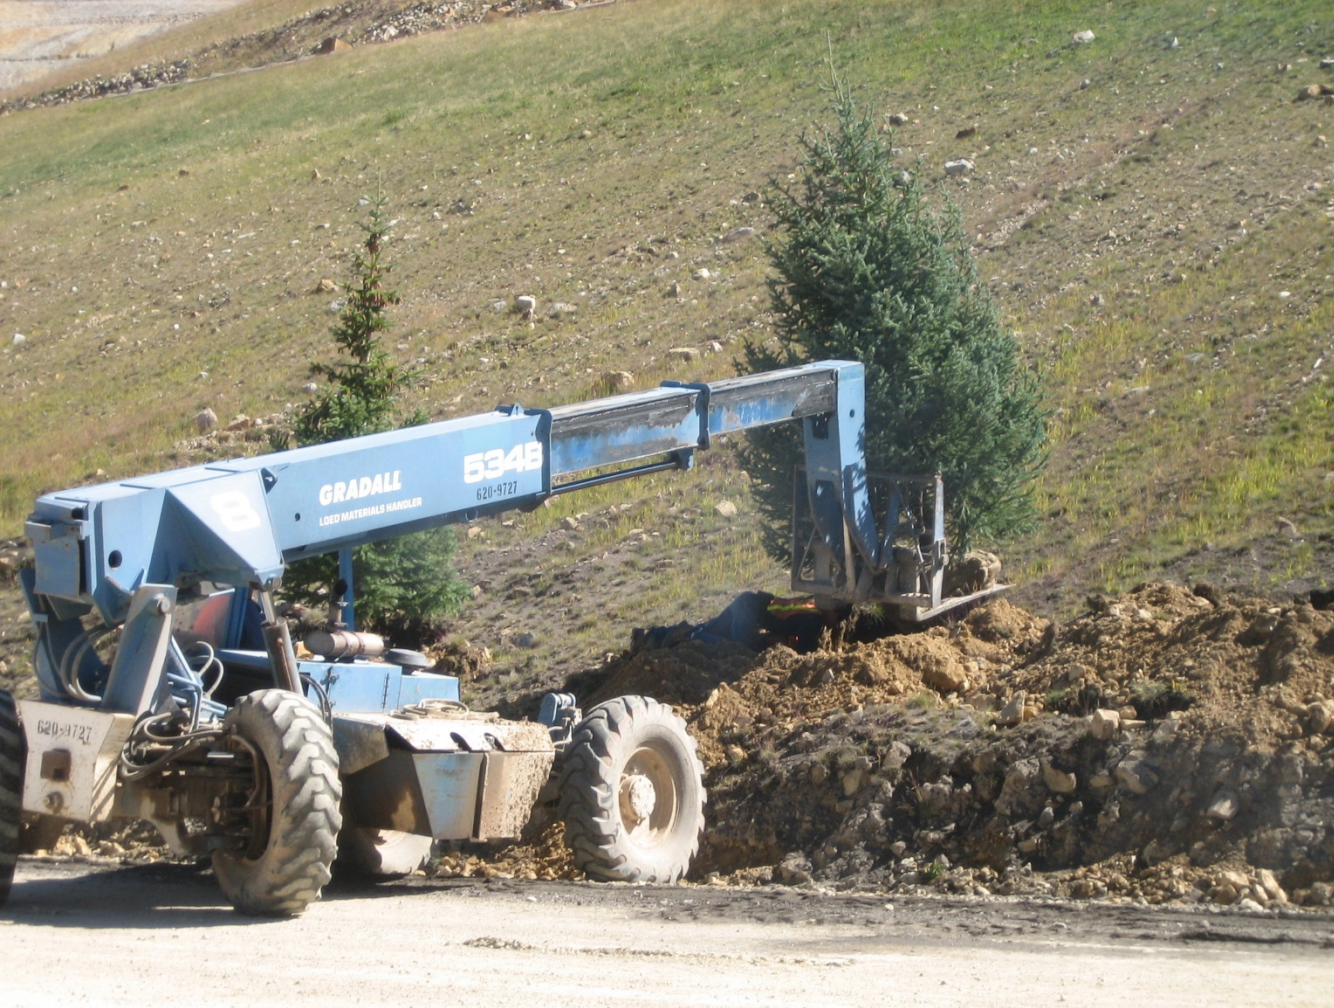
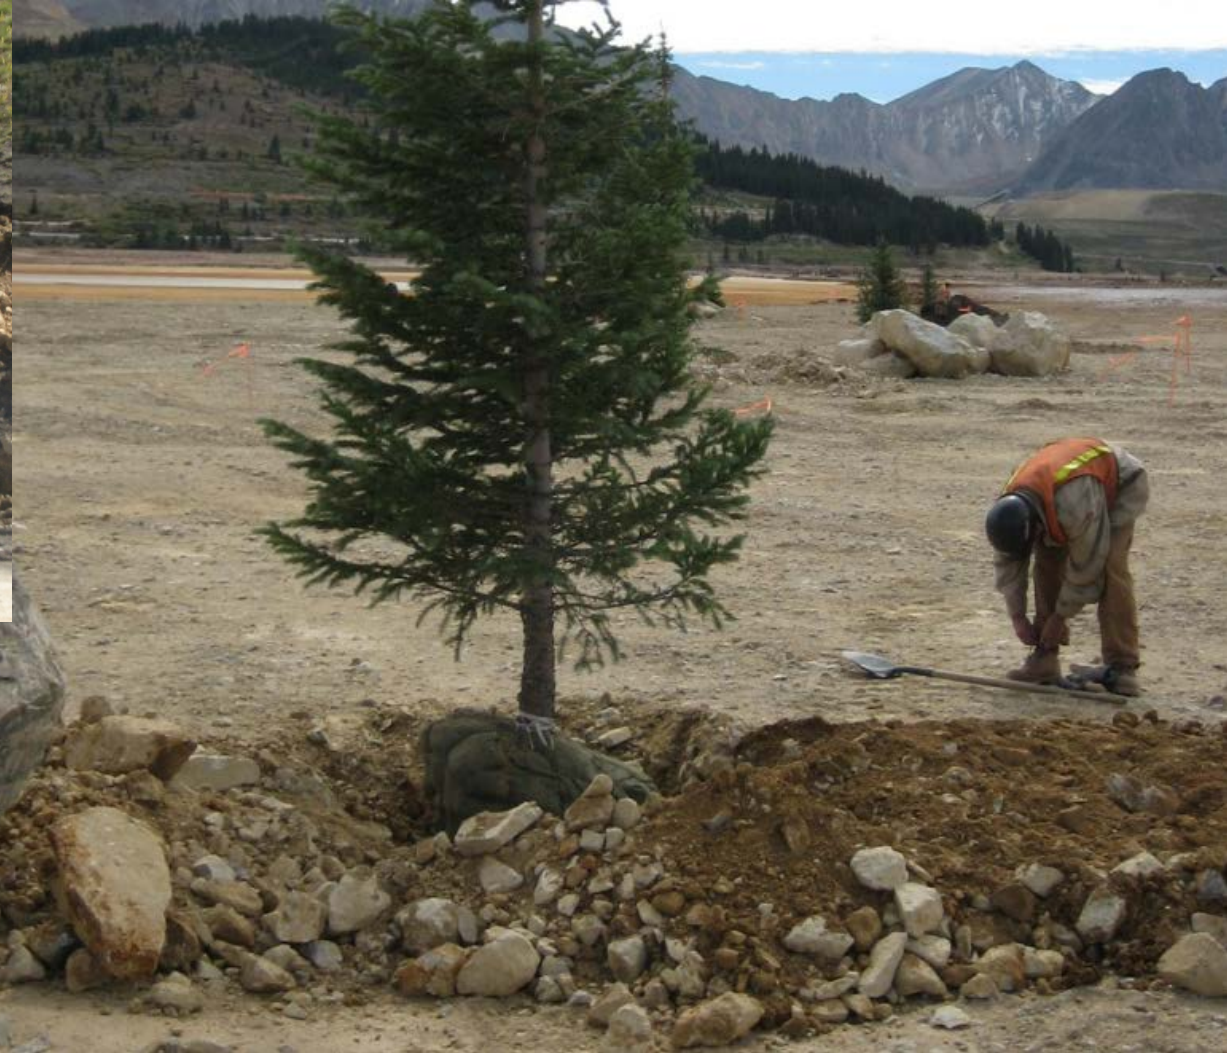
Tree Placed in Hole

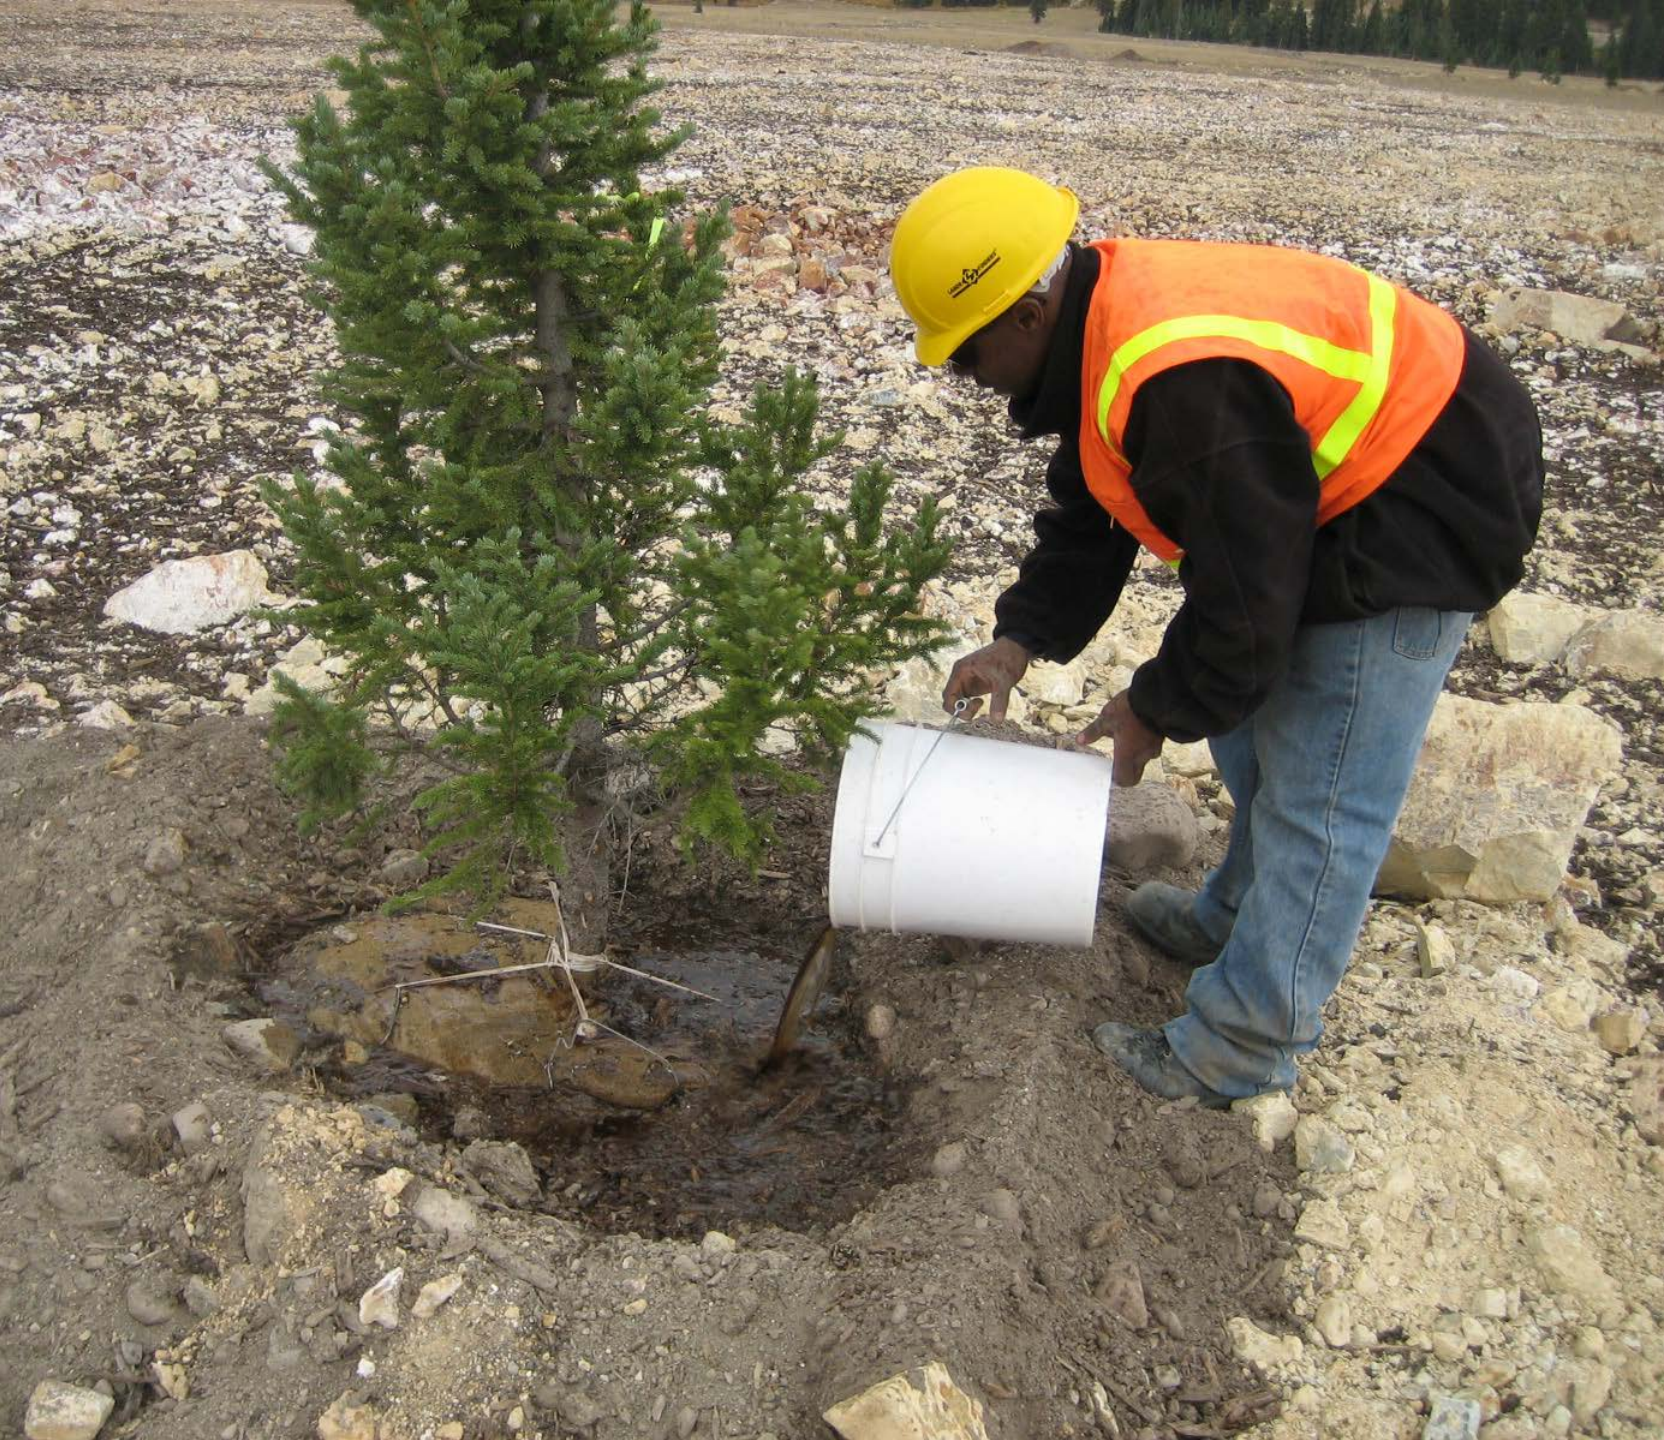
Tree Backfilled

- Topsoil
- Old Woodchips
- Compost
- Additives
 - Terrasorb
 - Mycorrhiza

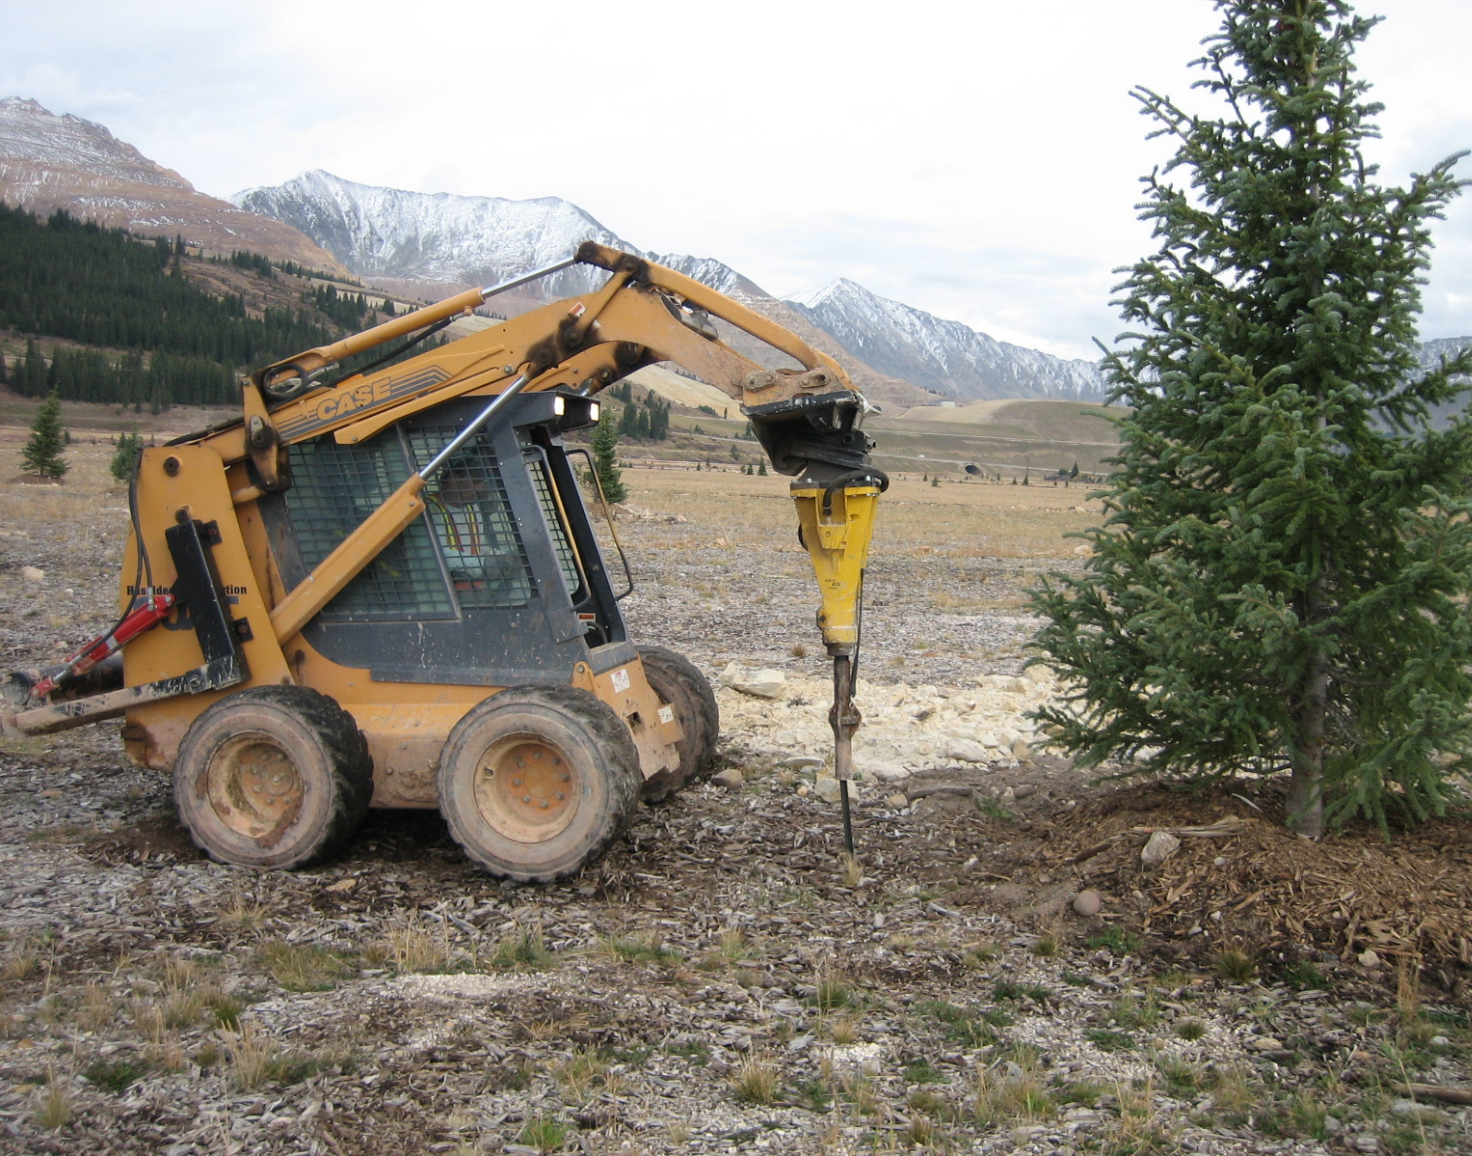
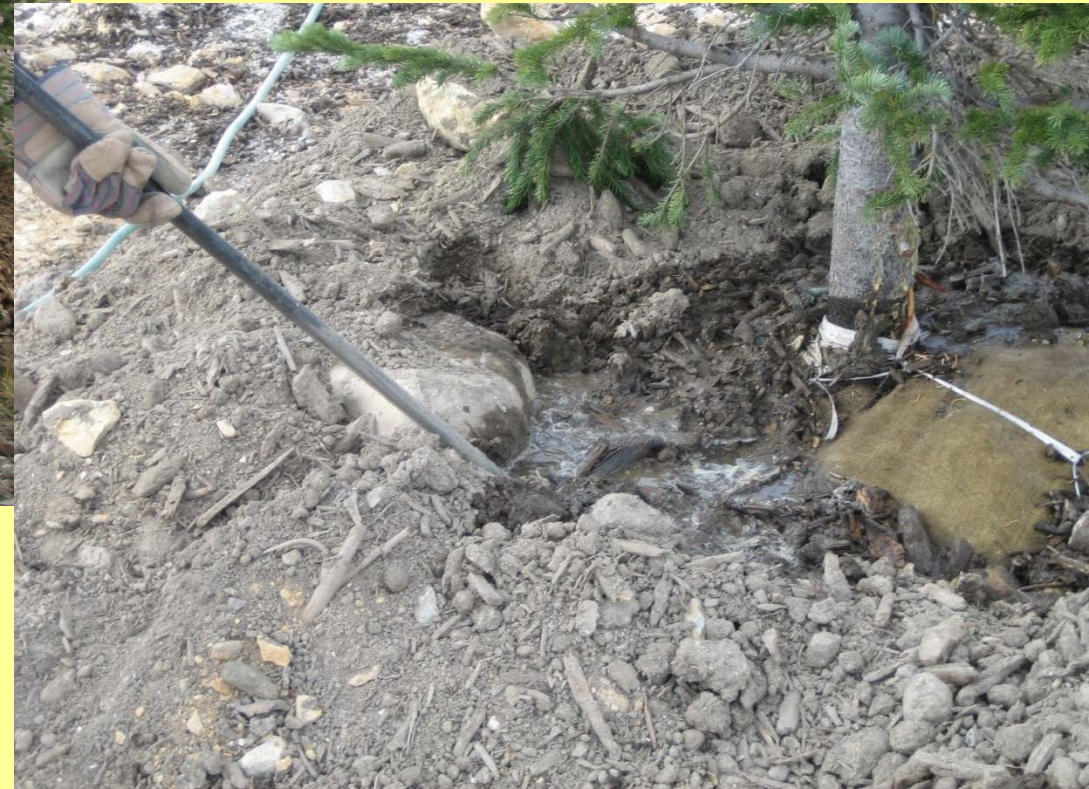
Trees Mulched, Staked, & Irrigated

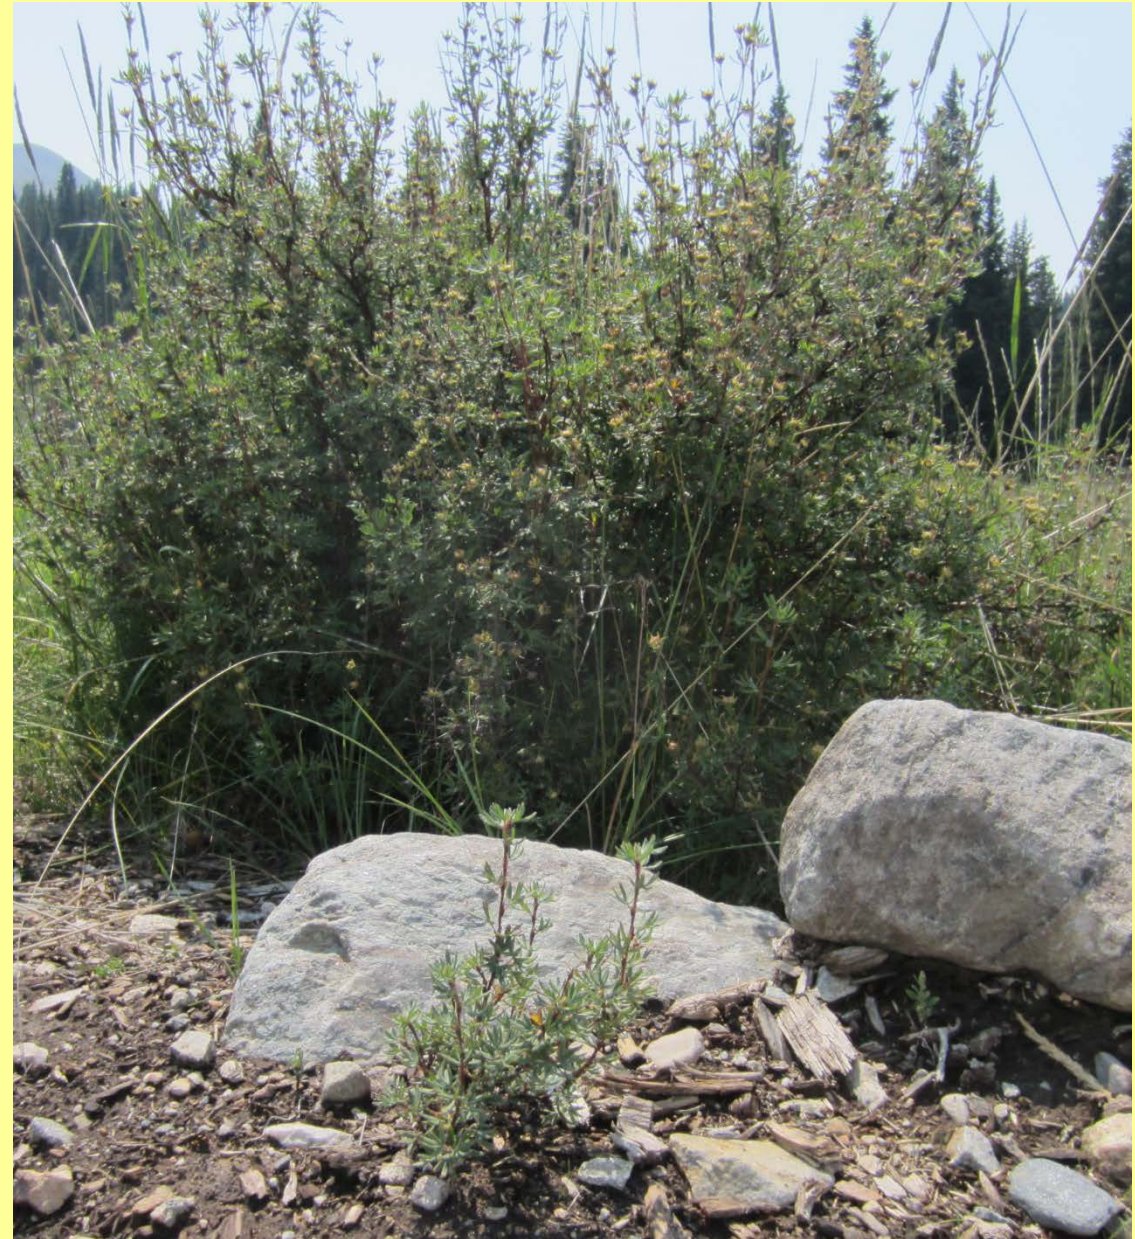
Results – Shrub Transplants

- 226 planted
- 218 (96%) alive in 2012
 - 97% Willows
 - 100% Birch
 - 100% Cinquefoil
 - 60% Currants
- All mortality on Robinson TSF likely due to drying

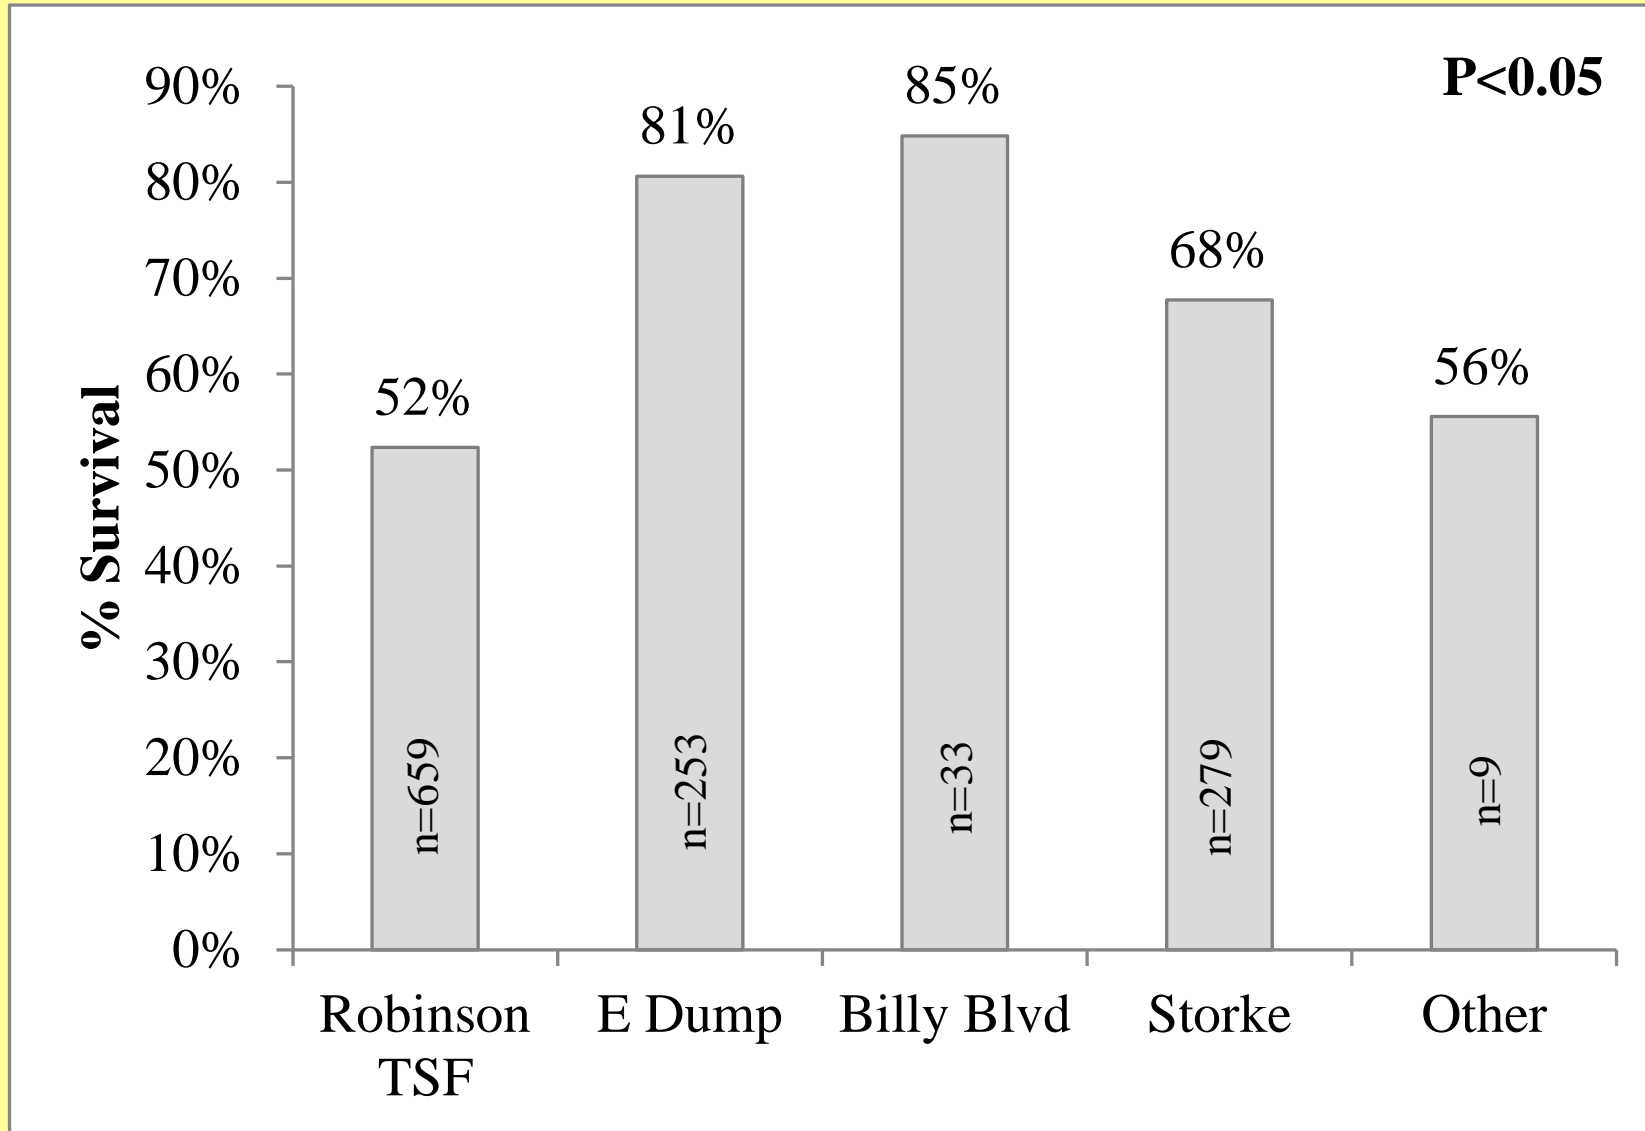
Results – Tree Transplants by Location

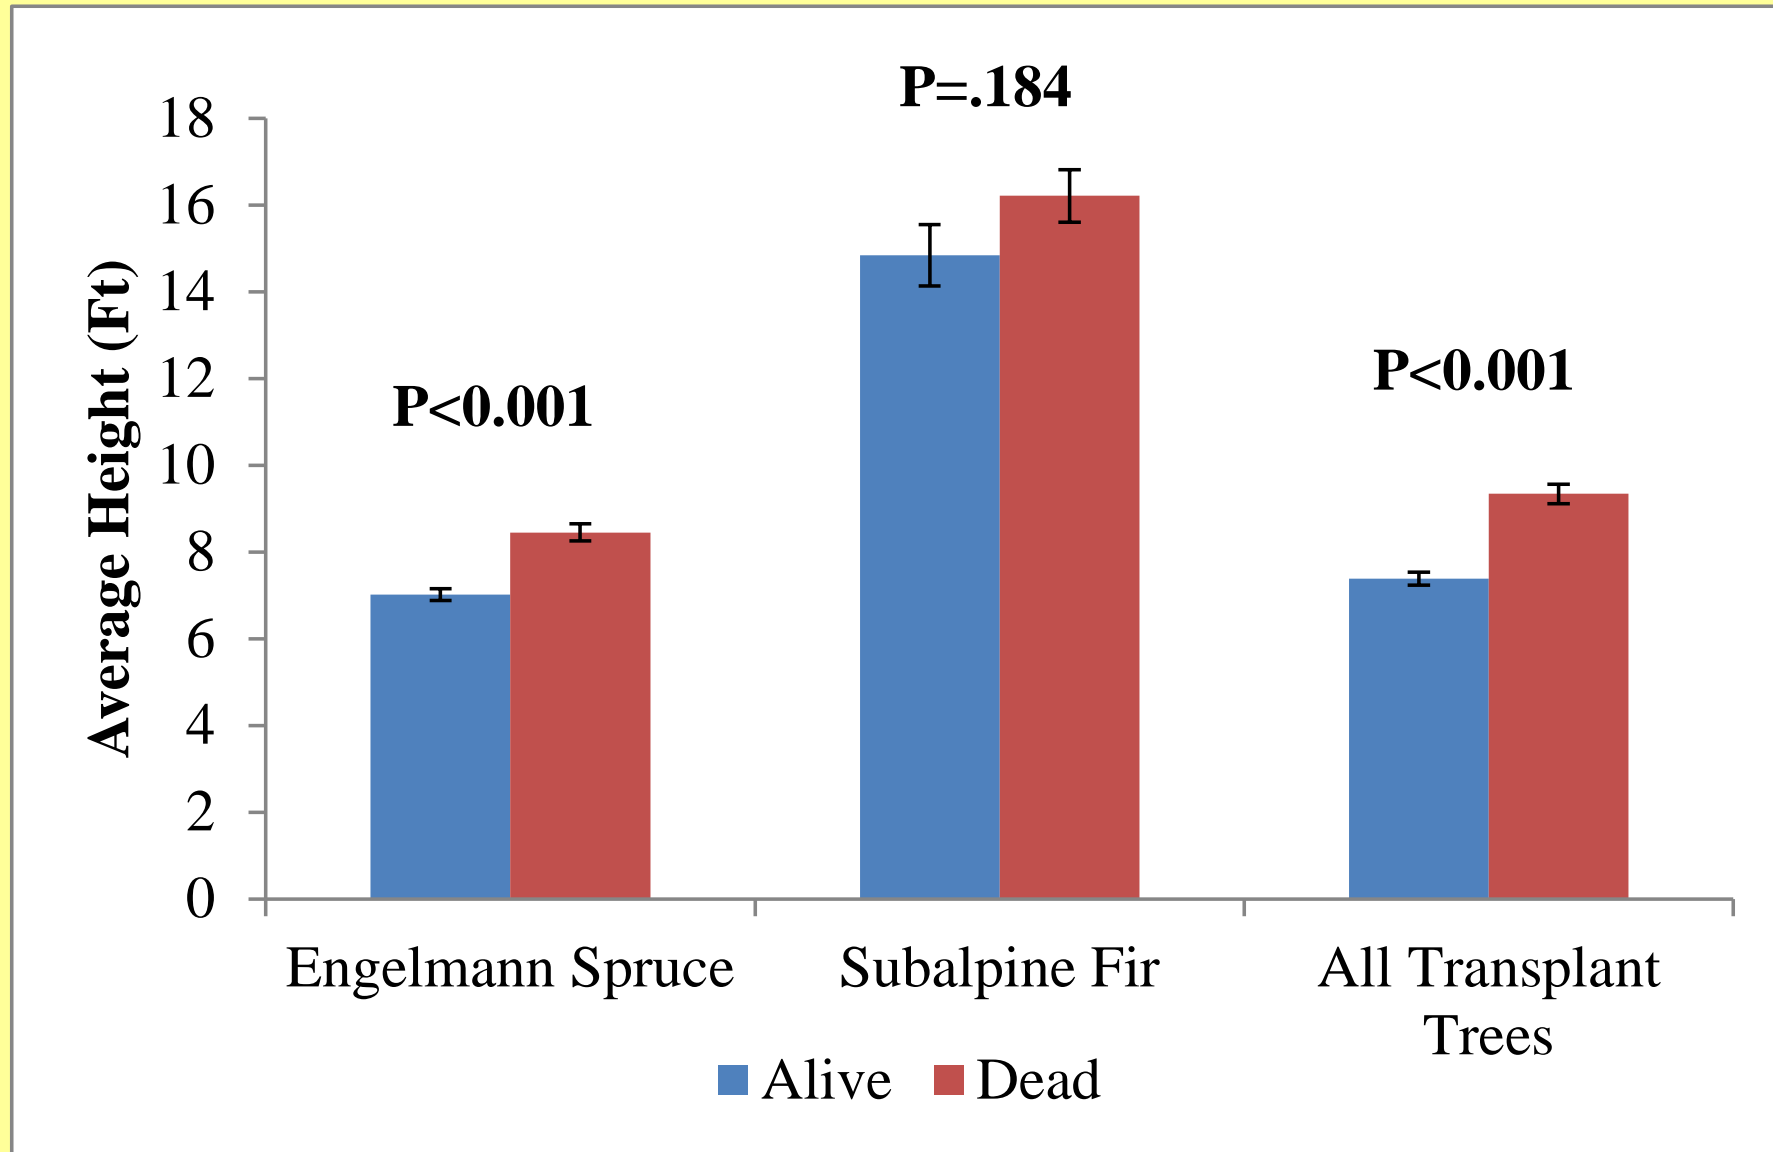
Results – Tree Transplants by Height

- Locally harvested trees more successful than those trees imported from Wyoming
- Shorter trees were more successful than tall trees
- Trees planted into locally stripped subsoil materials were more successful than those transplanted into rocky pit run material
- Trees planted in areas reclaimed without compost were more successful than those planted into compost
- 6% loss to elk damage represents a preventable loss of \$20,000 to \$50,000 in trees
- Spring watering before the monsoons start may have been beneficial
